SITE INSPECTION REPORT FOR 210 MLD STP BINGAWAN

BINGAWAN STP - 210
MLD

Date:
26.11.2021

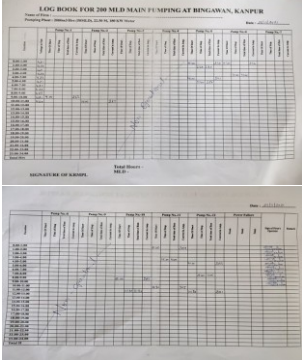
S. No	Equipment	Assessment of Current Condition	Assessment of Current Condition photo	Corrective Action Required	Corrective Action Completed by KRML	Original Date of Issue	Proposed Date to Resolve by KRML
1	Bypass Sluice Gate	Operational Leakage was found through the gates

Leakage through bypass sluice gate must be rectified at earliest		26-10-2021	
2	Reverse flow	When STC / UPJN team reached the site, reverse flow was being found in the inlet chamber because from the 8 nos. of provided working pumps, only 2nos. / 3nos. pumps was being run by KRML at every time
