SITE INSPECTION REPORT FOR 42 MLD Sajari STP

SAJARI STP

Date:
11.01.2022

INSPECTED BY:
UPJN Team:
1) Mr. Ajay Kanaujia (Chemist)
STC Team:
1) Mr. Sunil Basutkar (Mechanical Expert)
2) Mr. Rohit Suman (Supp. Engr. Mechanical)

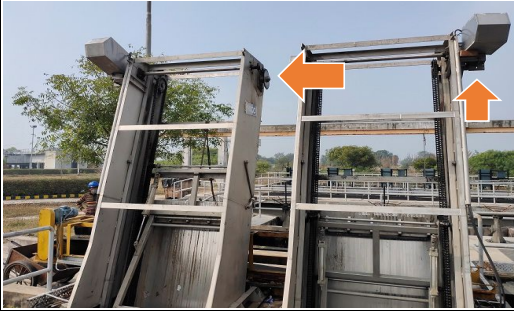
S. No.	Equipment	Assessment of Current Condition	Assessment of Current Condition Photo	Corrective Action Suggested by STC	Corrective Action Completed by KRMPL	Original Date of Issue	Proposed Date to Resolve by KRMPL	
A	INLET CHAMBER							
1	Inlet Sluice Gates	Operational						
2	Mech. Coarse screen (no.1)	<p>Non-Operational.</p> <p>1) Auto-system is installed recently but not working properly.</p> <p>2) Screen motor canopy was found supported with brick</p>

<p>1) Need to be fixed at the earliest.</p> <p>2) Auto system level settings needs to be done for proper functioning and it should be checked by UPJN & PE.</p> <p>3) Provide proper support if needed</p>		<p>1) 11.01.2022</p> <p>2) Since handover 11-10-2019</p>		LONG PENDING
		<p>After around 2 months, the rake teeth has been changed on 22.12.2021</p>				11.01.2022		
3	Mech. Coarse screen (no.2)	<p>1) Manually operational but not automated</p> <p>2) After around 2 months, the rake teeth has been changed on 22.12.2021</p>

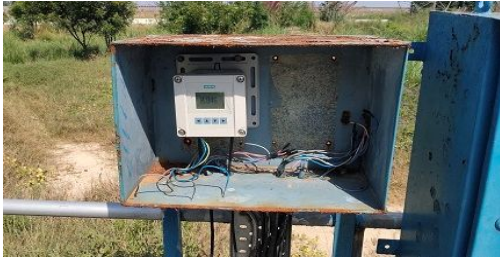
4	Mechanical Screen Level transmitter display	<p>1) Auto System of Mech Coarse Screen -1 & 2 are Under Maintenance</p> <p>2) Not operating the mechanical screen perfectly</p> <p>3) Level sensor of 2nd mechanical screen is not available</p>

<p>1) The level has to be correctly set as per the inflow level.</p> <p>2) Closing gate must be fixed to the level transmitter casing box.</p> <p>3) Painting needs to be done on the casing box.</p>		<p>Since handover 11-10-2019</p>	<p>28.02.2022</p> <p>31.12.2021</p> <p>31.12.2021</p>	LONG PENDING
5	Belt Conveyor	Operational						
6	Belt Conveyor disposal							
7	Mech. Coarse Screen On-site Panel	<p>1) After around 5 months, Door glasses have now fixed on 26.12.2021</p> <p>2) Some of the indicators not working</p>		<p>Non working indicators should be replaced.</p>		31.07.2021		LONG PENDING
B	RAW SEWAGE PUMPING STATION

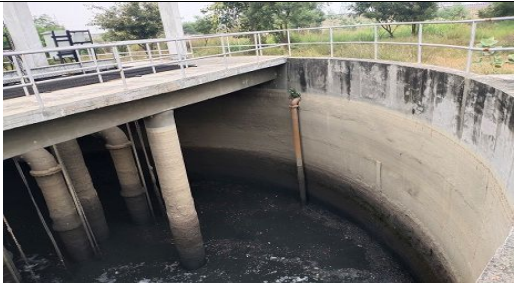
1	Raw Sewage Pump-01	Non-Operational		1) Need to be rectified at the earliest. 2) Discharge line pressure gauge needs to be replaced		1) 10.01.2022 2) 21.09.2021	15.01.2022	LONG PENDING
2	Raw Sewage Pump-02	Operational		Discharge line pressure gauge needs to be fixed and the PG line must be cleaned		31.07.2021	15.01.2022	LONG PENDING
3	Raw Sewage Pump-03	Operational						
4	Raw Sewage Pump-04	Non-Operational		1) Need to be rectified at the earliest. 2) Discharge line pressure gauge needs to be replaced.		1) 30.12.2021 2) 31.07.2021	15.01.2022	LONG PENDING
5	Raw Sewage Pump-05	Operational		Discharge line pressure gauge needs to be replaced		27-10-2021	15.01.2022	LONG PENDING
6	Collection Sump Lever sensor	No level transmitter was found inside collection sump

Install the level transmitter at the earliest and maintain the levels of the collection sump on regular basis.		18.11.2021		As per Article 8.8 (a), this has to be provided by the concessionaire

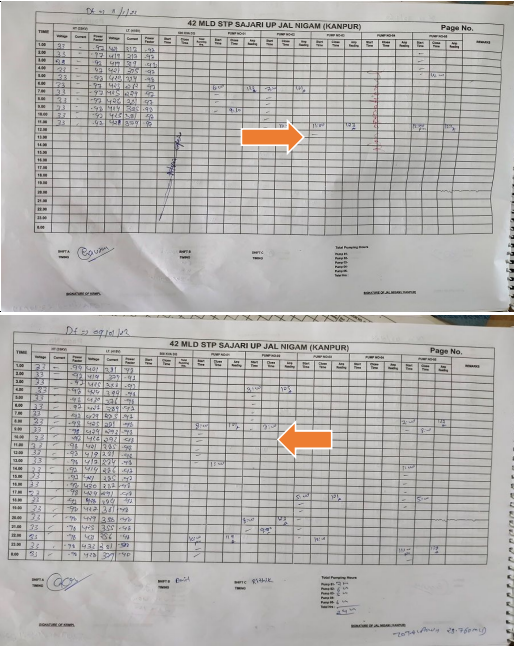
7	Raw Sewage Pumps operation	<p>1) When STC team reached the site, it was found that only one pump was being running by KRMPL. Upon asking by PE, KRMPL started one more pump.</p> <p>2) On previous dates, it was found that KRMPL was running one pump most of the time and on some time, two pumps are being operated.</p> <p>3) Pumps were found not being operated at night hours.</p>

<p>At an average of 23 MLD flow (which is 55 % of the average design flow) is coming, therefore atleast 2 to 3 nos. of pumps has to be operated during peak flow & atleast 1 to 2 nos. of pumps to be operated during non peak flow on regular basis in rotational way to tackle the problem of backflow/ reverse flow.</p> <p>In case the flow increase more than 23 MLD, more pumps needed to be operated.</p>		27-10-2021		
8	EOT	After around 2 months, the Upward movement of rope was rectified on 22.12.2021.		Do lubrication work on regular basis

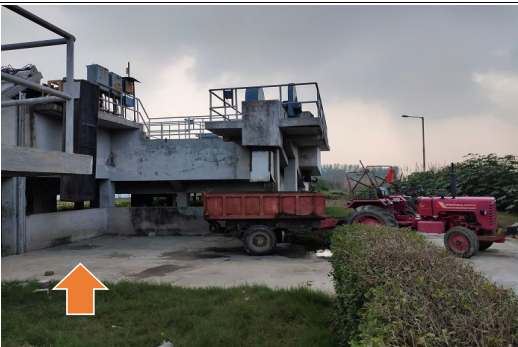
9	Grit Disposal	Trolleys were found below grit chute but no trolley was found available below conveyor chute.

<ol style="list-style-type: none"> 1) Provide trolley below conveyor chute. 2) Remove the grit on regular basis. 3) Apart from this, make sure that spare trolley must be provided in case of shifting/ removing grit. 		11.01.2022

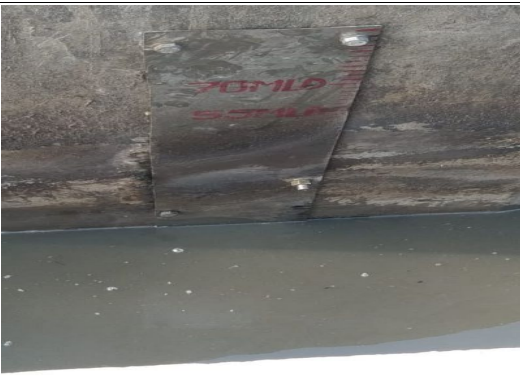
10	Parshall Flume	No ultrasonic level sensor was found at site. Also, the fixed scale is not readable.

1) Level sensor must be installed at the earliest. 2) Readable scale must be installed. 3) Chart for flow measurement must be fixed at the earliest. 4) Kindly provide the necessary documents on the basis of which scale reading has been provided. 5) KRMPL must record the flow through parshall flumes at every required time intervals on daily basis and its register has to be maintained.		1) Since handover 11-10-2019 2) 11.01.2022		LONG PENDING As per Article 8.8 (a), this has to be provided by the concessionaire
11	PST 1	Operational Sewage is not flowing uniformly through weir notch

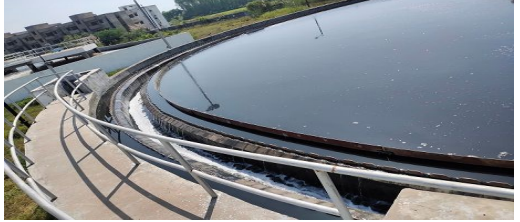
1) Weir notch must be levelled at earliest, 2) Vibration check on regular basis through vibration meter and lubrication to be done on regular basis for PST-1.		27-10-2021	31.01.2022	LONG PENDING
12	PST 2	Operational 1) Sewage is not flowing uniformly through weir notch. 2) Local push buttons was found not working

1) Weir notch must be levelled at earliest. 2) Local push buttons must be rectified at the earliest. 3) Vibration check on regular basis through vibration meter and lubrication to be done on regular basis for PST-2.		27-10-2021	31.01.2022 15.01.2022	LONG PENDING

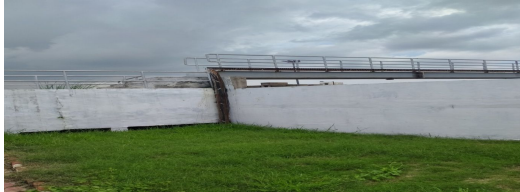
13	Cable tray of PST-1 & PST-2	PST-1 & PST -2 Cable tray has been found rusted condition

Need to paint the rusted cable tray		31.07.2021	15.01.2022	LONG PENDING
D AREATION TANK								
1	Aerator no 1	Operational

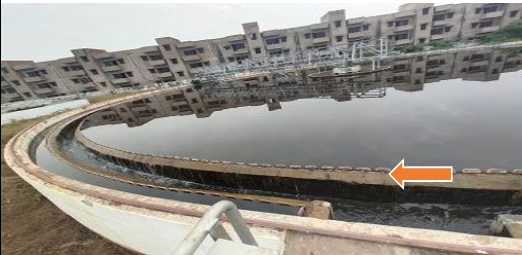
1	SST 1	Operational 1) Hand railing was not found beside RCC stair 2) Sewage is not flowing uniformly through weir notch		1) Hand railing must be provided at the earliest 2) Weir notch must be levelled at earliest.		27-10-2021	31.01.2022	LONG PENDING
2	SST 2	Sewage is not flowing uniformly through weir notch

Weir notch must be levelled at earliest.		18.11.2021	31.01.2022	LONG PENDING
3	Return sludge pump 1	After approx 9 months since 03.03.2021, pump was fixed on 25.12.2021 and is now operational.				11.01.2022		
4	Return sludge pump 2	Operational After around a month, on-site starter was fixed on 07.01.2022.		In the register, operator is mentioning 2nd pump non-operational & 3rd pump operational which needs to be corrected and this kind of error must not be repeated any further.		22.12.2021		
5	Return sludge pump 3	Non-Operational Pressure Gauge not available		1) Needs to be repaired at the earliest. 2) Pressure gauge must be fixed at earliest.		09.12.2021	31.01.2022	PENDING

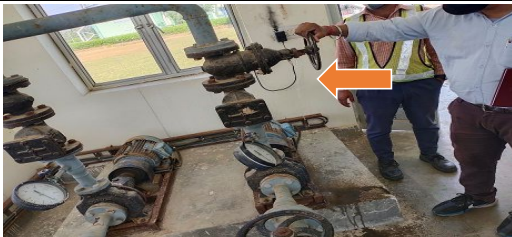
F	CHLORINATION AREA							
1	Chlorine Tonners(Total Qty.=06 Nos)	Operational 1) The missing tonners were finally brought at site on 11.12.2021 which were missing since 04.01.2020. 2) Weighing machine is not available at site.		1) Weighing machine must be provided at site. 2) KRMPL must ensure no chlorine leakage from the tonner and chlorination system.		27.10.2021		PENDING
2	Booster Pump no. 1 & 2	1) Operator doesn't know the operation perfectly. 2) Even after closing the gate valves, some flow was been observed through valves. Also leakage through valve was found

1) Leakage from Gate valve and through its internal gland must be fixed at earliest. 2) Deploy experienced operator who knows the operation.		21-09-2021	15.01.2022	LONG PENDING
3	Chlorination Leak detection device	During visit, cylinder was changed and there was leakage of chlorine but leak detecting device sensor doesn't sensed chlorine. It shows that leak detecting device is not working. Non-Operational

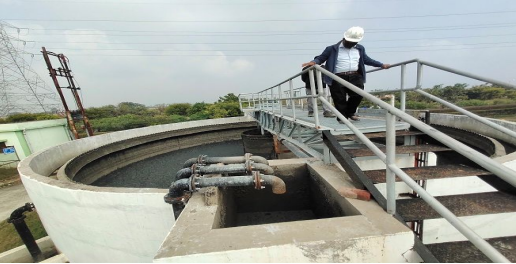
G	Sludge system							
1	Sludge thickeners 1	Operational Sludge Thickener is filled with sludge and influent is not properly treated by Sludge Thickener. No outlet flow of supernatant through weir plate was observed and weir plate was found choked.

1) Do cleaning of Sludge thickner. 2) Overhaul whole mechanical system 3) Painting of MS structures must be done at the earliest.		03.03.2021		PENDING
2	Sludge thickeners 2	After around 10 months of non-operational since 03.03.2021, it was made operational on 07.01.2022. This thickner was taken into cleaning and without informing/ witnessing it to UPJN or PE, sludge was filled on 07.01.2022.

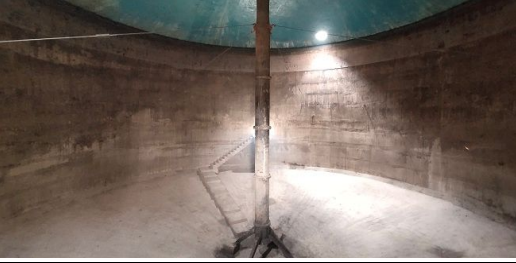
6	Sludge digester-02	Non-Operational PE along with UPJN, have inspected digester no. 2 and found that the replaced impeller is colliding with the surrounding DI pipe which is causing heavy noise, which means installation work is not properly done. PE letter no. 1385 dated 11.01.2022 has been issued regarding the inspection for compliance.

Needs to be rectified at the earliest		01.06.2020		LONG PENDING
7	Flow Meter for Bio gas.	Non-Operational

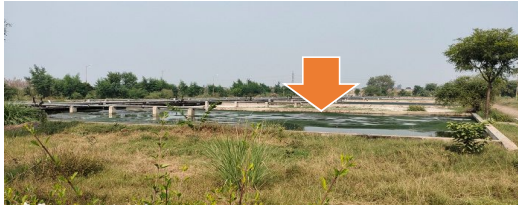
9	Gas engine -2	Operational						
10	Gas engine -3	Operational						
11	Gas Scrubbers	Operational		UPIN has advised KRMPL to connect a pipe from scrubber exit directly to H2S analyser for knowing the value of H2S present in scrubbed gas just exiting scrubber.		11.01.2022		
12	Bio gas compressor - 1	Operational						
13	Sludge drying bed 1	Filled with sludge

Beds are required to be emptied periodically and Sludge to be disposed on regular basis		23.02.2021		No record of disposal of sludge is available.
14	Sludge drying bed 2	<p>After approx 10 months since 23.02.2021, the sludge cleaning work started from 24.12.2021 and cleaning work has been completed but the removed sludge is lying beside the bed on the road resulting in road blockage.</p> <p>As per the register, cleaning work of this bed continued till 04.01.2022 which means from 04.01.2022, the removed sludge which is lying on the road has not been removed from the plant.</p>

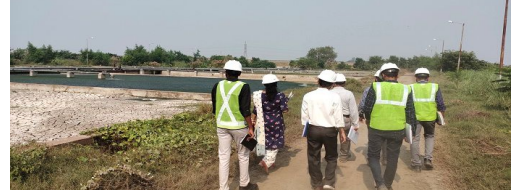
15	Sludge drying bed 3	Filled with sludge

Beds are required to be emptied periodically and Sludge to be disposed on regular basis		23.02.2021		No record of disposal of sludge is available.

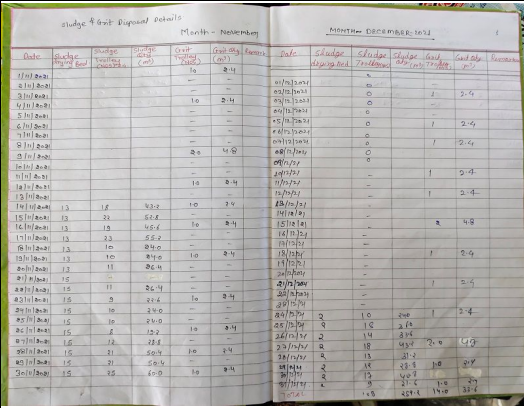
16	Sludge drying bed 4	Filled with sludge		Beds are required to be emptied periodically and Sludge to be disposed on regular basis		23.02.2021		No record of disposal of sludge is available.
17	Sludge drying bed 5	Filled with sludge						
18	Sludge drying bed 6	Filled with sludge						
19	Sludge drying bed 7	Filled with sludge						
20	Sludge drying bed 8	Filled with sludge						
21	Sludge drying bed 9	Filled with sludge						
22	Sludge drying bed 10	Filled with sludge						
23	Sludge drying bed 11	Filled with sludge						
24	Sludge drying bed 12	Filled with sludge						
25	Sludge drying bed 13	<p>After approx 9 months since 23.02.2021, the sludge cleaning work was started from 14.11.2021 and continued till 20.11.2021 but the cleaning work was pending as stated in PE's Dec. 2021 inspection report.</p> <p>At the time of visit, we have been informed that wet sludge has been taken in the drying bed. But the entry of sludge cleaning work which was pending is not found in the register entry, which means either KRMP L has taken the wet sludge without cleaning the bed completely or KRMP L had not mentioned it in the register.</p>

<p>KRMP L is either misleading us by not cleaning the drying bed completely or not maintaining the register properly.</p> <p>If the pending desludging work was done, then where is the entry of the work? Kindly Justify?</p>		11.01.2022

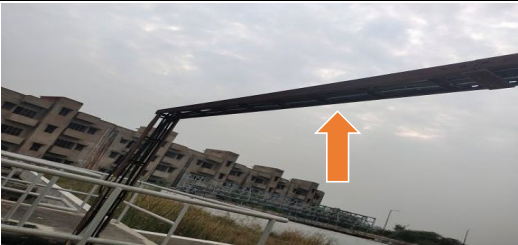
34	Dilution water submersible pump- 2	Operational 1) Various Nut bolts was found rusted. 2) Cable tray was found rusted

1) Replace all rusted nut bolts with GI nut bolts. 2) Painting must be done on cable tray.		18.11.2021	31.12.2021 15.01.2022	LONG PENDING
35	Filtration pump no. 1	Non-Operational		Needs to be rectified at the earliest.		01.12.2021		LONG PENDING
36	Filtration pump no. 2	Operational						
37	Treated effluent outlet channel							
Miscellaneous								
1	Motor Canopy	STC found that no canopies were present on the motors of equipments		Fix canopy to each motors of equipments.		27-10-2021	31.01.2022	Long Pending
2	Chlorination Unit Stock & consumption register							
3	Laboratory	1) Deployed Chemist do not have the right training/ experience for conducting laboratory analyses. 2) Daily analysis results reported by KRMPL are not matching with NABL laboratory (Shriram) reports		1) Trained chemist has to be deployed for testings at laboratory. 2) Lab. Chemist has to maintain date wise base data of all the testings done. 3) Fecal coliform tests must be done properly. 4) A piping system must be connected to exhaust of laminar air flow cabinet and must be discharged outside laboratory room/ building. 5) Laboratory testings needs be done correctly by following right procedure.		27-10-2021		LONG PENDING

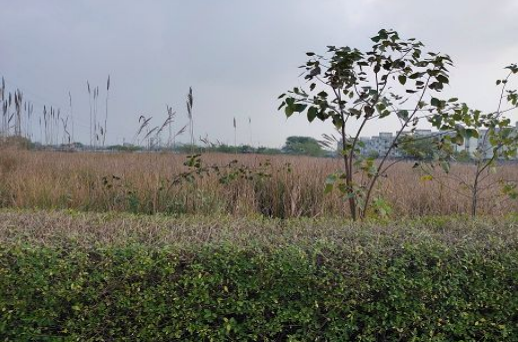
4	Log Books & Register			1) Log Books and registers must be maintained and remain available for all units 2) Maintenance register must be filled properly.		27-10-2021		Pending
5	House Keeping works	At various locations inside the plant, no house keeping works was found.

1) House keeping work at all locations inside the plant has to be done for which deployment of manpowers needs to be done. 2) Do the house keeping works on regular basis		27-10-2021		LONG PENDING

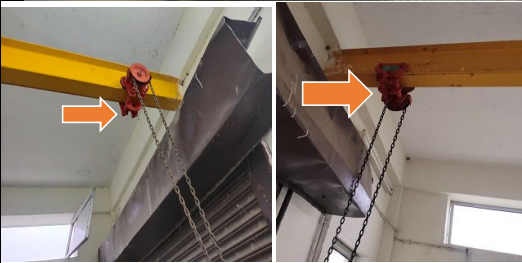
6	Equipments Numbering			Numbering must be provided in bold letters to all the equipments so that it could be seen easily and there should not remain any confusion about which item is no. 1 & which is no. 2		27-10-2021	31.01.2022	LONG PENDING
7	Manually operated crane	Manually operated crane pulley in Return sludge pump house, primary sludge pump house, thickened sludge pump house etc. were missing lifting chain.

Provide the lifting chain at every places.		18.11.2021		Pending Not Provided yet as indicated in KRMPL Letter no. 2037 dated 23.12.2021 for compliance to inspection carried on 18.11.2021 by PE.
