SITE INSPECTION REPORT

Jajmau STP - 130 MLD

Date:04.01.2022

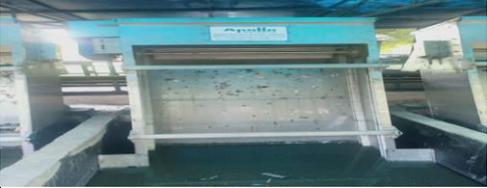
S. No.	Equipment	Assessment of Current Condition	Assessment of Current Condition Photo	Current defects and Corrective Action Suggested by STC, PE	Original Date of Issue	Proposed Date to Resolve by KRMPL	Current Status of Compliance
5	Mechanical Fine Screen no. 2	Operated

<ol style="list-style-type: none"> Mechanical screen of teeth are damaged , KRMPL has not been repaired. Mechanical Fine Screen are need to be installed as per approved drawing. Screen needs to be clean periodically depends on the sewage. Mechanical Screen not working with auto system and without sensor .Need to be fixed the auto system immediately. New Cables should be laid properly in cable trays. Autosystem and level sensor meter has not been installed by KRMPL till date. 	23.11.2021		Pending
6	Mechanical Fine Screen no. 3	operated

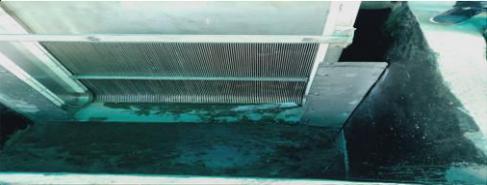
<ol style="list-style-type: none"> Mechanical Fine Screen are need to be installed as per approved drawing. Screen erection/ installation work is not verified by STC . Mechanical Screen not working with auto system and without sensor, need to be fixed the auto system immediately. Procedure of screens hasw not been submit by KRMPL. Without getting approval for shut down and charging the Raw sewage for the same work. KRMPL has not been submitted any approval. Autosystem and level sensor meter has not been installed by KRMPL till date. 	23.11.2021		Pending

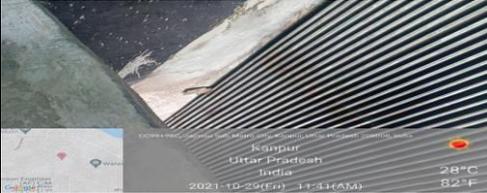
7	Manual Screen no. 1	Operated

<ol style="list-style-type: none"> KRMPL has been installed GI anchor fashners in submergence condition for screen. Need to be reaplced SS316/SS304 anchor fashaner. KRMPL without getting approval for shut down and charging the Raw sewage for the same work. KRMPL has not been submitted any approval. 	23.11.2021		Pending

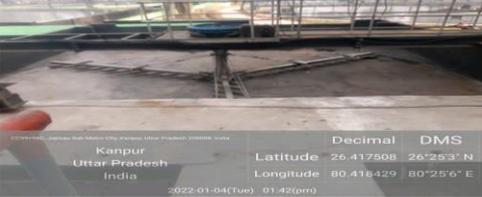
<ol style="list-style-type: none"> Outer side painting work in progress in Grit Chamber 03. Seepages need to be grouted under renovation work by KRMPL. Log Book need to be maintained. 	01.03.2021		Lond pending
9	Grit Mechanism-1	Operated

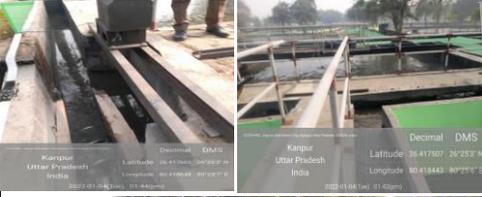
<ol style="list-style-type: none"> Renovation work found satisfactory. Organic pump need to be installed as per approved drawing. Cable need to be layed at Cable tray as per approved drawing. LPBS need to be installed as per approved drawing. KRMPL without getting approval for shut down and charging the Raw sewage for the same work. KRMPL has not been submitted any approval. KRMPL has not been submitted installation procedure for Grit Mechanism System. 	01.03.2021		Lond pending

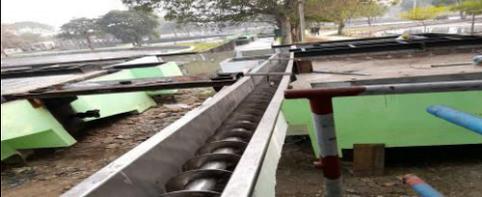
10	Grit Mechanism-2	Operated

<ol style="list-style-type: none"> Renovation work found satisfactory. Organic pump need to be installed as per approved drawing. Cable need to be layed at Cable tray as per approved drawing. LPBS need to be installed as per approved drawing. KRMPL without getting approval for shut down and charging the Raw sewage for the same work. KRMPL has not been submitted any approval. KRMPL has not been submitted installation procedure for Grit Mechanism System. 	01.03.2021		Lond pending
11	Grit Mechanism-3	Not operational

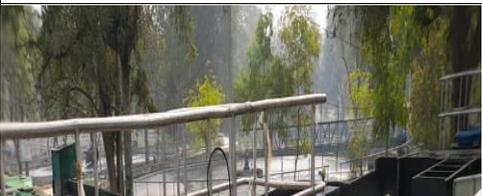
<ol style="list-style-type: none"> KRMPL need to provide proper access to Grit mechanism platform . Renovation in screw conveyor channel is pending. KRMPL without getting approval for shut down and charging the Raw sewage for the same work. KRMPL has not been submitted any approval. KRMPL has not been submitted installation procedure for Grit Mechanism System. KRMPL has not submitted any RFI's(Request for Inspection). 	01.03.2021		Lond pending

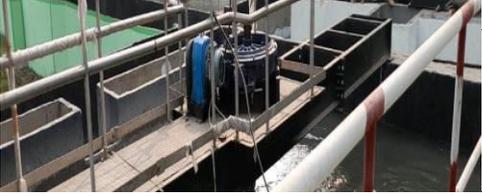
12	Grit Classifier -1	Working

<ol style="list-style-type: none"> Not in working due to foundation damage. Need to be repair immediately and to be replace as per the CA Grit Classifier alignment has not been done by KRMPL as per approved drawing. Organic pump need to be replaced as per approved drawing. 	01.03.2021		Lond pending

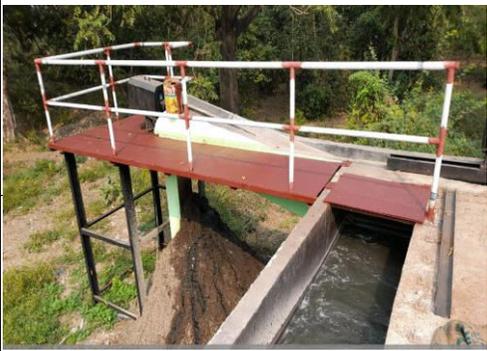
<ol style="list-style-type: none"> 1. Not in working due to foundation damage. 2. Need to be repair immediately and to be replace as per the CA 3. Grit Classifier alignment has not been done by KRMPL as per approved drawing. 4. Organic pump need to be replaced as per approved drawing. 	01.03.2021		Long pending
14	Grit Classifier -3	Not working / Under maintenance

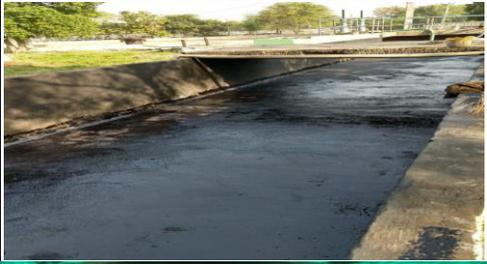
D	Parshall flume and flow meter						
16	Parshall Flume and Flow Channel (Civil)	Structure renovation work done

<ol style="list-style-type: none"> 1. Painting procedure has not been submitted by KRMPL. 2. Channel renovation work done but hydrotest of this channel is pending. 3. Level scale need to be installed for proper flow measurement. 	23.11.2021		Pending
18	Flow meter	Operational

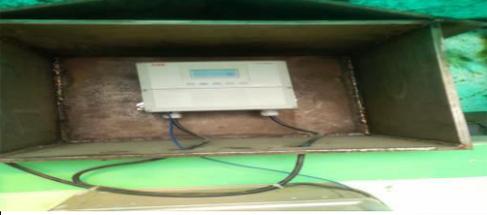
<ol style="list-style-type: none"> 1. Flow meter found working and under the trial run. 2. Glass door need to be installed for Flow meter 3. Commissioning has not completed yet. 4. Cable to be laid properly in cable tray and conduit pipe. 5. Log Book need to be maintained. 	23.11.2021		Pending
E	Distribution Chamber -1

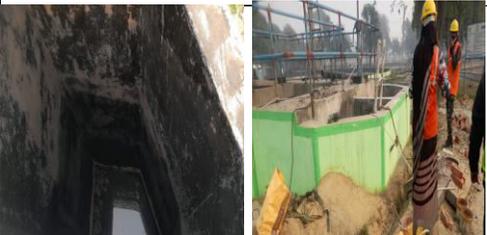
<ol style="list-style-type: none"> 1. Only outer face of distribution chamber for Primary sedimentation tank partially done by KRMPL. 2. Inside Rcc wall, base and platform required renovation work. 3. Railing and its foundation needs to be replaced. 4. Reinforced exposed and need to be repaired. 5. All Sluice gate need to be replaced. 6. Cable trench depth should be as per IS code. 7. Earthing laying should be as per IS code. 	01.03.2021		Long Pending

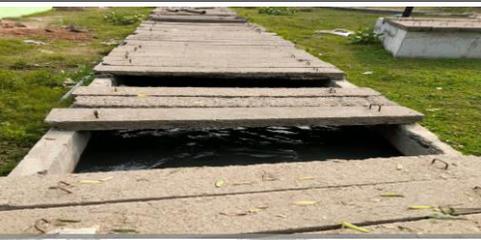
<ol style="list-style-type: none"> Renovation of RCC channel need to be repair with proper cleaning, Cracks repairs, HoneyComb removal work, damaged part of wall and covers. 	01.03.2021		Long pending
H	Aeration tank

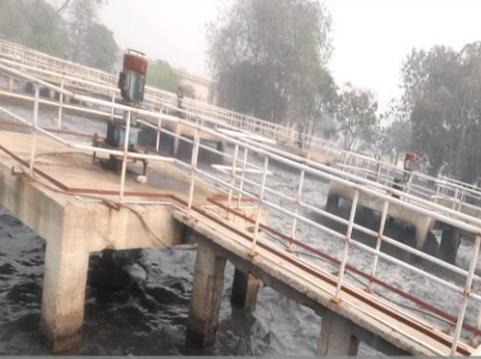
<ol style="list-style-type: none"> Cracks repairing work done by KRMPL only for outer side of wall. In Aeration Tank platform Slab, where machine is mounted vibrated tremendously, Slab & beam strengthening is required to increase weight of Unit Increasing weight of RCC member's vibration will be controlled. KRMPL instructed to submit the structural strengthening Methodology for Aeration Tank . Aeration Inlet and outlet gates need to be replace . Foundation plate need to be painted. Cable gland need to be fixed in the Pump termination Box. Log Book need to be maintained. 	01.03.2021		Long Pending

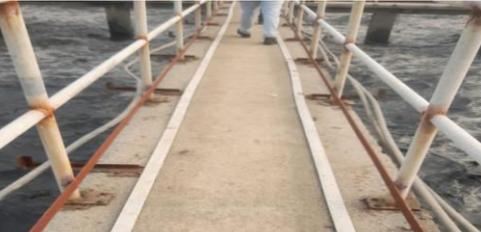
<ol style="list-style-type: none"> Renovation work of outer side is in progress in Aeration Tank 02 Columns need to be renovate.. Walkway to be strengthen and repaired. New Hand railing need to be installed on walkway. GAD of Hand railing and material certificate of hand railing needs to be furnished. Base plate of Hand railing needs to be blasting and painting after approval from UPJN. Certify the tye of anchors and fasteining. (Nuts/bolts). Cable need to be laid in cable tray. LPBS system to be install at site 	01.03.2021		Long Pending
34	Aerator no. 7	4 Operational

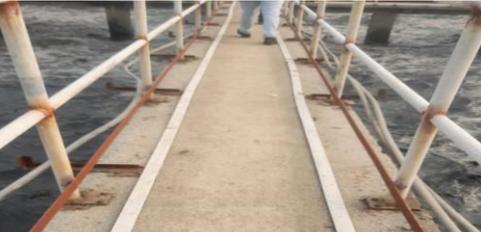
<ol style="list-style-type: none"> Aerators need to be replaced. Canopies to be installed on the top of motors. Cable to be laid in cable tray.

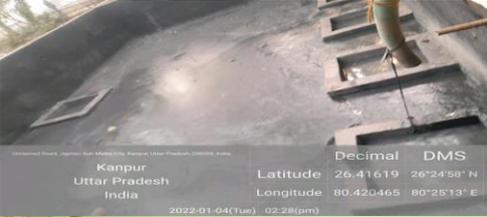
Kanpur Uttar Pradesh India Latitude: 26.41619 Longitude: 80.420465 Decimal: 26.41619 DMS: 26°24'59" N 80°25'13" E 2022-01-04(Tue) 02:28(p.m)	1.Sludge cleaning work done by KRMPL only top of slab. 2. Renovation work done by KRMPL only slab top. 3. KRMPL need to clean sump from bottom of slab.	01.03.2021		Long Pending
66	Return Sludge Pump House (Civil)	Needs rehabilitation

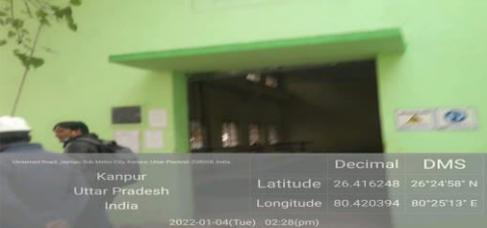
Kanpur Uttar Pradesh India Latitude: 26.416248 Longitude: 80.420394 Decimal: 26.416248 DMS: 26°24'58" N 80°25'13" E 2022-01-04(Tue) 02:28(p.m)	1.Only outer face painting work partially done by KRMPL. 2. Dewatering arrangement need to be arrange. 3.Foundation of pumps need to be renovate. 4.KRMPL need to submit Civil drawing of foundation for renovation work. 5. Renovation work of internal wall need to be done. 6.Lighting arrangement and Cable to be laid in cable tray. 7.LPBS system to be install at site 8.Cable need to be dressed properly 9.All Indoor Light to be replace immediately 10.Log Book need to be maintained.	01.03.2021		Long Pending

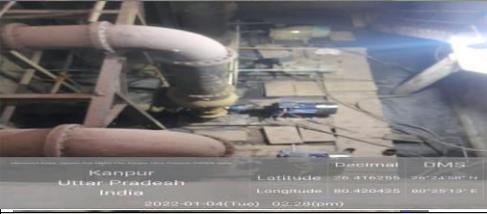
67	Return Sludge Pump no. 1	Non Operational

Kanpur Uttar Pradesh India Latitude: 26.416305 Longitude: 80.420455 Decimal: 26.416305 DMS: 26°24'59" N 80°25'13" E 2022-01-04(Tue) 02:28(p.m)	1.Only pump No 2 and 3 are in working condition. 2.Cables to be arranged in proper manner and should be laid in cable tray. 3.Leakage has been detected in the pipes connecting to the Pumps. 4.Out of 4 nos. panel only 2 panel found in working condition. 5. 2 Nos new pumps has been installed by KRMPL without get any prior approval from UPJN/PE and KRMPL has not submitted any erection procedure as per CA schedule 11. 6.Erection and commissioning of pumps have been done by KRMPL.KRMPL has not complied the compliance raised by PE officials . 7. Thermometer and vibration meter should be at site.Vibration and Temperature reading has not mention in the daily log book. 8. Pump No 4 is fully burn due to not proper operate by KRMPL. 9.Pump No 3 is operational but pump shaft orientation anticlock wise due to NRV got damaged.It should be replaced.	10.12.2021		Pending

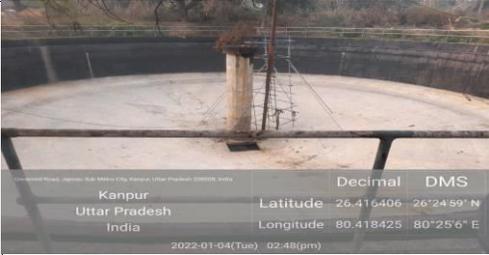
Kanpur Uttar Pradesh India Decimal DMS Latitude 26.416406 26°24'59" N Longitude 80.418425 80°25'6" E 2022-01-04(Tue) 02:48(pm)	<ol style="list-style-type: none"> Cleaning work of sludge thickener 01 has completed by KRMPL. Renovation need to be done for Interconnection pipe line of inlet and outlet of this chamber. Leakages need to be grouting as visual inner surface of wall after epoxy coating. Repair and Rehabilitate done for wall of sludge thickener. Plastering and finishing work done. Make structure free from the Cracks. Remote system to be installed for GST-1. Cable to be laid in cable tray. Sludge thickener mechanism need to be replaced. New Gravity Sludge Thickener equipments drawings have been vatted by PE / UPJN but KRMPL has not supplied as same. 	01.03.2021		Long Pending

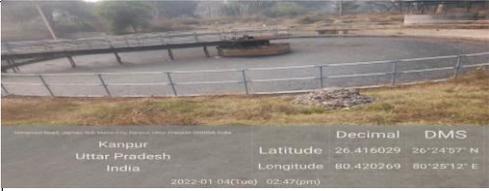
74	Gravity Sludge Thickener no. 2	Non-Operational

Kanpur Uttar Pradesh India Decimal DMS Latitude 26.416029 26°24'57" N Longitude 80.420269 80°25'12" E 2022-01-04(Tue) 02:47(pm)	<ol style="list-style-type: none"> Sludge Thickener found under maintenance Suggested to expedite the cleaning progress Civil structure to be repaired and make it free from any structural defects & deficiencies. Plastering and finishing works to be done. New Gravity Sludge Thickener equipments drawings have been vatted by PE / UPJN but KRMPL has not supplied as same. Remote system to be installed for GST-2. Cable to be laid in cable tray. Sludge thickener no.2 is to be replaced. Hand railing to be replace . 	01.03.2021		Long Pending
0	Thickened Sludge Pump House						
75	Thickened Sludge Pump House cum Sump (Civil works)	Structure needs rehabilitation

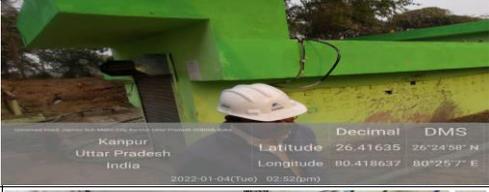
Kanpur Uttar Pradesh India Decimal DMS Latitude 26.41635 26°24'58" N Longitude 80.418637 80°25'7" E 2022-01-04(Tue) 02:52(pm)	<ol style="list-style-type: none"> Cleaning work of roof slab is in progress by KRMPL. Sump to be clean and rehabilitate. Precast cover slabs of Sump to be replaced . Pump house structure needs plastering and finishing works. Cracks should be treated with proper technique. Remote system to be installed for TSPH. Cable to be laid in cable tray. All Thickened sludge pumps to be replaced as per CA. Dewatering pump to be installed for removing extra water. EOT crane /ligning /exhaust fan to be inslanted . Log Book need to be maintained. 	10.12.2021		Pending

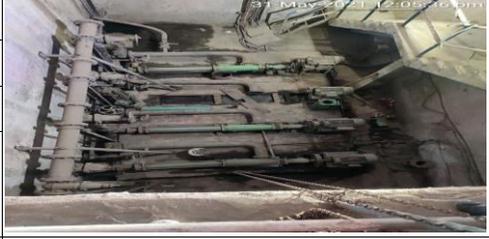
76	Thickened Sludge Pump no.1	Not operated

1. Need to be replaced	27.11.2021		Pending
77	Thickened Sludge Pump no.2	Not operated		1. Need to be replaced			
78	Thickened Sludge Pump no.3	Not operated		1. Need to be replaced			
79	Thickened Sludge Pump no.4	Not operated		<ol style="list-style-type: none"> Need to be replaced Indor lighting need to be repalce immediately Cable need to be dressed properly Cable tray need to be paited Digestor cleaning work can be done with safety precaution . 			
p	Primary Sludge Digesters

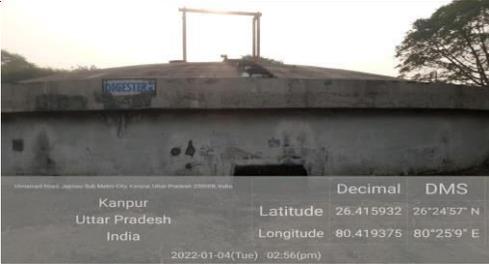
<ol style="list-style-type: none"> Cleaning work of digester done partially by KRMPL. Outer face cracks repair work is in progress by KRMPL. Removal of centrally located sludge mixing shaft from Primary Digester 1. Gate to be overhaul Civil Structure of the Digester to be renovate and cracks to be treated. Leakage to be Arrested in the Digester. Installation of the Railing at the boundary of the dome. 	01.03.2021		Long Pending
81	Primary Sludge Digester no. 2	Not operational

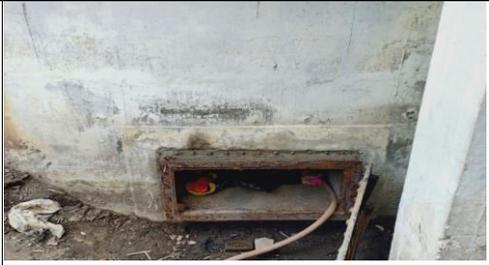
<ol style="list-style-type: none"> Cleaning work of Primary digester done partially. Outer face cracks repair work is in progress by KRMPL. Gate to be overhaul Civil Structure of the Digester to be renovate and cracks to be treated. Leakage to be Arrested in the Digester. Installation of the Railing at the boundary of the dome. 	01.03.2021		Long Pending

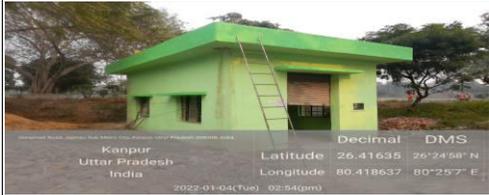
<ol style="list-style-type: none"> Sump to be clean and renovate. Installation of the railing on the boundary of the sump. Precast cover to be replaced or constructed on the sump. Stairs at the pump house to be renovate. Plastering work and finishing work to be done in the pump house. Foundation of the pumps to be repaired. Railing to be repair in the Pump house. LPBS System to be installed for GST-1. Cable need to be laid in cable tray. Dewatering pump to be installed. Log Book need to be maintained. 	01.03.2021		Long Pending

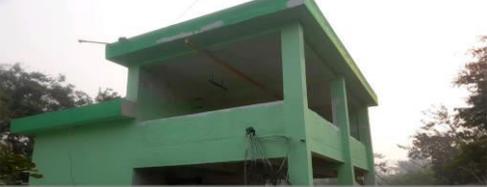
<ol style="list-style-type: none"> 1. Plastering and finishing work of the Centrifuge building and centrate Pump house. 2. Railing and steel ladder to be repaired or replaced as per site condition. 3. Housekeeping to be done. 4. Sign boards are required. 5. No approach road found at site to get on thsi unit/component. 6. Proper lighting arrangement to be required at site. 7. As per CA centrifuge to be repaired. 7. All centrate pump 4 no. to be replace. 	01.03.2021		Long Pending
89	Centrifuge Pump no.1	All centrifuge were in dilapidated condition and dismantling work is completed

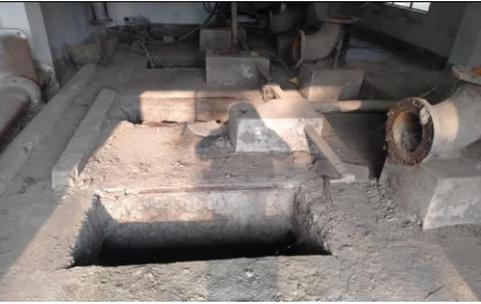
T	Centrate / Supernatant Pump House				01.03.2021		
93	Centrate Building cum Sump (Civil works)

<ol style="list-style-type: none"> 1. Plastering and finishing work of the Centrifuge building and centrate Pump house. 2. Railing and steel ladder to be repaired or replaced as per site condition. 3. Housekeeping to be done. 4. Sign boards are required. 5. No approach road found at site to get on thsi unit/component. 6. Proper lighting arrangement to be required at site. 			
94	Supernatant Pump no.1	Pump already dismantled by KRMPL		As per CA pump to be replaced .	01.03.2021		Long Pending
95	Supernatant Pump no.2	Pump already dismantled by KRMPL		As per CA pump to be replaced .

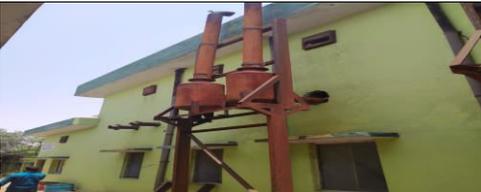
104	Gas Flaring no.2	Dismantling in progress by KRMPL		1. Design, drawing has been vatted by PE and KRMPL has not supplied as same	23.11.2021		Pending

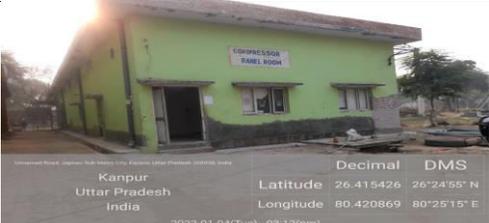
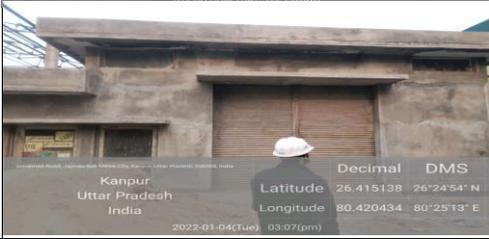
<p>Decimal DMS Kanpur Uttar Pradesh India Latitude 26.415138 26°24'54" N Longitude 80.420434 80°25'13" E 2022-01-04(Tue), 03:07(pm)</p>	<ol style="list-style-type: none"> 1. Roof slab cleaning work is in progress. 2. KRMPL is doing surface roof treatment for compressor panel room slab while KRMPL didn't submit any methodology, Work process and Work Plan. 3. Outer face plaster work is in progress by KRMPL with mortar (1:3) cement:sand ratio. 4. Plaster work should be proper thickness, verticality and smoothness but KRMPL is not doing same as per CA specification. 4. Cracks repairing work in ceiling slab is in progress by KRMPL. 5. KRMPL has engaged 9 Nos of labour for civil work. 	10.12.2021		Pending

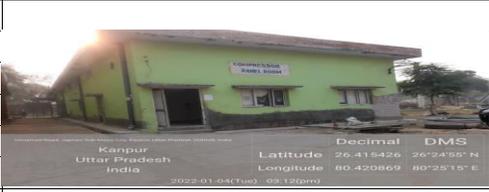
<p>Decimal DMS Kanpur Uttar Pradesh India Latitude 26.415426 26°24'55" N Longitude 80.420869 80°25'15" E 2022-01-04(Tue), 03:12(pm)</p>	AS per CA, Biogas compressor to be replaced .					
106	Biogas Compressor no.1	Dismantling done by KRMPL							
107	Biogas Compressor no.2	Dismantling done by KRMPL							
108	Biogas Compressor no.3	Dismantling done by KRMPL					01.03.2021		Long Pending
109	Biogas Compressor no.4	Dismantling done by KRMPL							
110	Biogas Compressor no.5	Dismantling done by KRMPL							
Y	Dual Fuel Generator				01.03.2021		Long Pending		
111	DFG no.1	not oprated

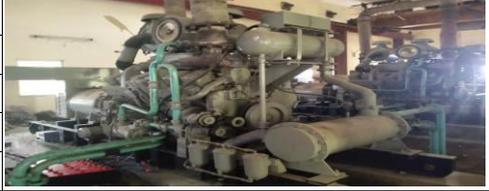
<ol style="list-style-type: none"> 1. Proper lighting arrangement to be required at site. 2. DFG to be replaced as per CA and BEP. 3. Derating of DFG calculation need to be of 2 DFG for plant operation 	01.03.2021		Long Pending		
112	DFG no.2	Operated

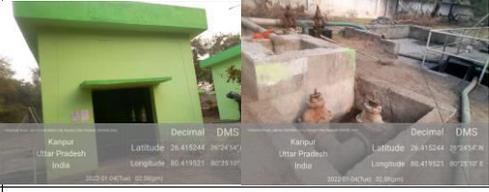
<p>Decimal DMS Kanpur Uttar Pradesh India Latitude 26.415044 26°24'54" N Longitude 80.419921 80°25'09" E 2022-01-04(Tue), 03:06(pm)</p> <p>Decimal DMS Kanpur Uttar Pradesh India Latitude 26.415044 26°24'54" N Longitude 80.419921 80°25'09" E 2022-01-04(Tue), 03:06(pm)</p>	1. Civil structure needs finishing work to be done.	01.03.2021		Long pending		
117	Filtrate Pump no.1	Not working		1. As per CA, Filtrate pump to be replaced.	01.03.2021		Pending

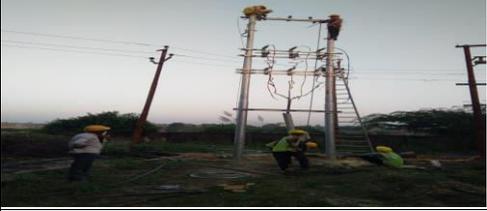
1. DP structure erection work not as per approved drawing ,need to be installed as per approved drawing . 2. DP pole earthing work in not done.need to be eathed immediately . 3. Pole foundation need to done properly.			Long pending
AB	New Units (Construction)				01.03.2021		
119	TEPH cum Sump	To be constructed		1. Shifting of existing of Utilities at proposed CCT and TEPH area. 2. Site Clearance required.			Long pending
120	Chlorine Contact tank						
Remarks:- A) Internal and External Painting work (for Structures and Building):- KRMPL did not work properly by which it is not acceptable and it did not fulfill acceptance criteria as per CA 1. All painted work surfaces shall be uniform and pleasing in appearance. 2. The colour ,texture etc shall match exactly with the approved samples. 3. All stains ,splashes and slatters of paints shall be removed from surrounding surfaces. KRMPL need to take necessary action for proper Painting work. B) Internal road need to be renovate but KRMPL did not submit any Internal road plan layout for recommendation. C) All E&M equipments need to be replaced as per CA schedule 11.				Signature: TEAM LEADER STC KANPUR
