National Mission for Clean Ganga- Development, Rehabilitation with
Operation & Maintenance of STPs at Kanpur under Hybrid Annuity based PPP mode

Sub: HAM KANPUR: 15 MLD STP Unnao Site Inspection Report dated 13th January
2022

SITE INSPECTION REPORT - 15 MLD STP AT UNNAO

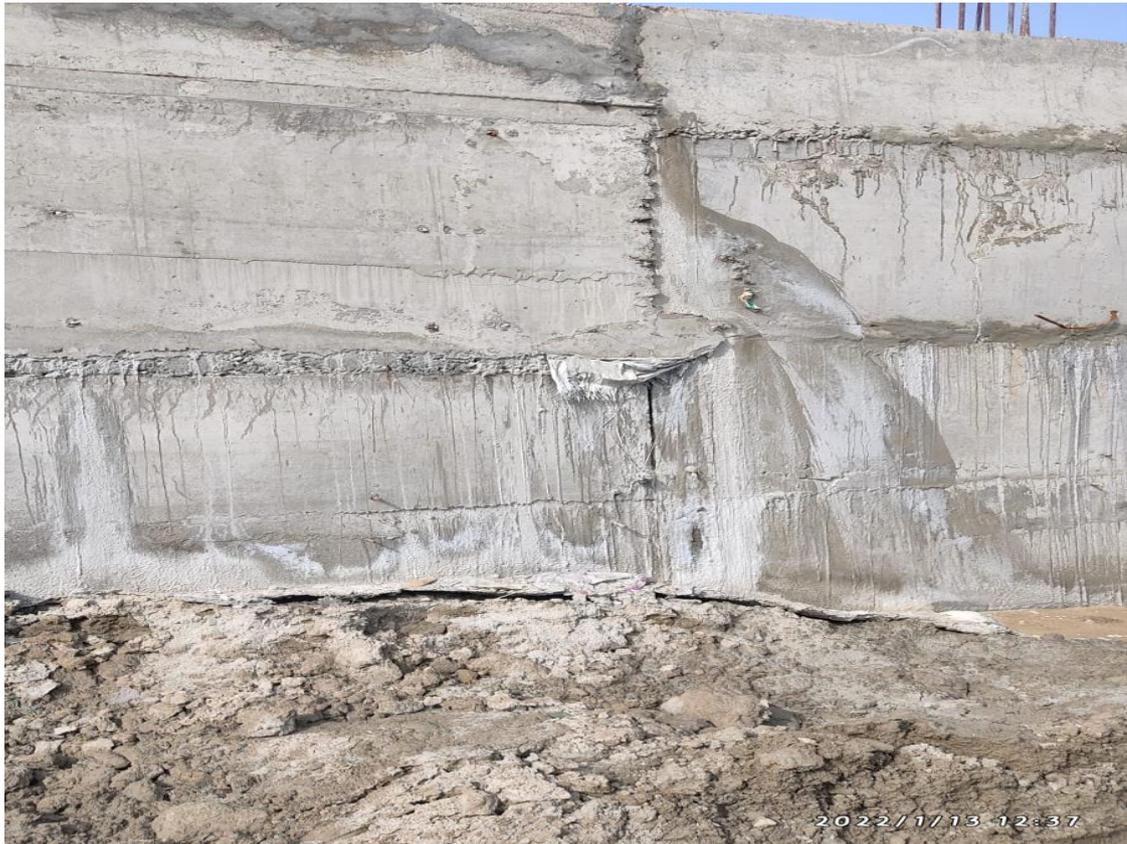
- V. During visits, some issues in construction and quality works of boundary wall were observed by STC which are as following:
- VI. Concreting of compound wall has not been done properly and it is rough. This has occurred due to KRMPL has not used proper shuttering for casting & also finishing of top surface level is poor due to poor shuttering arrangement. Photographs attached:
- VII. Clear cover is not exactly as per design due to use of wide range of cover blocks;
- VIII. KRMPL is not using vibrator frequently at time of casting due to which at some locations honey combing was observed. KRMPL has been instructed to rectify it and use vibrator in regular practice.

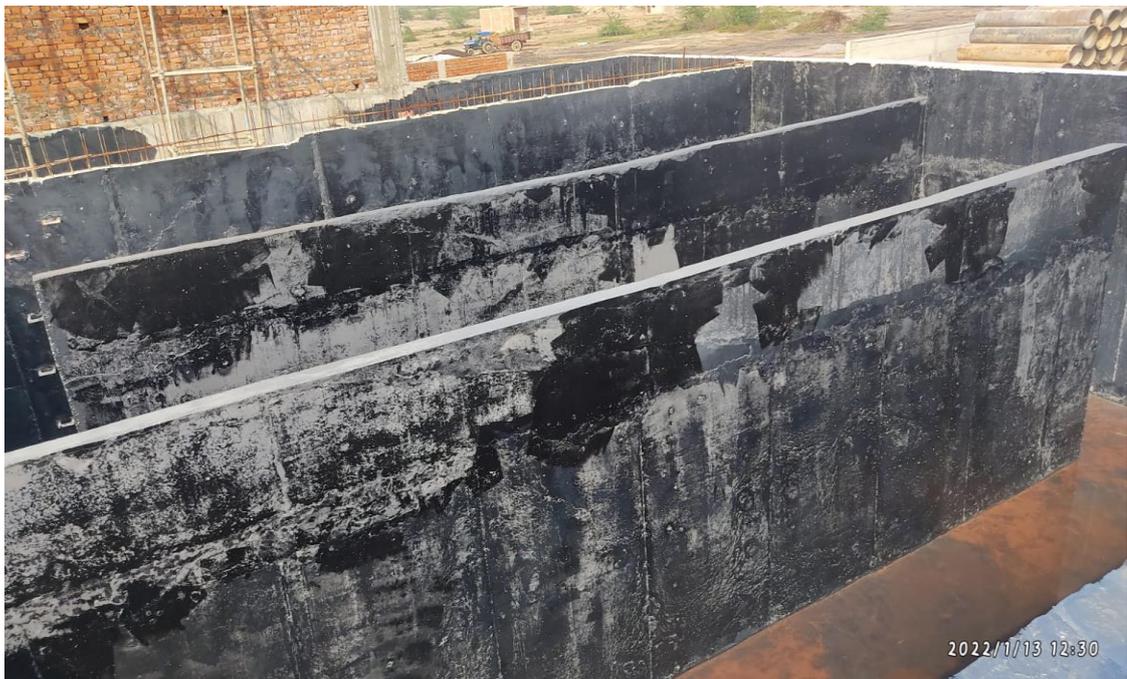
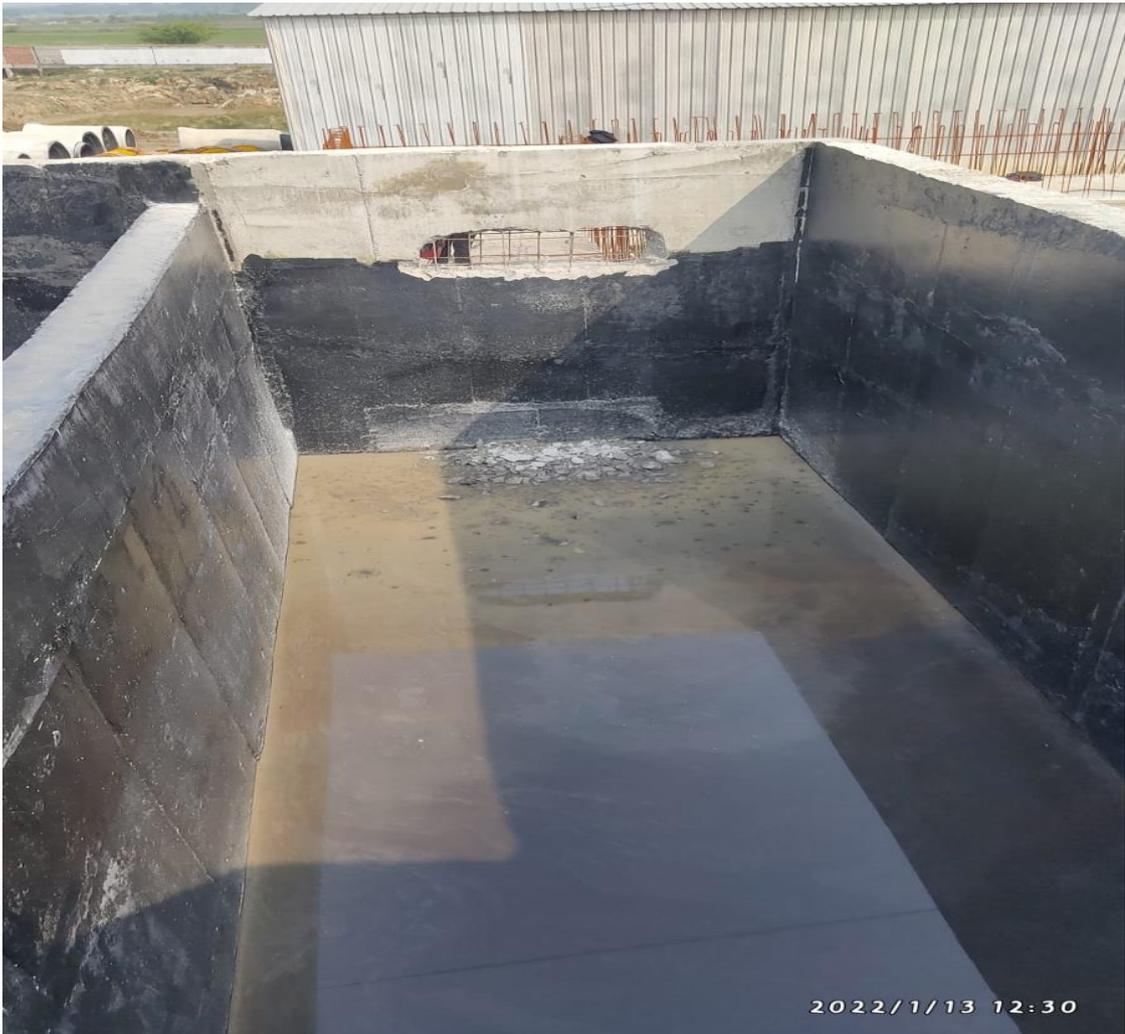
- IX. At admin building & Staff Quarter, brick work and Plaster work is almost done, finishing work in progress.
- X. During inspection observed in Chlorination tank, coal tar epoxy coating in not done uniformly.

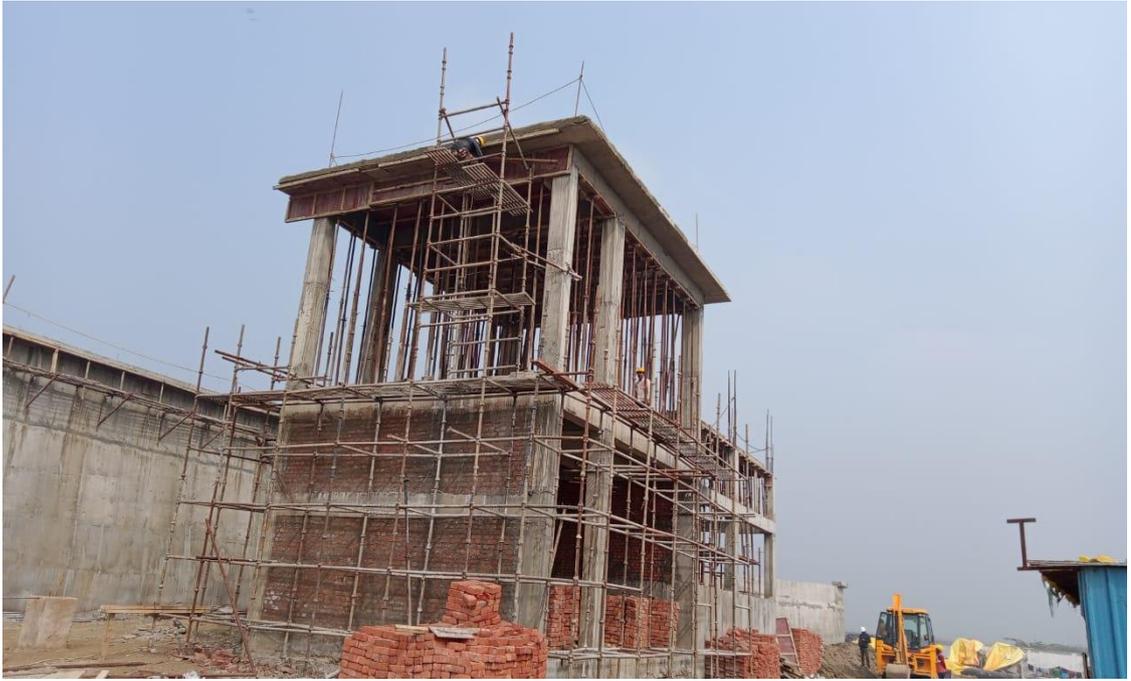
- XI. **Improper Brick masonry in Centrifuge Building:** Improper Brick masonry work found in Staff quarter & Centrifuge Building. Brick Masonry is not found in vertical alignment. Raking in masonry is also improper. Brick masonry work Plum is not in vertical alignment. Joint in brick masonry found less quantity of mortar above the Lintel Beam Level.

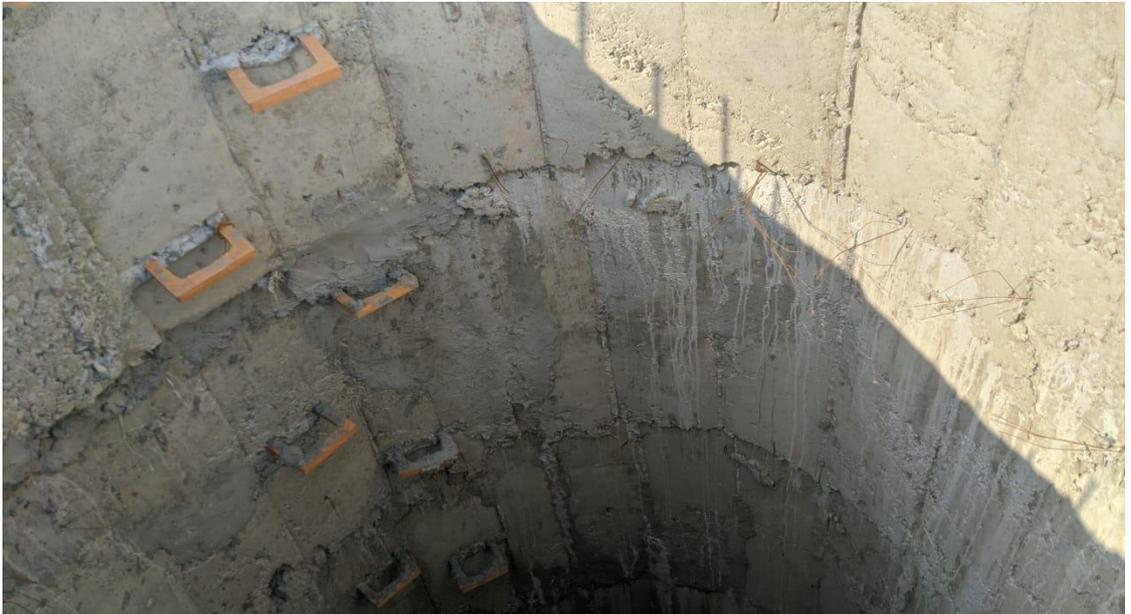
- XII. Out of 46 manholes only 04 manholes has constructed. Quality of RCC work in found very poor. PE/STC and EE Unnao UPJN had already are KRMPL many time directed to dismantle these manholes and reconstruct with proper finishing. But KRMPL not dismantling yet.

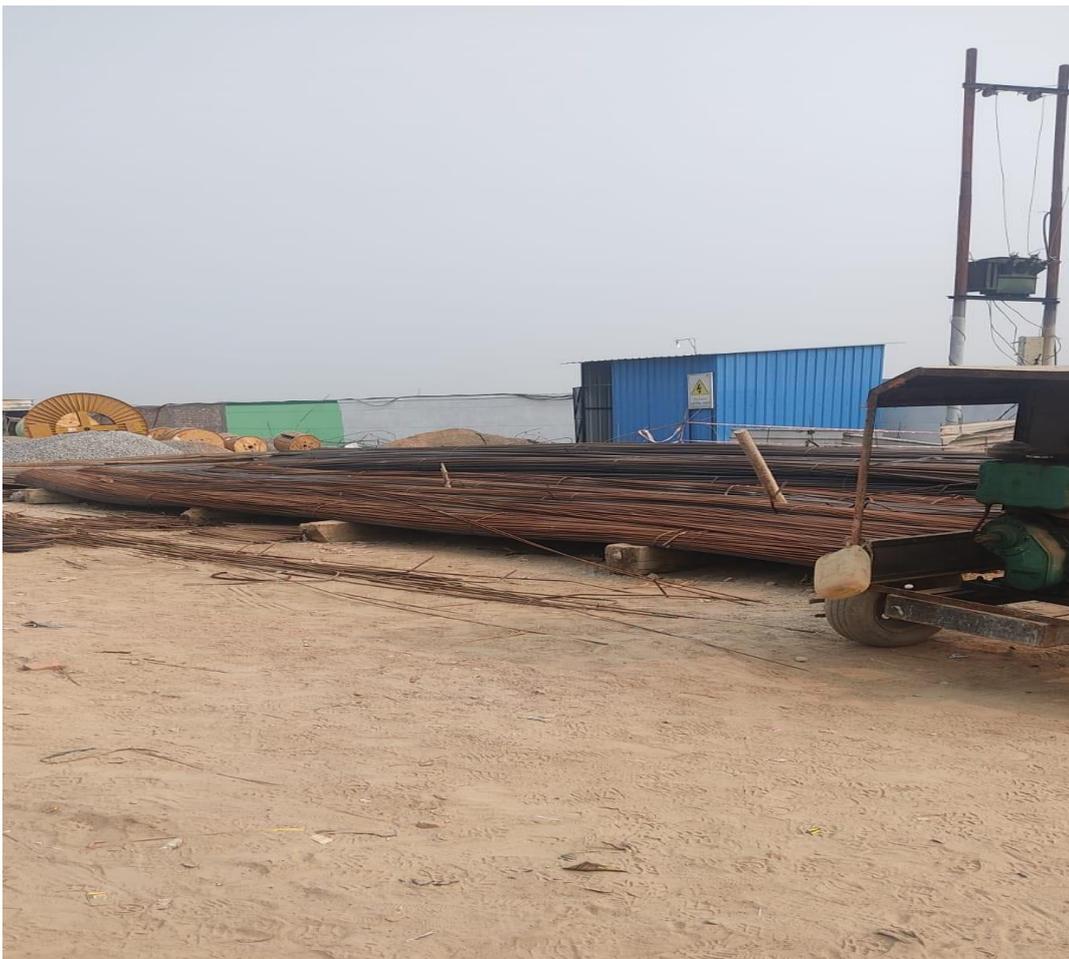
- I. The reinforcement steel was found kept in open area, due to which corrosion has started. KRMPL has been told many times that open storage of steel is undesirable. KRMPL need to store steel material as per **IS code 4082:1996(Recommendations on stacking and storage of construction materials and components at site) point no. 4.13.1 page no. 5.**
