<div>STC</div> <div>SITE INSPECTION OF JAJMAU ASSOCIATED IPS REPORT</div>					Parmiya IPS - 3.5 MLD	Date: 18.1.2022	VIRTUAL INSPECTED BY: PE, UPJN UPJN-Jen Mr. Ajit Singh Civil UPJN Jen- Mr. Ashish Sheyaal E&M UPJN Chemist-Mr Ajay Kanojiya STC-Team 1.Mr .Dr. Giridhar prabhukar (Team Leader and watse water Expert) 2. Mr. J.P. Tripathi(O&M- In charge) Mr Anuj Kushwaha(Support Engineer Civil) 2. Mr Ajay Kumar Goyal(Support Engineer Mechanical) KRML-Team 1. Mr Shriram -Incharge

SITE INSPECTION OF JAJMAU ASSOCIATED IPS REPORT					Shishmau IPS -45 MLD	Date: 18.01.2022	VIRTUAL INSPECTED BY: PE, UPJN UPJN-Jen Mr. Ajit Singh Civil UPJN Jen- Mr. Ashish Sheyaal E&M UPJN Chemist-Mr Ajay Kanojiya STC-Team 1.Mr .Dr. Girdhar prabhukar (Team Leader and watse water Expert) 2. Mr. J.P. Tripathi(O&M- In charge) Mr Anuj Kushwaha(Support Engineer Civil) 2. Mr Ajay Kumar Goyal(Support Engineer Mechanical) KRML-Team 1. Mr Shriram -incharge

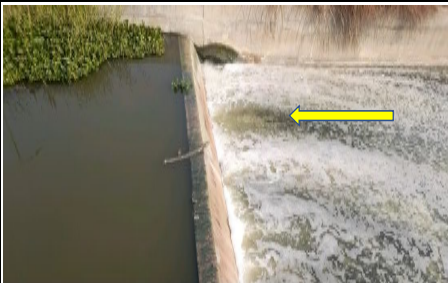
S. No.	Equipment	Assessment of Current Condition	Assessment of Current Condition Photo	Current defects and Corrective Action Suggested by STC, PE	Original Date of Issue	Proposed Date to Resolve by KRML	Current Status of Compliance
1	All work						
1	Parmiya Nala Tapping	Overflow Condition since handover date

Over flow condition found since handover. Upjn need to take action in this regards.	25.08.2021		Pending at the end of UPJN.
2	Inlet Chamber	Epoxy coating found improper in inlet chamber.

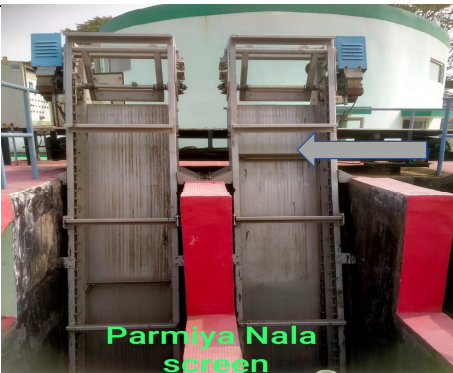
4	Coarse bar Bar Screen Chamber(2-Mechanical , 1-Manual)	Mechanical screen 1 & 2 are operational not being operated regularly whenever STC/UPJN PM visited the site it was found that both the screen were not being operated. KRMPL statred the mechanical screens and conveyor belt when asked by STC team.

<ol style="list-style-type: none"> <li>Both screens and conveyor belt need to be operated regularly.</li> <li>UPJN/STC has inspected the site but everytime mechanical screen and conveyor belts found in un-operational position. UPJN/STC asked to operator then they start mechanical screen and conveyor belt. This is false practice and it is not acceptable.</li> <li>Mechanical Screen No 1 &amp; 2 found in working condition.</li> <li>Lubrication of E&amp;M equipment no are not doing by KRMPL.</li> <li>Solid Chute is not fix at end of Conveyor belt.</li> <li>Stud bolt lubrication has not done by KRMPL</li> <li>Trolley required for garbage disposal still KRMPL has not provided.</li> <li>Sensor system need to be arranged by KRMPL.</li> </ol>	15.12.2021		Pending

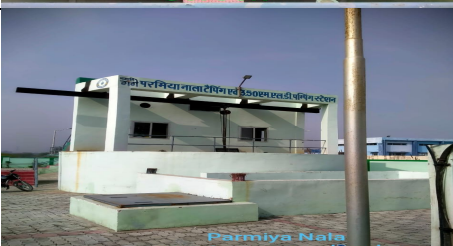
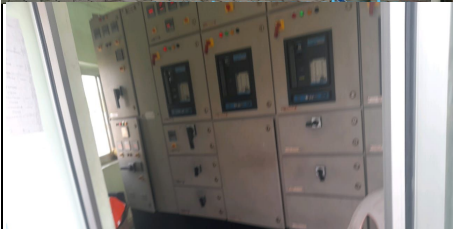
4	Pump house cum Panel room	<ol style="list-style-type: none"> <li>Horizontal and vertical cracks found in pump house structure.</li> <li>Control panel of pump no 4 found damaged.</li> </ol>

<ol style="list-style-type: none"> <li>Monorail painting work and load certification of manual Chain pully block didn't done by KRMPL.</li> <li>control panel of pump no 4 required rectification.</li> <li>Cracks Repairing work and painting work required.</li> <li>Caliberation of Flow meter need to be submitted by KRMPL.</li> </ol>	15.12.2021		Pending
i	Pump No.1 ( Capacity =170 m3/hr)	Operational

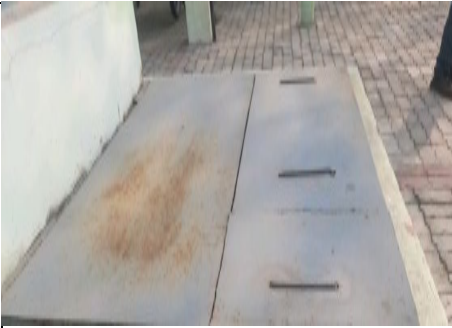
9	Valve Chamber	Frame chamber of valve chamber found rusted.

1.Red oxide primer and painting work should be done by KRML for MS cover.	15.12.2021		Pending
10	Back flow Condition	Back flow of sewerage from Parmiya Tapping shows near Culvert(Aunpriya merrage home)

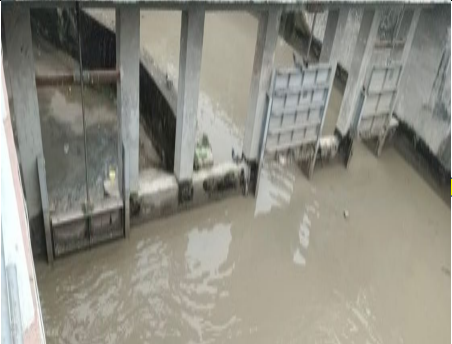
S. No.	Equipment	Assessment of Current Condition	Assessment of Current Condition Photo	Current defects and Corrective Action Suggested by STC, PE	Original Date of Issue	Proposed Date to Resolve by KRML	Current Status of Compliance
1	All work						
1	Shishamau Nala Tapping	Overflow conition not found.

No overflow condition. Sewer flow is below 100 mm from overflow condition.	15.12.2021

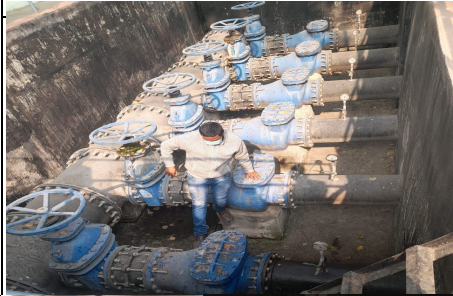
<ol style="list-style-type: none"> <li>1.pressure guage of pump no 2 is not in woking condition.</li> <li>2.Pump No 2 and Pump No 5 line and leakages.</li> <li>3. Valve and NRV directions are not visualize during operation.So KRMPL has shown the direction on as stated above.</li> </ol>	15.12.2021		Pending
7	DG set	Both DG set found operational but diesel fuel found short.

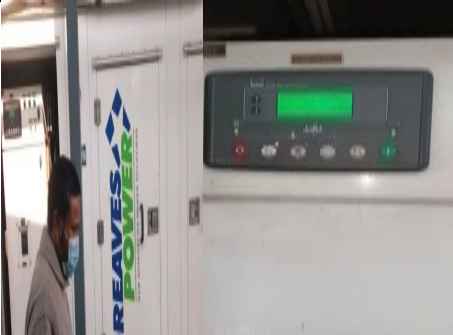
<ol style="list-style-type: none"> <li>1. Both DG set is in working condition.</li> <li>2. DG log book is not mainatining by KRMPL.</li> <li>3. Only 40% diesel available at DG set- 1 and 36% diesel available at DG set-2.</li> <li>4. 8 Nos light are functional out of 11 Nos.</li> </ol>	15.12.2021		Pending

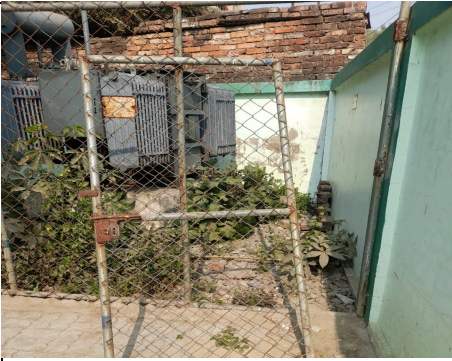
8	Transformer

<p>Transformer found operational but their entry gate is damage.</p>	<p>1. Cleaning work need to be done at Transformer yard area.</p> <p>2. Entry gate need to be repair</p>	21.12.2021		Pending
	Remarks	<p>1. CCTV installation work need to be done by KRMPL for IPS Parmiya and IPS Shishamau .</p> <p>2. Power backup need to be installed by KRMPL for flowmeter and IPSs.</p> <p>3. Painting work need to be done by KRMPL beacause acceptance criteria not fulfilled yet given below:-</p> <p>i) All painted surfaces shall be uniform and pleasing apperance.</p> <p>ii) The colour,textures etc shall match exactly with approved samples.</p> <p>iii) All stains,splashes and splatters of paint shall be removed from surrounding surfaces.</p>
