SITE INSPECTION REPORT FOR 210 MLD STP BINGAWAN				BINGAWAN STP - 210 MLD		INSPECTED BY: UPJN Team 1) Mr. Gyanand Chaudhary (PM1) 2) Mr. Ajay Kanaujia (Chemist) 3) Mr. Mahipal Singh (JE, E&M) 4) Mr. Ajit Singh (JE, Civil) STC Team: 1) Dr. Giridhar Prabhu Kr., (TL) 2) Mr. J.P. Tripathi, (O&M Expert) 3) Mr. Rohit Suman (Supp. Engr. Mech.)

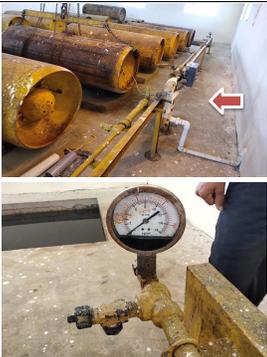
99	Chlorine Tonners (Total 20 Nos)	<p>1) Vaccum box no. 1 is not available. 2) Gas line is not clear. 3) PG is non-functional</p>

<p>1) Vaccum box no. 1 must be fixed at the earliest. 2) Gas line must be cleaned. 3) Pressure Gauge must be replaced.</p>			22.01.2022	
100	Gas Holder No.01	<p>Non Operational When UPJN & STC officials visited site, non of KRMPPL technical personnel were present at site to assist and elaborate the defects and get the gas holder alignment checked by UPJN & STC officials.</p>		<p>1) Gas level indicaor is missing . 2) Pressure guage shall be install 3) Gas holder alignment must get inspected by UPJN & STC.</p>			28-01-2020	LONG PENDING
101	Gas Holder No.02	<p>Operational</p>

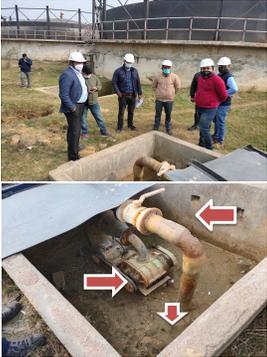
<p>1) Gas level indicaor is missing. 2) Pressure guage shall be install.</p>				PENDING
102	Gas Blower	<p>Non Operational 1) At the time of visit, blower was found not working. 2) Leakage was observed through the gas valves etc. 3) Various Nut-bolts were found missing. 4) MCB box was found lying on mud. 5) Blower chamber was found filled with mud. 6) No Cover/ Canopy was found over blower.</p>

<p>1) Need to be rectified at the earliest. 2) Leakage must be fixed. 3) Missing nut-bolts must be installed. 4) On Site panel box must be installed. 5) Blower Chamber must be cleaned. 6) Canopy/ Cover must be provided</p>			26.11.2021	LONG PENDING

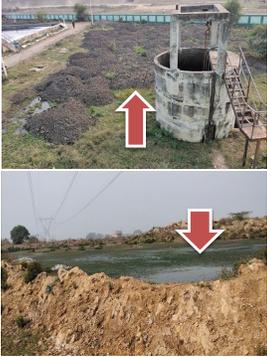
Needs to be painted	26.11.2021 (Since long back)		Long Pending
114	Sludge Disposal	When STC / UP Jal Nigam team reached the site, we found the sludge was being disposed beside BFP building and various other locations on the ground without any permission. As instructed by ED (Technical) on 08.10.2021 that sludge disposal is to be done as per norms of UPPCB. UPPCB vide their letter no. 1386/5-658/21 dated 04.12.2021 also instructed KRMPPL to dispose the sludge as per the norms but still sludge is being disposed on the ground at an inappropriate place.

Sludge disposal must be done as per UPPCB norms.	01.12.2021		LONG PENDING
115	Final Polishing Unit 1 & 2	When UP, JN & STC officials reached the site, it was found that FPU lagoons are completely filled with sludge
