<div>STC</div> <div>SITE INSPECTION OF JAJMAU ASSOCIATED IPS REPORT</div>					Nawabganj IPS 15 MLD	Date: 4/01/2022	INSPECTED BY: UPJN Representative Mr Ajeet Singh-Jen Civil Mr Ashish Shrivastava-Jen E&M STC Representatives 1. Mr Ajay Goyal-Support Engineer Mechanical 2. Mr Anuj Kushwaha-Support Engineer Civil 3. Mr Rahul Sarwan- Support Engineer - Electrical KRMPL Representatives 1. Mr Sri Krishna, Plant-InCharge

</div> <div> <p>SITE INSPECTION OF JAJMAU ASSOCIATED IPS REPORT</p> </div>					Permat IPS	Date: 4/01/2022	INSPECTED BY: UPJN Representative Mr Ajeet Singh-Jen Civil Mr Ashish Sheyal-Jen E&M STC Representaatives 1. Mr Ajay Goyal-Support Engineer Mechanical 2. Mr Anuj Kushwaha-Support Engineer Civil 3. Mr Rahul Sarwan- Support Engineer - Electrical KRMPL Representatives 1. Mr Sri Krishna, Plant-InCharge

<div>STC</div> <div>SITE INSPECTION OF JAJMAU ASSOCIATED IPS REPORT</div>					Baba Ghat -7 MLD	Date: 4/01/2022	INSPECTED BY: UPJN Representative Mr Ajeet Singh-Jen Civil Mr Ashish Sheyal-Jen E&M STC Representaives 1. Mr Ajay Goyal-Support Engineer Mechanical 2. Mr Anuj Kushwaha-Support Engineer Civil 3. Mr Rahul Sarwan- Support Engineer - Electrical KRMPL Representatives 1

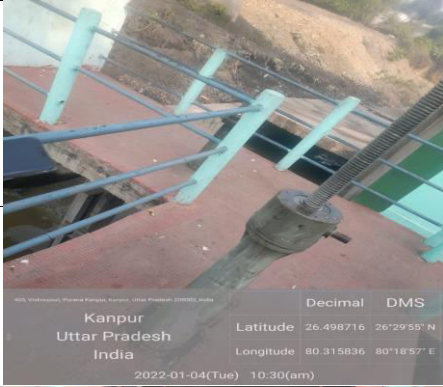
S. No.	Equipment	Assessment of Current Condition	Assessment of Current Condition Photo	Current defects and Corrective Action Suggested by STC, PE	Original Date of Issue	Proposed Date to Resolve by KRMPL	Current Status of Compliance
1	All work						
1	Inlet Over Flow Condition	Overflow condition found

1. During site visit overflow is continue since handover 28.06.2021. 2. No action taken by KRMPL after several times informed by MMCG, UPJN and STC representatives. 3. Under renovation of IPS Nawabganj, KRMPL need to stop overflow condition of sewage by increasing adequate pumping.	28.06.2021		Long Pending
2	Inlet Chamber	1. Cleaning of inlet chamber need to be done. 2. Staircase damaged tile need to renovate.

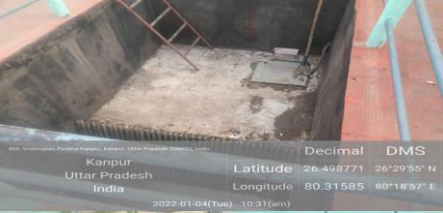
1. Cleaning of inlet chamber need to be done. 2. Staircase damaged tile need to renovate.	23.11.2021		Pending
3	Screen Chamber	1. Garbages was available.

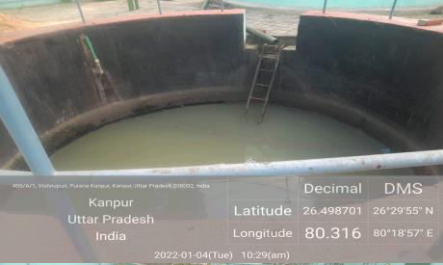
1. Garbage cleaning work need to be compulsory. 2. Garbages Trolley need to be available at site.	23.11..2021		Pending

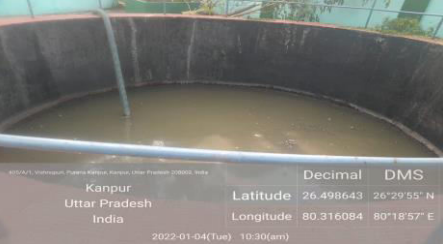
4	Receiving Chamber 1	Overflow condition found since handover

1. Proper pumping arrangement need to be done by KRMPL. 2.Receiving chamber need to be clean. 3. After cleaning work of this chamber required renovation work need to be done.	28.06.2021		Long Pending
5	Receiving Chamber 2	Overflow condition found since handover		1. Proper pumping arrangement need to be done by KRMPL. 2.Receiving chamber need to be clean. 3. After cleaning work of this chamber required Renovation work need to be done. 4. KRMPL is using 20HP submersible pump for dewatering this chamber but this is insufficient pumping.	28.06.2021		Long Pending

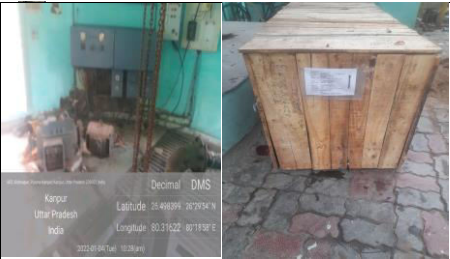
6	Pump House No.1	Civil Structure in unsatisfactory Condition

<p>1.Surface roof treatment is pending for Pump house.</p> <p>2.All indoor lightening need to be replaced.</p> <p>3. Exhaust fan 2 Nos need to be replaced.</p> <p>4. Cable to be lay in the cable tray properly.</p> <p>5. KRMPL has painted the pump house no 1 with poor workmanship. This should be rework.</p> <p>6. Log book is not proper maintaining by KRMPL staff as per prescribed format.</p> <p>7. New 3 Nos of pumps have recieved at site on 31.12.2021 for Pump House 01. (2 Nos. 300cum/hr and 1 Nos 156 cum/hr).</p> <p>8. Flow meter need to be installed by KRMPL.</p> <p>9. 2 Nos light is not working.</p> <p>10. Foundation work of pump house 01 need to be start by KRMPL.</p> <p>11. Electrical hoist need to be replaced as per renovation plan.</p>	23.11.2021		Pending
i	Pump no.1 (Capacity ~297 m3/hr)	Pumps found functional

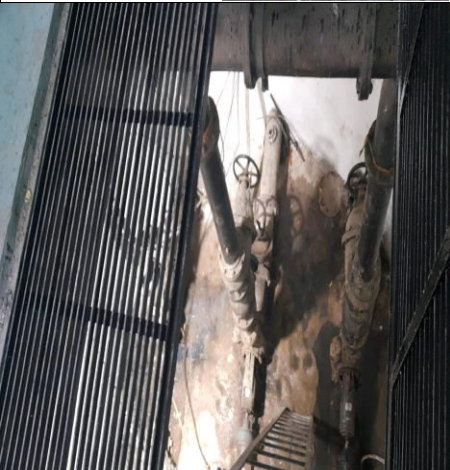
Need to be replaced as per Renovation Plan	23.11.2021		Pending

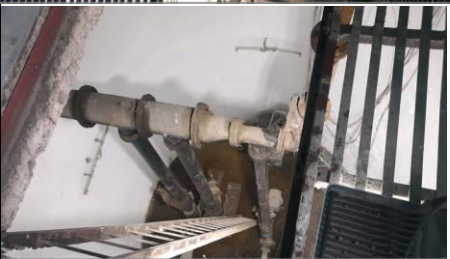
<p>1.Surface roof treatment is pending for Pump house</p> <p>2. Conseeionare is using this room as a store room stacking of Cement bags and diesel drum.</p> <p>3. Exhaust fan 2 nos needs to be replaced.</p> <p>4. Tube light 1 nos need to be replaced.</p> <p>5. Pump House pump. found not to be working.</p> <p>6.KRMPL has done painting work inside and outside of the pump house no 1 with poor workmanship. This should be rework.</p> <p>7. KRMPL had promised to UPJN/STC. Three New Pumps installation work in Pump house No 2 on 28.12.2021 but KRMPL has not statred the RCC foundation work for pumps.UPJN and STC is monittrng the above activity on regular basis but KRMPL did not any action regarding installation.</p> <p>8. Electrical hoist need to be replaced as per renovation plan.</p>	23.11.2021		Pending

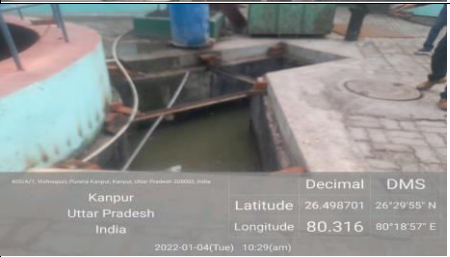
8	Open Channel and Sluice Gate	Civil Structure in unsatisfactory Condition

<p>1. M.S fabrication work done but not covered on drain.This may cause any accident.</p> <p>2. KRMPL has not submitted and approval of fabrication work.</p> <p>3. Sluice gate need to be replace under renovation.</p>	23.11.2021		Pending

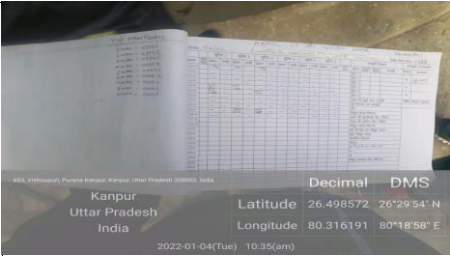
14	Logbook	Log book of pump house 01 not maintained by KRMPL

1. KRMPL need to maintained logbook for pumps. 2. Log book of DG set need to maintained properly. 3. KRMPL need to maintain and inform UPJN and PE for Material Register. 4. KRMPL need to maintain Visitor Register. 5. Security guard need to be deploy. 6. No labour deploy by KRMPL for renovation work. 7. Operators are non technical person. They are not understanding the Pump Capacity , Flow of Discharge, Peak Flow and maintain the records.	4.1.2022		Pending
<div>

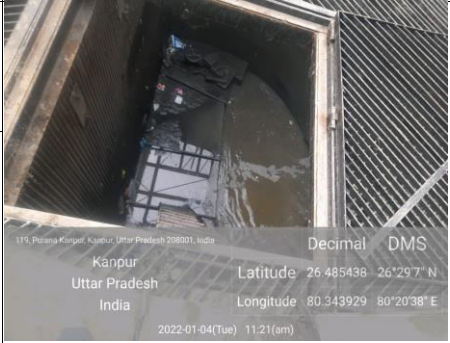
1. Renovation required inner and outer surface of this chamber. 2. Plaster work need to be done. 3. Cleaning and landscaping need to be done. 4. M5 frame cover should be painted.	23.11.2021		Pending
3	Receiving Chamber	Civil Structure is in satisfactory condition

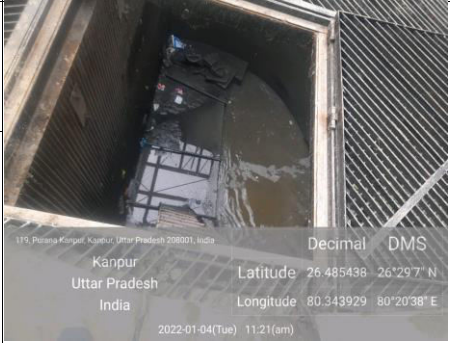
1. Renovation required inner and outer surface of this chamber. 2. Plaster work need to be done. 3. Cleaning and landscaping need to be done. 4. M5 frame cover should be painted. 5. KRMPL O&M incharge shows their unethical behaviour with STC and UPJN when we asked the sump level.	23.11.2021		Pending

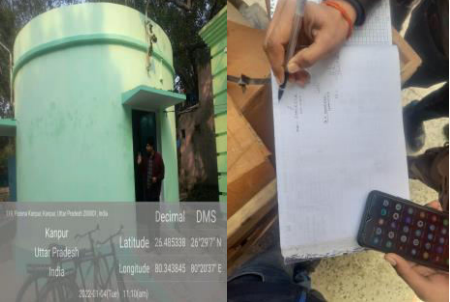
4	Pump house No. 1	Civil Structure is in unsatisfactory condition

1. Painting work carried out by KRMPL for Outer and inner surface of Pump house but workmanship found very poor. These all are represent improper quality of painting work. 2. Required repairing the cracks., 3.Replacement of damaged Door,window,louvers and ventilators. 4. Outdoor lighteninging 6 Nos need to be replced. 5. DG set is not working for Pump house 01. 6. Log book is not proper maintaining by KRMPL staff with all required details because as per their logbook flow is 57.6 MLD while KRMPL provided daily report 52 MLD for 31th Dec 2021 report. 7. Flow meter need to be installed by KRMPL. 8. Dewatering pumps need to be arrange at bottom of Pump house. 9. Flooring work need to be carried out by KRMPL. 10. Internal lightening arrangement need to be replaced for DG set room of Pump house 01. 11. Operators are non technical person. They are not understanding the Pump Capacity , Flow of Discharge, Peak Flow and maintain the records.	23.11.2021		Pending

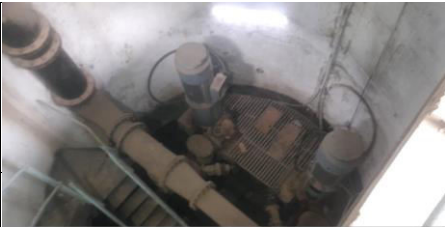
i	Pump No.1(pump capacity =900 m3/hr)	Pump found operational

Need to be replaced as per Renovation Plan	23.11.2021		Pending
ii	Pump No.2(pump capacity =900 m3/hr)	Pump found operational

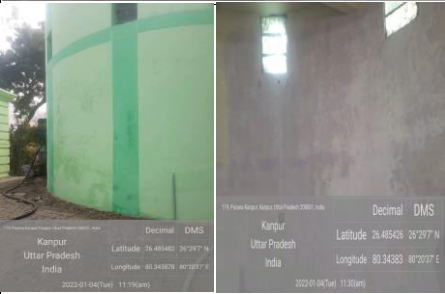
<ol style="list-style-type: none"> No labour engaged by KRMP for renovation work. Painting work need to be rework with proper workmanship and material as per recommended by UPIN and PE. KRMP did not submit any work plan, Methodology and material approval form PE / UPIN. Required repairing the cracks, Finishing activity painting work, Replacement of damaged Door, window, louvers and ventilators. All indoor lightening need to be replaced. Dewatering pumps need to be arrange at bottom of Pump house. Flooring work need to be carried out by KRMP. Flow meter need to be installed by KRMP. Operators are non technical person. They are not understanding the Pump Capacity, Flow of Discharge, Peak Flow and maintain the records. 	15.12.2021		Pending

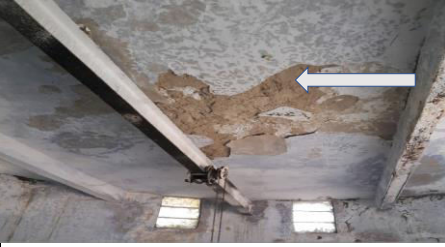
<ol style="list-style-type: none"> Required repairing the cracks, Finishing activity painting work, Replacement of damaged Door, window, louvers and ventilators. Pump 3 Nos found not in working condition. 	23.11.2021		Pending

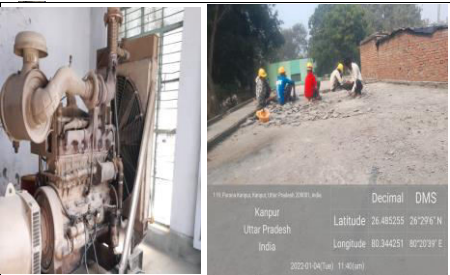
7	DG room	Civil Structure is in unsatisfactory condition

1. Required repairing the cracks, Finishing activity painting work, Replacement of damaged Door, window, louvers and ventilators. 2. KRMPL engaged 5 labours for roof renovation work. 3. KRMPL did not submit any work plan to renovate the roof treatment work. 2. KRMPL is not maintaining the log book of DG set.	23.11.2021		Pending
8	Metering room	Civil Structure is in unsatisfactory condition		1. Required repairing the cracks, Finishing activity painting work, Replacement of damaged Door, window, louvers and ventilators	23.11.2021		Pending
9	Panel Room	Civil Structure is in unsatisfactory condition

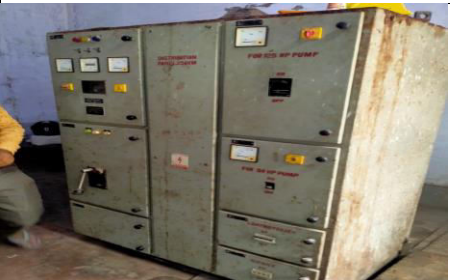
1. Required repairing the cracks, Finishing activity painting work, Replacement of damaged Door, window, louvers and ventilators. 2. Panel Volt meters and Ammeters need to be replaced. 3. All Phase Indicator need to be replaced.	23.11.2021		Pending

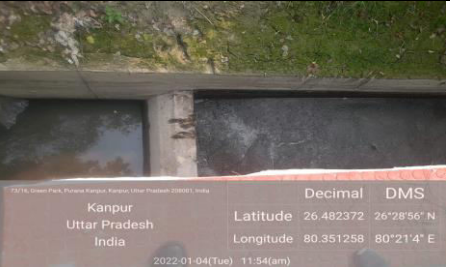
1. During site visit it was found that there are no Overflow or Bypass of sewage found.	4.01.2022		Pending

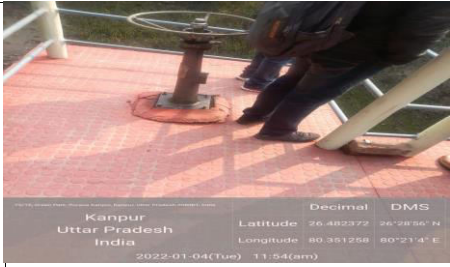
2	Inlet Chamber (Civil)	Civil Structure is in satisfactory condition

Kanpur Uttar Pradesh India Decimal Latitude: 26.482372, Longitude: 80.351258 DMS Latitude: 26°28'56" N, Longitude: 80°21'4" E 2022-01-04(Tue) 11:54(am)	1. All gates need to be lubrication. 2. Sludge need to be remove from inlet part of IPS.	23.11.2021		Pending
3	Screen Chamber	Civil Structure is in satisfactory condition	  Kanpur Uttar Pradesh India Decimal Latitude: 26.482308, Longitude: 80.351228 DMS Latitude: 26°28'56" N, Longitude: 80°21'4" E 2022-01-04(Tue) 11:54(am)	1. Garbages removal work should be done on regular basis. 2. Trolley need to be available at side for disposal of gargaes.	23.11.2021		Pending
4	Receiving chamber	Civil Structure is unsatisfactory condition.	  Kanpur Uttar Pradesh India Decimal Latitude: 26.482414, Longitude: 80.351239 DMS Latitude: 26°28'56" N, Longitude: 80°21'4" E 2022-01-04(Tue) 11:55(am)	1. Chamber need to be clean and cover properly. 2. All valves need to be replace. 3. All stud bolts and gasket need to be replace. 4. Lubrication for valves and pumps ,sluice gates need to be done by KRMPL. 5. Pressure guage need to be provided by KRMPL.	15.12.2021		Pending

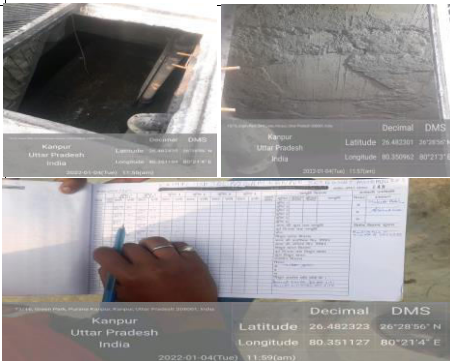
5	Pump House	Civil Structure is in good condition.

Kanpur Uttar Pradesh India Decimal Latitude: 26.482323, Longitude: 80.351127 DMS Latitude: 26°28'56" N, Longitude: 80°21'4" E 2022-01-04(Tue) 11:59(am)	1. Exposure of steel in staircase bottom slab need to be renovate. 2. Inside the pump house, Light is not working. 3. EOT load test required by KRMPL. 4. Flow meter need to be installed by KRMPL. 5. Log book is not proper maintaing by KRMPL staff at site with all details. 6. Staircase is in bad condition and need to be renovate. 7. Cable dressing need to be done properly. 8. Operators are non technical person. They are not understanding the Pump Capacity , Flow of Discharge, Peak Flow and maintain the records.	23.11.2021		Pending
i	Pump no.1(Capacity=309 m3/hr)	Operational	 	1. Pump No 1 is not in woking condition. 2. Need to be replaced as per Renovation Plan	15.12.2021		Pending

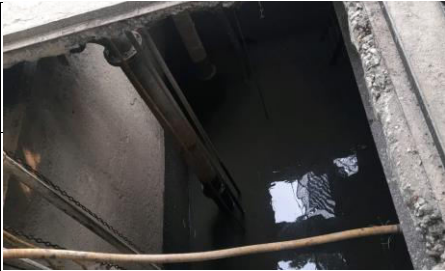
ii	Pump no.2(Capacity=309 m3/hr)	Operational

Need to be replaced as per Renovation Plan	23.11.2021		Pending
iii	Pump no.3(Capacity=168 m3/hr)	Operational

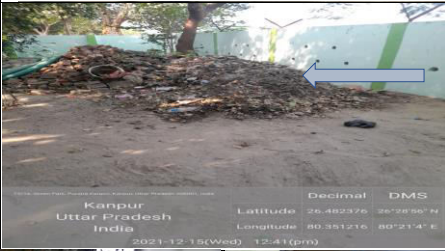
Need to be replaced as per Renovation Plan	23.11.2021		Pending
6	Boundary wall and landscaping area	Civil Structure is in good condition.

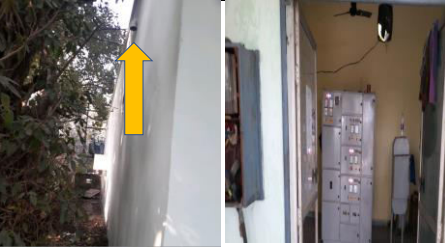
Kanjur Uttar Pradesh India Latitude 26.482374 Longitude 80.351216 2021-12-15(Wed) 12:41(pm)	1. Fencing work is pending. 2. Total 2 Nos of light is in working condition out of 10 Nos. 3. Security guard need to be arrange by KRMPL. 4. Cleaning work need to be carried out by KRMPL.	23.11.2021		Pending
7	Panel Room	Structure is in unsatisfactory condition

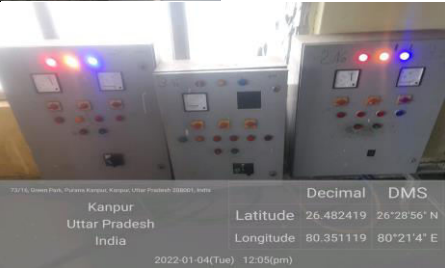
1. Front door glass need to be repair. 2. Panel Volt meters and Ammeters need to be replaced. 3. All Phase Indicator need to be replaced. 4. Rain water pipe need to be fixed.	23.11.2021		Pending
8	DG Room	Civil Structure is in good condition.

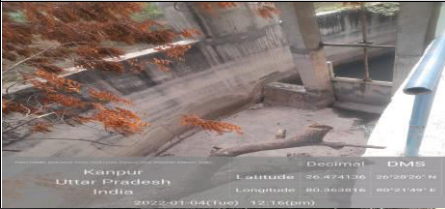
During site visit it was found that there are no Overflow/Bypass of sewage not found as on 4.1.2022	4.0.2022		Pending
2	Inlet Chamber	Civil Work is in satisfactory Condition

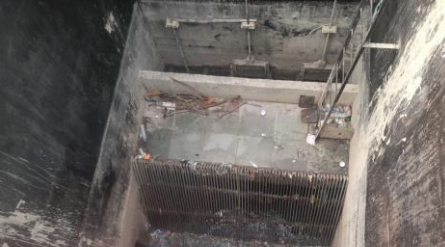
1. All gates need to be lubrication.	15.12.2021		pending
3	Manual bar Screen Chamber	Civil Work is in satisfactory Condition

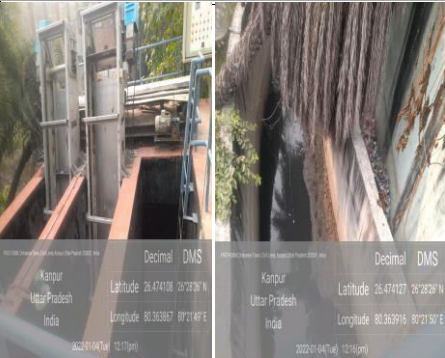
1. Screen No. 1 , Chain is not in proper alignment. 2. Auto System and level sensor meter is not in woking condition. 3. Screen panel On/Off main power selector switch has been found in not working properly. 4. Screen No. 2 is in working condition. 5. Conveyor belt is in working condition. 6. Garbages need to be remove on regularly. 7. Garbage trouly need to be available at Site. 8. All leakages of Oil need to be repair. 9. Conveyor belt is not working in auto mode. 10. Screen No 1 is not working in manual mode.	15.12.2021		pending

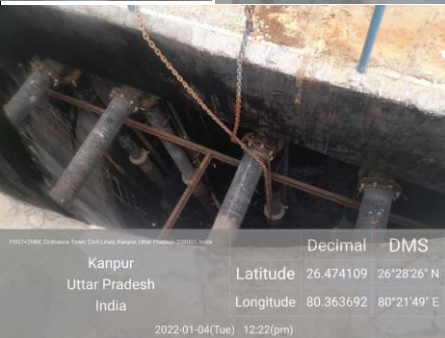
5	Pump House	Civil Work is in satisfactory Condition

1. Pump No 1,2 and 4 is in working condition. 2. Electricity connection is pending for motor of Pump No 3 3. EOT crane painting work is pending and Test certificate of load test also required. 4. Only 2 Nos of light is in woking condition out of 6 Nos in IPS campus. 5. Operators are non technical person. They are not understanding the Pump Capacity , Flow of Discharge, Peak Flow and maintain the records.	23.11.2021		pending

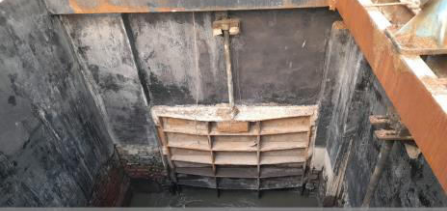
<p>CGEP+RQHL Jajmau, Kanpur, Uttar Pradesh 208006, India</p> <p>Decimal DMS</p> <p>Kanpur Latitude 26.417152 26°25'1" N</p> <p>Uttar Pradesh Longitude 80.42465 80°25'28" E</p> <p>India</p> <p>2022-01-04(Tue) 04:22(pm)</p>	1. Proper barricade required. 2. Cleaning work need to be done. 3. Balance renovation work need to be done by KRMPL. 4. 2 Nos gate to be replaced as per CA schedule 11 . 5. Bypass gate gear system is in working condition .	16.12.2021		Pending
1	Receiving chamber-1	Civil work is in satisfactory condition

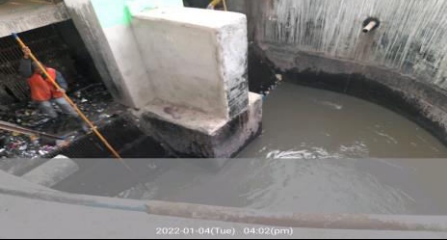
<p>2022-01-04(Tue) 04:02(pm)</p>	1. Cleaning work need to be done. 2. Balance renovation work need to be done by KRMPL. 3. Hand rail need to be repair. 4. Level marking work need to be done by KRMPL.	23.11.2021		Pending

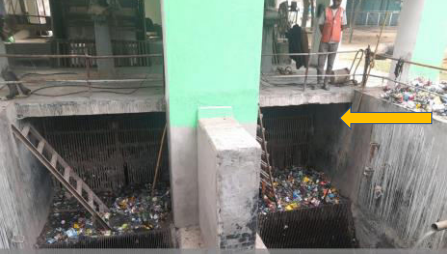
2	Manual bar Screen Chamber	Civil work is in satisfactory condition

1. Garbages need to be remove regularly. 2. KRMPL is dumping the garbage in CSPS Jajmau Campus. 3. Balance renovation work need to be done. 4. MS screen need to be replace. 5. Plaster work need to be done with proper quality. 6. Garbage trolley need to be available at site	16.12.2021		Pending
3	Mechanical Coarse Screen chamber	Civil work is in satisfactory condition

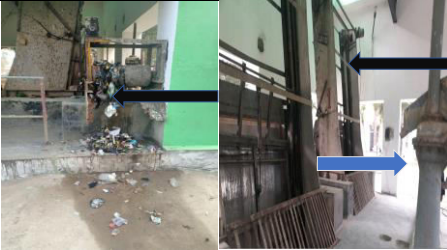
1. Mechanical No 1 is in working condition. 2. Mechanical No 2 is not in working condition. 3. Sluice gate at Inlet and Outlet need to be replaced. 4. Garbages need to be remove regularly. 5. Painting work need to be done with proper workmanship for inside and outside of building. 6. Electric switch board need to be repair. 7. Drain water pipe need to be fixed. 8. Cleaning and landscaping work need to be done. 9. Coveyor belt chute need to be replaced by KRMPL.	23.11.2021		Pending

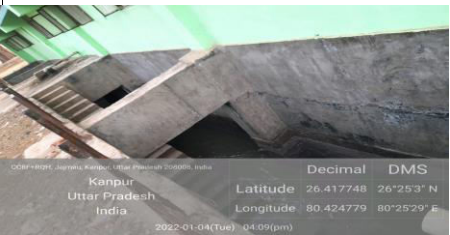
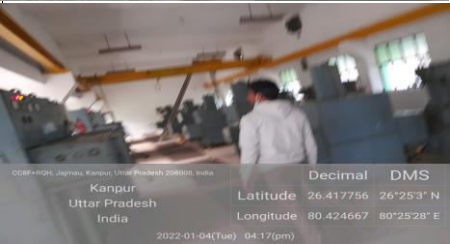
5	Pump House	Civil work is in unsatisfactory condition

<p>1. Renovation work is in under progress.</p> <p>2. Broken glass of window, door need to be repair.</p> <p>3. Indoor 14 Nos lightening work need to be replaced.</p> <p>4. CCTV camera need to be replaced / Repair.</p> <p>5. Panel Volt meters and Ammeters need to be replaced.</p> <p>6. All Phase Indicator need to be replaced.</p> <p>7. EOT painting ongoing without approval and EOT load test has not conducted by KRML.</p> <p>8. Vibration has not checked by Operator on regular basis.</p> <p>9. Log book is not proper maintain by KRML staff as per prescribed format.</p> <p>10. 1 Nos is in working condition out of 2 Nos of dewatering pumps.</p> <p>11. Total 14 Nos of light available at CSPS but it was not in working condition, it should be replace as per Contract.</p> <p>12. Rain water pipe need to be fixed.</p> <p>13. Out of 7 Nos of pumps installed, 6 Nos of pumps are in working condition.</p> <p>14. Operators are non technical person. They are not understanding the Pump Capacity, Flow of Discharge, Peak Flow and maintain the records.</p>	23.11.2021		Pending

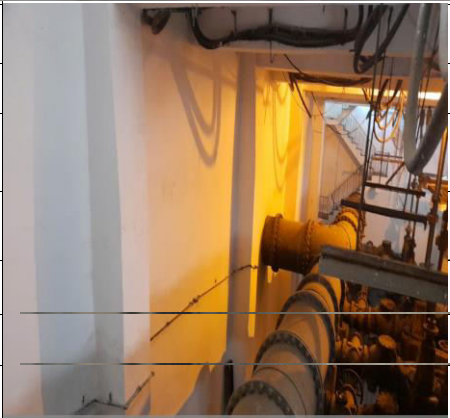
I	Pump no.1 (Capacity 2160 m3/hr)	Non Operational

1. Need to be replaced as per Renovation Plan	14.08.2021		Pending
II	Pump no.2 (Capacity 2160 m3/hr)	Operational		1. Need to be replaced as per Renovation Plan	13.12.2021		Pending
III	Pump no.3 (Capacity 2160 m3/hr)	Operational		1. Need to be replaced as per Renovation Plan	23.11.2021		Pending
IV	Pump no.4 (Capacity 2160 m3/hr)	Operational		1. Need to be replaced as per Renovation Plan	23.11.2021		Pending
V	Pump no.5 (Capacity 2160 m3/hr)	Operational		1. Need to be replaced as per Renovation Plan. 2. Heavy vibration in pump need to be repaired	23.11.2021		Pending
VI	Pump no.6 (Capacity 2160 m3/hr)	Operational		1. Need to be replaced as per Renovation Plan	23.11.2021		Pending
VII	Pump no.7 (Capacity 2160 m3/hr)	Operational		1. Need to be replaced as per Renovation Plan	23.11.2021		Pending
6	Substation building	Operational

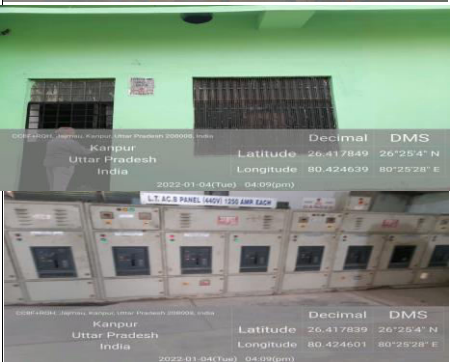
<p>1. 11KV HTVCB panel to be replaced.</p> <p>2. LT A.C.B panel 440 V found non functional.</p> <p>3. All light to be replaced in sub station.</p> <p>4. All store material dumped in substation building.</p>	16.12.2021		Pending

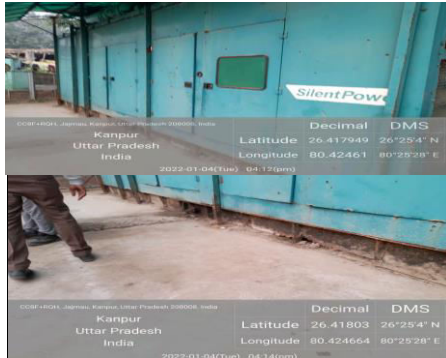
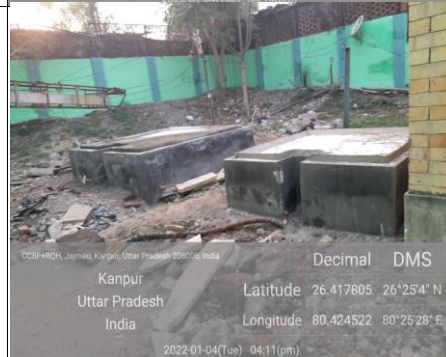
7	DG yard	Operational	<div>

<div><div>DCB#4R02L, Jaipur, Kanpur, Uttar Pradesh, 200000, India</div><div><div>Kanpur</div><div>Uttar Pradesh</div><div>India</div></div><div><div>Latitude</div><div>26.41803</div><div>26°25'4" N</div></div><div><div>Longitude</div><div>80.424664</div><div>80°25'28" E</div></div><div>2022-01-04(Tue) 04:17(pm)</div></div></div><td><div>1. DG set is in working condition when it was checked coolant is need to fill.</div><div>2. MS base frame need to be replace.</div><div>3. DG yard need to be clean.</div><div>4. Log book need to be maintain for DG set.</div></td><td>4.1.2022</td><td>Pending</td></div>	<div>1. DG set is in working condition when it was checked coolant is need to fill.</div> <div>2. MS base frame need to be replace.</div> <div>3. DG yard need to be clean.</div> <div>4. Log book need to be maintain for DG set.</div>	4.1.2022	Pending

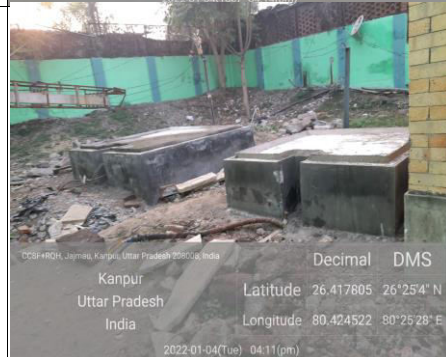
8	Transformer Yard	Operational	<div>

<div><div>DCB#4R02L, Jaipur, Kanpur, Uttar Pradesh, 200000, India</div><div><div>Kanpur</div><div>Uttar Pradesh</div><div>India</div></div><div><div>Latitude</div><div>26.417805</div><div>26°25'4" N</div></div><div><div>Longitude</div><div>80.424522</div><div>80°25'28" E</div></div><div>2022-01-04(Tue) 04:11(pm)</div></div></div> <td><div>1. Transformer foundation done by KRMPL but the didi not provide any inspection information during RCC work .</div><div>2. Renovation of Transformer yard need to be done.</div></td> <td>16.12.2021</td> <td>Pending</td>	<div>1. Transformer foundation done by KRMPL but the didi not provide any inspection information during RCC work .</div> <div>2. Renovation of Transformer yard need to be done.</div>	16.12.2021	Pending
9	Boundary wall	Civil work is in unsatisfactory condition	<div>

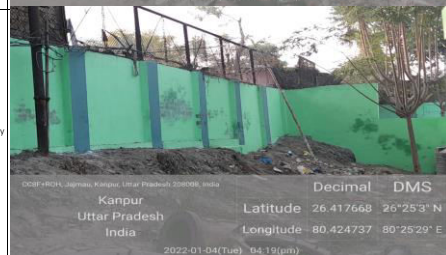
<div><div>DCB#4R02L, Jaipur, Kanpur, Uttar Pradesh, 200000, India</div><div><div>Kanpur</div><div>Uttar Pradesh</div><div>India</div></div><div><div>Latitude</div><div>26.417668</div><div>26°25'3" N</div></div><div><div>Longitude</div><div>80.424737</div><div>80°25'29" E</div></div><div>2022-01-04(Tue) 04:19(pm)</div></div></div> <td><div>1. Poor workmanship and material did not done by KRMPL. Rework is required</div><div>2. Landscaping area need to be clean.</div></td> <td>4.1.2022</td> <td>Pending</td>	<div>1. Poor workmanship and material did not done by KRMPL. Rework is required</div> <div>2. Landscaping area need to be clean.</div>	4.1.2022	Pending

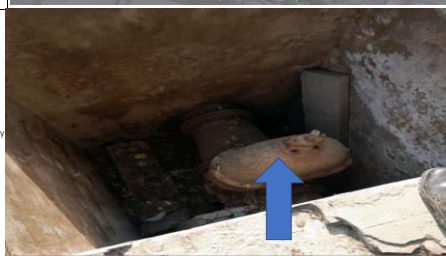
10	Sluice valve Chamber	Civil work is in unsatisfactory condition	<div>

</div>	<div>1.Discharge line chamber should be cover with frame cover.</div> <div>2. Internal cleaning need to be done.</div> <div>3. Internal plaster work need to be done.</div> <div>4. Valve need to be replaced as per approved renovation plan.</div>	23.11.2021	Pending
<div>Remarks:- A). Internal and External Painiting work (for Structures and Buildings):- KRMPL did not work properly by which it is not acceptable and Painting work does not fulfill acceptance criteria of Painting specification as per CA</div> <div>1. All painted work surfaces shall be uniform and pleasing in appearance.</div> <div>2.The colour ,texture etc shall match exactly with the approved samples.</div> <div>3. All stains, splashes and slatters of paints shall be removed form surrounding surfaces.</div> <div>KRMPL need to take necessary action for proper Painting work.</div> <div>B) All E&M equipments need to be replaced as per CA schedule 11.</div>				<div>Signature:</div> <div>TEAM LEADER</div> <div>STC KANPUR</div> <div>
