SITE INSPECTION REPORT FOR 43 MLD JAJMAU PHASE-II STP

JAJMAU PHASE-II
STP - 43 MLD

Inspection Date: 18.1.2022

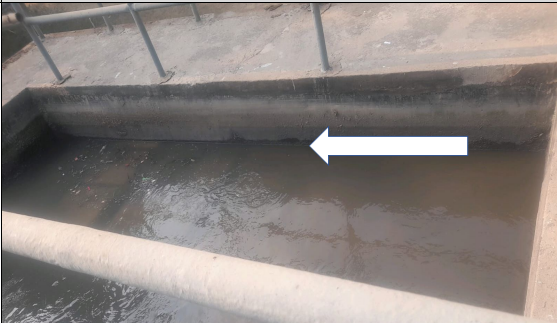
S. No.	Equipment	Assessment of Current Condition	Assessment of Current Condition Photo	Corrective Action Suggested by STC	Original Date of Issue	Proposed Date to Resolve by KRMPL	Current Status of Compliance
A	Inlet Chamber	1.Intel chamber painting for internal and external surfaces are not satisfactory. 2.Lubrication of sluice gate not done. 3.Cleaning work of chamber is pending.

1. Chamber and hand railing painting work need to be done. 2. Sluice gate need to be lubrication 3. Cleaing of inlet chamber need to be done.	21.09.2021		Pending.
1	Fine Screen No.1(Mecahnical)	Opertaional

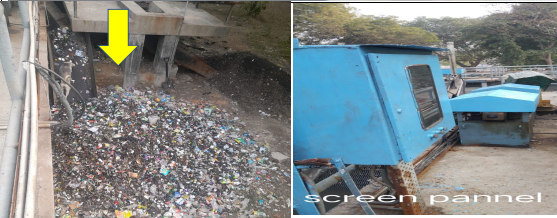
2	Fine Screen No.2 (Mecahnical)	Not Operational (Fine screen no 2 found not in proper operation)

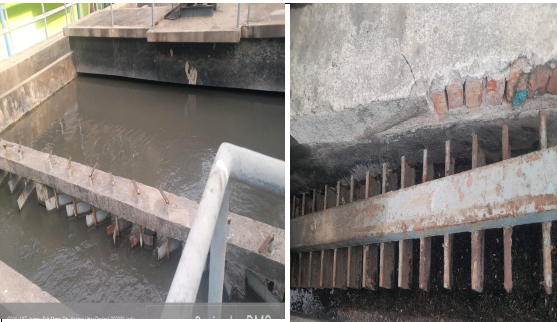
1	Grit chamber-1 1)Organic pump withMotor 2)Scraper 3)Classifier Mechanism	Classifier system is not in proper operation.

<ul style="list-style-type: none"> 1. Grit removal system is functional but classifier system is not functional since handover and ED(Projects) also instructed to KRMPL for taken action. 2. Painting needs to be done to equipment / covers wherever rusting. 3. Organic pump need to be repaired. 4. Cable tray need to be painted. 5. All E&M equipments shall be lubricate on regular basis and maintain the log book at site. 6. Log book need to be maintained 	30.09.2021		Pending
C	Inlet flow meter	Operational

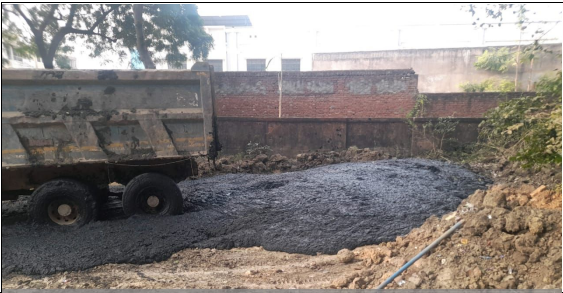
M	Landscaping work	Sludge disposed found in Campus area by KRMPL.

<p>1. KRMPL is being dispose the sludge in STP campus area.</p> <p>2. ED (Technical) visited on 07.10.2021 directed to KRMPL to dispose the sludge as per UPPCB/ NGT norms</p>	07.10.2021		Pending
Remarks:-			<p>1. At the time of power failure there are no power backup is available from E has been shutting down the STP which has deteriorated process of the 43 MLD STP plant.</p> <p>2. CCTV cameras required to installed immediately at centrifuge equipments as agreed by KRMPL.</p> <p>3. Both the dosing pumps are not proper dosing ,Poly electrolyte. Therefore pumps need to replaced and rectify the issues.</p> <p>4. Landscaping work need to be done by KRMPL.</p> <p>5. All mechanical,electrical and instrumentation equipments need to be functional properly.</p> <p>6. Painting work need to be done by KRMPL beacause acceptance criteria not fulfilled yet given below:-</p> <p>i) All painted surfaces shall be uniform and pleasing apperance.</p> <p>ii) The colour,textures etc shall match exactly with approved samples.</p> <p>iii) All stains,splashes and splatters of paint shall be removed from surrounding surfaces.</p>
