SITE INSPECTION REPROT

PANKHA 30 MLD STP

Date of Inspection	08/01/2022
PE Inspection Team & KRMPL Personnel	Mr. Sunil Basutkar – Mechanical Expert, STC Kanpur Mr. Rohit Suman-Support Engineer-Mechanical, STC Kanpur Mr. Rahul- Support Engineer- Electrical, STC Kanpur Mr. Satendra Sharma - Support Engineer- Civil, STC Kanpur ----- Mr. Shawaz - Mechanical Engineer Mr. Raman Kundu – Electrical Engineer, KRMPL Kanpur
LOCATION	STP 30 MLD PANKHA

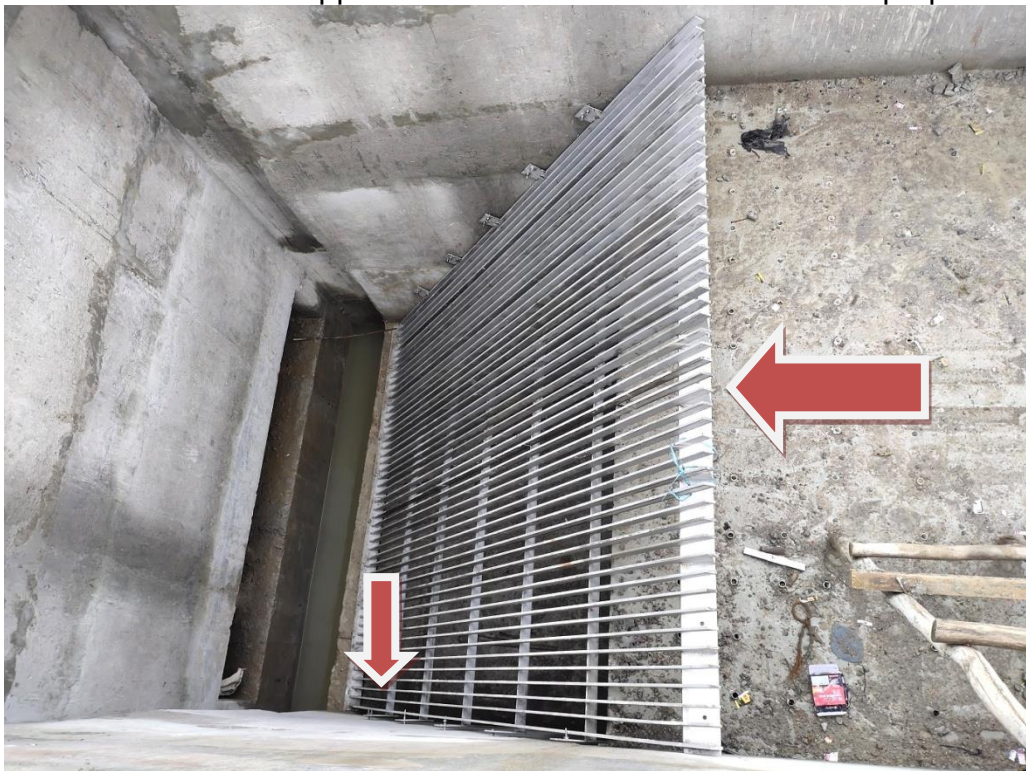
1. Manual Screen (I&D Thermal Nala A):

- Installation of manual screen was not found as per the drawing, the differences as under;
- Anchor fasteners were found missing at several places.
- Upper section of the manual screen was found approx 1 ft. above RCC slab which should suppose to fix at the level of RCC slab for proper fixing.

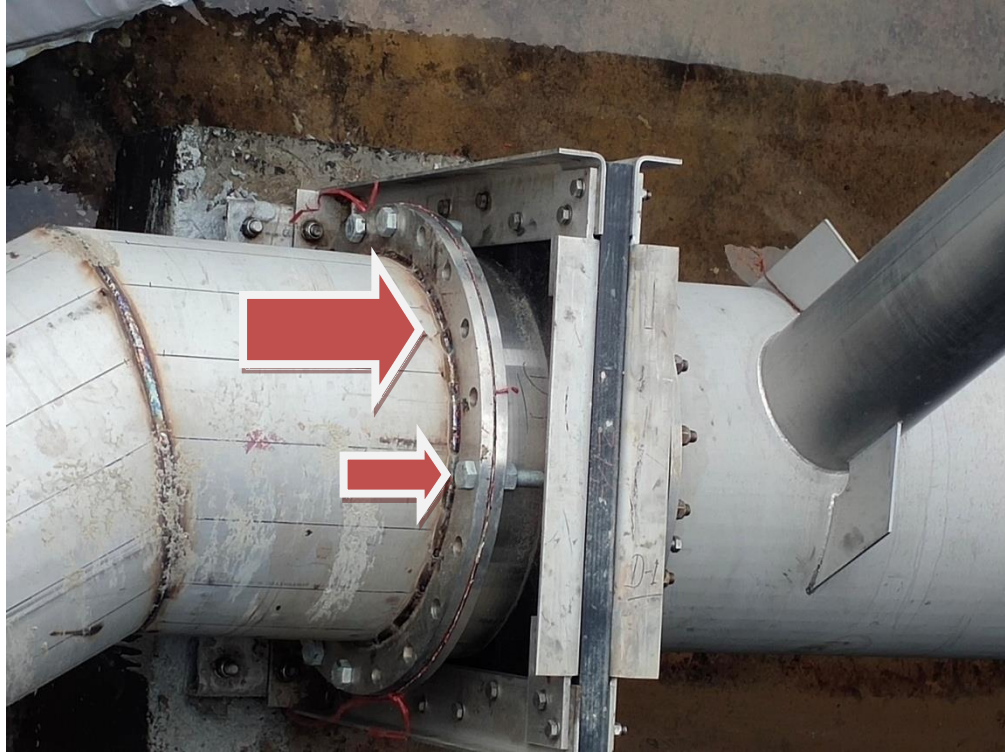
- KRMPL has to submit the specification of the gasket used in the installation for review.
- SS 316/ 304 nut bolts were found missing at various places and on some places GI nut bolts were found which is not acceptable. Nut-bolts were found in loose condition at various places.

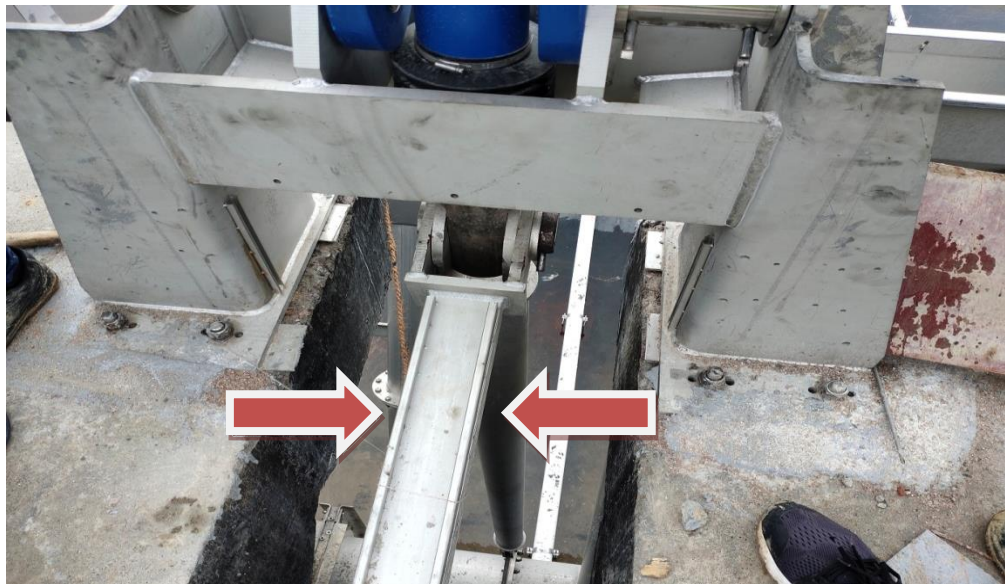
- Switches and sensors were not found installed at respective place.

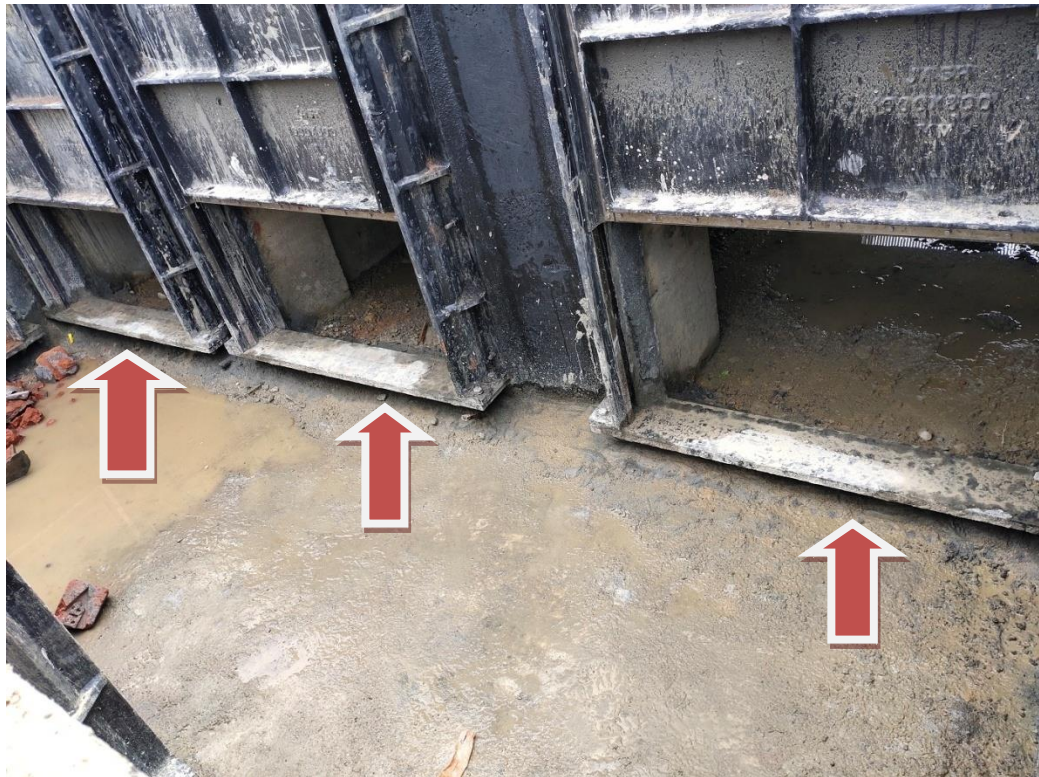
3. PTU & Grit Mechanism Gates:

- Gates were not found properly installed as per drawing. The differences are as under;
- Bottom part of the gate should be leveled with RCC slab but found approx 120mm to 150mm above to that of RCC slab.

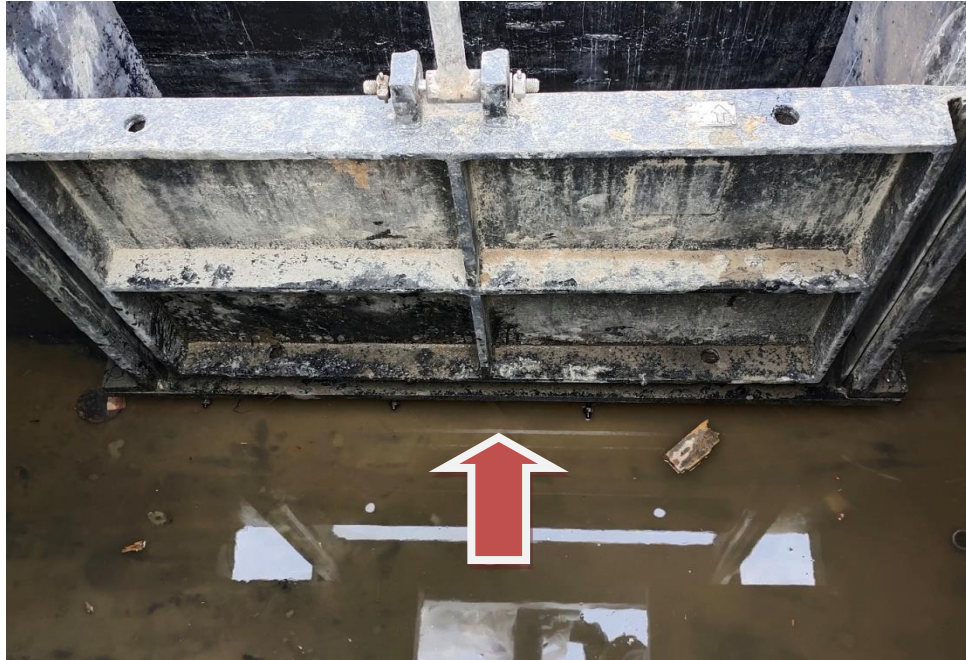
4. Inlet Gates of SBR Basin 1/ 2/ 3/ 4:

- Gates were not found properly installed as per drawing. The differences are as under;
- Bottom part of the gates should be leveled with RCC slab but found approx 120mm to 150mm above to that of RCC slab.

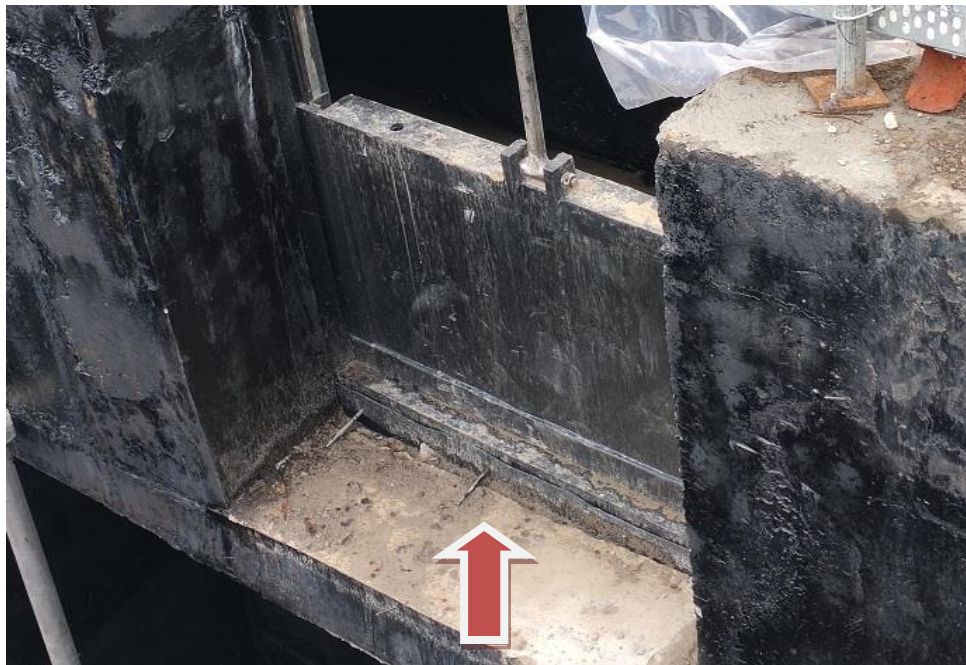
- Some of the gates grouting work found not done yet.

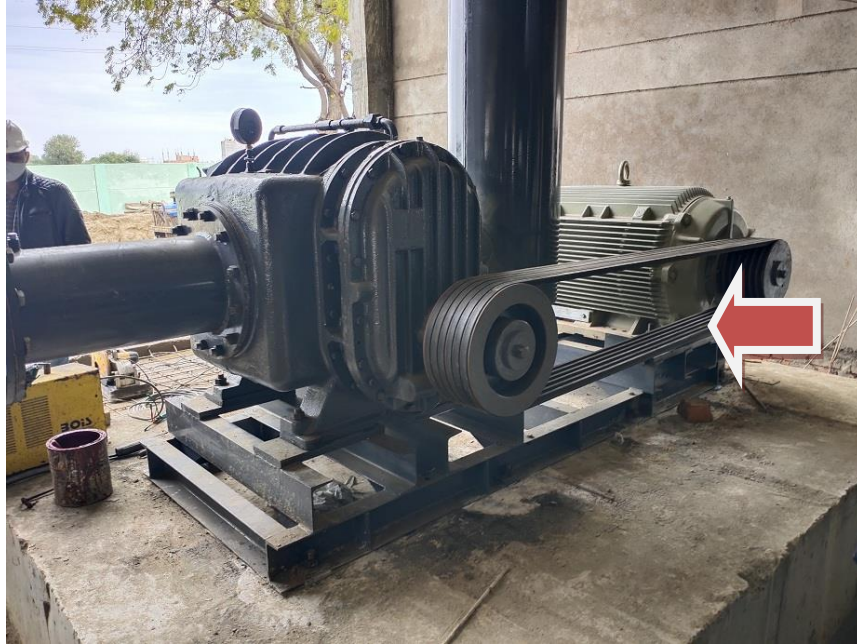
- Pulley safety guard was not found fixed.

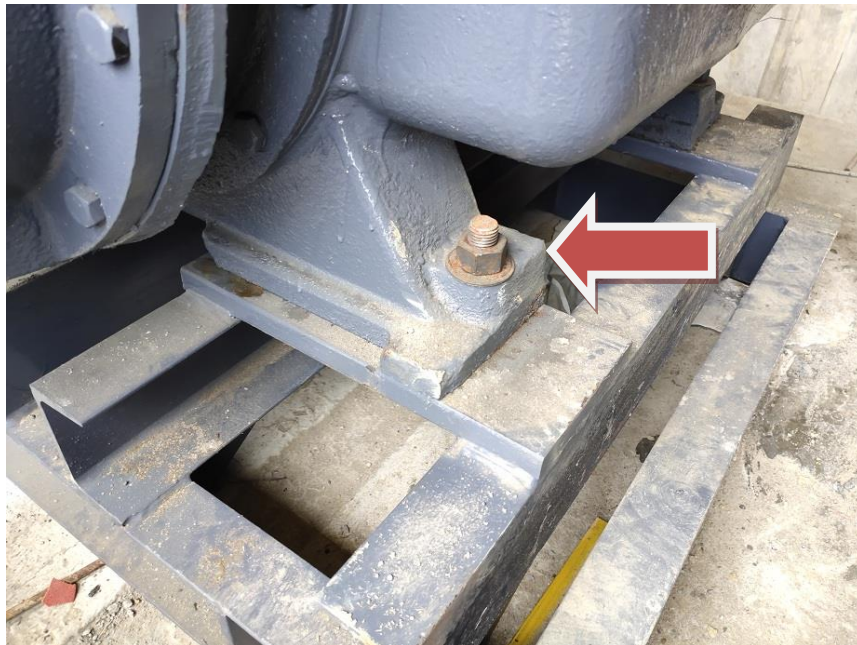
- Nut bolts found rusted at various places and no lubrication was found on the nut bolts. Also various nut bolts were found in loose condition.

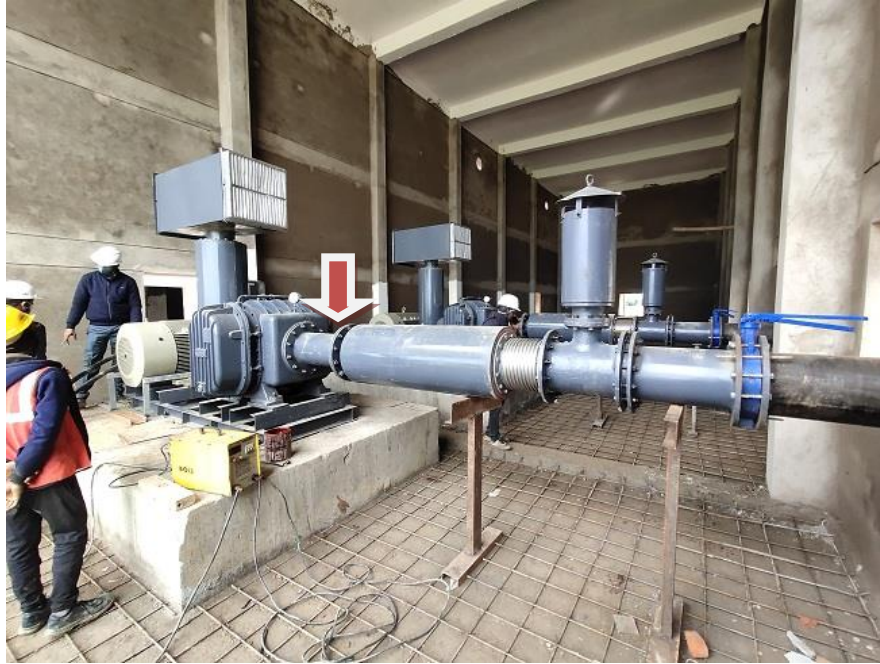
- Acoustic hood was not installed yet.

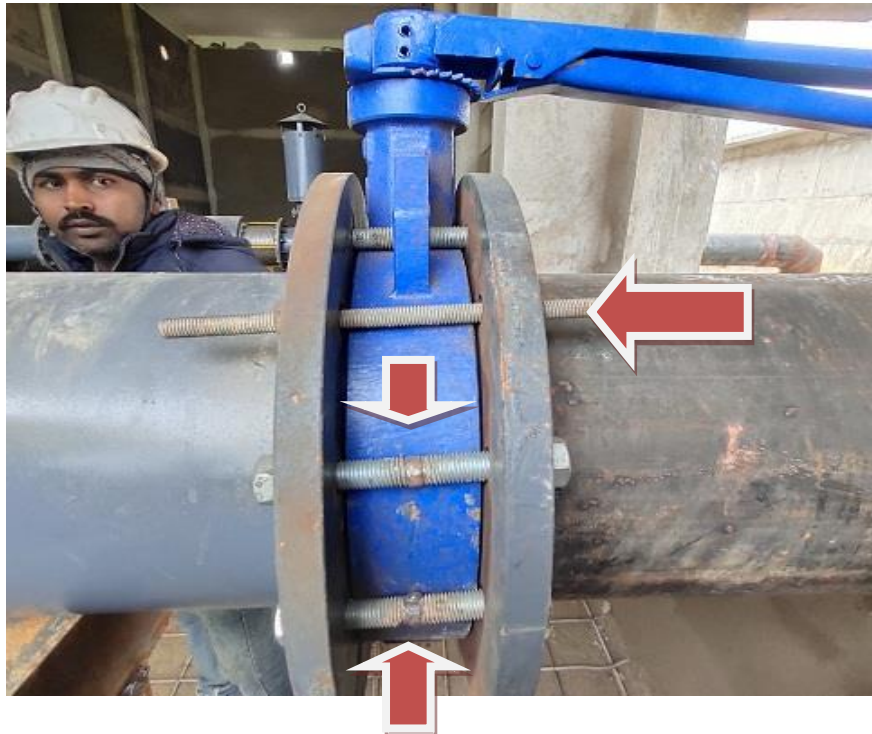
- All NRV's and valve's directions must be properly fixed and checked.
- Pressure gauges were not found installed.
- KRMPPL has to submit the specifications of the gasket used in the installation for review.
- KRMPPL could not check the base frame level due to KRMPPL personnel could not provide necessary instruments/ manpower.
- Damaged/ temporary fixed nut bolts at various places have to be replaced.

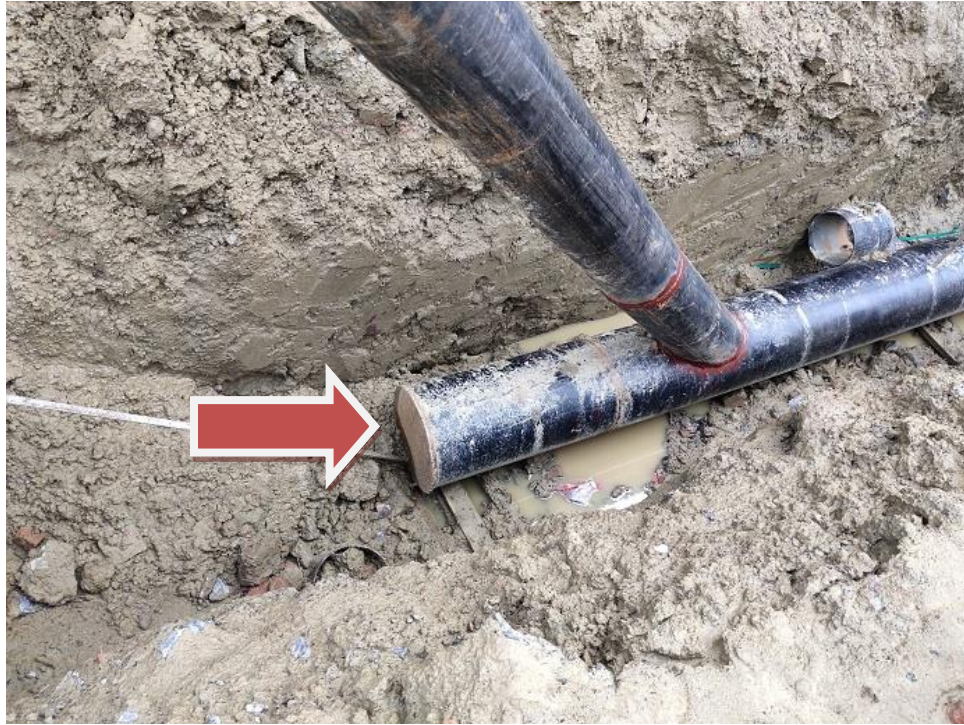
- End part of MS pipe from blower was found not as per drawing. The end has to be packed with blind flange instead of permanent fixing.

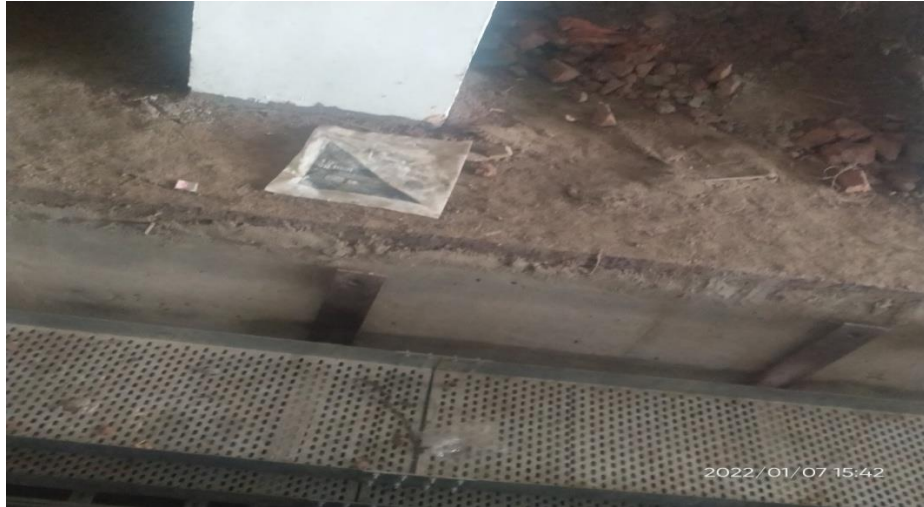
6. PMCC & APFC Panel:

- Checker plate fixing work was not done on cable trenches.
- Insert plates of cable trays were found in loose condition.
- Earthing of APFC panel was not done.
- Insert plates and cable tray was not found fixed inside trench for MPS & PTU cables.
- Cable dressing was not done properly. Cable dressing should be done by clamps.

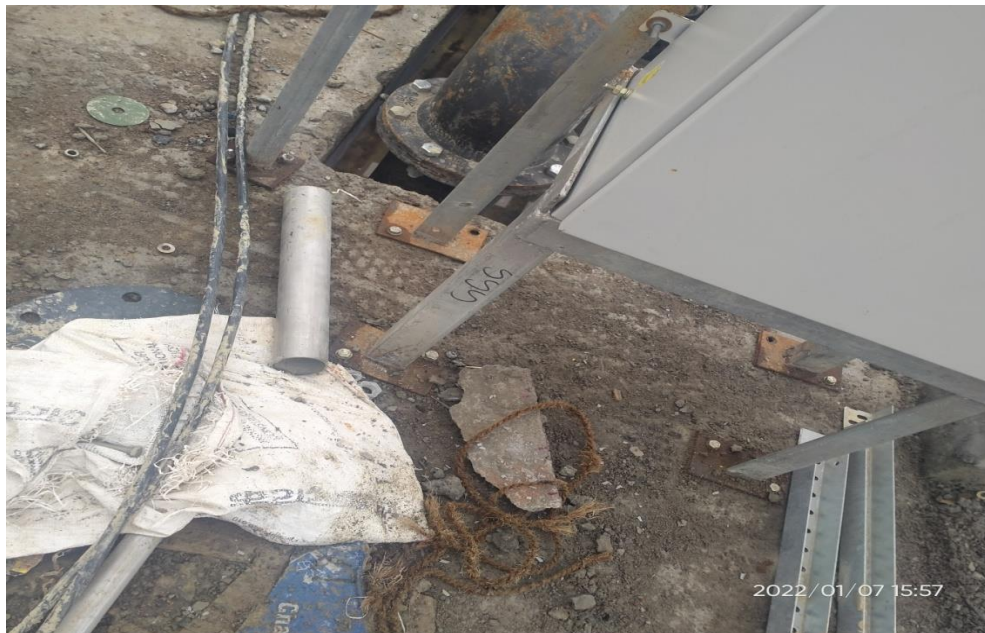
7. RAS & SAS LCS:

- LCS Panels were not fixed properly through anchor fastener at multiple positions.
