National Mission for Clean Ganga- Development, Rehabilitation with  
Operation & Maintenance of STPs at Kanpur under Hybrid Annuity based PPP mode

**Sub: HAM KANPUR:** Inspection Report of 43 MLD Jajmau Phase 2, Inspection done on 30.03.2022

SITE INSPECTION REPORT FOR 43 MLD JAJMAU PHASE-II STP

Inspection Date: 30.03.2022

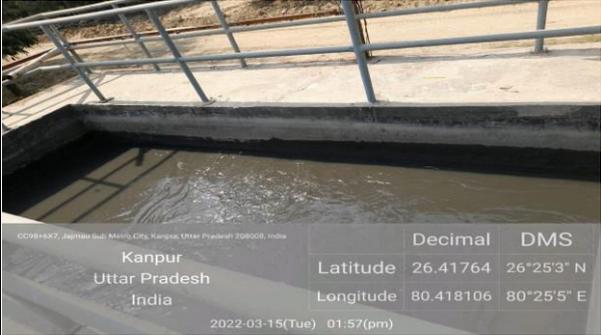
S. No.	Equipment	Assessment of Current Condition	Assessment of Current Condition Photo	Corrective Action Suggested by STC	Original Date of Issue	Proposed Date to Resolve by KRMPL	Current Status of Compliance												
A	Inlet Chamber	1.Intel chamber painting for internal and external surfaces are not satisfactory. 2.Lubrication of sluice gate not done. 3.Cleaning work of chamber is pending.

<p>CC081447, Jajmau Sub Metro City, Kanpur, Uttar Pradesh 206009, India</p> <table border="1"> <thead> <tr> <th></th> <th>Decimal</th> <th>DMS</th> </tr> </thead> <tbody> <tr> <td>Kanpur</td> <td></td> <td></td> </tr> <tr> <td>Uttar Pradesh</td> <td>Latitude 26.41764</td> <td>26°25'3" N</td> </tr> <tr> <td>India</td> <td>Longitude 80.418106</td> <td>80°25'5" E</td> </tr> </tbody> </table> <p>2022-03-15(Tue) 01:57(pm)</p>		Decimal	DMS	Kanpur			Uttar Pradesh	Latitude 26.41764	26°25'3" N	India	Longitude 80.418106	80°25'5" E	<ol style="list-style-type: none"> <li>1. Chamber and hand railing painting work need to be done.</li> <li>2. Sluice gate need to be lubrication</li> <li>3. Cleaing of inlet chamber need to be done.</li> </ol>	21.09.2021		Pending.

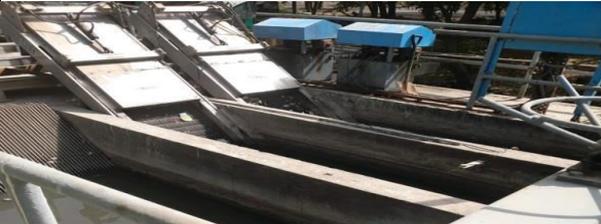
Decimal	DMS																	
Kanpur																			
Uttar Pradesh	Latitude 26.41764	26°25'3" N																	
India	Longitude 80.418106	80°25'5" E																	
1	Fine Screen No.1(Mecahnical)	Non-operated and not proper alignment

<p>CC081447, Jajmau Sub Metro City, Kanpur, Uttar Pradesh 206009, India</p> <table border="1"> <thead> <tr> <th></th> <th>Decimal</th> <th>DMS</th> </tr> </thead> <tbody> <tr> <td>Kanpur</td> <td></td> <td></td> </tr> <tr> <td>Uttar Pradesh</td> <td>Latitude 26.417707</td> <td>26°25'3" N</td> </tr> <tr> <td>India</td> <td>Longitude 80.418173</td> <td>80°25'5" E</td> </tr> </tbody> </table> <p>2022-03-30(Wed) 02:41(pm)</p>		Decimal	DMS	Kanpur			Uttar Pradesh	Latitude 26.417707	26°25'3" N	India	Longitude 80.418173	80°25'5" E	<ol style="list-style-type: none"> <li>1.Fine Screen need to be cleaning properly.</li> <li>2. Screen Level Sensor need to replaced.</li> <li>3. Screen panel autosystem need to be repaired.</li> <li>4. Panel stand need to be painted.</li> <li>5. Cable tray need to be replaced and painted.</li> <li>6.All light creen area aneed to be replaced.</li> <li>7. Disposal material need to be removed on regular basis.</li> <li>8. Manual trolly need to be provided for Disposal material.</li> <li>9. All motors need to covered by canopies.</li> <li>10. Fine screen 2 (mechanical) need to maintenace for proper functional.</li> </ol>	21.09.2021		Pending.

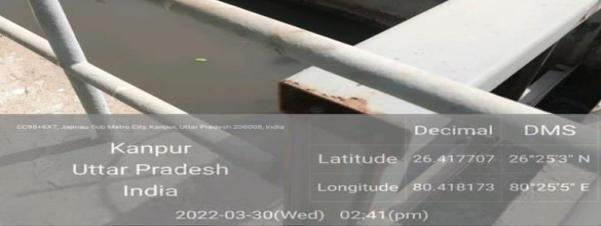
Decimal	DMS																	
Kanpur																			
Uttar Pradesh	Latitude 26.417707	26°25'3" N																	
India	Longitude 80.418173	80°25'5" E																	
2	Fine Screen No.2 (Mecahnical)	Not Operational (Fine screen no 2 found not in proper operation)

<p>CC081447, Jajmau Sub Metro City, Kanpur, Uttar Pradesh 206009, India</p> <table border="1"> <thead> <tr> <th></th> <th>Decimal</th> <th>DMS</th> </tr> </thead> <tbody> <tr> <td>Kanpur</td> <td></td> <td></td> </tr> <tr> <td>Uttar Pradesh</td> <td>Latitude 26.417707</td> <td>26°25'3" N</td> </tr> <tr> <td>India</td> <td>Longitude 80.418173</td> <td>80°25'5" E</td> </tr> </tbody> </table> <p>2022-03-30(Wed) 02:41(pm)</p>		Decimal	DMS	Kanpur			Uttar Pradesh	Latitude 26.417707	26°25'3" N	India	Longitude 80.418173	80°25'5" E	<ol style="list-style-type: none"> <li>1.Fine Screen need to be cleaning properly.</li> <li>2. Screen Level Sensor need to replaced.</li> <li>3. Screen panel autosystem need to be repaired.</li> <li>4. Panel stand need to be painted.</li> <li>5. Cable tray need to be replaced and painted.</li> <li>6.All light creen area aneed to be replaced.</li> <li>7. Disposal material need to be removed on regular basis.</li> <li>8. Manual trolly need to be provided for Disposal material.</li> <li>9. All motors need to covered by canopies.</li> <li>10. Fine screen 2 (mechanical) need to maintenace for proper functional.</li> </ol>	21.09.2021		Pending.

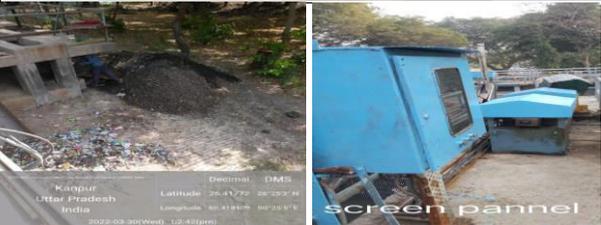
Decimal	DMS																	
Kanpur																			
Uttar Pradesh	Latitude 26.417707	26°25'3" N																	
India	Longitude 80.418173	80°25'5" E																	
3	Fine Screen No.3(Manual)	Opertaional

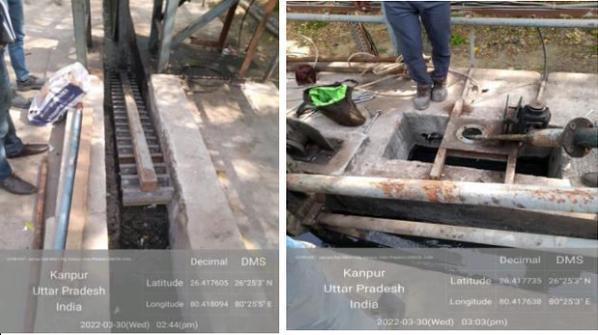
B.	Grit Mechanism					
1	Grit chamber-1 1)Organic pump with Motor 2)Scraper 3)Classifier Mechanism	Operational

<p>1. KRMPPL has not taken any permission from UPJN/STC before charge grit chamber on 17.03.2022. Shutdown duration was 08.03.2022 to 17.03.2022</p> <p>2. Alignment of classifier found improper .</p> <p>3. Painting needs to be done to equipment / covers wherever rusting.</p> <p>4. Organic pump checked and found satisfactory.</p> <p>5. Cable tray need to be painted.</p> <p>6. All E&amp;M equipments shall be lubricate on regular basis and maintain the log book at site.</p> <p>7. Log book need to be maintained</p> <p>8. KRMPPL need to clean grit chamber tank properly.</p> <p>9. Reapiring work in grit chamber need to be done.</p> <p>10. Coal tar epoxy coat need to be done.</p> <p>11. V-Notches/Weir plates were not available in Grit chamber.</p>	30.09.2021	Pending
C	Inlet flow meter	Operational

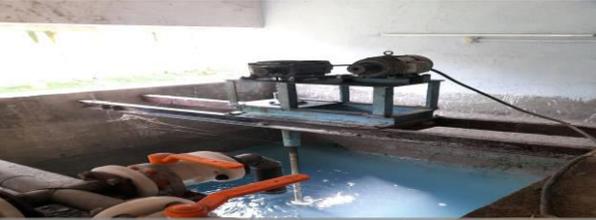
8	Agitator No.2	Non-Operational from 02.03.2022

<ol style="list-style-type: none"> <li>1. Rusted steel Structure need to be replaced.</li> <li>2. Coupling got broken on 02.03.2022, KRMPPL need to repaired on urgent basis.</li> <li>3. Cleaning of tank need to be done.</li> </ol>	21.09.2021		Pending
9	Digester No.1	Non-operated

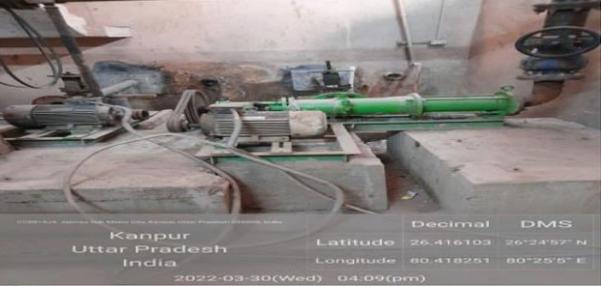
10	Digester feed Pump(No.1 & 2)	One operated One-Non-operated

<p>Decimal DMS Latitude 26.416103 26°24'57" N Longitude 80.418251 80°25'5" E 2022-03-30(Wed) 04:09(pm)</p>	<ol style="list-style-type: none"> <li>1. Need to be overhaul and servicing.</li> <li>2. Lubrication of pump need to be done.</li> <li>3. Thickened sludge feed pump no. 2 non available at site since handover.</li> <li>4. Thickened sludge feed pumps required pressure transmitter at discharge line.</li> </ol>	21.09.2021		Pending
G	Sludge Thickner No.1	Non-Operated

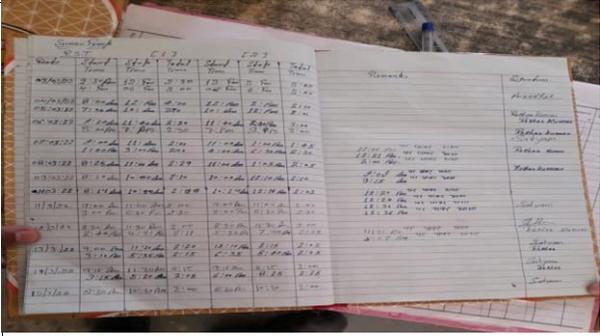
M	Documentation	KRMPL has not maintained documentation work properly

<ol style="list-style-type: none"> <li>1. KRMPL need to maintained all logbooks properly with operational and non-operational equipemnets included dates.</li> <li>2. KRMPL has not maintained any breakdown data of equipments.</li> <li>3. Visitor register has not maintained by KRMPL.</li> </ol>	21.09.2021		Pending
