National Mission for Clean Ganga- Development, Rehabilitation with
Operation & Maintenance of STPs at Kanpur under Hybrid Annuity based
PPP mode

Shah Technical Consultants Private Limited

Sub: HAM KANPUR: Inspection Report of 130 MLD IPS and STP Jajmau facilities Phase I, Inspection done on 02.03.2022.

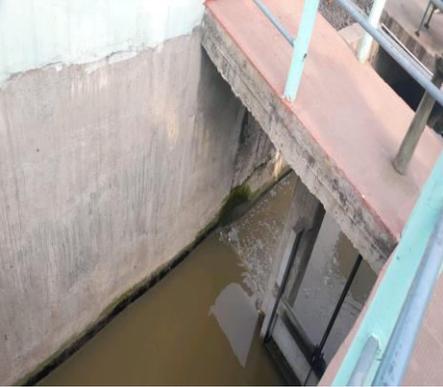
S. No.	Equipment	Assessment of Current Condition	Assessment of Current Condition Photo	Current defects and Corrective Action Suggested by STC, PE	Original Date of Issue	Proposed Date to Resolve by KRMPL	Current Status of Compliance
1	All work						
1	Inlet Over Flow Condition	Overflow condition found since handover

<ol style="list-style-type: none"> 1. During site visit overflow is continue since handover 28.06.2021. 2. No action taken by KRMPL after several times informed by NMC, UPJN and STC representatives. 3. Under renovation of IPS Nawabganj, KRMPL need to stop overflow condition of sewage by increasing adequate pumping. 	28.06.2021		Long Pending
2	Inlet Chamber	<ol style="list-style-type: none"> 1. Cleaning of inlet chamber need to be done. 2. Staircase damaged tile need to renovate.

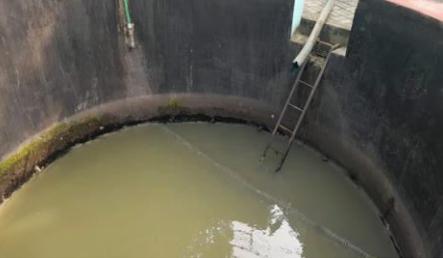
<ol style="list-style-type: none"> 1. Garbage cleaning work need to be compulsory. 2. Garbages Trolly need to be available at site. 	23.11.2021		Pending
4	Receiving Chamber 1	Overflow condition found since handover

<ol style="list-style-type: none"> 1. Proper pumping arrangement need to be done by KRMPL. 2. Receiving chamber need to be clean. 3. Manual screen need to be installed under renovation. 4. After cleaning work of this chamber required renovation work need to be done. 	28.06.2021		Long Pending
5	Receiving Chamber 2	Overflow condition found since handover

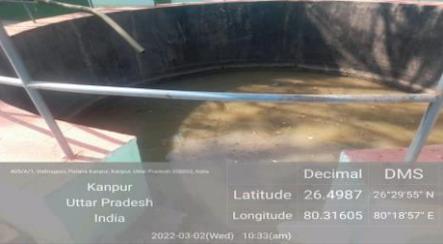
<ol style="list-style-type: none"> 1. Proper pumping arrangement need to be done by KRMPL. 2. Receiving chamber need to be clean. 3. After cleaning work of this chamber required Renovation work need to be done. 4. Manual screen need to be installed under renovation. 5. KRMPL is using ZHP submersible pump for dewatering this chamber but this is insufficient pumping. 	28.06.2021		Long Pending

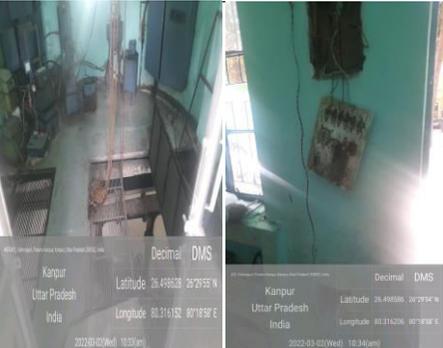
6	Pump House No.1	Civil Structure in unsatisfactory Condition

<p>Decimal DMS Kanpur Uttar Pradesh India Latitude 26.498628 26°29'55" N Longitude 80.316192 80°18'58" E 2022-03-04 (Wed) 10:34(am)</p>	<p>1.Surface roof treatment is pending for Pump house. 2.All indoor lightening need to be replaced. 3. Exhaust fan 2 Nos need to be replaced. 4. Cable to be lay in the cable tray properly. 5. KRMPL has painted the pump house no 1 with poor workmanship. This should be rework. 6. Log book is not proper maintaining by KRMPL staff as per prescribed format. 7. New 3 Nos of pumps have recieved at site on 31.12.2021 for Pump House 01 (2 Nos. 300cum/hr and 1 Nos 156 cum/hr). 8. Flow meter need to be installed by KRMPL. 9. 2 Nos light is not working. 10. Foundation work of pump house 01 need to be start by KRMPL. 11. Electrical hoist need to be replaced as per renovation plan. 12. Outdoor lightening not fixed properly.</p>	23.11.2021		Pending

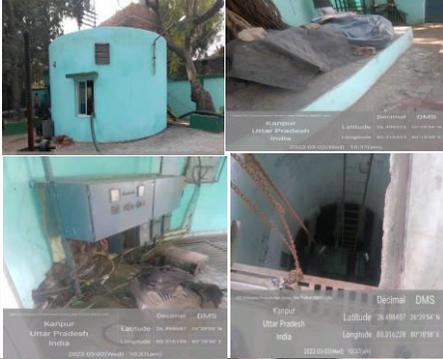
<p>Decimal DMS Kanpur Uttar Pradesh India Latitude 26.498618 26°29'55" N Longitude 80.316199 80°18'58" E 2022-03-02(Wed) 10:34(am)</p>	Need to be replaced as per Renovation Plan	23.11.2021		Pending
7	Pump House No.2	Civil Structure in unsatisfactory Condition

<p>Decimal DMS Kanpur Uttar Pradesh India Latitude 26.498487 26°29'54" N Longitude 80.316228 80°18'58" E 2022-03-02(Wed) 10:37(am)</p>	<p>1.Surface roof treatment is pending for Pump house 2. Consessionare is using this room as a store room stacking of Cement bags and diesel drum. 3. Exhaust fan 2 nos need to be replaced. 4. Tube light 1 nos need to be replaced. 5. Pump House pump found not to be working. 6. KRMPL has done painting work inside and outside of the pump house no 1 with poor workmanship. This should be rework. 7. Discharge line of the pumps to be dismantled by KRMPL without any information to UPJN/STC. 8. Dismantling of pumps done by KRMPL without any information to UPJN/STC. 9. Raw sewage pumps, 3 Nos. of Pump House No. 2 were damaged due to flooding on 18.01.2022. They were refurbished/ repaired and delivered to site on 15.02.2022. Raw sewage pumps and motors of Pump house No. 2 were found at site but KRMPL has not installed them. 10. NIV & Electrical hoist need to be replaced as per renovation plan.</p>	23.11.2021		Pending

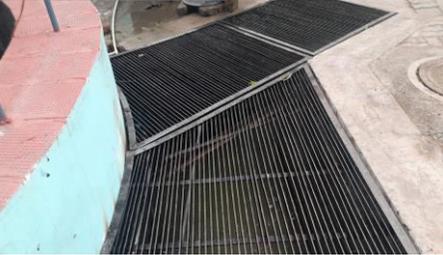
8	Open Channel and Sluice Gate	Civil Structure in unsatisfactory Condition

<p>1. KRMPL has not submitted and approval of fabrication work. 2. Sluice gate need to be replace under renovation.</p>	23.11.2021		Pending

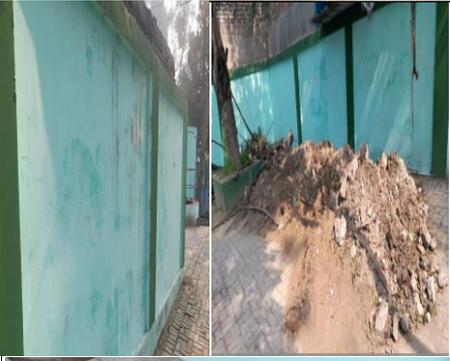
9	Boundary wall and landscaping area	Civil Structure in unsatisfactory Condition

<p>1.KRMPL has painted the boundary wall with poor workmanship. This should be rework. 2. Cleaning work of campus area need to be done by KRMPL. 3. 8 Nos of outside lights only 4 Nos is in working condition.</p>	23.11.2021		Pending
10	Valve Chamber	Civil Structure in unsatisfactory Condition

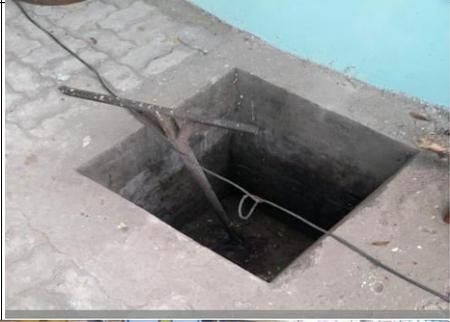
<p>1. Valve chamber should be plastered and Covered properly. 2. All valves need to be replace.</p>	23.11.2021		pending
11	Transformer Yard	Civil Structure in satisfactory Condition

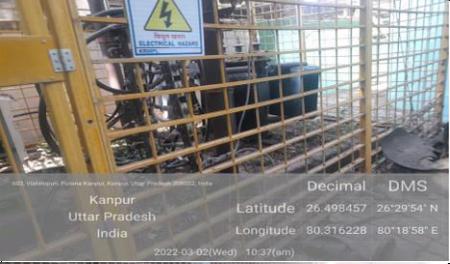
<p style="text-align: center;"> Kanpur Uttar Pradesh India 2022-03-02(Wed) 10:37(am) </p> <p style="text-align: center;"> Decimal DMS Latitude 26.498457 26°29'54" N Longitude 80.316228 80°18'58" E </p>	<p>1. Yard area need to be clean</p>	23.11.2021		Pending
12	DG set room	Civil Structure in satisfactory Condition

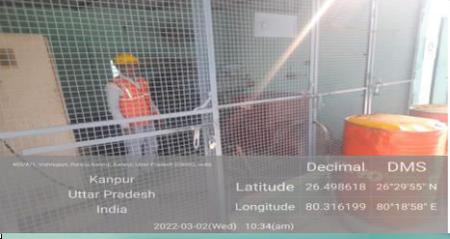
<p style="text-align: center;"> Kanpur Uttar Pradesh India 2022-03-02(Wed) 10:34(am) </p> <p style="text-align: center;"> Decimal DMS Latitude 26.498618 26°29'55" N Longitude 80.316199 80°18'58" E </p>	<p>1. DG set is in working condition. 2. Log book of DG set is not maintaining by KRMPL. 3. Diesel surplus quantity is not available at site. 4. Smog exhaust pipe length is not sufficient as per CPCB/CPHEEO guidelines.It must be replaced on urgent basis.</p>	23.11.2021		Pending

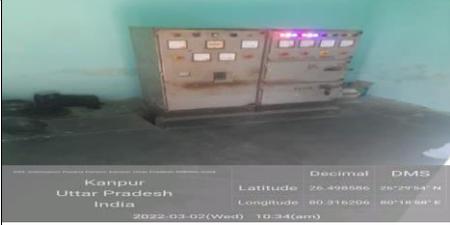
13	Metering Room	Civil Structure in unsatisfactory Condition

<p style="text-align: center;"> Kanpur Uttar Pradesh India 2022-03-02(Wed) 10:34(am) </p> <p style="text-align: center;"> Decimal DMS Latitude 26.498606 26°29'54" N Longitude 80.316206 80°18'58" E </p>	<p>1. Seepage is available in the wall of this room this should be rectified. 2. Panel Volt meters and Ammeters need to be replaced. 3.All Phase Indicator need to be replaced.</p>	23.11.2021		pending

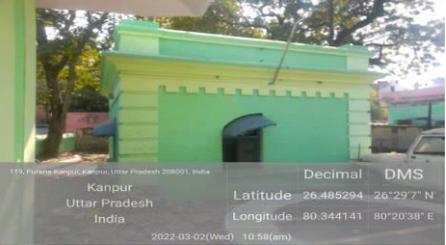
<p>119, Purania Kanpur, Kanpur, Uttar Pradesh 208001, India</p> <p>Decimal DMS Latitude 26.485502 26°29'7" N Longitude 80.344153 80°20'38" E</p> <p>2022-03-02(Wed) 10:56(am)</p>	1. Need to be replaced as per Renovation Plan	23.11.2021		Pending
6	Pump House No. 3	Civil Structure is in unsatisfactory condition

<p>119, Purania Kanpur, Kanpur, Uttar Pradesh 208001, India</p> <p>Decimal DMS Latitude 26.485294 26°29'7" N Longitude 80.344141 80°20'38" E</p> <p>2022-03-02(Wed) 10:58(am)</p>	<ol style="list-style-type: none"> 1.Required repairing the cracks, Finishing activity painting work, Replacement of damaged Door,window,louvers and ventilators. 2. Pump 3 Nos found not in working condition. 3. Design and drawing for E&M shall be submitted by KRMPL. 4. Outside and inside painting work done by KRMPL under renovation. 	23.11.2021		Pending

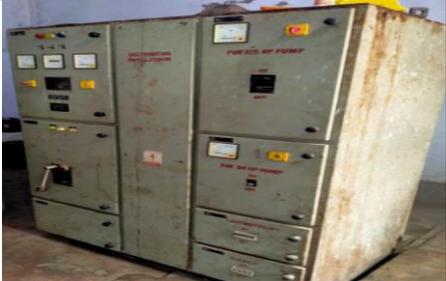
9	Panel Room	Civil Structure is in unsatisfactory condition

<ol style="list-style-type: none"> 1. Inside and outside painting work done by KRMPL under renovation. 2. Replacement of damaged Door,window,louvers and ventilators. 2. Panel Volt meters and Ammeters need to be replaced. 3. All Phase Indicator need to be replaced. 	23.11.2021		Pending
10	Logbook	Log book of pump house 01 and pump house no. 02 has not maintained by KRMPL properly

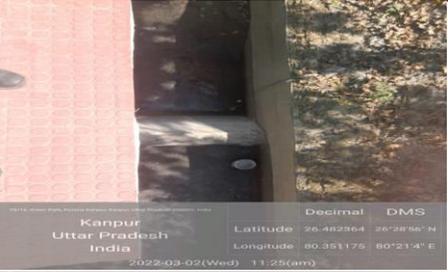
S. No.	Equipment	Assessment of Current Condition	Assessment of Current Condition Photo	Current defects and Corrective Action Suggested by STC, PE	Original Date of Issue	Proposed Date to Resolve by KRMPL	Current Status of Compliance	
A								
All work								
1	Inlet Over Flow Condition	During site visit it was found that there are no Overflow or Bypass of sewage found.

1. During site visit it was found that there are no Overflow or Bypass of sewage found. 2. Raw sewage by-pass sluice gate need to be replaced. Design,drawing need to be submitted by KRMPL.	4.01.2022		Pending	
2	Inlet Chamber (Civil)	Civil Structure is in satisfactory condition

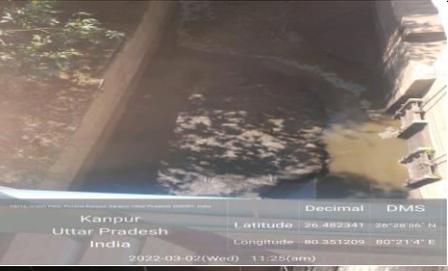
1. All gates need to be lubrication. 2.Sludge need to be remove from inlet part of IPS.	23.11.2021		Pending	
3	Screen Chamber	Civil Structure is in satisfactory condition

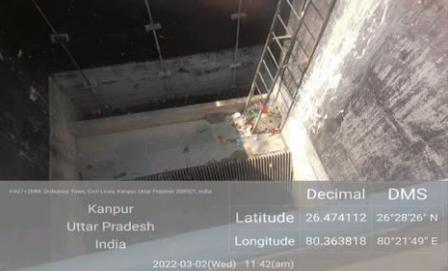
1. Garbages removal work should be done on regular basis. 2. Trolly need to be available at side for disposal of gargaes.	23.11.2021		Pending

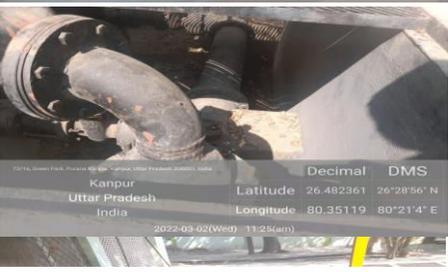
4	Receiving chamber	Civil Structure is unsatisfactory condition.

1. Chamber need to be clean and cover properly. 2. All valves need to be replace. 3. All stud bolts and gasket need to be replace. 4. Lubrication for valves and pumps, sluice gates need to be done by KRMPL 5. Pressure guage need to be provided by KRMPL.	15.12.2021		Pending

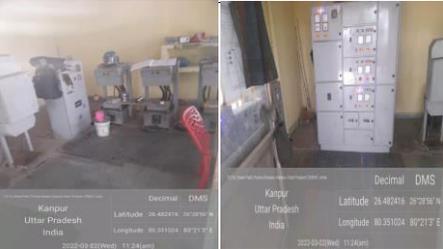
<p>Decimal DMS Latitude 26.48235 26°28'56" N Longitude 80.350943 80°21'7" E 2022-03-02(Wed) 11:26(am)</p> <p>Decimal DMS Latitude 26.48266 26°29'57" N Longitude 80.350507 80°21'1" E 2022-03-02(Wed) 11:26(am)</p>	<ol style="list-style-type: none"> 1. Fencing work is pending. 2. Only 1 Nos outdoor light is working condition out of 4 Nos. 3. Security guard need to be arrange by KRMPL. 4. Cleaning work need to be carried out by KRMPL. 	23.11.2021		Pending
7	Panel Room	Structure is in unsatisfactory condition

<p>Decimal DMS Latitude 26.48234 26°28'56" N Longitude 80.351024 80°21'7" E 2022-03-02(Wed) 11:26(am)</p> <p>Decimal DMS Latitude 26.48246 26°28'56" N Longitude 80.351024 80°21'7" E 2022-03-02(Wed) 11:26(am)</p>	<ol style="list-style-type: none"> 1. Front door glass need to be repair. 2. Panel Volt meters and Ammeters need to be replaced. 3. All Phase Indicator need to be replaced. 4. Rain water pipe need to be fixed. 	23.11.2021		Pending

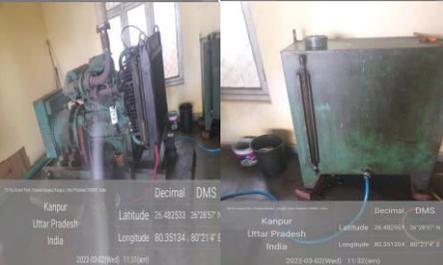
8	DG Room	Civil Structure is in good condition.

<p>Decimal DMS Latitude 26.48233 26°28'57" N Longitude 80.35134 80°21'4" E 2022-03-02(Wed) 11:26(am)</p> <p>Decimal DMS Latitude 26.48234 26°28'57" N Longitude 80.35104 80°21'4" E 2022-03-02(Wed) 11:26(am)</p>	<ol style="list-style-type: none"> 1. Need to be replaced immediately DG set. 2. KRMPL is not maintaining the log book for DG set. 3. Smog exhaust pipe length is not sufficient as per CPCB/CPHEEO guidelines. It must be replaced on urgent basis. 	23.11.2021		Pending

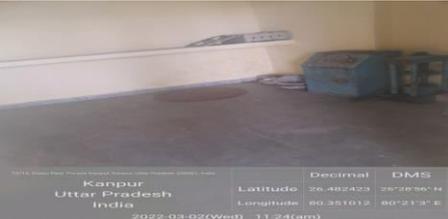
9	Store Room	Civil Structure is in unsatisfactory condition.

1. Door need to be fixed. 2. Dampness should be removed as per equired action. 3. Electric switch board need to be replace	23.11.2021		Pending
10	Logbook	Logbooks are not maintain properly by KRMPL

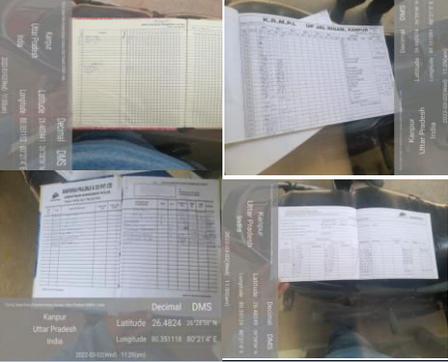
1. Log book of pumps and DG set are not being maintained by KRMPL. 2. KRMPL has not arranged adequate number of staff (Operators, Sweepers and relievers) for proper O&M of IPS and attendance register manipulated staff details. Operators are non technical person. They are not understanding the Pump Capacity, Flow of Discharge, Peak Flow and maintain the records. 3. KRMPL need to maintain Visitor Register. 4. Security guard need to be deploy. 5. No labour available by KRMPL for renovation work.	28.06.2022		Pending
STC SITE INSPECTION OF JAJMAU ASSOCIATED IPS REPORT					Guptar Ghat	Date: 02/03/2022	INSPECTED BY: UPJN Representative Mr Ajeet Singh-Jen Civil STC Representatives 1. Mr Anuj Kushwaha-Support Engineer Civil KRMPL Representatives 1. Mr Dhermendra Pratap Singh, KRMPL personnel

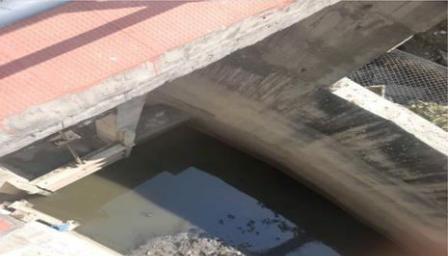
S. No.	Equipment	Assessment of Current Condition	Assessment of Current Condition Photo	Current defects and Corrective Action Suggested by STC, PE	Original Date of Issue	Proposed Date to Resolve by KRMPL	Current Status of Compliance
A							
All work							
1	Inlet Over Flow Condition	No over flow

During site visit it was found that there are no Overflow/Bypass of sewage not found as on 02.03.2022	02.03.2022		Pending
2	Inlet Chamber	Civil Work is in satisfactory Condition

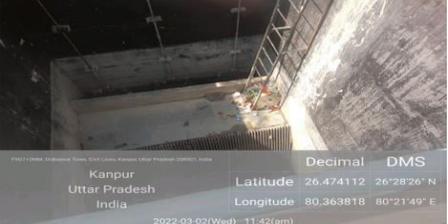
1. All gates need to be lubrication.	15.12.2021		pending
3	Manual bar Screen Chamber	Civil Work is in satisfactory Condition

1. Garbages need to be remove on regularly. 2. Garbage trouilly need to be available at Site.	23.11.2021		pending

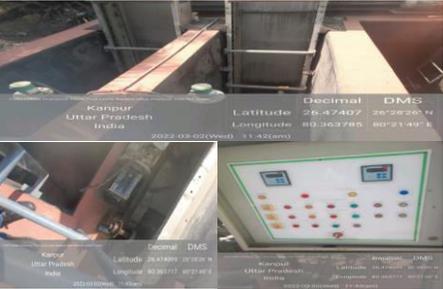
<p>4</p>	<p>Mechanical bar screen Chamber</p>	<p>Civil Work is in satisfactory Condition</p>

<ol style="list-style-type: none"> Both mechanical screen and conveyor belt found non-operational at the time of inspection. It was started when asked by URIN/STC representative. Screen No. 1, Chain is not in proper alignment. Auto System and level sensor meter is not in working condition. Screen panel On/Off main power selector switch has been found in not working properly. Screen No. 2 is in working condition. Conveyor belt is in working condition. Garbages need to be remove on regularly. Garbage trouly need to be available at Site. All leakages of Oil need to be repair. Conveyor belt is not working in auto mode. Screen No 1 is not working in manual mode. 	<p>15.12.2021</p>		<p>pending</p>
<p>5</p>	<p>Pump House</p>	<p>Civil Work is in satisfactory Condition</p>

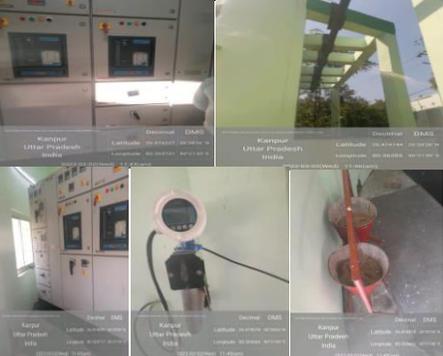
<ol style="list-style-type: none"> Pump No 1, 2 and 3 is in working condition. Pump no 4 is found non-operational since 18.01.2022. EOT crane painting work is pending and Test certificate of load test also required. Only 3 Nos of light is in woking condition out of 7 Nos in IPS campus. Operators are non technical person. They are not understanding the Pump Capacity , Flow of Discharge , Peak flow and maintain the records. 	<p>23.11.2021</p>		<p>pending</p>

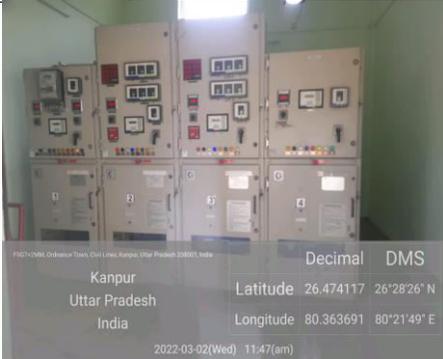
<p>6</p>	<p>Panel room</p>	<p>Civil Work is in satisfactory Condition</p>

<ol style="list-style-type: none"> Pump flow meter is not in woking conditio sice handover. 	<p>23.11.2021</p>		<p>pending</p>
<p>7</p>	<p>Metering room</p>	<p>Civil Work is in satisfactory Condition</p>

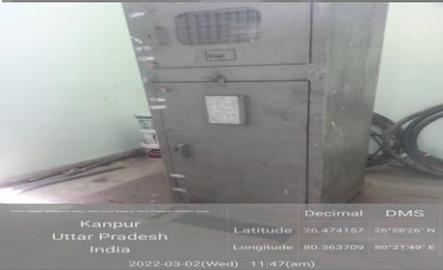
<ol style="list-style-type: none"> Meter room need to be clean with proper facility of Electric switch and light inside the room. 	<p>23.11.2021</p>		<p>pending</p>

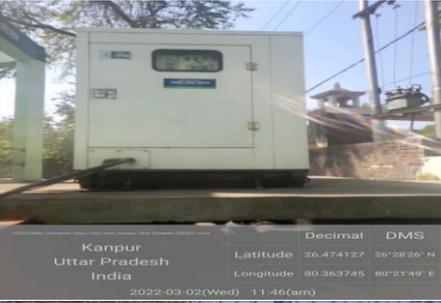
8	DG room	Civil Work is in satisfactory Condition

<ol style="list-style-type: none"> DG set is not in working condition. Log book of DG set is not maintain by KRMPL. Smog exhaust pipe length is not sufficient as per CPCB/CPHEEO guidelines. It must be replaced on urgent basis. 	23.11.2021		pending
9	Transformer yard	Civil Work is in satisfactory Condition

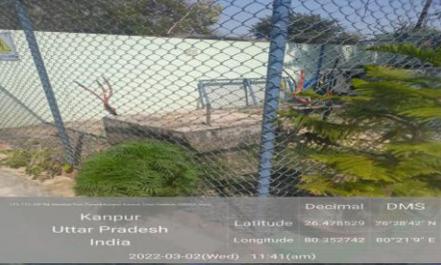
<ol style="list-style-type: none"> Transformer No 1 is not available at site since 13.12.2021 Transformer yard area need to clean. All earthing chamber need to be cover. 	13.12.2021		pending
10	Handrailing work	Unsatisfactory Condition

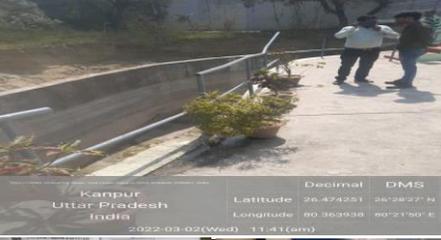
<ol style="list-style-type: none"> Damaged hand railing need to be repair. Security guard need to be arrange by KRMPL 	23.11.2021		pending
11	Logbook/Records/Documentation	Logbooks are not maintain properly by KRMPL

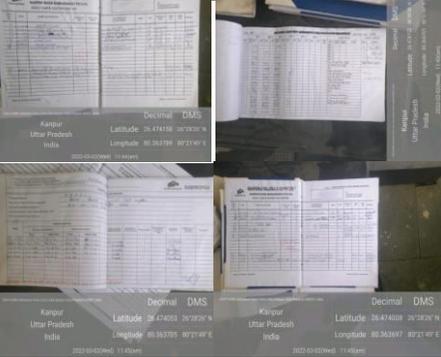
<ol style="list-style-type: none"> Log book of pumps and DG set are not being maintained by KRMPL. KRMPL has not arranged adequate number of staff (Operators, Sweepers and relievers) for proper O&M of IPS and attendance register manipulated staff details. Operators are non technical person. They are not understanding the Pump Capacity , Flow of Discharge, Peak Flow and maintain the records. KRMPL need to maintain Visitor Register. Security guard need to be deploy. No labour available by KRMPL for renovation work. 	23.07.2021		Pending

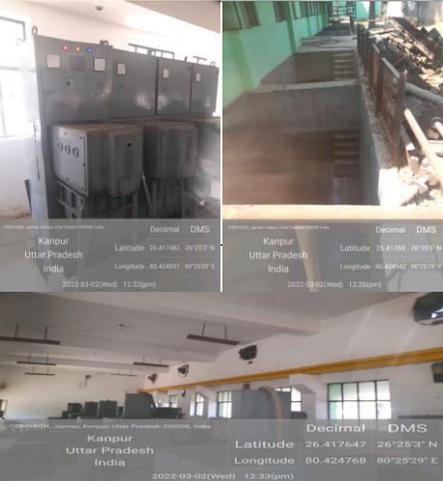
5	Pump House	Civil work is in Satisfactory condition

<ol style="list-style-type: none"> Renovation work is in under progress. Broken glass of window , door need to be repair. Indoor 14 Nos lightning work need to be replaced. CCTV camera need to be replaced / Repair. Panel Volt meters and Ammeters need to be replaced. All Phase indicator need to be replaced. EOT painting ongoing without approval and EOT load test has not conducted by KRMPL. Vibration has not checked by Operator on regular basis. Log book is not proper maintain by KRMPL staff as per prescribed format. 1 Nos is in working condition out of 2 Nos of dewatering pumps. Total 14 Nos of light available at CPSPS but it was not in working condition, it should be replace as per Contract. Rain water pipe need to be fixed. Operators are non technical person. They are not understanding the Pump Capacity , Flow of Discharge, Peak Flow and maintain the records. 	23.11.2021		Pending

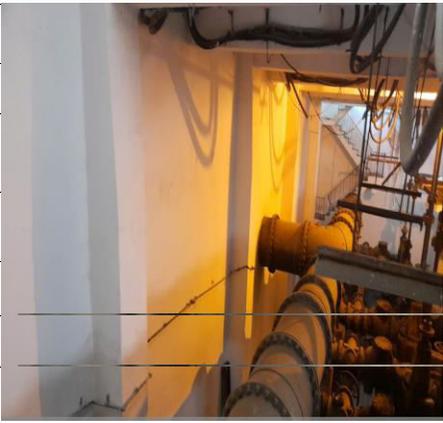
1.Need to be replaced as per Renovation Plan	14.08.2021		Pending
II	Pump no.2 (Capacity 2160 m3/hr)	Non operational		1.Need to be replaced as per Renovation Plan	13.12.2021		Pending
III	Pump no.3 (Capacity 2160 m3/hr)	Non Operational since 18.01.2022		1.Need to be replaced as per Renovation Plan	23.11.2021		Pending
IV	Pump no.4 (Capacity 2160 m3/hr)	Non operational since 18.01.2022		1.Need to be replaced as per Renovation Plan	23.11.2021		Pending
V	Pump no.5 (Capacity 2160 m3/hr)	Operational		<ol style="list-style-type: none"> Need to be replaced as per Renovation Plan. Heavy vibration in pump need to be repaired 	23.11.2021		Pending
VI	Pump no.6 (Capacity 2160 m3/hr)	Operational		1.Need to be replaced as per Renovation Plan	23.11.2021		Pending
VII	Pump no.7 (Capacity 2160 m3/hr)	Operational		1.Need to be replaced as per Renovation Plan	23.11.2021		Pending

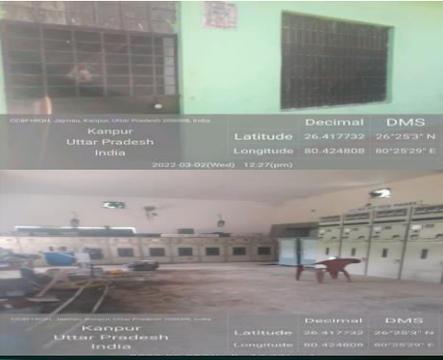
<ol style="list-style-type: none"> 11KV HTVCB panel to be replaced. LT A.C.B panel 440 V found non functional. All light to be replaced in sub station. All store material dumped in substation building. 	16.12.2021		Pending

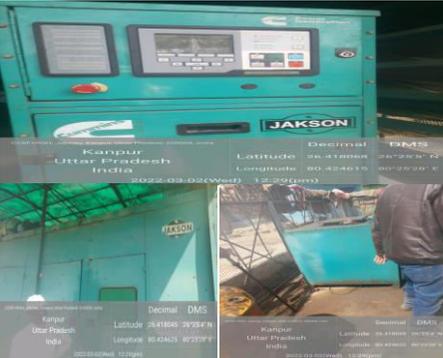
<ol style="list-style-type: none"> 1. DG set is in working condition when it was checked coolent is need to fill. 2. MS base frame need to be replace. 3. DG yard need to be clean. 4. Log book need to be maintain for DG set. 5. Smog exhaust pipe length is not sufficientr as per CPCB/CPHEEO guidelines.It must be replaced on urgent basis. 	4.1.2022		Pending
8	Transformer Yard	Operational

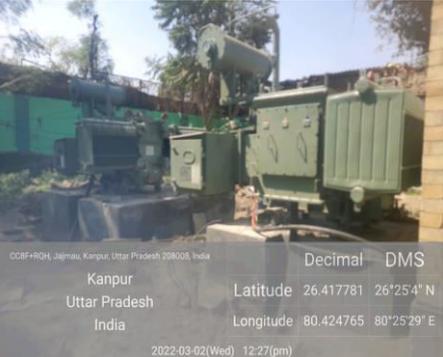
<ol style="list-style-type: none"> 1. Transformer foundation done by KRMPL but the didi not provide any inspection information during RCC work. 2. Renovation of Transformer yard need to be done. 	16.12.2021		Pending
9	Boundary wall	Civil work is in unsatisfactory condition

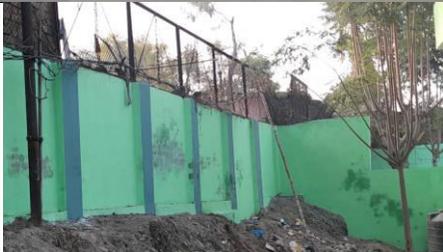
<ol style="list-style-type: none"> 1. Poor workmanship and materail did not done by KRMPL. Rework is required 2. Landscaping area need to be clean. 	4.1.2022		Pending
10	Sluice valve Chamber	Civil work is in unsatisfactory condition

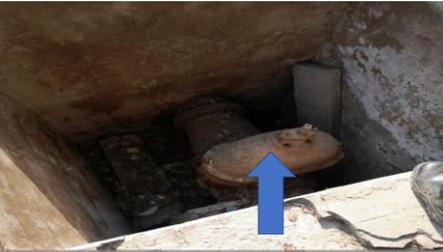
<ol style="list-style-type: none"> 1. Discharge line chamber should be cover with frame cover. 2. Internal cleaning need to be done. 3. Internal plaster work need to be done. 4. Valve need to be replaced as per approved renovation plan. 	23.11.2021		Pending

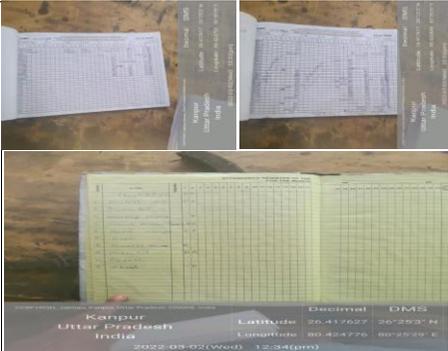
<p>1. Log book of pumps and DG set are not being maintained by KRMPL. 2. KRMPL has not arranged adequate number of staff (Operators, Sweepers and relievers) for proper O&M of IPS and attendance register manipulated staff details. Operators are non technical person. They are not understanding the Pump Capacity , Flow of Discharge, Peak Flow and maintain the records. 3. KRMPL need to maintain Visitor Register. 4. Security guard need to be deploy. 5. No labour available by KRMPL for renovation work.</p>	<p>23.07.2021</p>		<p>Pending</p>
<p>Remarks- A) Internal and External Painiting work (for Structures and Building):- KRMPL did not work properly by which it is not acceptable and it did not fulfill acceptance criteria as per CA 1. All painted work surfaces shall be uniform and pleasing in appearance. 2. The colour ,texture etc shall match exactly with the approved samples. 3. All stains, splashes and slatters of paints shall be removed from surrounding surfaces. KRMPL need to take necessary action for proper Painting work. B) Smog exhaust pipe length is not sufficient as per CPCB/CPHEEO guidelines. It must be replaced on urgent basis. C) All E&M equipments need to be replaced as per CA schedule 11. D) CCTV need to be installed. E) Power backup need to be arranged by KRMPL. F) Inlet and outlet flow meter need to be installed. G) Overflow condition need to be controlled for IPSs, CSPS.</p>			<p>Signature:</p> <p>TEAM LEADER STC KANPUR</p>

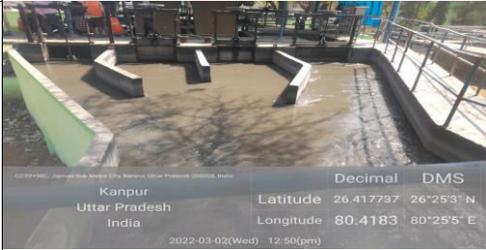
<p>Kanpur Uttar Pradesh India Decimal DMS Latitude 26.417797 26°25'3" N Longitude 80.4183 80°25' E 2022-03-02(Wed) 12:50(pm)</p>	<ol style="list-style-type: none"> Hand Railing and its foundation needs to be repaired. Finishing work of inlet chamber chamber need to done properly . 	01.03.2021		Lond pending

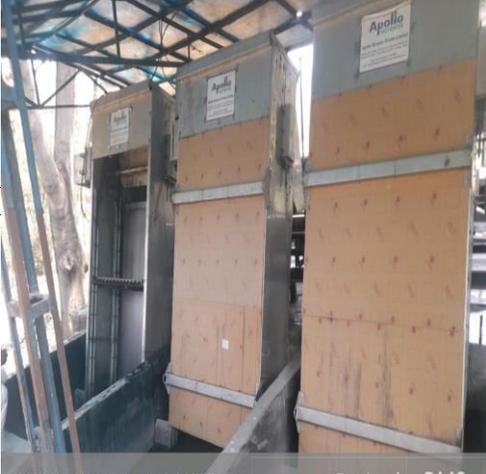
<p>CC39-H8C, Jajmau Sub Metro City, Kanpur, Uttar Pradesh 206008, India Decimal DMS Latitude 26.41762 26°25'3" N Longitude 80.418282 80°25' E 2022-03-02(Wed) 12:50(pm)</p>	<ol style="list-style-type: none"> Gate may be motorized if possible Hand railing to be replaced . Shed to be replace. 	01.03.2021		Pending
B	Fine Screen Chamber (Mechanical / Manual)						
3	Screen Chamber (Civil)	Need Renovation

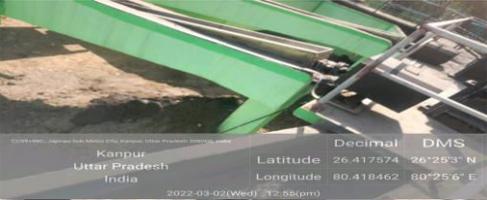
<ol style="list-style-type: none"> Outer side painting work in progress in Grit Chamber 03. Log Book need to be maintained. Handrails need to be provided by KRMPL. Flooring need to be done by KRMPL. 	01.03.2021		Lond pending
9	Grit Mechanism-1

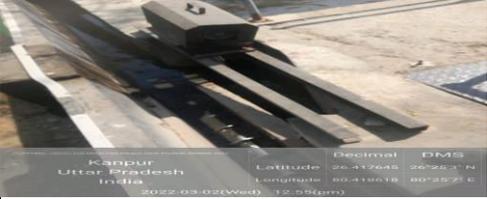
<ol style="list-style-type: none"> Renovation work found satisfactory. Organic pump need to be installed as per approved drawing. Cable need to be layed at Cable tray as per approved drawing. LPBS need to be installed as per approved drawing. KRMPL without getting approval for shut down and charging the Raw sewage for the same work. KRMPL has not been submitted any approval. KRMPL has not been submitted installation procedure for Grit Mechanism System. 	01.03.2021		Lond pending

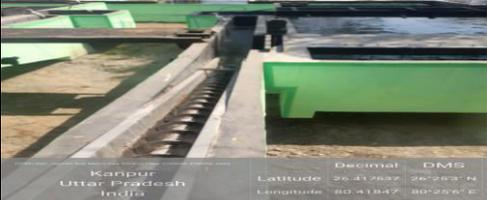
<ol style="list-style-type: none"> Renovation work found satisfactory. Organic pump need to be installed as per approved drawing. Cable need to be layed at Cable tray as per approved drawing. LPBS need to be installed as per approved drawing. KRMPL without getting approval for shut down and charging the Raw sewage for the same work. KRMPL has not been submitted any approval. KRMPL has not been submitted installation procedure for Grit Mechanism System. 	01.03.2021		Lond pending
11	Grit Mechanism-3

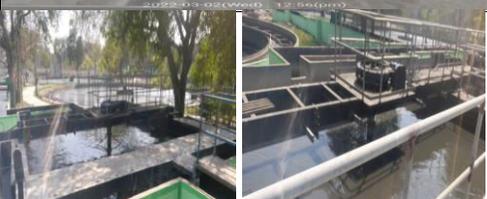
<ol style="list-style-type: none"> KRMPL need to provide proper excess to Grit mechanism platform . Renovation in screw conveyor channel is pending. KRMPL without getting approval for shut down and charging the Raw sewage for the same work. KRMPL has not been submitted any approval. KRMPL has not been submitted installation procedure for Grit Mechanism System. KRMPL has not submitted any RFI's(Request for Inspection). 	01.03.2021		Lond pending

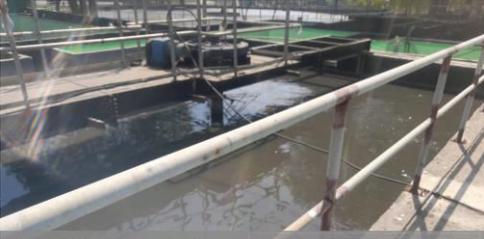
<ol style="list-style-type: none"> 1. Not in working due to foundation damage. 2. Need to be repair immediately and to be replace as per the CA 3. Grit Classifier alignment has not been done by KRMPL as per approved drawing. 4. Organic pump need to be replaced as per approved drawing. 	01.03.2021		Long pending
14	Grit Classifier -3

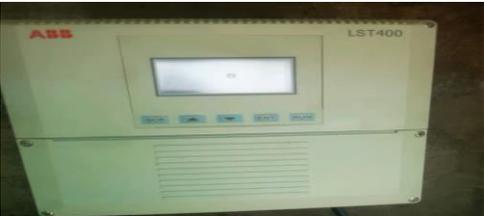
<ol style="list-style-type: none"> 1. Power backup arranged by KRMPL 19.02.2022. 2. Flow meter found working and under the trial run. 2. Glass door need to be installed for Flow meter 3. Commissioning has not completed yet. 4. Cable to be laid properly in cable tray and conduit pipe. 5. Log Book need to be maintained. 	23.11.2021		Pending
E	Distribution Chamber -1

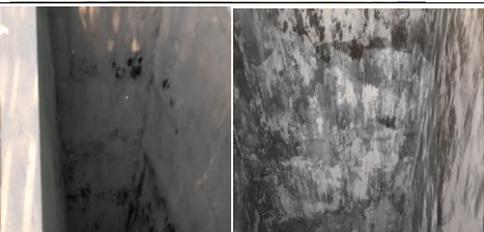
<ol style="list-style-type: none"> 1. Distribution chamber for Primary sedimentation tank partially done by KRMPL. 2. Inside Rcc wall, base and platform required renovation work. 3. Railing and its foundation needs to be replaced. 4. Reinforced exposed and need to be repaired. 5. All Sluice gate need to be replaced. 6. Cable trench depth should be as per IS code. 7. Earthing laying should be as per IS code. 	01.03.2021		Long Pending
