SITE INSPECTION REPORT FOR 210 MLD STP BINGAWAN					BINGAWAN STP - 210 MLD		Date: 25.03.2022	INSPECTED BY: STC Team: 1) Mr. J.P. Tripathi, (O&M Expert) 2) Mr. Satish Kamraju (Process Expert) 3) Mr. Rohit Suman (Supp. Engineer Mechanical) 4) Mr. Pankaj Rawat (Supp. Supervisor Civil) KRMPPL Team: 1) Mr. Abhishek Pandey (Process Engr.) 2) Mr. Sundeep Sharma (Site Incharge)

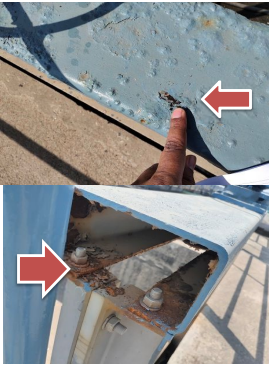
37	Painting works on PTU	When Painting work is not done properly on the items on PTU. By scratching through nails only, the painted parts is coming out and the below portion was found rusted. Also the inner parts are not being painted as shown in the pictures.

Painting must be done properly and all the rusted parts on PTU needs to be painted. Apart from this, painting procedure needs to be submitted at the earliest. All the parts on which painting is not done by following standard procedure, needs to be repainted properly.		26.11.2021 (Since long back)		Long Pending
38	RTOLMS sampling bucket on PTU	When STC team reached site, it was found that the bucket from where sewage is being pumped to RTOLMS was found filled with sludge and all the holes was found choked.

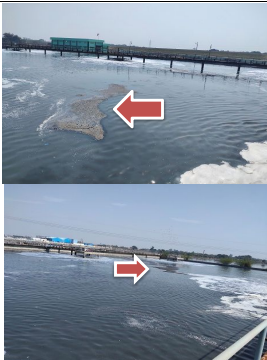
80	Aerator no. 17	Operational After almost 1/2 months of non-operational since 22.02.2022, it was made operational on 03.03.2022.				25.03.2022		
81	Aerator no. 18	Non-Operational		Need to be rectified at the earliest.		22.02.2022		
82	Aerators earthing	All aerators earthing work found not available		All aerators earthing strip connection must be done at the earliest.		22.01.2022		Long Pending
83	Aeration Lagoon no. 1	1) When STC / UPJN team reached the site, a joint depth measurement for aeration lagoon no. 1 was done at three different points, and sludge was found at an average depth of 0.6m below the top water level, which means 3.4 m approx. sludge is present inside aeration lagoon no. 1 at corners. 2) At the time of visit, no desludging work was found. 3) At the middle portions of the lagoon, sludge was seen above the top water levels also with clearly indicates that the lagoon is completely filled with sludge.

Desludging needs to be done on immediate basis.		26.11.2021 (Since long back)	15.01.2022	Long Pending

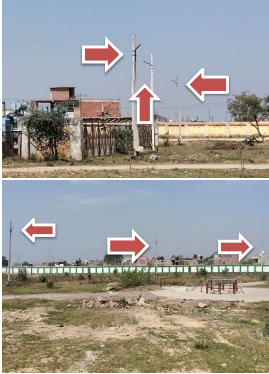
122	LT Panel Room	Various indicators, ammeters , voltmeters etc were found not working		All non-working indicators, ammeters, voltmeters etc must be replaced at the earliest.	25.03.2022		
123	Plant External Lights	When UPJN & PE officials visited site, it was found that some of the lights were replaced and various lights are still not working/ not available, which needs to be rectified / replaced.

Defective lights needs to be replaced at the earliest.	28.01.2020		LONG PENDING
124	Water taps at various locations inside plant	When UPJN & PE visited the site, it was found that at various locations, the water taps are not working and the civil works are damaged and on some places no foundation and drain line were available.
