SITE INSPECTION REPORT FOR 42 MLD Sajari STP

Date:
07.03.2022

INSPECTED BY:
STC Team:
1) Dr. Giridhar Prabhu Kumar (TL) 2.
Mr. L.K.Rao (Safety Expert)
3) Mr. Rohit Suman (Supp. Engr.
Mechanical)
4) Mr. Pankaj Rawat (Supp. Sup. Civil)

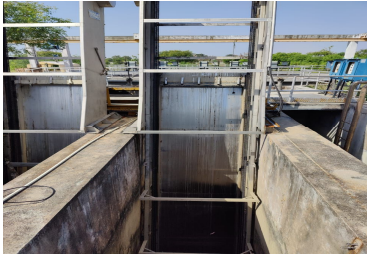
1) Need to be rectified at the earliest. 2) Auto system level settings needs to be done for proper functioning and it should be get checked by UPJN & PE.		1) 06.03.2022 2) Since handover 11-10-2019		LONG PENDING
3	Mech. Coarse screen (no.2)	Operational 1) When UPJN & STC team reached site, we found both mechanical screens in still condition. Upon asking by UPJN & STC team, KRMPL started running the screen manually. Manually operational but not automated. 2) Level sensor is not installed yet for automated.

1) Every time during visit, it was found in still condition, Needs to be operated on regular basis. 2) Level sensor has to be installed at earliest for automation.		1) 08.02.2022 2) Since handover 11-10-2019	28.02.2022	LONG PENDING

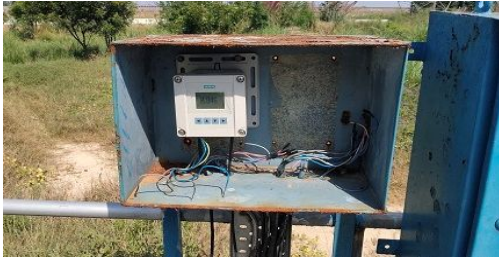
4	Mechanical Screen Level transmitter display	1) Auto System of Mech Coarse Screen -1 & 2 are Under Maintenance 2) Not operating the mechanical screen perfectly 3) Level sensor of 2nd mechanical screen is not available

1) The level setting system has to be corrected as per the inflow level for mechanical screen no. 1 and level sensor for mechanical screen no. 2 has to be installed at earliest for automation. 2) Closing gate must be fixed to the level transmitter casing box. 3) Painting needs to be done on the casing box.		Since handover 11-10-2019	28.02.2022 31.12.2021 31.12.2021	LONG PENDING
5	Belt Conveyor	When UPJN & STC team reached site, we found conveyor belt in still condition and by seeing the belt condition, it has been observed that KRMPL is not running the belt regularly as per requirement. Upon asking by UPJN & STC team, KRMPL started running the belt.		Every time during visit, conveyor belt was found in still condition, Needs to be operated on regular basis.		08.02.2022

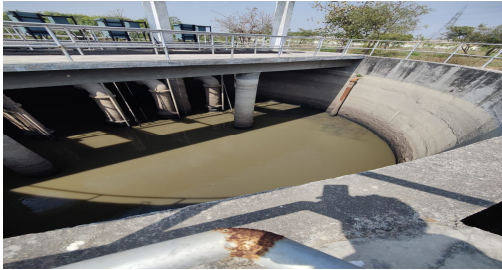
8	RAW SEWAGE PUMPING STATION							
1	Raw Sewage Pump-01	Non-Operational		1) Need to be rectified at the earliest. 2) Discharge line pressure gauge needs to be replaced		1) 10.01.2022 2) 21.09.2021	15.01.2022	LONG PENDING
2	Raw Sewage Pump-02	Non-Operational		1) Need to be rectified at the earliest. 2) Discharge line pressure gauge needs to be replaced		1) 13.02.2022 2) 31.07.2021	15.01.2022	LONG PENDING
3	Raw Sewage Pump-03	Operational						
4	Raw Sewage Pump-04	Operational After almost 2 months of non-operational since 31.12.2021, it was made operational on 07.03.2022		Discharge line pressure gauge needs to be replaced.		31.07.2021	15.01.2022	LONG PENDING
5	Raw Sewage Pump-05	Operational		Discharge line pressure gauge needs to be replaced		27-10-2021	15.01.2022	LONG PENDING
6	Collection Sump Lever sensor	No level transmitter was found inside collection sump

Install the level transmitter at the earliest and maintain the levels of the collection sump on regular basis.		18.11.2021		As per Article 8.8 (a), this has to be provided by the concessionaire

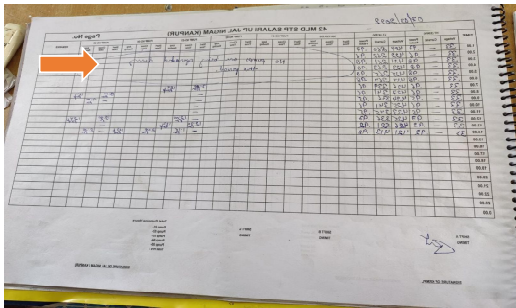
7	Raw Sewage Pumps operation	1) When STC team reached site, no free fall was being observed and only one pump was being found operational during the visit resulting in reverse flow. Upon asking by STC, KRMPPL started operating two more pumps. 2) Pumps were found not being operated at night hours.

At an average of around 23 MLD flow (which is 55 % of the average design flow) is coming, therefore atleast 2 to 3 nos. of pumps has to be operated during peak flow & atleast 1 to 2 nos. of pumps to be operated during non peak flow on regular basis in rotational way to tackle the problem of backflow/ reverse flow. In case the flow increase more than 23 MLD, more pumps needed to be operated.		27-10-2021		
8	EOT	Operational		Do lubrication work on regular basis				
9	Raw Sewage Pump Starter cable	Raw Sewage pump starter cable dressing are not done

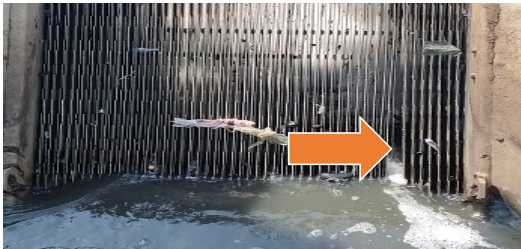
12	Electro-Magnetic flow meter		 	Get the calibration done & submit the calibration certificate at earliest		Since handover 11-10-2019		LONG PENDING
13	Panel Room	1) HT Panel & float cum boost charger ammeter not working. 2) Some of the indoor light lights not working. 3) One no. exhaust fan not working.		1) HT Panel ammeter need to be replace. 2) Indoor light 7 no. need to be replace. 3) Exhaust fan 1 no. need to be repaire. 4) Float cum boost charger ammeter need to be repaire immediately.		21-09-2021		LONG PENDING
C PRIMARY UNIT								
1	Fine screen (No. 1 Mech)	The bar spacing at some places in the screen has increased.

Need to be rectified at earliest.		27-10-2021	15.01.2022	Pending
2	Fine screen (No.2 Mech)	The bar spacing at some places in the screen has increased.	 	Need to be rectified at earliest.		27-10-2021	15.01.2022	Pending
3	Fine Mechancial Screen auto system	No level sensor were present around fine mechanical screen.		1) Level sensor must be installed at earliest. 2) Fine screen must be automated at earliest.		Since handover 11-10-2019	Past date i.e 28.02.2021, is mentioned in KRMPL letter no. 2037 dated 23.12.2021	LONG PENDING

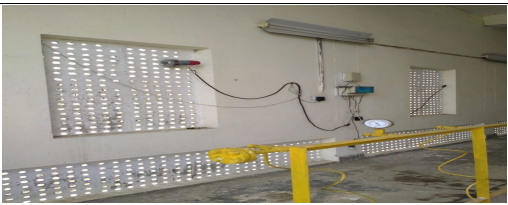
3	Chlorination Leak detection device	<p>During visit, cylinder was changed and there was leakage of chlorine but leak detecting device sensor doesn't sensed chlorine. It shows that leak detecting device is not working.</p> <p>Non-Operational</p>

Leakage detection device should be rectified and get it checked by UPJN/ PE		31.07.2021		LONG PENDING
4	Safety shower	Operational						
G Sludge system								
1	Sludge thickeners 1	<p>Operational</p> <p>When STC team reached site, it was found that sludge thickener is filled with sludge and influent is not properly treated by Sludge Thickener. It was observed that the sludge is being overflowing through the weir plates and the scum settled on the thickner surface (as depicted in the picture) was manually cleaning and discharging into the outlet launder. Also, at various points weir plate was found damaged & chocked.</p>

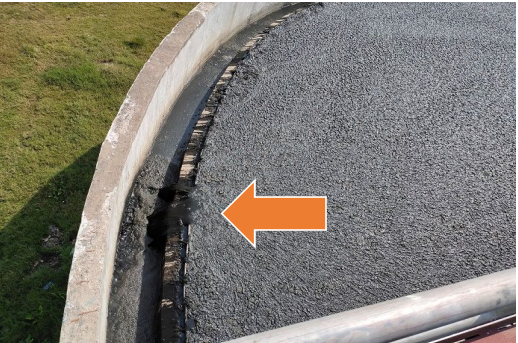
2	Sludge thickeners 2	<p>Operational</p> <p>After around 10 months of non-operational since 03.03.2021, it was made operational on 07.01.2022.</p> <p>This thickner was taken into cleaning and without informing/ witnessing it to UPJN or PE, sludge was filled on 07.01.2022.</p> <p>When STC team reached site, it was found that sludge thickener is filled with sludge and influent is not properly treated by Sludge Thickener. It was observed that the sludge is being overflowing through the weir plates and the scum settled on the thickner surface (as depicted in the picture) was manually cleaning and discharging into the outlet launder. Also, at various points weir plate was found damaged & chocked..</p>

<p>1) Sludge thickner processing must be stabilised and proper expertise must be given to the plant incharge monitoring the operation. Also experienced operator must be deployed.</p> <p>2) Damaged weir plate must be fixed and weir plate must be cleaned & levelled.</p> <p>3) Painting of MS structures must be done at the earliest.</p>		11.01.2022		PENDING

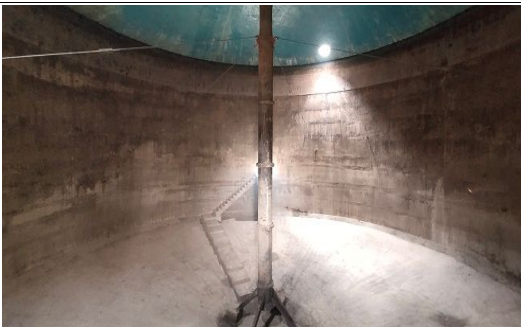
6	Sludge digester-02	<p>Non-Operational</p> <p>1) PE along with UPJN, have inspected digester no. 2 and found that the replaced impeller is colliding with the surrounding DI pipe which is causing heavy noise, which means installation work is not properly done. PE letter no. 1385 dated 11.01.2022 has been issued regarding the inspection for compliance.</p> <p>2) Voltas vendor inspected the digester on 07.03.2022 and he will submit his observations in the coming days.</p>

Needs to be rectified at the earliest		01.06.2020		LONG PENDING
7	Flow Meter for Bio gas.	Non-Operational

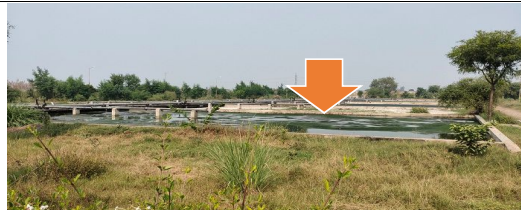
12	Bio gas blower 1 & 2	Operational						
	Pressure & Temperature Gauges inside Scrubber room	Various pressure & temperature gauges were found not working		Pressure & temperature gauges needs to be replaced		07.03.2022		
13	Sludge drying bed 1	Filled with sludge

Beds are required to be emptied periodically and Sludge to be disposed on regular basis		23.02.2021		No record of disposal of sludge is available.

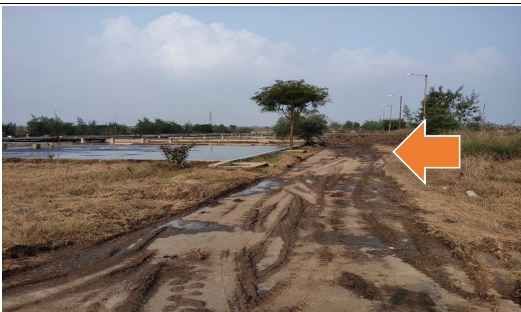
14	Sludge drying bed 2	<p>After approx 10 months since 23.02.2021, the sludge cleaning work started from 24.12.2021 and cleaning work has been completed but the removed sludge is lying beside the bed on the road resulting in road blockage.</p> <p>As per the register, cleaning work of this bed continued till 04.01.2022 which means from 04.01.2022, the removed sludge which is lying on the road has not been removed from the plant.</p>

Removed sludge lying on the road must be cleaned at the earliest.		11.01.2022		Pending
15	Sludge drying bed 3	After approx 1 year since 23.02.2021, the sludge cleaning work started from 27.02.2022 and cleaning work is in progress		Beds are required to be emptied periodically and Sludge to be disposed on regular basis		07.03.2022		Pending
16	Sludge drying bed 4	Filled with sludge		Beds are required to be emptied periodically and Sludge to be disposed on regular basis		23.02.2021		No record of disposal of sludge is available.

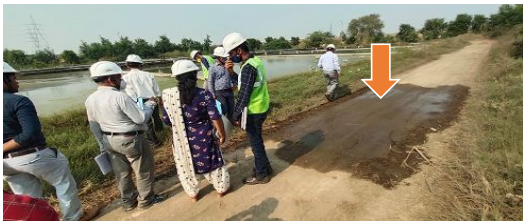
31	Sludge drying bed	Leakage found around sludge drying bed

<p>1) Needs to be restored at the earliest.</p> <p>2) RCC Slab must be provided on all chambers.</p>		29.10.2021		Pending
32	Tubewell pump 1	Operational						
33	Dilution water submersible pump-1	Operational

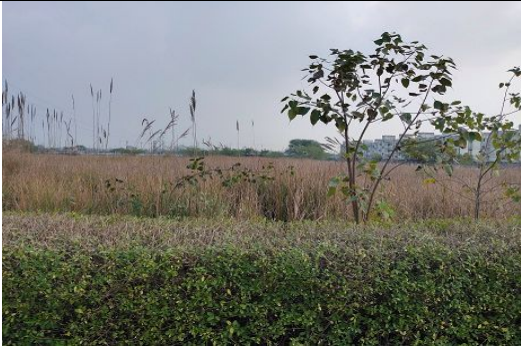
4	Log Books & Register			1) Log Books and registers must be maintained and remain available for all units 2) Maintenance register must be filled properly.				
5	House Keeping works	At various locations inside the plant, no house keeping works was found.

1) House keeping work at all locations inside the plant has to be done for which deployment of manpowers needs to be done. 2) Do the house keeping works on regular basis		27-10-2021		LONG PENDING
6	Equipments Numbering			Numbering must be provided in bold letters to all the equipments so that it could be seen easily and there should not remain any confusion about which item is no. 1 & which is no. 2		27-10-2021	31.01.2022	LONG PENDING
