National Mission for Clean Ganga- Development, Rehabilitation with
Operation & Maintenance of STPs at Kanpur under Hybrid Annuity based PPP mode

Sub: HAM KANPUR: Inspection Report of 43 MLD IPS and STP Jajmau facilities Phase II, Inspection done on 15.03.2022

SITE INSPECTION OF JAJMAU ASSOCIATED IPS REPORT				Parmiya IPS - 3.5 MLD	Date: 15.03.2022	INSPECTED BY: UPJN Team 1. Mr. Ajeet Singh, J.En Civil 2. Mr. Ankit Singh, J.En E&M 3. Mr. Ashish Seyal, J.En E&M STC-Team 1. Dr. Girdhar Prabhukumar, Team Leader cum Waste water Expert. 2. Mr Anuj Kushwaha(Support Engineer Civil) 3. Mr Ajay Goyal (Support Engineer- Mechanical) KRMLP-Team 1. Mr Satyam Bharati, Process Engineer

SITE INSPECTION REPORT FOR 43 MLD JAJMAU PHASE-II STP

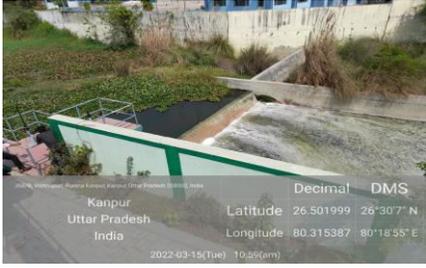
S. No.	Equipment	Assessment of Current Condition	Assessment of Current Condition Photo	Current defects and Corrective Action Suggested by STC, PE	Original Date of Issue	Proposed Date to Resolve by KRMLP	Current Status of Compliance
1	All work						
1	Parmiya Nala Tapping	Overflow Condition since handover date

<p>Decimal DMS Kanpur Latitude 26.501999 26°30'7" N Uttar Pradesh Longitude 80.315387 80°18'55" E India 2022-03-15(Tue) 10:52(am)</p>	Over flow condition found since handover. Upjn need to take action in this regards.	25.08.2021		Action to be taken by UPJN
2	Inlet Chamber	Epoxy coating found improper in inlet chamber.

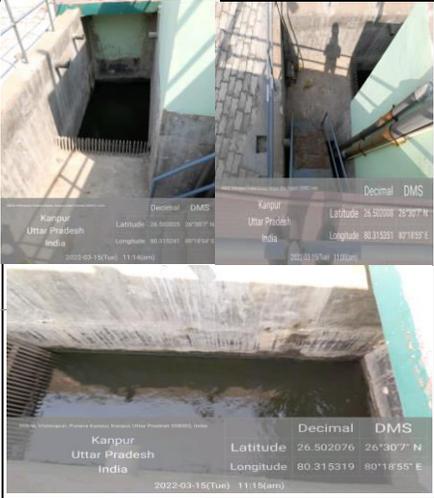
3	Coarse bar Screen Chamber(Manual)	Garbages and rusted MS stair and handrailing found

<ol style="list-style-type: none"> 1. Removal of polythene,papers,plastic should be on regular basis. 2. Painting work should be done by KRMPPL for MS Staircase and handrails. 3. Trolley for garbages disposal arranged by KRMPPL. 	15.12.2021		Pending
4	Coarse bar Bar Screen Chamber(2-Mechanical , 1- Manual)	Mechanical screen 1 &2 are operational not being operated regularly whenever STC/UPJN PM visited the site it was found that both the screen were not being operated.KRMPPL statred the mechanical screens and conveyor belt when asked by STC team.

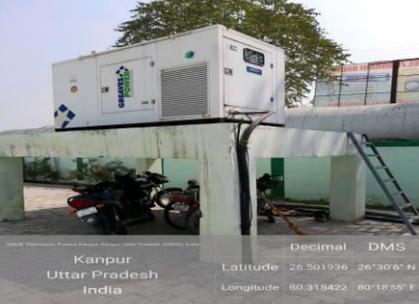
6	DG set	DG set found operational and Horizontal and vertical cracks found in civil structure.

<p>Decimal DMS Kanpur Uttar Pradesh India Latitude 26.501936 26°30'6" N Longitude 80.315422 80°18'55" E 2022-03-15(Tue) 11:10(am)</p>	<ol style="list-style-type: none"> 1. DG set is in working condition. 2. Exhaust chimney height of DG set is not as per CPCB norms. 3. Crackss repairing work and painting work should be done by KRMPPL. 4. Electric pole found rusted,It need to be rectified. 5. KRMPPL has not maintained diesel stock at site. 6. Handrails need to be fixed at DG set platform and MS Ladder. 	15-12-2021		Pending
7	Boundary wall	<ol style="list-style-type: none"> 1. Horizontal and vertical cracks found in civil structure. 2. Painting work found unpleasing appearances and non uniform.

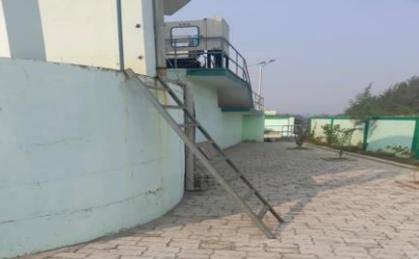
8	Internal road, Land scaping work and Campus Lightening work	<ol style="list-style-type: none"> 1. Interlocking road found settlement. 2. Utility unavailability for water drinking and daily purpose. 3. Electric pole has started to rust.

<ol style="list-style-type: none"> 1. Under renovation of IPS ,Interlocking road found settlement some location inside campus, That must be rectified by KRMPPL. 2.Total light 8 Nos in working condition. 3. Utility of water connection need to be arranged for drinking and daily purpose. 4.Painting work of electripole is required. 	15.12.2021		Pending
9	Valve Chamber	Frame chamber of valve chamber found rusted.

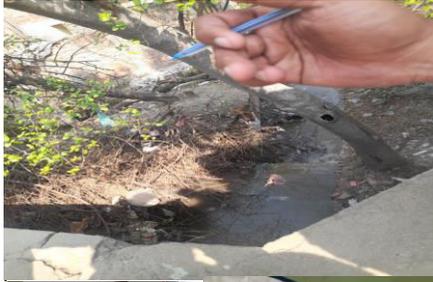
10	Back flow Condition	Back flow of sewerage from Parmiya Tapping shows near Culvert(Aunpriya merrage home)

1.Pump houses 1 and 2 need to be funtional Nawabganj IPSS to resolve the back flow condition.	21.12.2021		Pending
11	Documentation	KRMPL has not maintained documenattiuon work properly.

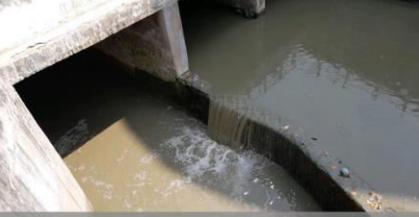
1	Shishamau Nala Tapping	Overflow conition found.

<p>Decimal DMS Latitude 26.489506 26°29'22" N Longitude 80.331175 80°19'52" E 2022-03-15(Tue) 12:19(pm)</p>	<p>1. During visit it was found that there is overflow condition of channel. 2. Silt removal work need to be done by KRMPL. 3. UPJN/STC asked to KRMPL to measured the depth of Shishamau Nala.</p>	15.02.2022		Pending
i	Manual Coarse bar screen Chamber	Civil struture is in satisfactory condition

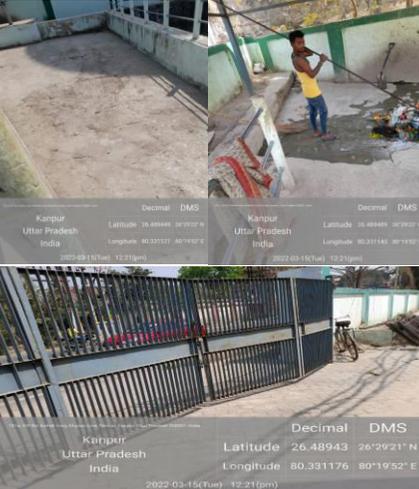
ii	RCC slab of Shashamau NALA tapping	Civil structure is in unsatisfactory condition

<p>Decimal DMS Latitude 26.489448 26°29'32" N Longitude 80.331131 80°19'52" E 2022-03-15(Tue) 12:21(pm)</p> <p>Decimal DMS Latitude 26.489448 26°29'32" N Longitude 80.331131 80°19'52" E 2022-03-15(Tue) 12:21(pm)</p> <p>Decimal DMS Latitude 26.489443 26°29'21" N Longitude 80.331176 80°19'52" E 2022-03-15(Tue) 12:21(pm)</p>	<p>1.Renovation of slab top surface should be rectified by KRMPL. 2.Garbage material should be remove from campus. 3.Renovation of boundary wall required. 4.Settled Interlocking area should be rectify by KRMPL 5.M.S gate should be repair by KRMPL 6. CCTV installation need to be done.KRMPL has promised to installed CCTV within a month. 7. KRMPL operators and sweepers are working without safety shoes, safety helmets and Safety Jackets at site.</p>	15.12.2021		pending

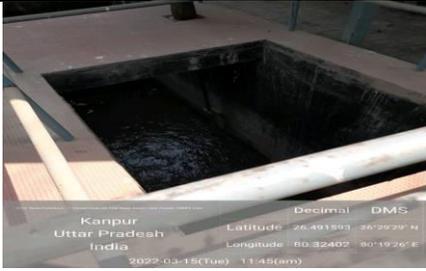
2	Inlet Chamber	Epoxy coating found improper in inlet chamber.

1. Cleaning need to be done. 2. Epoxy Coating need to be done.	15.12.2021		Pending
3	Coarse bar Screen Chamber(Manual)	Civil work is in satisfactory condition

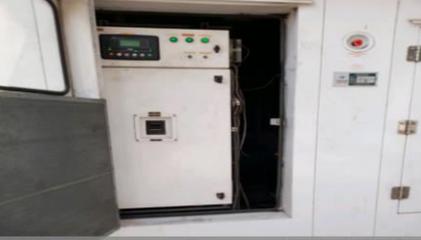
<p>Decimal DMS Latitude 26.489979 26°29'23" N Longitude 80.330468 80°19'49" E 2022-03-15(Tue) 11:54(am)</p>	<ol style="list-style-type: none"> 1.Pressure guage of pump no 2 is not in woking condition. 2.Pump No 2 and Pump No 5 line and leakages. 3. Valve and NRV directions are not visualize during operation.So KRMPL has shown the direction on as stated above. 	15.12.2021		Pending	
7	DG set	Both DG set found operational but diesel fuel found short.

<p>Decimal DMS Latitude 26.489966 26°29'23" N Longitude 80.330391 80°19'49" E 2022-03-15(Tue) 11:54(am)</p>	<ol style="list-style-type: none"> 1. Both DG set is in working condition. 2. DG log book is not mainatining by KRMPL. 3. Only 33% diesel available at DG set- 1 and 33% diesel available at DG set-2. 4. 8 Nos light are functional out of 11 Nos. 	15.12.2021		Pending

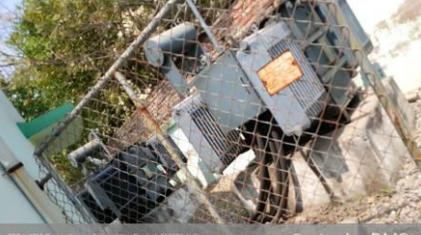
8	Transformer	Transformer found operational but their entry gate is damage.

<p>Decimal DMS Latitude 26.489956 26°29'23" N Longitude 80.330483 80°19'49" E 2022-03-15(Tue) 11:47(am)</p>	<ol style="list-style-type: none"> 1. Cleaning work need to be done at Transformer yard area. 2. Entry gate need to be repair. 3. Transformer breather silica gel in pink colour,It need to be replaced. 	21.12.2021		Pending

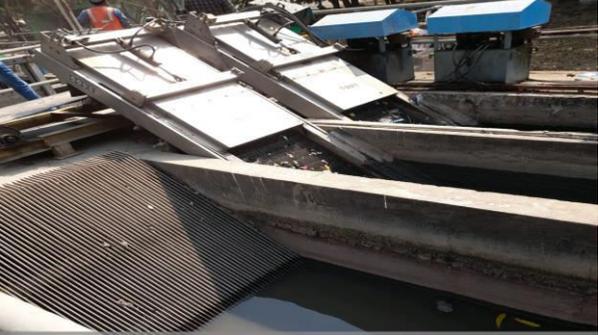
CCPR-667, Jajmau Sub Merit City, Kanpur, Uttar Pradesh 208009, India Kanpur Uttar Pradesh India Decimal DMS Latitude 26.41764 26°25'3" N Longitude 80.418106 80°25'5" E 2022-03-15(Tue) 01:57(pm)	1. Chamber and hand railing painting work need to be done. 2. Sluice gate need to be lubrication 3. Cleaing of inlet chamber need to be done.	21.09.2021		Pending.
1	Fine Screen No.1(Mecahnical)	Non-operated and not proper alignment

CCPR-667, Jajmau Sub Merit City, Kanpur, Uttar Pradesh 208009, India Kanpur Uttar Pradesh India Decimal DMS Latitude 26.41766 26°25'3" N Longitude 80.41808 80°25'5" E 2022-03-15(Tue) 01:58(pm)	1.Fine Screen need to be cleaning properly. 2. Screen Level Sensor need to be replaced. 3. Screen panel autosystem need to be repaired. 4. Panel stand need to be painted. 5. Cable tray need to be replaced and painted. 6.All light creen area need to be replaced. 7. Disposal material need to be removed on regular basis. 8. Manual trolly need to be provided for Disposal material. 9. All motors need to be covered by canopies. 10. Fine screen 2 (mechanical) need to maintenace for proper functional.	21.09.2021		Pending.

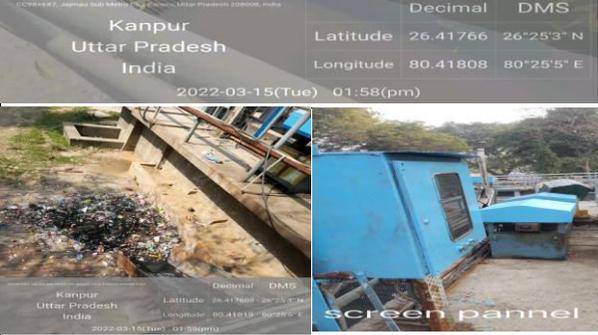
2	Fine Screen No.2 (Mecahnical)	Not Operational (Fine screen no 2 found not in proper operation)

CCPR-667, Jajmau Sub Merit City, Kanpur, Uttar Pradesh 208009, India Kanpur Uttar Pradesh India Decimal DMS Latitude 26.41766 26°25'3" N Longitude 80.41808 80°25'5" E 2022-03-15(Tue) 01:58(pm)		21.09.2021		Pending.
3	Fine Screen No.3(Manual)	Opertaional

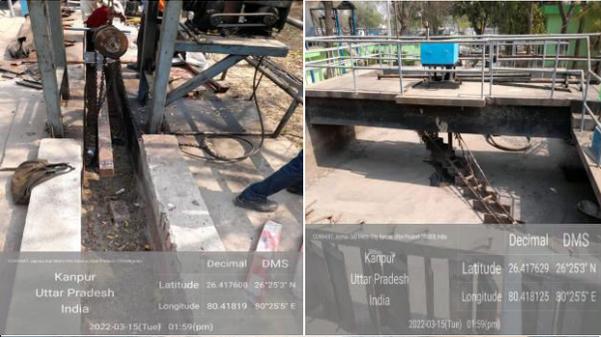
B.	Grit Mechanism					
1	Grit chamber-1 1)Organic pump with Motor 2)Scraper 3)Classifier Mechanism	Grit classifier system shutdown from 08.03.2022

<ol style="list-style-type: none"> Grit removal system previously shutdown on 27.02.2022 to 01.03.2022 and after that Grit classifier shutdown from 08.03.2022 for repairing of grit classifier mechanism. Alignment of classifier is in under progress. Installation of new blades is in progress. Painting needs to be done to equipment / covers wherever rusting. Organic pump need to be repair. Cable tray need to be painted. All E&M equipments shall be lubricate on regular basis and maintain the log book at site. Log book need to be maintained KRMPL need to clean grit chamber tank properly. Repairing work in grit chamber need to be done. Coal tar epoxy coat need to be done. 	30.09.2021	Pending
C	Inlet flow meter	Operational

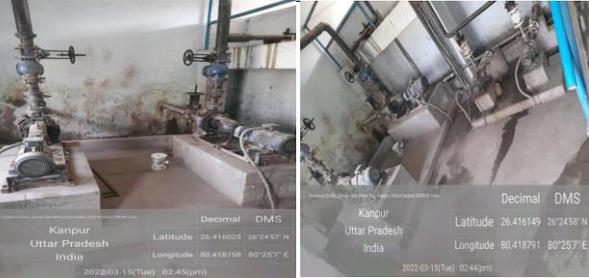
<p>1.Screen panel voltmeter need to be replaced. 2. Dosing agitator ammeter need to be replaced .</p>	21.09.2021		Pending
F	Sludge System						
1	Centrifuge feed pump(No.1 &2)	Operational-1 Nos Pump No.2 found non-functional

<p>1. Pump cleaning need to be required. 2. Pump lubrication need to be done on regular basis by KRMPPL. 3. Pump RPM need to be increase as per design. 4. Vibration and Temperature need to be measure on regular basis. 5. Pump log book has not maintained by KRMPPL. 6. Pump no. 02 found heavy vibration due to bearing in damaged condition.Bearing need to be changed.</p>	21.09.2021		Pending
2	Centrifuge panel	Operational

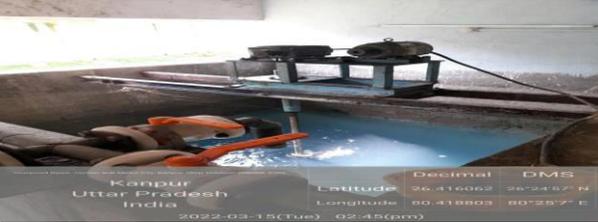
Decimal	DMS																	
Kanpur																			
Uttar Pradesh	Latitude	26.416093 26°24'57" N																	
India	Longitude	80.418846 80°25'7" E																	
8	Agitator No.2	Non-Operational from 02.03.2022

<p>Kanpur Uttar Pradesh India</p> <table border="1"> <thead> <tr> <th></th> <th>Decimal</th> <th>DMS</th> </tr> </thead> <tbody> <tr> <td></td> <td>Latitude</td> <td>26.416062 26°24'57" N</td> </tr> <tr> <td></td> <td>Longitude</td> <td>80.418803 80°25'7" E</td> </tr> </tbody> </table> <p>2022-03-15(Tue) 02:45(pm)</p>		Decimal	DMS		Latitude	26.416062 26°24'57" N		Longitude	80.418803 80°25'7" E	<ol style="list-style-type: none"> 1. Rusted steel Structure need to be replaced. 2. Coupling got broken on 02.03.2022, KRMPPL need to repaired on urgent basis. 3. Cleaning of tank need to be done. 	21.09.2021		Pending			
	Decimal	DMS																	
	Latitude	26.416062 26°24'57" N

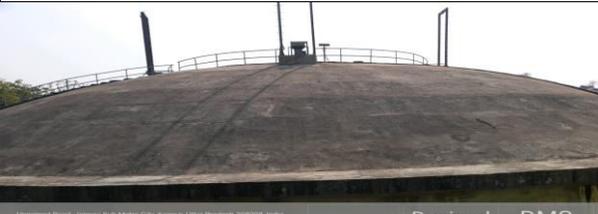
Longitude	80.418803 80°25'7" E																	
9	Digester No.1	Non-operated

<p>Unnamed Road, Jajmau Sub Metro City, Kanpur, Uttar Pradesh 208008, India</p> <table border="1"> <thead> <tr> <th></th> <th>Decimal</th> <th>DMS</th> </tr> </thead> <tbody> <tr> <td>Kanpur</td> <td></td> <td></td> </tr> <tr> <td>Uttar Pradesh</td> <td>Latitude</td> <td>26.415975 26°24'57" N</td> </tr> <tr> <td>India</td> <td>Longitude</td> <td>80.418868 80°25'7" E</td> </tr> </tbody> </table> <p>2022-03-15(Tue) 02:50(pm)</p>		Decimal	DMS	Kanpur			Uttar Pradesh	Latitude	26.415975 26°24'57" N	India	Longitude	80.418868 80°25'7" E	<ol style="list-style-type: none"> 1. Digster Need to be cleaned. 2. Civil Leakage need to be repaired. 3. Pressure relive valve need to be calibration. 4. All four nos of motors need to be repaired. 5. Canopies need to be replace. 6. HDPE gas pipe line need to be proper support. 	21.09.2021		Pending

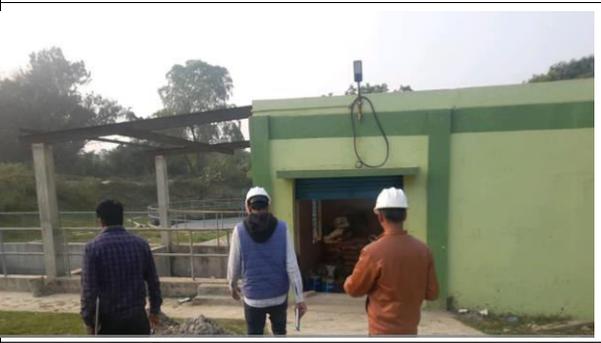
Decimal	DMS											
Kanpur Uttar Pradesh India	Latitude 26.416169 Longitude 80.418244	26°24'58" N 80°25'5" E											
2	Thickened Sludge Pump house and Pumps 1 nad 2 Nos.	Pump no 1 , Operational since 05.02.2022 Pump no. 2, Non-operational since handover

<ol style="list-style-type: none"> 1. Need to be Overhaul and repair. 2. Cleaning work need to be done. 3. Viberation and Temperature need to be measure on regular basis. 	21.09.2021		Pending						
H	Blower Room

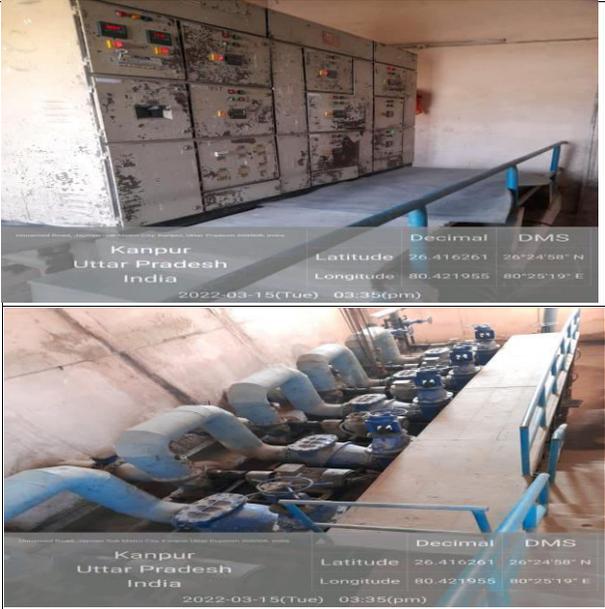
<ol style="list-style-type: none"> 1. Pump No 2 are not in working condition since 20.02.2022. 2. Each pump capacity 900m3/hr. 3. Lubrication of each equipment need to be done. 4. Log book need to be maintain properly. 5. Vibration and Temperature need to be measure on regular basis. 6. Ameter need to be repaired. 	21.09.2021		Pending
L	RSPH, Pumps no.1 and 2 ,800m3/hr	Operational

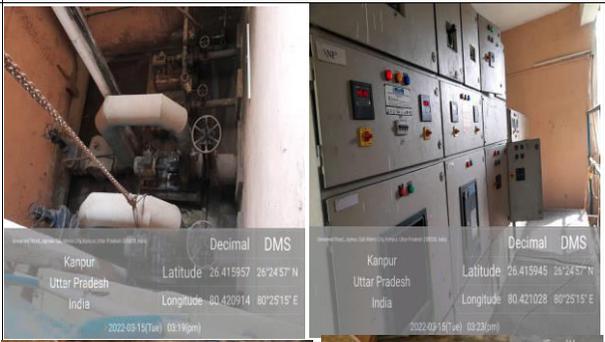
<ol style="list-style-type: none"> 1. 2 Nos. of pumps in Operational(1 W +1 S). 2. Excess sludge pump No. 2 operational from 15.02.2022 3. Ameter need to be repaired. 4. Pump no. 2 got heavy vibration, it must be repaired. 5. Heavy vibration found in waste activated sludge pump no. 1 . 6. All pumps need to lubrication. 	21.9.2021		Pending
M	Documentation	KRMPL has not maintained documentation work properly
