**SITE INSPECTION REPORT FOR 210 MLD STP BINGAWAN**

**BINGAWAN STP - 210 MLD**

**Date:**  
**27.05.2022**

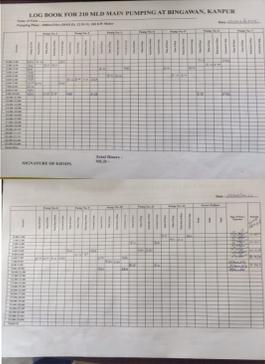
At an average of 130 MLD flow (which is 62 % of the average design flow) is coming, therefore atleast 5 nos. of pumps are to be operated during peak flow & atleast 3 nos. pumps to be operated during non peak flow on regular basis in rotational way to tackle the problem of backflow/ reverse flow. In case the flow increase more than 130 MLD, more pumps needed to be operated.		26-10-2021		The plant is designed for an average flow of 210 MLD and a peak flow of 420 MLD and for that 8 working pumps are provided. So when the average flow is 130 MLD (i.e. 62% of designed flow) which means peak flow is 260 MLD, then 5 nos. (i.e. 62% of provided pumps as per design) of pumps to be operated at peak hours and 3 pumps to be operated at non-peak hours, which KRMPL is not following

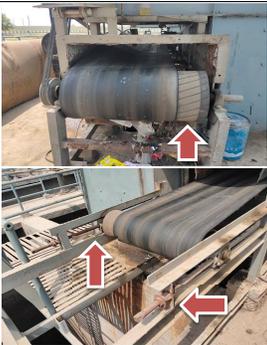
10	Conveyor belt	Operational When UPJN & STC team visited the site, it was observed that the Belt conveyor is not alignment properly and the screenings were not properly collected on the conveyor. On this, KRMPL's operator informed that the alignment issue is due to damaged check nut bolts.

1) Belt alignment needs to be done immediately. 2) Debris disposal from the belt conveyor to be done regularly. 3) Trolley must be provided every time and at the time of shifting debris, spare trolley also needs to be provided.		11.04.2022 25.03.2022		False information was provided in KRMPL letter no. 2455 dated 12.05.2022 regarding compliance to PE inspection.
11	Sluice Gate Slab	When STC team reached the site, it was again found that the damaged slab which was casted in the past has again found damaged. This means that KRMPL is not doing casting work properly and not deployed any civil engineer as of now at site for supervision work.

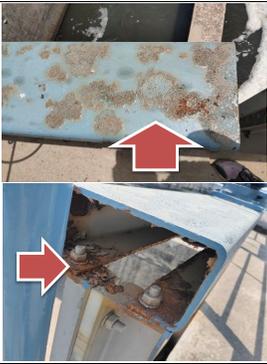
39	Painting works on PTU	When UPJN & PE visited site, it was found that painting work is not done properly on the items on PTU. By scratching through nails only, the painted parts is coming out and the below portion was found rusted. Also various parts which was not painted properly was again get corroded as shown in the pic.

<p>Painting must be done properly and all the rusted parts on PTU needs to be painted.</p> <p>Apart from this, painting procedure needs to be submitted at the earliest.</p> <p>All the parts on which painting is not done by following standard procedure, needs to be repainted properly.</p>			26.11.2021 (Since long back)		<p>Long Pending</p> <p>False information was provided in KRML letter no. 2455 dated 12.05.2022 regarding compliance to PE inspection.</p>
40	RTOLMS sampling bucket on PTU			Bucket must be clean and sludge must be removed daily.					
41	Grit removal mechanism-Detritor no.01 Main drive, Classifier drive, Organic pump	Operational 1) Very less quantity of grit was being removed by the grit classifier. 2) No canopy found on motors of equipments.

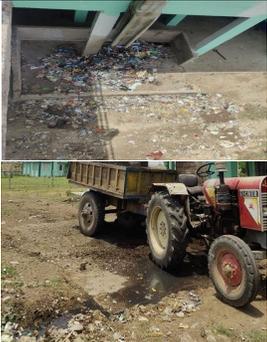
46	Grit Disposal Area	When UPJN & PE visited the site, it was found that no trolley was provided for screening collection and much of the screenings was getting splashed to the nearby locations.  Proper drains and CC road below grit tray are still not prepared which is creating pollution & unhygienic environmental condition.

<p>Trolley at every location needs to be provided for collection of Grit from chutes &amp; screenings from conveyor every time as directed by NMCG team and PE also.</p> <p>CC way need to be prepared as required for this area and required drain also needs to be provided.</p>			26-10-2021	30.10.2021	<p>LONG PENDING</p> <p>False information was provided in KRML letter no. 2455 dated 12.05.2022 regarding compliance to PE inspection.</p>

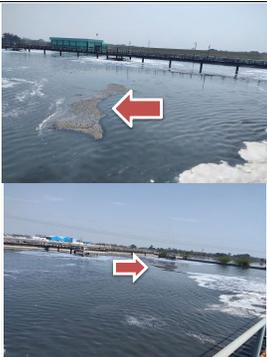
86	Aeration Lagoon no. 1	<p>1) When STC / UPJN team reached the site, a joint depth measurement for aeration lagoon no. 1 was done at three different points, and sludge was found at an average depth of 0.6m below the top water level, which means 3.4 m approx. sludge is present inside aeration lagoon no. 1 at corners.</p> <p>2) At the time of visit, no desludging work was found.</p> <p>3) At the middle portions of the lagoon, sludge was seen above the top water levels also with clearly indicates that the lagoon is completely filled with sludge.</p>

<p>Desludging needs to be done on immediate basis.</p> <p>In the meeting dated 11.04.2022, ED (T) NMCG directed KRMPPL to submit complete and detailed plan &amp; schedule for bypass line within 7 days (i.e., 18.04.2022).</p> <p>ED (T) NMCG directed KRMPPL to submit cleaning schedule of aeration lagoon within 7 days (i.e., 18.04.2022).</p>		26.11.2021 (Since long back)	15.01.2022 New date 31.08.2022	Long Pending

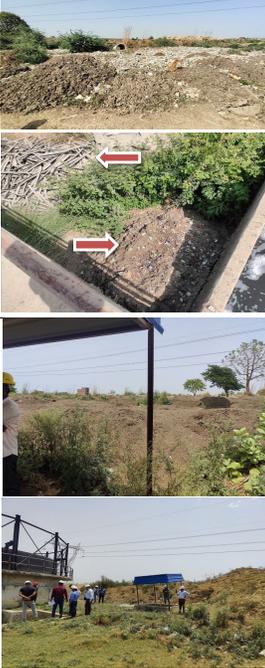
113	House Keeping	<p>House Keeping work is found to be in very poor condition. This implies that KRMPPL is not doing house keeping work which is clear from the photographs.</p>

<p>House keeping work of the plant needs to be improved at the earliest and done regularly. Sufficient manpower for house keeping work must be deployed.</p>		26.10.2021		<p>LONG PENDING</p> <p>False information was provided in KRMPPL letter no. 2455 dated 12.05.2022 regarding compliance to PE inspection.</p>
114	Leakage at Civil Unit	<p>When UPJN &amp; PE visited site, heavy leakage was observed as shown in the picture because of which the area below division channel was filled with sewage. Also leakages from various structures were found.</p>

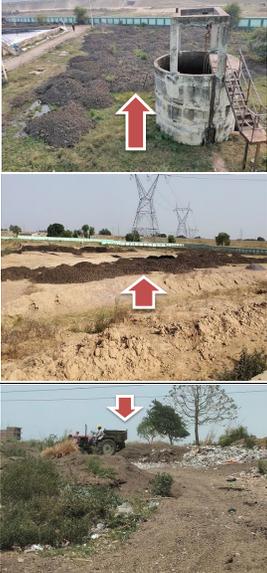
119	MS structures, Hand railings in whole plant, MS staires	Various MS Structures, MS staires and all the hand rails on UASB reactors etc were found totally rusted		Epoxy painting must be done properly by following standard procedure on all the corroded items of the plant at the earliest.	26.11.2021 (Since long back)	30.06.2022	Long Pending
120	UASB Reactor Hand railing.	Hand rails on the UASB reactors are totally rusted.		Handrailing needs to be either replaced or painted with epoxy paint at the earliest.	26.11.2021 (Since long back)	30.06.2022	Long Pending
121	Sludge Disposal	<p>When STC / UP Jal Nigam team reached the site, we found that still sludge was being disposed at various locations inside the plant on the ground without any permission.</p> <p>As instructed by ED (Technical) on 08.10.2021 &amp; 11.04.2022 that sludge disposal is to be done as per norms of UPPCB but still KRMPL is not following it.</p> <p>UPPCB vide their letter no. 1386/5-658/21 dated 04.12.2021 also instructed KRMPL to dispose the sludge as per the norms but still sludge is being disposed on the ground at an inappropriate place.</p>

<p>Still UPPCB norms are not being followed and sludge disposal is being done inside the plant on the muddy ground.</p> <p>Sludge disposal must be done as per UPPCB norms.</p> <p><b>In the meeting dated 11.04.2022, ED (T) NMCG directed KRMPL to follow UPPCB norms for sludge disposal &amp; storage inside the plant but KRMPL still not following the norms.</b></p>	01.12.2021		LONG PENDING
