SITE INSPECTION REPORT FOR 210 MLD STP BINGAWAN					BINGAWAN STP - 210 MLD		Date: 30.06.2022	INSPECTED BY: UPJN Team: 1)Mr. Mahipal Singh (JE, E&M) STC Team: 1) Mr. Rohit Suman, Supp. Engineer, Mechanical. 2) Mr. Rahul Sarwan, Supp. Engineer, Electrical KRMPL Team: Mr. Anirban Mukherji and KRMPL team

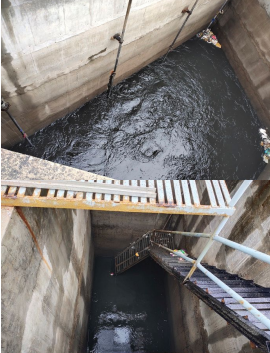
Leakages from the bypass sluice gate must be fixed.		27.05.2022		Pending
2	Reverse flow	When UPJN & PE visited site, no free fall was found and reverse flow was being observed. From this, it is evident that KRMPL is not operating required nos. of pumps as per flow.

Required nos. of pumps needs to be operated to tackle the problem of reverse/ back flow and free fall needs to be maintained in the collection sump every time.		26-10-2021

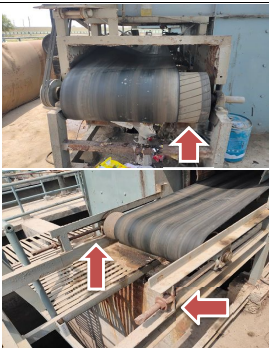
10	Conveyor belt	<p>Operational</p> <p>When UPJN & STC team visited the site, it was observed that the Belt conveyor is not alignment properly and the screenings were not properly collected on the conveyor.</p> <p>On this, KRMPL's operator informed that the alignment issue is due to damaged check nut bolts.</p> <p>Apart from this, the belt conveyor was found in still condition during visit on 30.06.2022 and no operator was found near the unit.</p>

<ol style="list-style-type: none"> 1) Belt alignment needs to be done immediately. 2) Belt conveyor needs to be operated regularly. 3) Debris disposal from the belt conveyor to be done regularly. 4) Trolley must be provided every time and at the time of shifting debris, spare trolley also needs to be provided. 		11.04.2022 25.03.2022		Pending
11	Sluice Gate Slab	<p>When UPJN & STC team reached the site, it was again found that the damaged slab which was casted in the past has again found damaged. This means that KRMPL is not doing casting work properly and not deployed any civil engineer as of now at site for supervision work.</p>

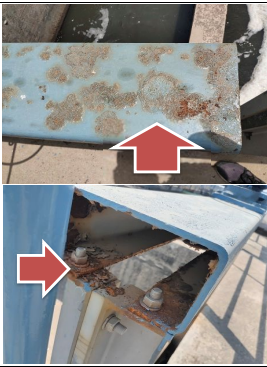
39	Painting works on PTU	When UPJN & PE visited site, it was found that painting work is not done properly on the items on PTU. By scratching through nails only, the painted parts is coming out and the below portion was found rusted. Also various parts which was not painted properly was again get corroded as shown in the pic.

Painting must be done properly and all the rusted parts on PTU needs to be painted. Apart from this, painting procedure needs to be submitted at the earliest. All the parts on which painting is not done by following standard procedure, needs to be repainted properly.		26.11.2021 (Since long back)		Long Pending
40	RTOLMS sampling bucket on PTU			Bucket must be clean and sludge must be removed daily.				
41	Grit removal mechanism-Detritor no.01 Main drive, Classifier drive, Organic pump	Operational 1) Very less quantity of grit was being removed by the grit classifier. 2) No canopy found on motors of equipments.

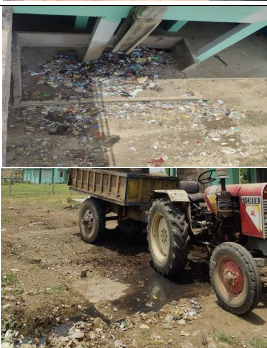
1) Level sensor must be installed at earliest. 2) Scale & chart for flow measurement must be fixed at earliest.		Since Handover 08-07-2019	2) 15.01.2022 new date 30.06.2022 2) 31.07.2022 new date	LONG PENDING
46	Grit Disposal Area	When UPJN & PE visited the site, it was found that no trolley was provided for screening collection and much of the screenings was getting splashed to the nearby locations. Proper drains and CC road below grit tray are still not prepared which is creating pollution & unhygienic environmental condition.

Trolley at every location needs to be provided for collection of Grit from chutes & screenings from conveyor every time as directed by NMCG team and PE also. CC way need to be prepared as required for this area and required drain also needs to be provided.		26-10-2021	30.10.2021	LONG PENDING

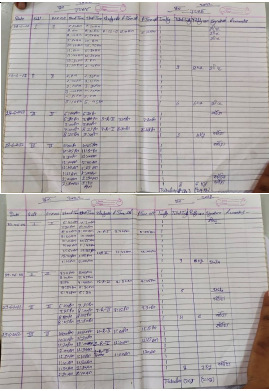
64	UASB reactors sludge withdrawing.	When UPJN & PE visited site, it was found from the register that sludge withdrawal are not being done from each reactors daily.

Required quantity of sludge needs to be withdrawn from all the reactors daily and accordingly required nos. of BFP & sludge pump need to be operated.		27.05.2022		Pending
65	Sampling Chamber	When STC / UPJN team reached the site, it was found that; 1) Some of the sampling chambers beside reactors are cleaned and various chambers were filled with sewage/ water and many sampling points were packed with concrete. 2) Various bottom sludge drawing pipes in the chambers are found choked and no sludge removal is taking place from the below pipe.

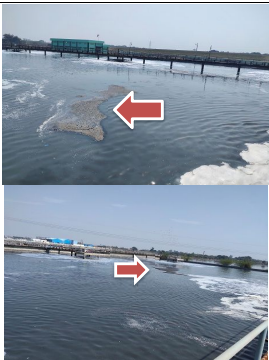
86	Aeration Lagoon no. 1	<p>1) When STC / UPJN team reached the site, a joint depth measurement for aeration lagoon no. 1 was done at three different points, and sludge was found at an average depth of 0.6m below the top water level, which means 3.4 m approx. sludge is present inside aeration lagoon no. 1 at corners.</p> <p>2) At the time of visit, no desludging work was found.</p> <p>3) At the middle portions of the lagoon, sludge was seen above the top water levels also with clearly indicates that the lagoon is completely filled with sludge.</p>

<p>Desludging needs to be done on immediate basis.</p> <p>In the meeting dated 11.04.2022, ED (T) NMCG directed KRML to submit complete and detailed plan & schedule for bypass line within 7 days (i.e., 18.04.2022).</p> <p>ED (T) NMCG directed KRML to submit cleaning schedule of aeration lagoon within 7 days (i.e., 18.04.2022).</p>		26.11.2021 (Since long back)	15.01.2022 New date 31.08.2022	Long Pending

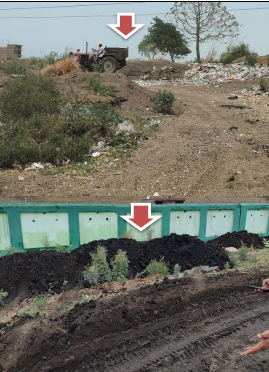
119	MS structures, Hand railings in whole plant, MS staires	Various MS Structures, MS staires and all the hand rails on UASB reactors etc were found totally rusted		Epoxy painting must be done properly by following standard procedure on all the corroded items of the plant at the earliest.		26.11.2021 (Since long back)	30.06.2022	Long Pending
120	UASB Reactor Hand railing.	Hand rails on the UASB reactors are totally rusted.		Handrailing needs to be either replaced or painted with epoxy paint at the earliest.		26.11.2021 (Since long back)	30.06.2022 New Date 31.08.2022	Long Pending
121	Sludge Disposal	When STC / UP Jal Nigam team reached the site, we found that still sludge was being disposed at various locations inside the plant on the ground without any permission. As instructed by ED (Technical) on 08.10.2021 & 11.04.2022 that sludge disposal is to be done as per norms of UPPCB but still KRMPL is not following it. UPPCB vide their letter no. 1386/5-658/21 dated 04.12.2021 also instructed KRMPL to dispose the sludge as per the norms but still sludge is being disposed on the ground at an inappropriate place.

<p>Still UPPCB norms are not being followed and sludge disposal is being done inside the plant on the muddy ground.</p> <p>Sludge disposal must be done as per UPPCB norms.</p> <p>In the meeting dated 11.04.2022, ED (T) NMCG directed KRMPL to follow UPPCB norms for sludge disposal & storage inside the plant but KRMPL still not following the norms.</p>		01.12.2021		LONG PENDING
