SITE INSPECTION REPORT FOR 42 MLD Sajari STP

SAJARI STP

Date:
08.06.2022

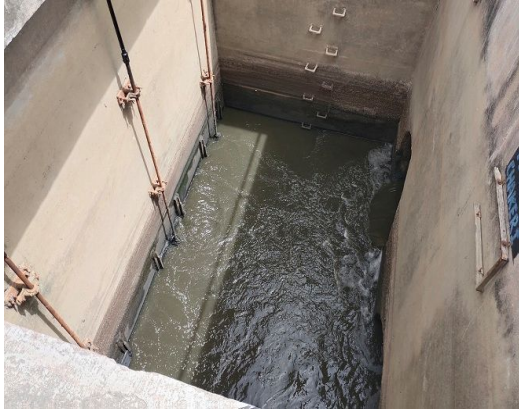
S. No.	Equipment	Assessment of Current Condition	Assessment of Current Condition Photo	Corrective Action Suggested by STC	Corrective Action Completed by KRMPL	Original Date of Issue	Proposed date to resolve by KRMPL	Remark
A	INLET CHAMBER							
1	Inlet Sluice Gates	<p>Operational</p> <p>When UPJN & PE visited site, it was again found that only one inlet sluice gate was opened and that is also not fully opened (approx. 30% was opened) where it should be opened fully at all time because of which uniform flow of sewage is not taking place.</p> <p>Every time, it has been observed that same issues are being repeated by KRMPL. Even in previous compliance report, KRMPL said that it will be done but still same issue was observed at site. Level difference was also observed between collection sump & inlet chamber of MPS because of this issue.</p>

Required number of sluice gates must be opened fully for uniform flow of sewage.		10.05.2022		Pending

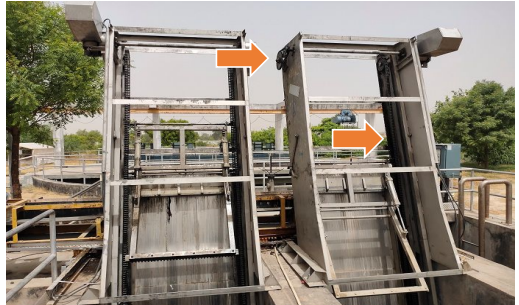
2	Mech. Coarse screen (no.1)	<p>Operational</p> <p>After approx. 3 months of non-operational since 06.03.2022, it was found operational on 08.06.2022 but still vibration and uneven sound was observed from the motor and gearbox arrangement because of which it may fail in future also if not resolved immediately.</p>		<p>1) Vibration & uneven sound issue need to be rectified at the earliest.</p> <p>2) Auto system level settings needs to be done for proper functioning and it should be get checked by UPJN & PE.</p> <p>In the meeting dated 11.04.2022, ED (T) NMCG directed KRMPL to rectify the screen at the earliest but not rectified yet completely.</p>		<p>1) 06.03.2022</p> <p>2) Since handover 11-10-2019</p>		LONG PENDING
3	Mech. Coarse screen (no.2)	<p>Non-Operational</p> <p>1) Level sensor is not installed yet for automated.</p>

<p>1) Need to be rectified at the earliest..</p> <p>2) Level sensor has to be installed at earliest for automation.</p> <p>In the meeting dated 11.04.2022, ED (T) NMCG directed KRMPL to rectify the screen at the earliest but not rectified yet.</p>		<p>1) 11.04.2022</p> <p>2) Since handover 11-10-2019</p>	<p>2) 28.02.2022 / New date given 31.08.2022</p>	LONG PENDING

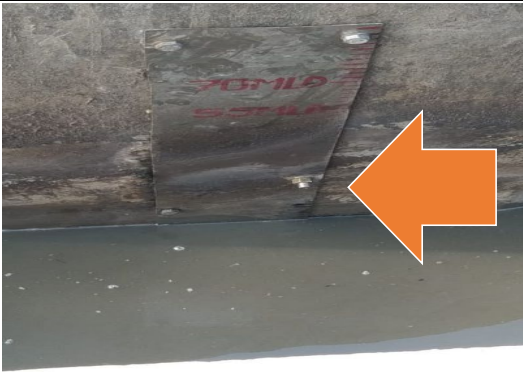
10	Parshall Flume	No ultrasonic level sensor was found at site. Also, the fixed scale is not readable.

1) Level sensor must be installed at the earliest. 2) Readable scale must be installed. 3) Chart for flow measurement must be fixed at the earliest. 4) Kindly provide the necessary documents on the basis of which scale reading has been provided. 5) KRMPL must record the flow through parshall flumes at every time intervals on daily basis and its register has to be maintained.		1) Since handover 11-10-2019 2) 11.01.2022		LONG PENDING As per Article 8.8 (a), this has to be provided by the concessionaire
11	PST 1	Operational It has been observed that torque meter is not available on the mechanism which is essential for knowing the equipment performance		1) Vibration check on regular basis through vibration meter and lubrication to be done on regular basis for PST-1. 2) Torque meter needs to be provided.		1) 27-10-2021 2) 08.06.2022	1) 31.01.2022 / 31.05.2022

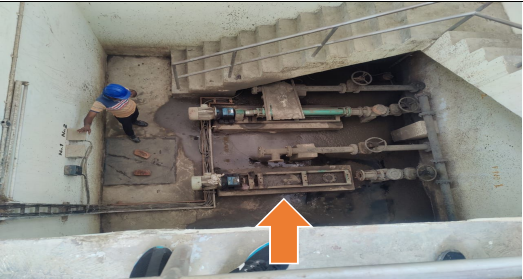
12	PST 2	Operational Local push buttons was found not working. It has been observed that torque meter is not available on the mechanism which is essential for knowing the equipment performance.		1) Local push buttons must be rectified at the earliest. 2) Vibration check on regular basis through vibration meter and lubrication to be done on regular basis for PST-2. 3) Torque meter needs to be provided.		27-10-2021 3) 08.06.2022	1) 31.01.2022 2) 15.01.2022/ 31.05.2022	LONG PENDING
13	Primary sludge pump no. 1	Non-Operational

Need to be rectified at earliest.		10.05.2022		Pending
14	Primary sludge pump no. 2	Operational						
D AREATION TANK								
1	Aerator no 1	Operational		Vibration to be checked on regular basis by vibration meter and lubrication needs to be done on regular basis for each areator.		21-09-2021	31.05.2022	LONG PENDING
2	Aerator no 2	Operational		Vibration to be checked on regular basis by vibration meter and lubrication needs to be done on regular basis for each areator.		21-09-2021	31.05.2022	LONG PENDING

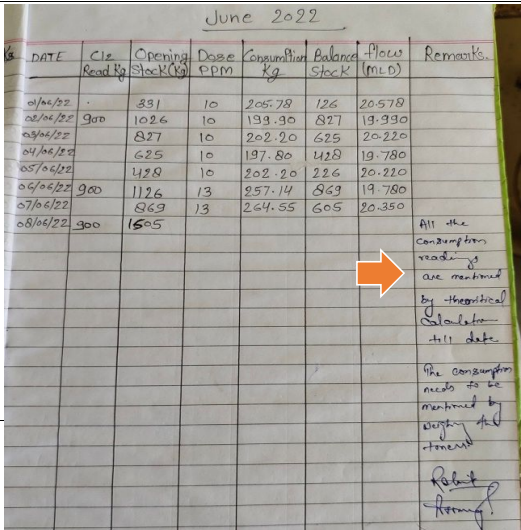
Need to be rectified at the earliest Simultaneously Schedule maintenance work needs to be conducted through the manufacturing agency and get it inspected by UPJN & PE.		04.05.2022		Pending
2	SST 2	Operational						
3	Return sludge pump 1	Non-Operational		Needs to be repaired at the earliest.		20.04.2022		
4	Return sludge pump 2	Operational		Some of the non working indicators needs to be replaced.		10.05.2022		
5	Return sludge pump 3	Non-Operational Pressure Gauge not available		1) Needs to be repaired at the earliest. 2) Pressure gauge must be fixed at earliest.		09.12.2021	31.01.2022/ 31.05.2022	LONG PENDING
F CHLORINATION AREA								
1	Chlorine Tonners(Total Qty.=06 Nos)	Operational 1) Chlorine cylinder is found totally rusted. 2) It has been observed that the mentioned chlorine dosing record is exact (upto two decimal points) @ 10 ppm as per flow for whole month, which can't be possible and this implies that still KRMPL is not making the entry by weighing the tonners. 3) Pressure gauge was not found working. 4) Some of the indoor lights were not working. 5) No permanent operator was found for chlorination unit.

1) KRMPL must check the expiry of the tonners and needs to make the documents available at tonner room. 2) Chlorine dosage entry must be done by weighing the tonners not by theoretical calculation. 3) Pressure gauge in tonner room must be replaced at earliest. 4) Non-working indoor lights must be replaced. 5) Experienced and permanent operator must be deployed for chlorination unit. 6) KRMPL must ensure no chlorine leakage from the tonner and chlorination system.		10.05.2022 27.10.2021		LONG PENDING

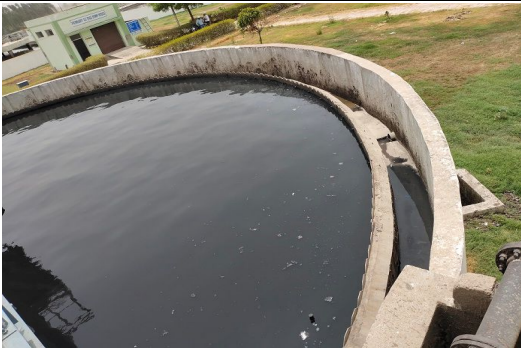
2	Sludge thickeners 2	<p>Operational</p> <p>After around 10 months of non-operational since 03.03.2021, it was made operational on 07.01.2022.</p> <p>This thickner was taken into cleaning and without informing/ witnessing it to UPJN or PE, sludge was filled on 07.01.2022.</p> <p>1) When UPJN & PE team reached site, it was found that no supernatant was overflowing through the weir notch and water level inside thickener was found approx. 300 mm below weir notch. Apart from this, dilution water & primary sludge intake was taking place at the time of visit.</p> <p>2) Also, at various points weir plate was found damaged & choked.</p> <p>3) No record of dilution water intake to thickeners was found at site.</p>

<p>1) Sludge thickner must be operated regularly, processing needs to be stabilised and proper expertise must be given to the plant incharge monitoring the operation. Also experienced operator must be deployed.</p> <p>2) Damaged & choked weir plates must be cleaned and rectified.</p> <p>3) Dilution water intake & supernatant overflow record need to be maintained.</p> <p>4) TSS test of supernatant overflowing thickener needs to be conducted and recorded.</p> <p>In the meeting dated 11.04.2022, ED (T) NMCG directed KRMPL to take appropriate measures to stabilize the thickening process at the earliest.</p>		11.01.2022		LONG PENDING

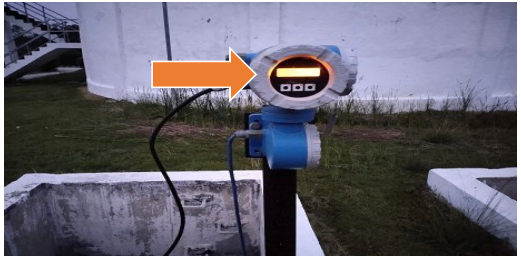
6	Sludge digester-02	<p>Operational</p> <p>KRMPL submitted Voltas inspection report for the inspection of the digester done on 07.03.2022 on which PE has given condition clearance to charge sludge into Digester no. 2 only after complying the conditions mentioned in STC letter no. 1526 dated 01.04.2022.</p> <p>KRMPL has charged the digester without complying STC letter no. 1526.</p>		<p>In the meeting dated 11.04.2022, ED (T) NMCG instructed KRMPL that it is the duty of KRMPL to get every rectification work witnessed by PE & UPJN and the issues raised by UPJN & PE must be complied.</p>		<p>11.04.2022</p> <p>01.06.2020</p>		
7	Flow Meter for Bio gas.	Non-Operational

Must be rectified at the earliest		18.11.2021	28.02.2022 / 31.07.2022	<p>LONG PENDING</p> <p>31.07.2022 date is proposed by KRMPL vide KRMPL Letter no. 2453 dated 11.05.2022.</p>

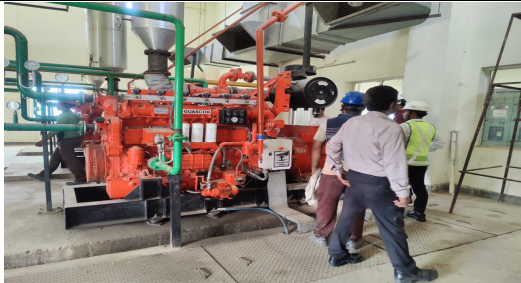
9	Gas engine -2	Operational						
10	Gas engine -3	Non Operational

Need to be rectified at earliest.		15.04.2022		
11	Gas Scrubbers	Operational		UPJN has advised KRMPL to connect a pipe from scrubber exit directly to H2S analyser for knowing the value of H2S present in scrubbed gas just exiting scrubber.		11.01.2022		Pending
12	Bio gas blower 1 & 2	Operational						
13	Pressure & Temperature Gauges inside Scrubber room	Various pressure & temperature gauges were found not working		Pressure & temperature gauges needs to be replaced		07.03.2022	31.05.2022	Pending
14	Sludge drying bed 1	Filled with sludge		Beds are required to be emptied periodically and Sludge to be disposed on regular basis		23.02.2021		LONG PENDING
15	Sludge drying bed 2	Filled with sludge since 04.01.2022				04.01.2022		LONG PENDING
16	Sludge drying bed 3	Filled with sludge since 08.03.2022				08.03.2022		LONG PENDING

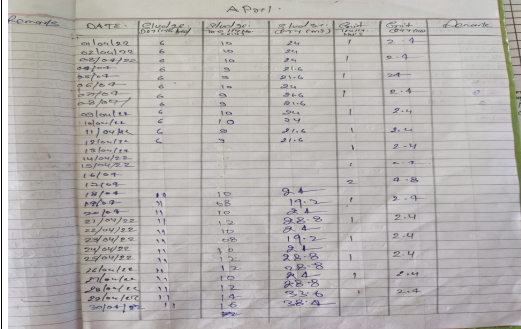
19	Sludge drying bed 6	Cleaning work in progress since 01.04.2022 but no work done after 12.04.2022

Beds are required to be emptied periodically and Sludge to be disposed on regular basis	11.04.2022	As per KRMPL Letter no. 2453 dated 11.05.2022 , out of the remaining 17 beds, 5 beds will be cleaned by 31.05.2022, 5 beds by 31.06.2022 & balance 7 by 31.07.2022	Pending
20	Sludge drying bed 7	Filled with sludge		Beds are required to be emptied periodically and Sludge to be disposed on regular basis	23.02.2021		LONG PENDING
21	Sludge drying bed 8	Filled with sludge					
22	Sludge drying bed 9	Filled with sludge					
23	Sludge drying bed 10	Filled with sludge					
24	Sludge drying bed 11	<p>When UPJN & PE visited site, it was found that the register pages found stick with each other and complete data was found maintained in a single day.</p> <p>After approx 1.2 years since 23.02.2021, the sludge cleaning work started from 18.04.2022 and was completed on 14.05.2022</p>

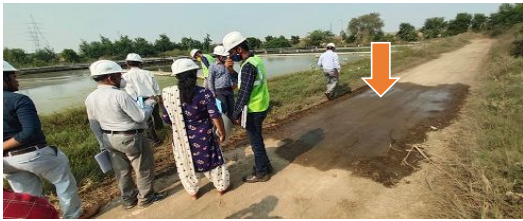
32	Sludge disposal from digester to Sludge drying bed.	When UPJN & PE visited site on 08.06.2022, all sludge drying beds were jointly seen by UPJN & PE and no wet sludge was found in any of the drying beds even when there is continuous sludge disposal taking place from the digesters as per KRMPL record keeping.		<p>This type of issue raises a question of doubt regarding sludge disposal and KRMPL record keeping.</p> <p>Sludge disposal needs to be done regularly as per the requirement to stabilize the processing and false record keeping needs to be stopped.</p>		08.06.2022		
33	Sludge drying bed	Leakage found around sludge drying bed

<p>1) Needs to be restored at the earliest.</p> <p>2) RCC Slab must be provided on all chambers.</p>		29.10.2021	15.06.2022	Pending
34	Tubewell pump 1	Operational						
35	Dilution water submersible pump-1	Operational

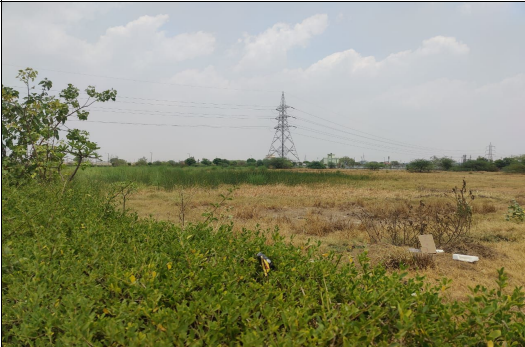
4	Log Books & Register	<p>No log book of dilution water, supernatant overflow from thickeners etc, filtration pump operation etc found at site.</p> <p>Apart from this, it was found that the drying bed desludging register pages found stick with each other and complete data was found maintained in a single day.</p> <p>Drying beds no. 4 & 12 was found empty but no record of it was found in the register which implies that false & misleading entries were maintained in the logbooks/ registers.</p>		<p>1) Log Books and registers must be maintained and remain available for all units.</p> <p>2) Maintenance register must be filled properly.</p>				Maintenance register proper filling suggestions had already been given to KRMP site incharge.
5	House Keeping works	At various locations inside the plant, no house keeping works was found.

<p>1) House keeping work at all locations inside the plant has to be done for which deployment of manpowers needs to be done.</p> <p>2) Do the house keeping works on regular basis</p>		27-10-2021		LONG PENDING

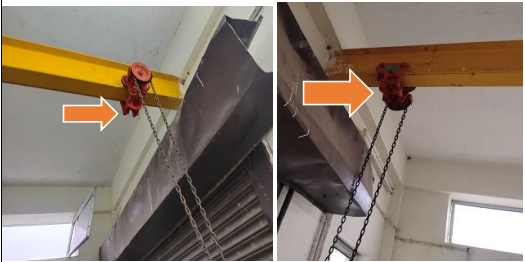
6	Equipments Numbering			Numbering must be provided in bold letters to all the equipments so that it could be seen easily and there should not remain any confusion about which item is no. 1 & which is no. 2		27-10-2021	31.01.2022	LONG PENDING Not done completely and it should be done properly.
7	Manually operated crane	Manually operated crane pulley in Return sludge pump house, primary sludge pump house, thickened sludge pump house etc. were missing lifting chain.

Provide the lifting chain at every places.		18.11.2021		LONG PENDING
8	Gas Holders			Level scale must be provided showing capacity of gas at various levels.		08.02.2022		LONG PENDING
