National Mission for Clean Ganga- Development, Rehabilitation with
Operation & Maintenance of STPs at Kanpur under Hybrid Annuity based PPP mode

Ref. STC / PE / KNP /1679 / Jajmau Phase I & II

Date : 29.06.2022

Sub: HAM KANPUR: Inspection Report of 130 MLD & 43 MLD IPSs and STP Jajmau facilities,
Inspection done on 06.06.2022 and 07.06.2022 and 20.06.2022.

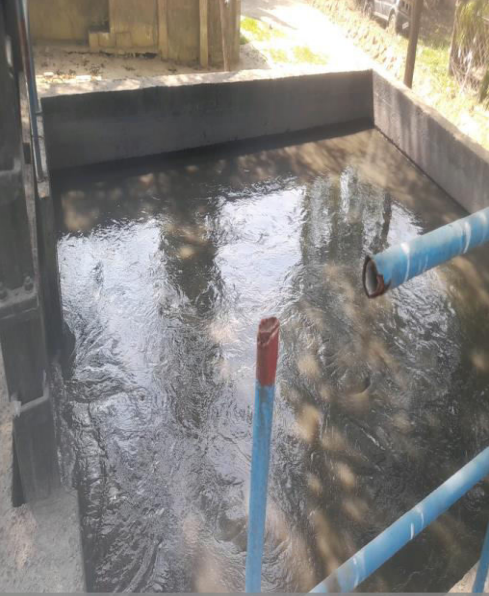
<ol style="list-style-type: none"> 1. All gates to be repalced. 2. Repairing work of free board of this chamber found very poor this must be repaired. 3. Renovation to be completed without getting approval ,testing & commissioning. 4. Handrailing need to be replaced. 	01.03.2021		Pending
1	Inlet Chamber (Civil)	Needs to be renovated in all respects.

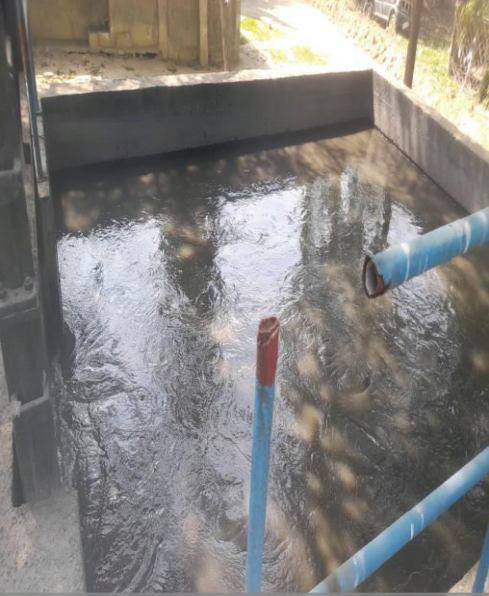
<ol style="list-style-type: none"> 1. Hand Railing and its foundation needs to be repaired. 2. Finishing work of inlet chamber chamber need to done properly . 	01.03.2021		Lond pending
2	Gates /Valves and Covering Shed	Need Overhauling / Replacement		<ol style="list-style-type: none"> 1. Gate may be motorized if possible 2. Hand railing to be replaced . 3. Shed to be replace. 	01.03.2021		Pending

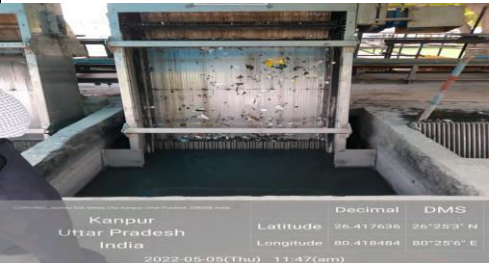
<ol style="list-style-type: none"> 1. KRMPL need to arrange sufficient poer backup to operate the mechanical scree. Garbages like Plastic bags,leather pieces, clothes must be removed from Belt conveyyor of Screen Chamber regularly. Removal of garbages should be taken seriously. 2. Need to be replaced the Sluice gates. 3. Proper Lighting need to be provided at Screen area. 4. Level scale should be properly clean and marking should be clearly visible. 5. MS Fabrication equipment & tools along with MS Shed also corroded & losses its strength. 6. In MS shed pipes are corroded & Colour of shed also worn out. 7. Mechanical Screen is not working with auto system and without sensor .Need to be fixed the auto system immediately. 8. New Cables should be laid properly in cable trays. 9. Handrailing need to be replace. 10. CCTV cameras are not functional. 11. Log Book need to be maintained. 	01.03.2021		Lond pending

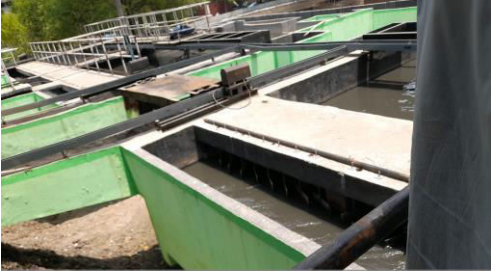
1. Renovation work found satisfactory. 2. Organic pump need to be installed as per approved drawing. 3. Cable need to be layed at Cable tray as per approved drawing. 4. LPBS need to be installed as per approved drawing. 5. KRMPL without getting approval for shut down and charging the Raw sewage for the same work. KRMPL has not been submitted any approval. 6. KRMPL has not been submitted installation procedure for Grit Mechanism System.	01.03.2021		Lond pending

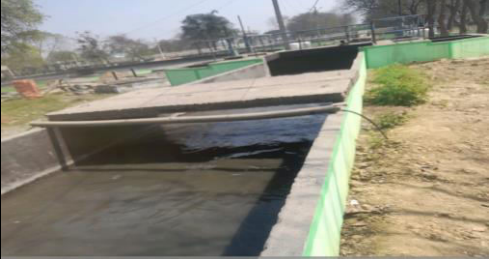
1. Painting procedure has not been submitted by KRMPL. 2. Channel renovation work done but hydrotest of this channel is pending. 3. Level scale needs to be installed for proper flow measurement.	23.11.2021		Pending

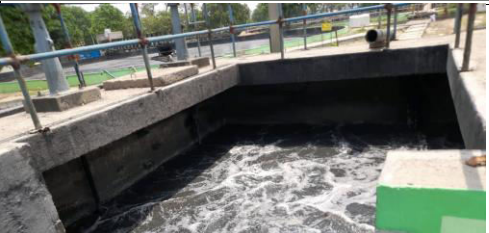
1. Distribution chamber for Primary sedimentation tank partially done by KRMPL. 2. Inside RCC wall, base and platform required renovation work. 3. Railing and its foundation needs to be replaced. 4. Reinforced exposed and needs to be repaired. 5. All Sluice gate needs to be replaced. 6. Cable trench depth should be as per IS code. 7. Earthing laying should be as per IS code.	01.03.2021		Long Pending

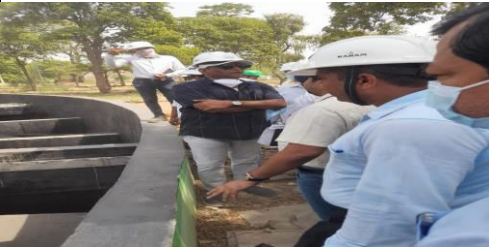
1. FST no. 1 Mechanical Bridge collapsed on 15.01.2022. 2. Outlet channel blocking work of Final sedimentation tank no. 1 on 05.02.2022 3. Plastering and finishing work to be done at FST-1. 3. FST 01 equipments need to be replaced. 4. Remote system to be installed for FST-1. 5. Cable need to be laid in cable tray. 6. Log Book need to be maintained. 7. E&M materials has not supplied by KRMPL for renovation work	01.03.2021		Long Pending
50	Final Sedimentation Tank no.2	Operational

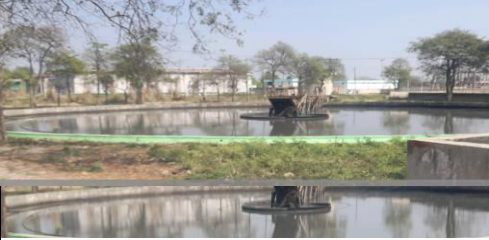
1. KRMPL need to arrange sufficient power backup to operational Final sedimentation tank 02. 2. FST 02 commissioned on 05.02.2022.	05.02.2022		Pending
51	Final Sedimentation Tank no.3	Operational

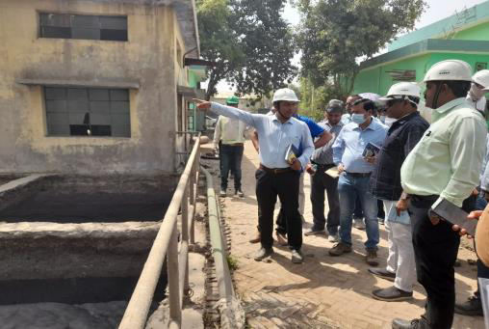
1. All pumps need to be repaired and get operational. 2. Civil Drawing of pump foundation not submitted by KRMPL for Renovation work. 3. 5 nos pumps are in working condition during site visit. 4. 2 Nos new pumps has been installed by KRMPL without get any prior approval from UPJN/PE and KRMPL has not submitted any erection procedure as per CA schedule 11. 5. Erection and commissioning of pumps have been done by KRMPL. KRMPL has not complied the compliance raised by PE officials. 6. KRMPL has not been submitted any design and drawings for Valves, NRVs, Dismantling joints etc. 7. Lighting arrangement and Cable to be laid in cable tray. 8. Thermometer and vibration meter should be at site. 9. Railing to be repaired till the renovation period. 10. Motor cover to be arranged. 11. Pressure gauge are found in damaged condition and need to be replaced. 12. Concessionaire should maintain log book of the pumps for proper record maintenance. 13. Leakage has been detected in some pumps which are in operation, and directed to repair the same immediately. 14. LBPS system to be install at site 15. Cable tray need to be painted immediately	01.03.2021		Long Pending

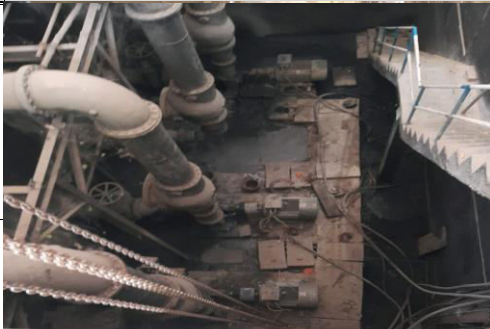
1.Sludge cleaning work done by KRMPL only top of slab. 2. Renovation work done by KRMPL only slab top. 2. KRMPL need to clean sump from bottom of slab.	01.03.2021		Long Pending
66	Return Sludge Pump House (Civil)	Needs rehabilitation

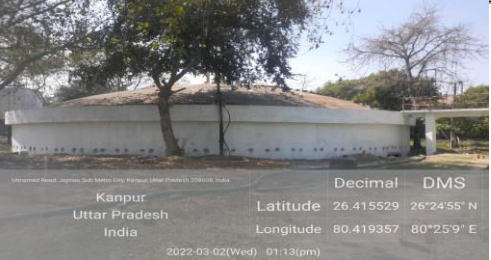
<ol style="list-style-type: none"> Cleaning work of digester done partially by KRMPL. Outer face cracks repair work and painting work is in progress by KRMPL. Removal of centrally located sludge mixing shaft from Primary Digester 1. Gate to be overhauled Civil Structure of the Digester to be renovate and cracks to be treated. Leakage to be Arrested in the Digester. Installation of the Railing at the boundary of the dome. 	01.03.2021		Long Pending
81	Primary Sludge Digester no. 2	Not operational

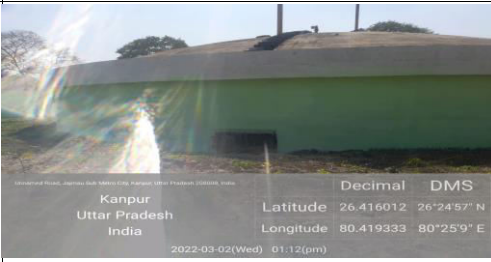
<ol style="list-style-type: none"> Cleaning work of Primary digester done partially. Outer face cracks repair and painting work is in progress by KRMPL. Gate to be overhauled Civil Structure of the Digester to be renovate and cracks to be treated. Leakage to be Arrested in the Digester. Installation of the Railing at the boundary of the dome. 	01.03.2021		Long Pending

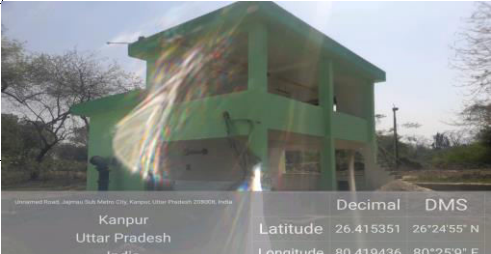
1. Plastering and finishing work of the Centrifuge building and centrate Pump house. 2. Railing and steel ladder to be repaired or replaced as per site condition. 3. Housekeeping to be done. 4. Sign boards are required. 5. No approach road found at site to get on this unit/component. 6. Proper lighting arrangement to be required at site. 7. All centrate pump 4 no. to be replaced.	01.03.2021		Long Pending
89	Centrifuge Pump no.1	All centrifuge were in dilapidated condition and dismantling work is completed

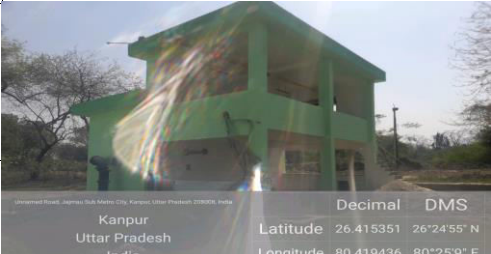
As per CA centrifuge/ BFP to be replaced.	01.03.2021		Long Pending
90	Centrifuge Pump no.2

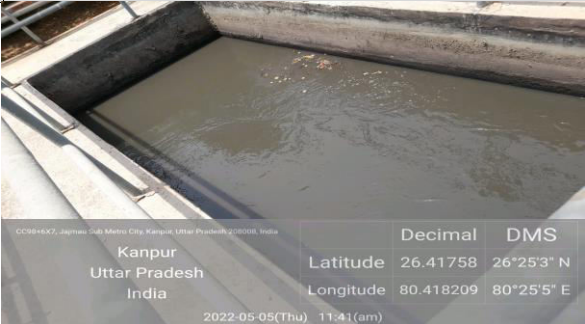
CC0846X7, Jajmau Sub Metro City, Kanpur, Uttar Pradesh 208008, India Kanpur Uttar Pradesh India Latitude 26.41758 Longitude 80.418209 2022-05-05(Thu) 11:41(am)	1. Chamber and hand railing painting work need to be done. 2. Sluice gate need to be lubrication 3. Cleaing of inlet chamber need to be done.	21.09.2021		Pending.
1	Fine Screen No.1(Mecahnical)	Mechanical fine screen 01 and 02 found non-operational.It was started when asked by UPJN and STC staff.

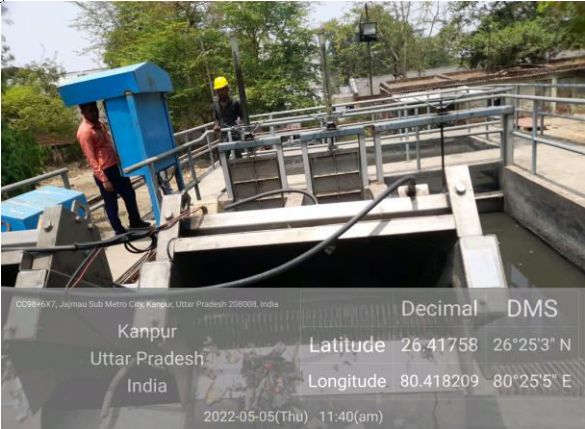
CC0846X7, Jajmau Sub Metro City, Kanpur, Uttar Pradesh 208008, India Kanpur Uttar Pradesh India Latitude 26.41758 Longitude 80.418209 2022-05-05(Thu) 11:40(am)	1.Fine Screen need to be cleaning properly. 2. Screen Level Sensor need to be replaced. 3. Screen panel autosystem need to be repaired. 4. Panel stand need to be painted. 5. Cable tray need to be replaced and painted. 6.All light creen area aneed to be replaced. 7. Disposal material need to be removed on regular basis. 8. Manual trolley need to be provided for Disposal material. 9. All motors need to covered by canopies. 10. Fine screen 2 (mechanical) need to maintenace for proper functional.	21.09.2021		Pending.

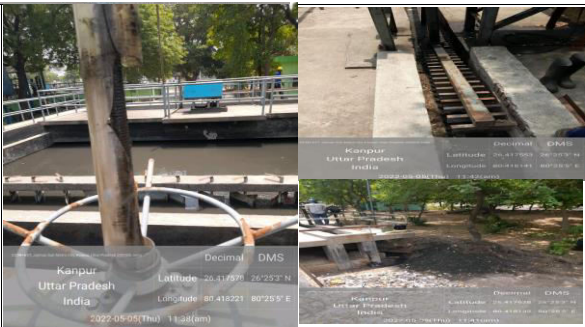
1. Grit removal system is functional but classifier system is not functional since handover and ED(Projects) also instructed to KRMPPL for taken action. 2. Painting needs to be done to equipment / covers wherever rusting. 3. Alignment of classifier found non-functional. 4. Cable tray need to be painted. 5. All E&M equipments shall be lubricate on regular basis and maintain the log book at site. 6. Log book need to be maintained	30.09.2021		Pending
C	Inlet flow meter	Operational

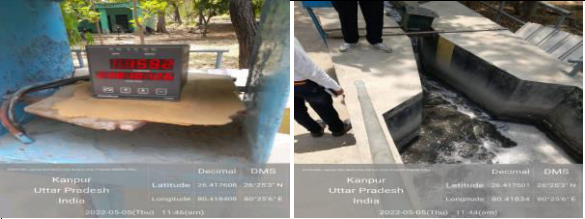
1. Flow meter cover need to be replaced. 2. Visual of flow is not clear. 3. Log book need to be maintained. 4. At the time of power failure there are no power backup is available for flow meter. So KRMPPL has to provide power backup facility. 5. Level scale needs to be paint.	21.09.2021		Pending

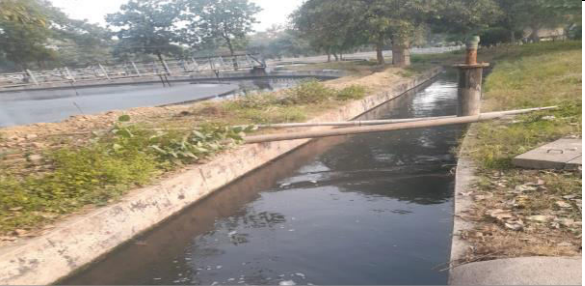
1. Open channel need to be cover with frame cover. 2. Repairing and Painting work need to be done.	16.12.2021		Pending
D	Primary Unit						
1	Primary sedimentation tank	Primary sludge wastage is not adequate due to which excessive gas bubbles were found on the surface of the clarifier.

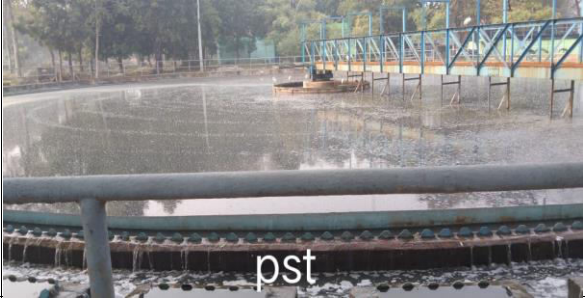
1. Cleaning work of PST need to be done. 2. Cracks repairing work need to be done. 3. Painting work need to be done. 4. "V" notch need to be replaced. 5. Handrailing work need to be paint. 6. Alignment need to be rectified for PST. 7. Log book need to be maintained. 8. Scum chamber need to be clean. 9. loose concrete work need to be cleaned and track should be proper grout. 10. Housekeeping need to be done. 11. Sludge need to be clean properly.	21.09.2021		Pending
E	Panel room	Operational

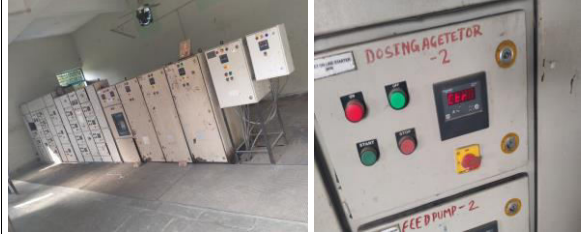
1. Screen panel voltmeter need to be replaced. 2. Dosing agitator ammeter need to be replaced.	21.09.2021		Pending

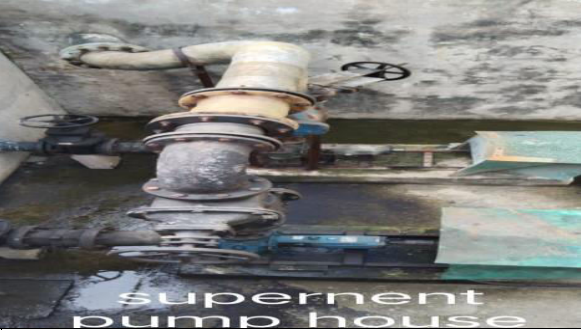
<p>1. We have found heavy vibration at Pump no 2 during visit. KRMPL need to be repair.</p> <p>2. Pipe support need to be replace as required .</p> <p>3. Vibration and Temperature need to be measure on regular basis.</p> <p>4. Pump log book has not maintained by KRMPL.</p> <p>5. Dewatering from the sump need to be required.</p>	16.12.2021		Pending
2	Thickened Sludge Pump house	Operational

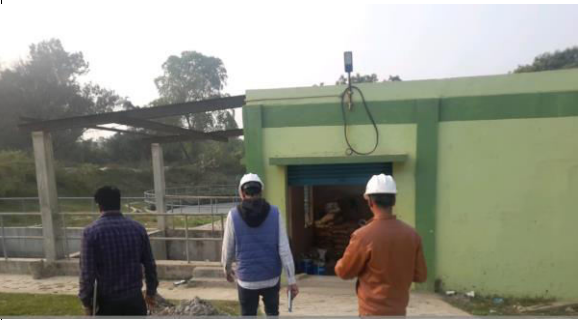
<p>1. Need to be Overhaul and repair .</p> <p>2. Cleaning work need to be done.</p> <p>3. Vibration and Temperature need to be measure on regular basis.</p>	21.09.2021		Pending

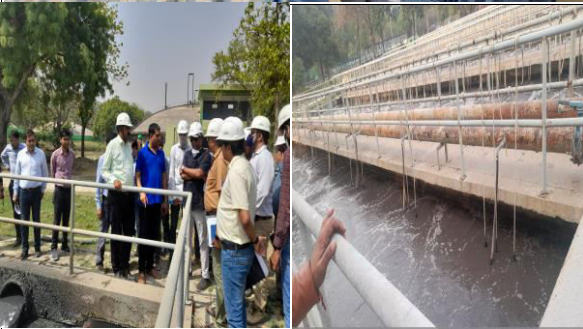
<ol style="list-style-type: none"> 1. Pipe lines need to be changed. 2. Valves need to be changed. 3. Handrails need to be painted. 4. Diffuser line need to be Cleaned and maintained records also. 5. Insulation required for discharge line of blower. 6. Rope need to be replaced. 	21.09.2021		Pending
J	Final Sedimentation tank	Operated

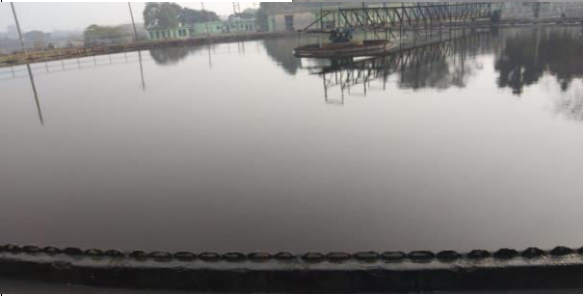
<ol style="list-style-type: none"> 1. Cleaning work need to be done. 2. Painting work need to be done. 3. Alignment of Mechanism need to be rectified. 4. "V" notch need to be replace. 	21.09.2021		Pending

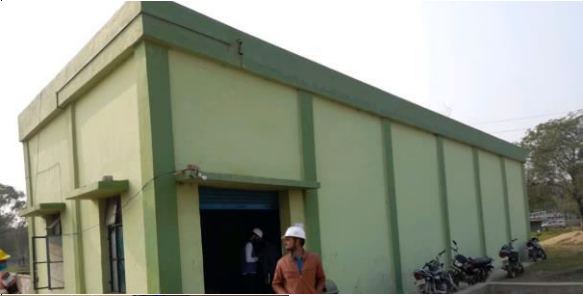
<ol style="list-style-type: none"> 1. All 5 Nos of pumps are in working condition. 2. Each pump capacity 900m3/hr. 3. Lubrication of each equipment need to be done. 4. Log book need to be maintain properly 	21.09.2021		Pending

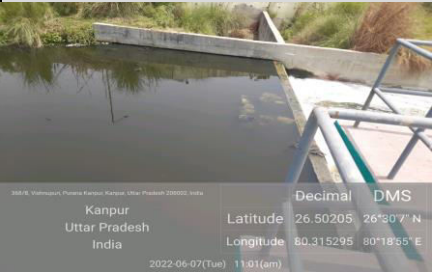
<p>2022-06-07(Tue) 11:01(am)</p> <p>Kanpur Uttar Pradesh India</p> <p>Decimal DMS Latitude 26.50205 26°30'7" N Longitude 80.315295 80°18'55" E</p>	Over flow condition found since handover. Upjn need to take action in this regards.	25.08.2021		Action to be taken by UPJN
2	Inlet Chamber	Epoxy coating found improper in inlet chamber.

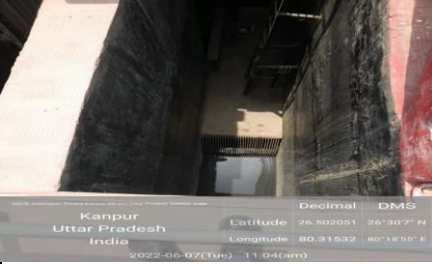
<p>2022-06-07(Tue) 11:04(am)</p> <p>Kanpur Uttar Pradesh India</p> <p>Decimal DMS Latitude 26.502051 26°30'7" N Longitude 80.31532 80°18'55" E</p>	1. Removal of polythene,papers,plastic should be on regular basis. 2. Painting work should be done by KRMPL for MS Staircase and handrails. 3. Trolly for garbages disposal arranged by KRMPL.	15.12.2021		Pending

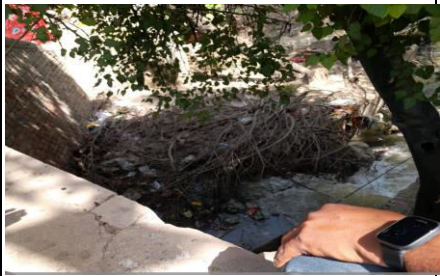
1. Pump houses 1 and 2 need to be functional Nawabganj IPSs to resolve the back flow condition.	21.12.2021		Pending
11	Documentation	KRMPL has not maintained documentatiuon work properly.

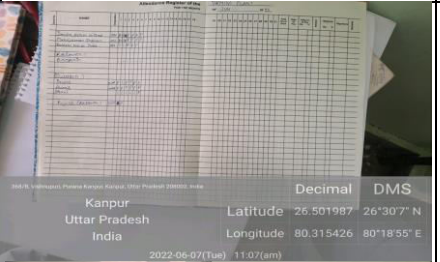
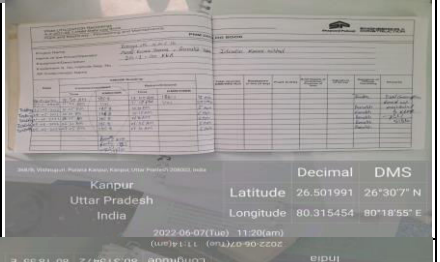
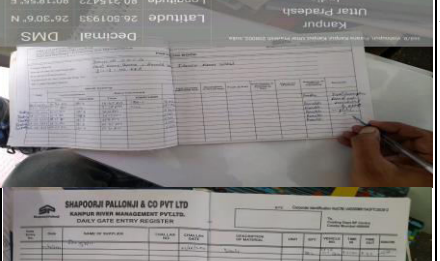
1. Security guard need to be arranged by KRMPL. 2. Diesel stock log book has not maintained by KRMPL on regular basis. 3. Pumps log book has not maintained properly. 4. Maintenance records was not available at site for all E&M equipments. 5. Arrangement of reliever for Operators and sweepers should be done by KRMPL. 6. DG log book has not maintained by KRMPL properly. 7. Material inward and outward registers need to be maintained by KRMPL properly.	15.12.2021		Long pending

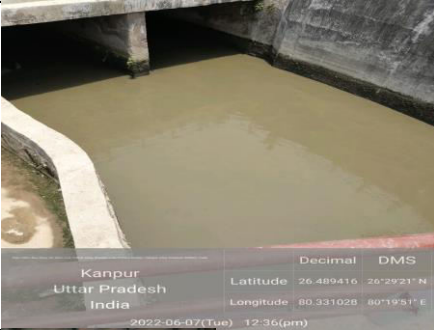
1. During visit it was found that there is no overflow condition of channel. 2. Brick work raised by KRML to avoid overflow condition on 24.03.2022,It was done 350mm height.	07.04.2022		
i	Manual Coarse bar screen Chamber	Civil struture is in satisfactory condition

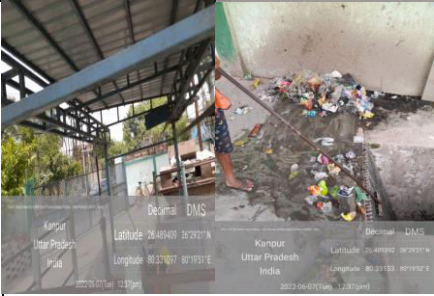
1.Handles of open channel gate didn't find.KRML need to installed all the Handles for gate. 2.Trolly for garbages disposal arranged by KRML. 3.Out of 3 Nos of Lights only 2 Nos is in working condition.	15.12.2021		Pending

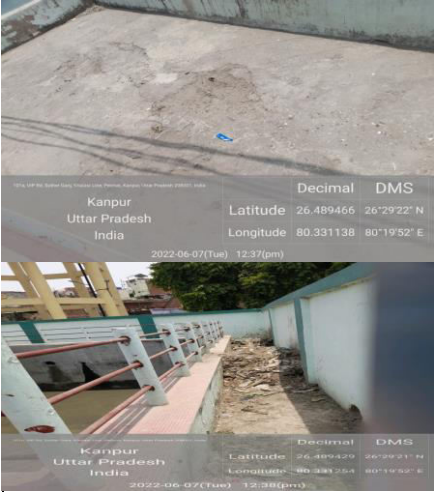
1.Renovation of slab top surface should be rectified by KRMPL. 2.Garbage material should be remove from campus. 3.Renovation of boundary wall required. 4.Settled Interlocking area should be rectify by KRMPL. 5.M.S gate should be repair by KRMPL 6. CCTV installation need to be done.KRMPL has promised to installed CCTV within a month.	15.12.2021		pending
2	Inlet Chamber	Epoxy coating found improper in inlet chamber.

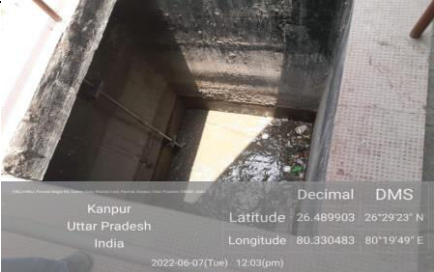
1. Cleaning need to be done. 2. Epoxy Coating need to be done.	15.12.2021		Pending
3	Coarse bar Screen Chamber(Manual)	Civil work is in satisfactory condition

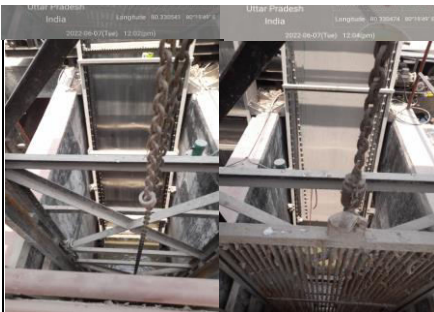
6. Trolley for garbages disposal arranged by KRMPL. 6. Log book need to be done properly. 7. CCTV installation need to be done.KRMPL has promised to installed CCTV within a month. 8. Emergency push button is not working in screen panel. 9. Chain-pully was not in working condition for Mechanical screen No. 1 10. Mechanical screen no. 1 and conveyor system are not working in auto mode.	15.12.2021	Pending
5	Pump house cum Panel room

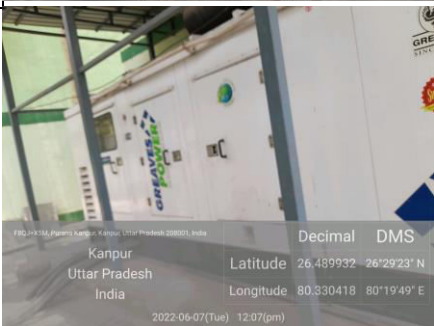
<p>1. Both DG set is in working condition.</p> <p>2. DG log book is not mainatining by KRMPL.</p> <p>3. Only 33% diesel available at DG set- 1 and 33% diesel available at DG set-2.</p> <p>4. 8 Nos light are functional out of 11 Nos.</p>	15.12.2021		Pending
8	Transformer	Transformer found operational but their entry gate is damage.

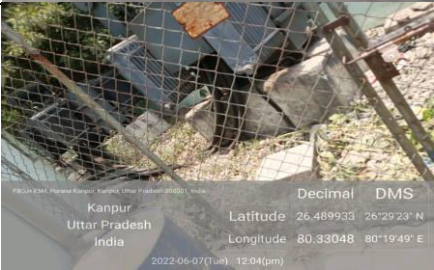
<p>1. Cleaning work need to be done at Transformer yard area.</p> <p>2. Entry gate need to be repair.</p> <p>3. Transformer breather silica gel in pink colour, it need to be replaced.</p>	21.12.2021		Pending

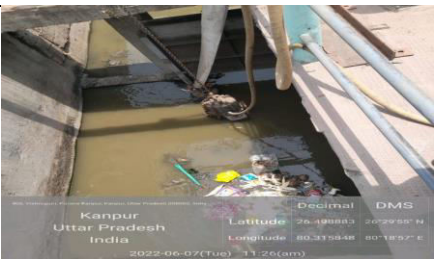
<p>1. During site visit overflow is continue since handover 28.06.2021.</p> <p>2. No action taken by KRMPPL after several times informed by NMCG, UPJN and STC representataives.</p> <p>3. Under rennovation of IPS Nawabganj , KRMPPL need to stop overflow condition of sewage by increasing adequate pumping.</p>	28.06.2021		Long Pending
2	Inlet Chamber	<p>1. Cleaning of inlet chamber need to be done.</p> <p>2. Staircase damaged tile need to renovate.</p>

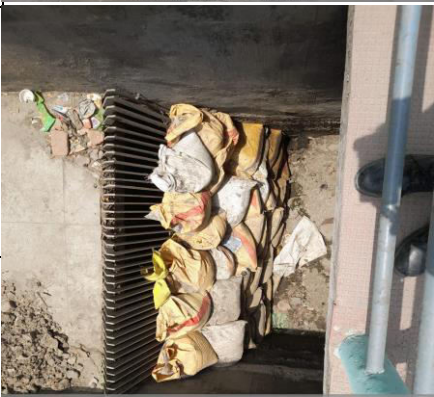
<p>1. Cleaning of inlet chamber need to be done.</p> <p>2. Staircase damaged tile need to renovate.</p>	23.11.2021		Long Pending
3	Screen Chamber	1. Garbages was available.

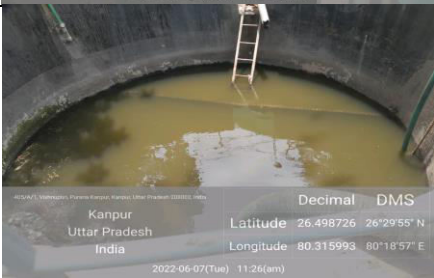
<p>1. Proper pumping arrangement need to be done by KRMPPL.</p> <p>2.Receiving chamber need to be clean.</p> <p>3. Manual screen need to be installed under renovation.</p> <p>4. After cleaning work of this chamber required renovation work need to be done.</p> <p>5. Damaged cable need to be remove immediately.</p>	28.06.2021		Long Pending

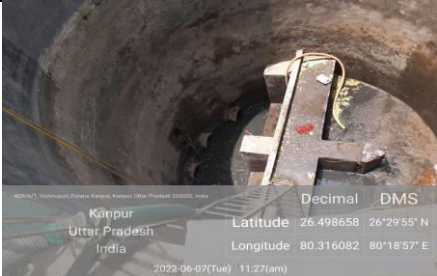
1. Receiving chamber 02 sludge removal work done. 2. Repairing work needs to be done by KRMPL.	28.06.2021		Long Pending
6	Pump House No.1	Civil Structure in unsatisfactory Condition

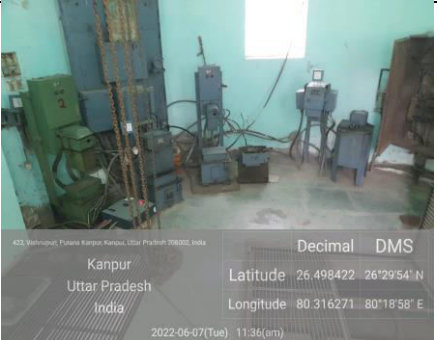
1.Surface roof treatment is pending for Pump house. 2.All indoor lightening need to be replaced. 3. Exhaust fan 2 Nos need to be replaced. 4. Cable to be lay in the cable tray properly. 5. KRMPL has painted the pump house no 1 with poor workmanship, This should be rework. 6. Log book is not proper maintaining by KRMPL staff as per prescribed format. 7. New 3 Nos of pumps have recieved at site on 31.12.2021 for Pump House 01 (2 Nos 300cum/hr and 1 Nos 156 cum/hr). 8. Flow meter need to be installed by KRMPL. 9. 2 Nos light is not working. 10. Foundation work of pump house 01 need to be start by KRMPL. 11. Electrical hoist need to be replaced as per renovation plan. 12. Outdoor lightening not fixed properly.	23.11.2021		Pending

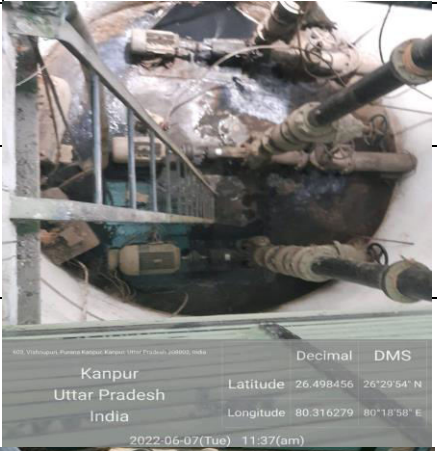
Need to be raplaced as per Rennovation Plan	23.11.2021		
ii	Pump no.2 (Capacity =156 m3/hr)	Pumps found functional		Need to be raplaced as per Rennovation Plan	23.11.2021		
iii	Pump no.3 (Capacity =297m3/hr)	Non functional		Pump no. 3 found non-operational since 27.05.2022,KRMPL needs to repair it on urgent basis.	23.11.2021		Pending

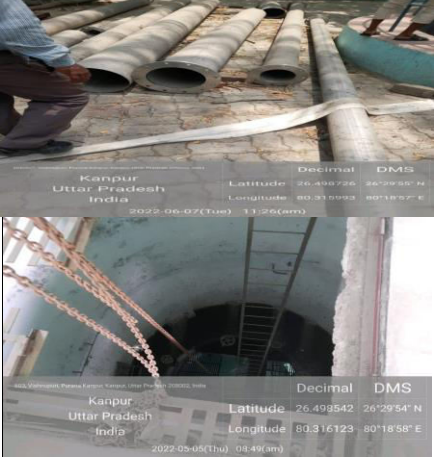
<p>1.Surface roof treatment is pending for Pump house</p> <p>2. Conseeionare is using this room as a store room stacking of Cement begs and diesel drum.</p> <p>3. Exhaust fan 2 nos needs to be replaced.</p> <p>4. Tube light 1 nos need to be replaced.</p> <p>5. Pump House pump found not to be working.</p> <p>6.KRMPL has done painting work inside and outside of the pump house no 1 with poor workmanship, This should be rework.</p> <p>7.Discharge line of the pumps to be dismatled by KRMPL without any information to UPJN/STC.</p> <p>8.Dismantling of pumps done by KRMPL without any information to UPJN/STC.</p> <p>9.Raw sewage pumps, 3 Nos. of Pump House No. 2 were damaged due to flooding on 18.01.2022. They were refurbished/ repaired and delivered to site on 15.02.2022. Raw sewage pumps and motors of Pump house No. 2 were found at site but KRMPL has not installed them .</p> <p>10. NRV & Electrical hoist need to be replaced as per renovation plan.</p>	23.11.2021		Pending

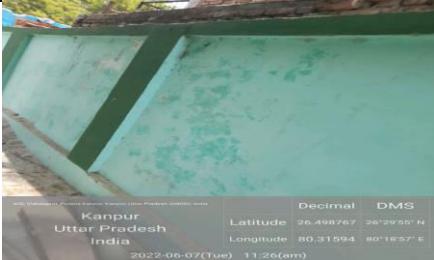
<p>1.KRMPL has painted the boundary wall with poor workmanship, This should be rework.</p> <p>2. Cleaning work of campus area need to be done by KRMPL.</p> <p>3. 8 Nos of outside lights only 4 Nos is in working condition.</p> <p>4. Valve chamber should be plastered and Covered properly.</p> <p>5. All valves need to be replace.</p>	23.11.2021		Pending
11	Transformer Yard	Civil Structure in satisfactory Condition

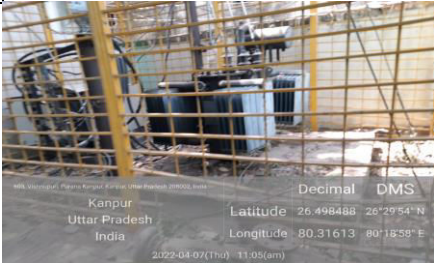
<p>1. Yard area need to be clean</p>	23.11.2021		Pending

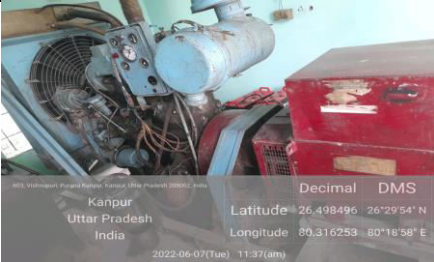
<p>Decimal DMS Latitude 26.498496 26°29'54" N Longitude 80.316253 80°18'58" E 2022-06-07(Tue) 11:37(am)</p>	<p>1. DG set is in working condition. 2. Log book of DG set is not maintaining by KRML. 3. Diesel surplus quantity is not available at site. 4. Smog exhaust pipe length is not sufficient as per CPCB/CPHEEO guidelines. It must be replaced on urgent basis.</p>	23.11.2021		Pending
13	Metering Room	Civil Structure in unsatisfactory Condition

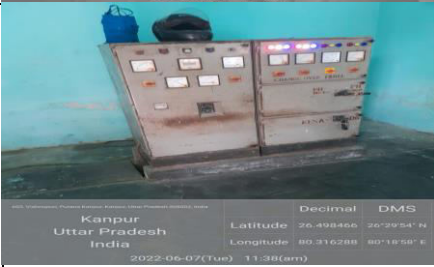
<p>Decimal DMS Latitude 26.498496 26°29'54" N Longitude 80.316253 80°18'58" E 2022-06-07(Tue) 11:38(am)</p>	<p>1. Seepage is available in the wall of this room this should be rectified. 2. Panel Volt meters and Ammeters need to be replaced. 3. All Phase Indicator need to be replaced.</p>	23.11.2021		pending
14	Logbook	Log book of pump house 01 not maintained by KRML

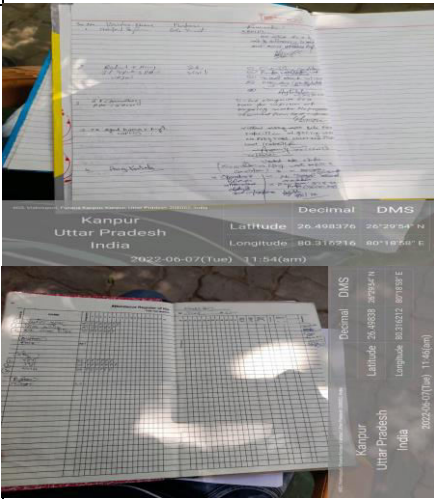
<p>Decimal DMS Latitude 26.498376 26°29'54" N Longitude 80.316216 80°18'58" E 2022-06-07(Tue) 11:54(am)</p>	<p>1. Security guard need to be arranged by KRML. 2. Diesel stock log book has not maintained by KRML on regular basis. 3. Pumps log book has not maintained properly. 4. Maintenance records was not available at site for all E&M equipments. 5. Arrangement of reliever for Operators and sweepers should be done by KRML. 6. DG log book has not maintained by KRML properly. 7. Material inward and outward registers need to be maintained by KRML properly.</p>	28.06.2021		Long Pending

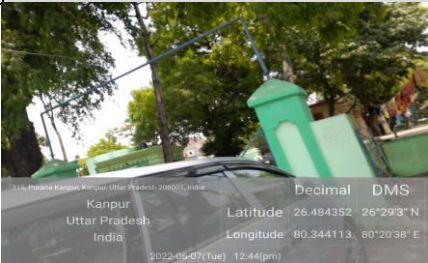
<p>115, Parmat Kanpur, Kanpur, Uttar Pradesh 208001, India</p> <p>Decimal DMS Latitude 26.484352 26°29'3" N Longitude 80.344113 80°20'38" E</p> <p>2022-06-07(Tue) 12:44(pm)</p>	1. KRMPL need to arrange informatory sign board of Parmat IPS need to be arranged. 2. Main entry gate need to be replaced.	07.04.2022		Pending
1	Inlet Chamber	Civil Structure is in satisfactory condition
