# SITE INSPECTION OF JAJMAU ASSOCIATED IPS REPORT

Nawabganj IPS 32  
MLD

Date: 27.10.2022

INSPECTED BY:  
STC Team

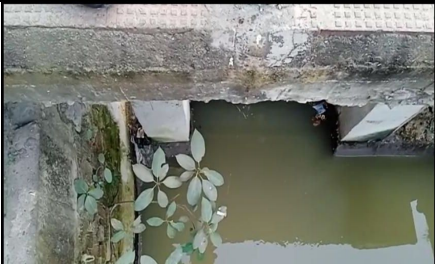
S. No.	Equipment	Assessment of Current Condition	Assessment of Current Condition Photo	Current defects and Corrective Action Suggested by PE	Original Date of Issue	Proposed Date to Resolve by KRMPL	Current Status of Compliance
1	All work						
1	Inlet Over Flow Condition	Overflow condition found since handover

1. During site visit overflow is observed since handover 28.06.2021. 2. No action has been taken by KRMPL despite being informed, several times by NMCG, UPJN and STC representatives. 3. As per renovation plan for IPS Nawabganj , KRMPL should increase adequate pumping to prevent overflow of sewage.	28.06.2021		Long Pending
2	Inlet Chamber	1. Cleaning of inlet chamber needs be done on regular basis. 2. Staircase damaged tile needs to be renovated.		1. Cleaning of inlet chamber needs be done on regular basis. 2. Staircase damaged tile needs to be renovated.	23.11.2021		Long Pending
3	Screen Chamber	1. Garbages has accumulated into screen chamber.		1. Garbage cleaning work should be done on regular basis. 2. Garbage Trolley should be made available at the site.	23.11..2021		Pending

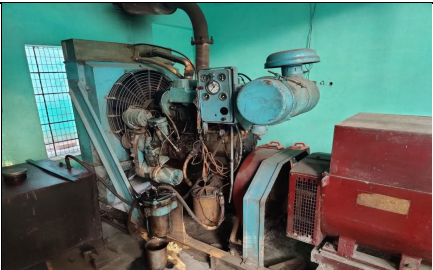
12	DG set room	Civil Structure in satisfactory Condition

<ol style="list-style-type: none"> <li>1. DG set is in working condition.</li> <li>2. Log book of DG set is not maintaining properly by KRMPL.</li> <li>3. Diesel surplus quantity is not available at site.</li> <li>4. Smog exhaust pipe length is not sufficient as per CPCB/CPHEEO guidelines. Therefore, it must be replaced on urgent basis.</li> </ol>	23.11.2021		Pending
13	Metering Room	Civil Structure in unsatisfactory Condition

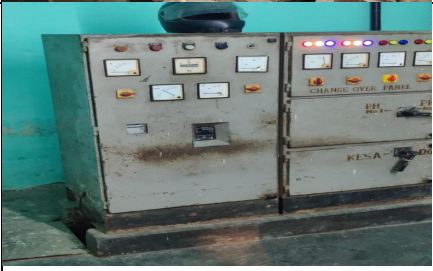
<ol style="list-style-type: none"> <li>1. Seepage was observed on the wall of this room. It should be rectified.</li> <li>2. Panel Volt meters and Ammeters needs to be replaced.</li> <li>3. All Phase Indicators needs to be replaced.</li> </ol>	23.11.2021		Long Pending
14	Logbook	Log book of pump house 01 not maintained by KRMPL

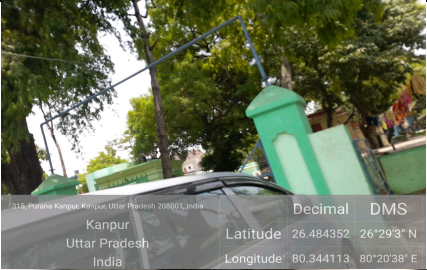
*	Main entry Gate	No informatory sign board for Parmat IPS was available at the entry gate.

1. KRMPL should arrange informatory sign board for Parmat IPS.	07.04.2022		Pending
1	Inlet Chamber	Civil Structure is in satisfactory condition

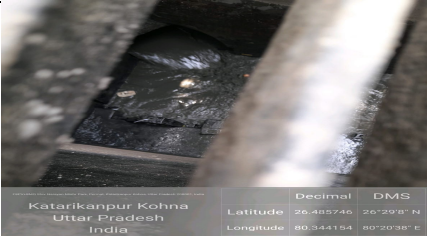
1. All kinds of Renovation work is pending in the inlet chamber. 2. Cleaning and landscaping work needed to be done. 3. KRMPL needs to deploy a security guard for the IPS.	23.11.2021		Pending
2	Screen Chamber	Civil Structure is in satisfactory condition

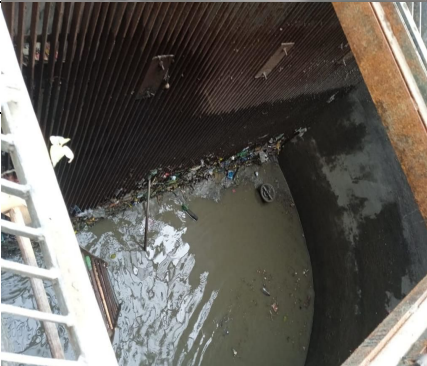
1. Renovation work is required for the inner and outer surface of the chamber. 2. Plaster work needs to be done. 3. Cleaning and landscaping work needs to be done. 4. MS frame cover should be painted.	23.11.2021		Pending
3	Receiving Chamber	Civil Structure is in satisfactory condition		1.Screens should be replacd  2.Garbage material needed to be removed on timely basis.  3. Renovation work is required for inner and outer surface of the Recieving chamber in all respect. 4. Cleaning and landscaping work needed to be done. 5. MS frame cover should be painted.	23.11.2021		Pending

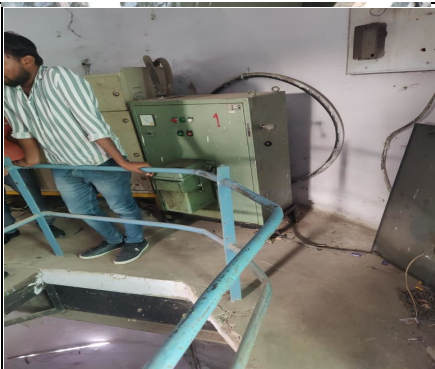
4	Pump house No. 2	Pump house no.2 is in unsatisfactory condition

<p>1. All pipelines were found in submergence condition.</p> <p>2. Both pumps were operational. NRV and Sluice gates needs to be replaced.</p> <p>3. All tubelights were not working properly.</p> <p>4. Drain water pump no-2 needs to be replaced.</p> <p>5. Ammeters on the LT panel were not in working condition.</p> <p>6. Motor termination Box cover</p>	23.11.2021		Pending
i	Pump No.1( pump capacity =900 m3/hr)	Pump found operational

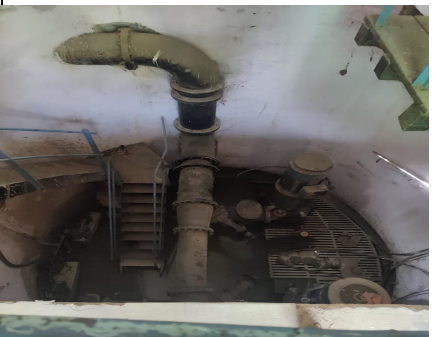
<p>New pump has been installed at 15.03.2022. But installation of new valves, pipeline and fittings are still pending.</p>	23.11.2021		Pending
ii	Pump No.2( pump capacity =900 m3/hr)	Pump found operational

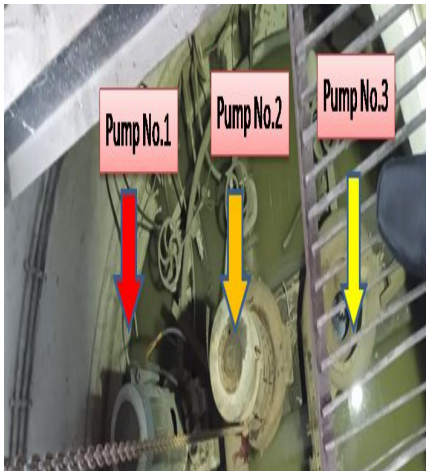
<p>1. Starter no-3 was found to be non-functional.</p> <p>2. Cable dressing was not done properly.</p> <p>3. Motor termination cover box was not fixed and cable gland was not fixed.</p> <p>4. No labour was engaged by KRMPL for renovation work.</p> <p>5. Cracks needs to be repaired, also damaged door, window, louvers and ventilators needs to be replaced.</p> <p>6. Dewatering pumps need to be replaced.</p> <p>7. Operators are non technical person. They do not have clear understanding of the Pump Capacity, Flow of Discharge, and Peak Flow at the site. Also records are not maintained properly.</p>	15.12.2021		Pending

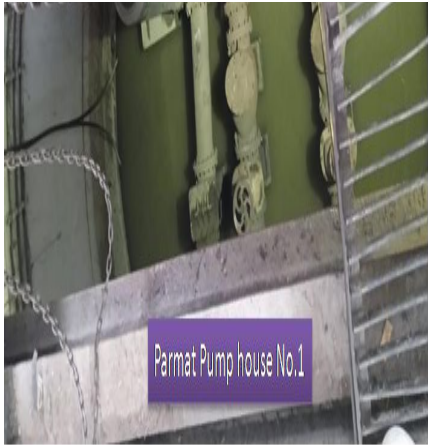
ii	Pump No.2( pump capacity =1320 m3/hr)	Non Operational

Pump no-2 is not working since date 30.09.2022.	23.11.2021		Pending
iii	Pump No.3( pump capacity =1320 m3/hr)	Non operational Pump no-3 is not available since handover.		1. Pump no.3 & valves ,NRV etc need to be replaced as per construction plan	23.11.2021		Pending
6	Pump House No. 3	Civil Structure is in unsatisfactory condition

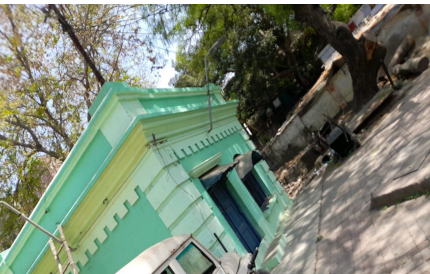
1.Pump house no-3 is defunct since handover.  2. Renovation work are pending from KRMPL's end.  3. Cracks needs to be repaired, and damaged door>window,louvers and ventilators needs to be replaced.	23.11.2021		Pending
7	DG room	Civil Structure is in unsatisfactory condition	 	1. Voltmeters, Ammeters were not in working condition.  2. According to the DG logbook, diesel was not available at the site.  3.DG set for Pump House no-1 was non operational.  4. Cracks needs to be repaired, and damaged door>window,louvers and ventilators needs to be replaced.  5. DG logbook is not maintained properly.  6. Smog exhaust pipe length was not sufficientr as per	23.11.2021		Pending

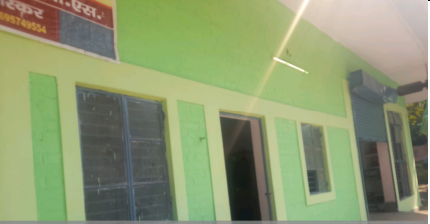
8	Metering room	Civil Structure is in unsatisfactory condition

1.Inside and outside painitng work completed by KRMPL under renovation. 2. Replacement of damaged Door>window,louvers and ventilators is pending. 3. Flooring work needs to be renovated.	23.11.2021		Pending

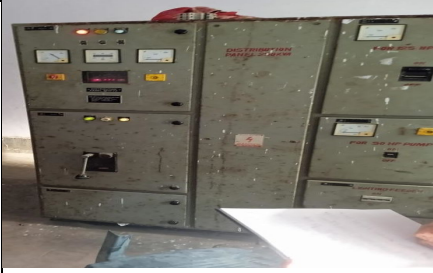
9	Panel Room	Civil Structure is in unsatisfactory condition

<p>1. Inside and outside painting work is completed by KRMPL under renovation.</p> <p>2. Damaged Door,window,louvers and ventilators needs to be replaced.</p> <p>2. Panel Volt meters and Ammeters needed to be replaced.</p> <p>3.All Phase Indicator needed to be replaced.</p>	23.11.2021		Pending
10	Logbook	Log book of pump house 01 and pump house no. 02 has not maintained by KRMPL properly

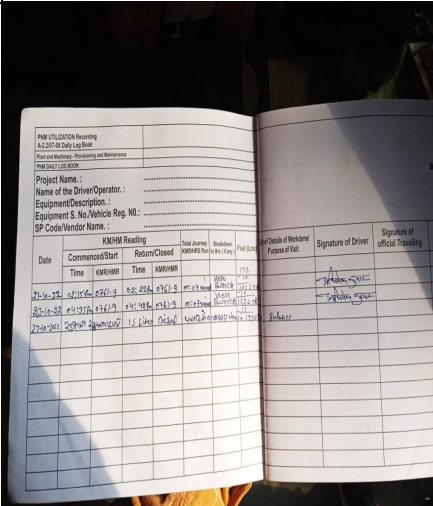
<p>1. Logbooks for pumps and DG sets are not properly maintained by KRMPL.</p> <p>2. KRMPL has not arranged adequate number of staff (Operators, Sweepers and relievers) for proper O&amp;M of IPS and attendance register contains manipulated staff details. Operators are non technical person. They do not have clear understanding of the Pump Capacity , Flow of Discharge, and Peak Flow at the site. Also the records are not maintained properly.</p> <p>3. Security guard needs to be deployed at the site.</p> <p>4. No labour available from KRMPL for renovation work.</p>	23.07.2021		Pending

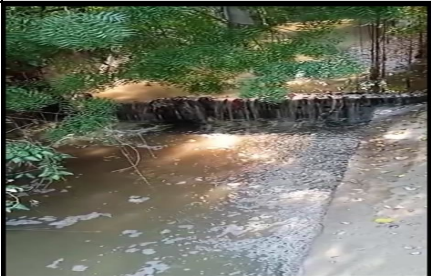
1. During the inspection, Overflow or Bypass of sewage was observed. 2. Raw sewage by-pass sluice gate need to be replaced. Design,drawing need to be submitted by KRMPL.	4.01.2022		Pending
2	Inlet Chamber (Civil)	Civil Structure is in satisfactory condition

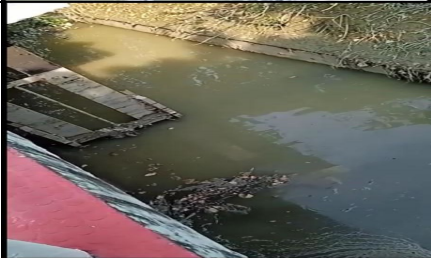
1. All gates needs to be lubricated. 2.Sludge should be removed regularly from inlet parts of IPS. 3. Regular cleaning of the chamber should be done.	23.11.2021		Pending
3	Screen Chamber	Civil Structure is in satisfactory condition

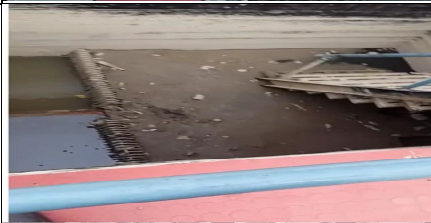
1. No sweeper was present in the screen chamber. 2. Garbage removal work and cleaning of the screen should be done on regular basis. 3. Trolly should be made available at the site for proper disposal of garbages. 4. Durind the inspection it was observed that screen was completly submerged at the site.	23.11.2021		Pending

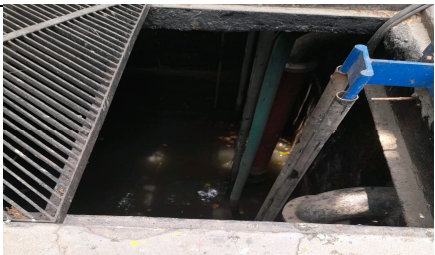
4	Receiving chamber	Civil Structure is unsatisfactory condition.

<ol style="list-style-type: none"> <li>1. Chamber should be cleaned and covered properly.</li> <li>2. All valves should be replaced.</li> <li>3. All stud bolts and gaskets should be replaced.</li> <li>4. Lubrication for valves and pumps ,sluice gates should be done by KRMPL.</li> <li>5. Pressure guage should be provided by KRMPL.</li> </ol>	15.12.2021		Pending
5	Pump House	Civil Structure is in good condition.

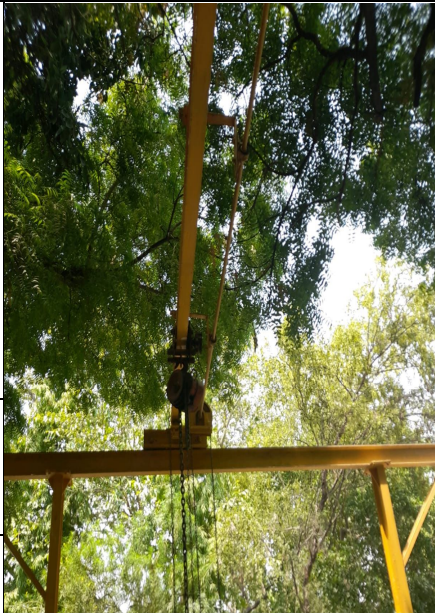
<ol style="list-style-type: none"> <li>1. Exposure of steel in staircase bottom slab needs to be renovated.</li> <li>2. Inside the pump house, it was observed that light was not working.</li> <li>3. EOT load test required by KRMPL.</li> <li>4. Flow meter need to be installed by KRMPL.</li> <li>5. Log book was not properly maintained by KRMPL staff at site.</li> <li>6. Staircase is in bad condition and needs to be renovated.</li> <li>7. Cable dressing needs to be done properly.</li> <li>8. Operators are non technical person. They do not have clear understanding of the Pump Capacity , Flow of Discharge, and Peak Flow. Also staff does not maintain the records properly.</li> <li>9. Utility water pump is not working since handover.</li> </ol>	23.11.2021		Pending

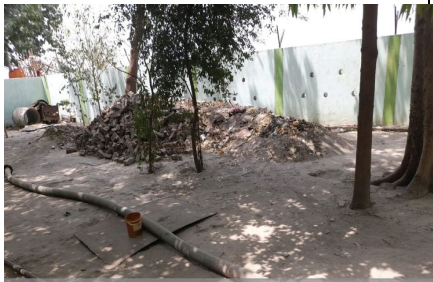
<ol style="list-style-type: none"> <li>1. Fencing work is pending.</li> <li>2.Security guard should be arranged by KRMPL.</li> <li>3. Cleaning work needs to be carried out by KRMPL.</li> </ol>	23.11.2021		Pending

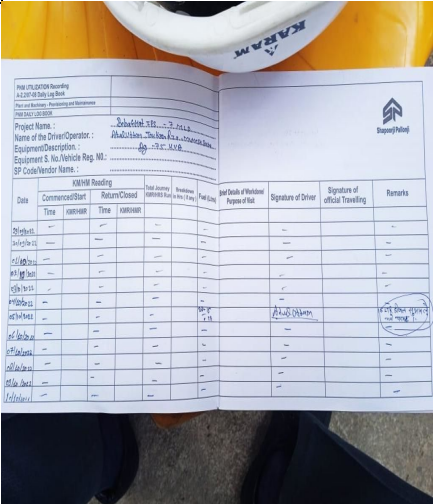
10	Logbook	Logbooks are not maintained properly by KRMPL

<p>1. Log book of pumps and DG set are not properly maintained by KRMPL.</p> <p>2. According to logbook, power was not supplied to the site on date 05.10.2022 from 1:30 pm to 4:50 pm. Supervisor Mohammad told STC team that, power cut was due to fault at Parmat Ghat IPS. But according to DG logbook, diesel was not available at the site from date 26.09.2022 to 26.10.2022. This indicates shortage of diesel supply at the site.</p> <p>3. Supervisor Mohammad, told STC team that KRMPL was earlier informed regarding limited diesel supply for the site and also raised the request to increase the diesel supply. But no action has been taken by KRMPL in this regard for Baba Ghat IPS.</p> <p>4. KRMPL has not arranged adequate number of staff (Operators, Sweepers and relievers) for proper O&amp;M of IPS. Operators are non technical person. They do not have clear understanding of the Pump Capacity, Flow of Discharge, and Peak Flow. Also records are not maintained properly.</p> <p>5. KRMPL needs to maintain Visitor Register.</p> <p>6. Security guard needs to be deployed.</p> <p>7. No labour was available from KRMPL for renovation work.</p>	28.06.2022		Pending

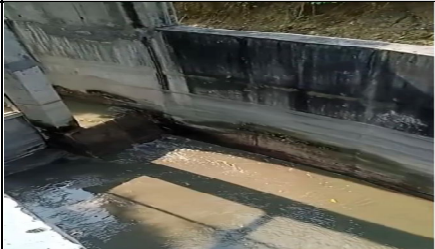
During site visit it was found that there was Overflow/Bypass of sewage .	02.03.2022		Pending
2	Inlet Chamber	Civil Work is in satisfactory Condition

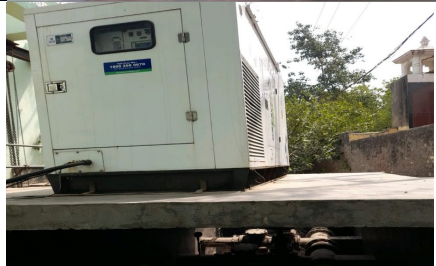
<ol style="list-style-type: none"> <li>1. DG set (125kv) was found to be in the working condition.</li> <li>2. Log book of DG set is not maintain by KRMPL properly.</li> <li>3. Smog exhaust pipe length is not sufficientr as per CPCB/CPHEEO guidelines.It must be replaced on urgent basis.</li> <li>4. Meter for diesel in the DG SET was not working.</li> <li>5. Diesel drum was found empty at the site.</li> </ol>	23.11.2021		pending
9	<b>Transformer yard</b>	Civil Work is in satisfactory Condition

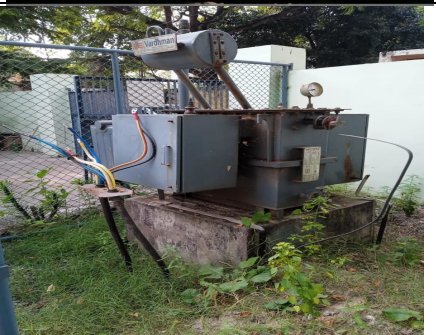
<ol style="list-style-type: none"> <li>1. Transformer no-2 (ACB 400 A) was not in working condition.</li> <li>2. Cable termination work, earthing work, testing and commissioning are pending.</li> </ol>	13.12.2021		pending
10	<b>Handrailing work</b>	satisfactory Condition		<ol style="list-style-type: none"> <li>1. Installation of handrails needs to be done by KRMPL properly.</li> <li>2. Security guard should be arranged by KRMPL.</li> </ol>	23.11.2021		pending

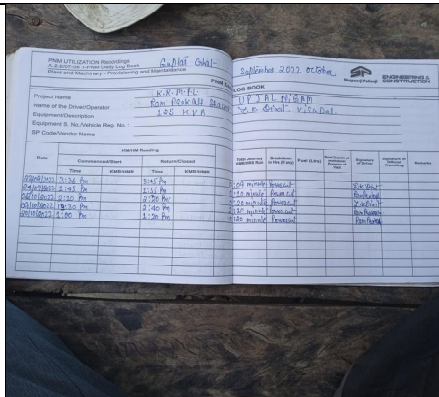
11	Logbook/Records/Documentation	Logbooks are not maintain properly by KRMPL

<p>1. Log book of pumps and DG set are being maintained by KRMPL.</p> <p>2. During the inspection only sweeper was answering the questions and showing the progress of the site. Therefore KRMPL must arrange adequate number of staff (Operators, Sweepers and relievers) for proper O&amp;M of IPS. Operators are non technical person. They do not have clear understanding of the Pump Capacity , Flow of Discharge, Peak Flow. The records are also not maintained properly.</p> <p>4. During the inspection it was observed that readings filled in the logbook was found to be manipulated. Due to this, it is difficult to determine the actual hours of operation for pumps. Therefore, hour meter should be installed.</p> <p>5. No labour available by KRMPL for renovation work.</p>	23.07.2021		Pending
<p><b>Remarks:-</b> A) Internal and External Painitng work (for Structures and Building):- KRMPL did not work properly by which it is not acceptable and it did not fulfill acceptance criteria as per CA</p> <p>1. All painted work surfaces shall be uniform and pleasing in appearance.</p> <p>2.The colour ,texture etc shall match exactly with the approved samples.</p> <p>3. All stains, splashes and slatters of paints shall be removed form surrounding surfaces.</p> <p>KRMPL need to take necessary action for proper Painting work.</p> <p>B) Smog exhaust pipe length is not sufficienr as per CPCB/CPHEEO guidelines.It must be replaced on urgent basis.</p> <p>C) All E&amp;M equipments need to be replaced as per CA schedule 11.</p> <p>D) CCTV need to be installed.</p> <p>E) Power backup need to be arranged by KRMPL.</p> <p>F) Inlet and outlet flow meter need to be installed.</p> <p>G) Overflow condition need to be controlled for IPSs,CSPS.</p>				<p><b>Signature:</b></p> <p><b>TEAM LEADER</b> <b>STC KANPUR</b></p>
