SITE INSPECTION REPORT FOR 43 MLD JAJMAU PHASE-II STP

JAJMAU PHASE-II
STP - 43 MLDDate: 13.10.2022
17.10.2022INSPECTED BY:
UPJN,STC and KRMPL team

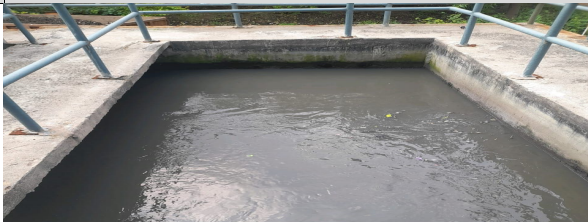
S. No.	Equipment	Assessment of Current Condition	Assessment of Current Condition Photo	Corrective Action Suggested by STC	Original Date of Issue	Proposed Date to Resolve by KRMPL	Current Status of Compliance									
A	Inlet Chamber	During site visit it was found that unit found functional

<div><small>388/359A(2) Morla nagar, Jajmau, Kanpur, Uttar Pradesh 208008, India</small><table><tr><td>Kanpur</td><td>Decimal</td><td>DMS</td></tr><tr><td>Uttar Pradesh</td><td>Latitude</td><td>26°25'3" N</td></tr><tr><td>India</td><td>Longitude</td><td>80°41'8.489" E</td></tr></table><small>2022-10-13(Thu) 11:06(am)</small></div>	Kanpur	Decimal	DMS	Uttar Pradesh	Latitude	26°25'3" N	India	Longitude	80°41'8.489" E	1. Chamber and hand railing painting work need to be done. 2. Sluice gate need to be lubrication 3. Cleaing of inlet chamber need to be done.	21.09.2021		Pending.
Kanpur	Decimal	DMS

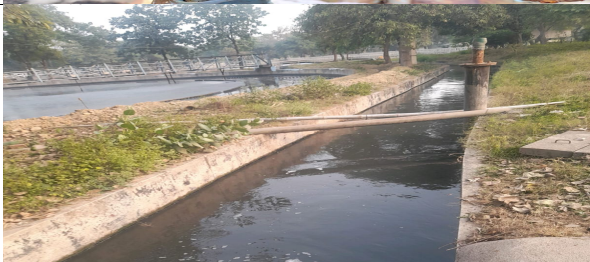
C	Inlet flow meter	During site visit it was found that flow meter found shutdown since September 2022	 	1. Log book need to be maintained. 2. At the time of power failure there are no power backup is available for flow meter. So KRMPL has to provided powewr backup facility. 3. Level scale needs to be paint. 4. Caliberation needs to be done by KRMPL because Flow meter shown their flow reading during "No flow condition"	21.09.2021		Pending															
	Open Channel	Operational

1. Open channel need to be cover with frame cover . 2. Repairing and Painitng work need to be done.	16.12.2021		Pending															
D	Primary Unit																					
1	Primary sedimentataion tank	Primary sedimentation tank functional from 27.07.2022. PST screw pump is under maintenace since 02.06.2022
