SITE INSPECTION REPORT				Jajmau STP - 130 MLD	Date: 13.10.2022 17.10.2022	INSPECTED BY: UPJN ,STC and KRMPL team	
S. No.	Equipment	Assessment of Current Condition	Assessment of Current Condition Photo	Current defects and Corrective Action Suggested by STC, PE	Original Date of Issue	Proposed Date to Resolve by KRMPL	Current Status of Compliance
A	Collection Chamber	Renovation work need to be done by KRMPL.

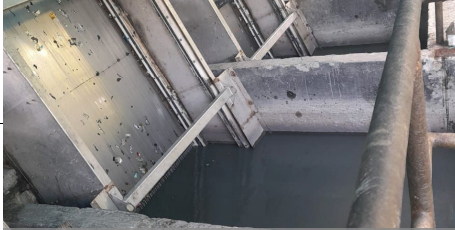
4	Mechanical Fine Screen no. 1	Functional

1. Mechanical Fine Screen are need to be installed as per approved drawing. 2. Mechanical screen of teeth are damaged , KRMPL has not been repaired. 3. Screen erection/ installation work is not verified by STC . 4. Mechanical Screen not working with auto system and without sensor, need to be fixed the auto system immediately. 5.Procedure of screens has not been submit by KRMPL. 6.Without getting approval for shut down and charging the Raw sewage for the same work. KRMPL has not been submitted any approval. 7.Autosystem and level sensor meter has not been installed by KRMPL till date.	23.11.2021		Pending
5	Mechanical Fine Screen no. 2	Functional

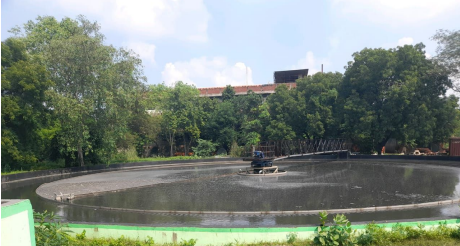
1.KRML has commisioned PST 01 on 25.08.2022. 2. Outer surface Plastering and finishing work to be done at PST1. 3.PST 01 mechanisn need to be replace. 4.Remote system to be installed for PST1. 5.Cable to be laid in cable tray. 6. Log Book need to be maintained.	01.03.2021		Long Pending
22	Primary Sedimentation tank-2	Operational ,Recomissioned on 21.09.2022

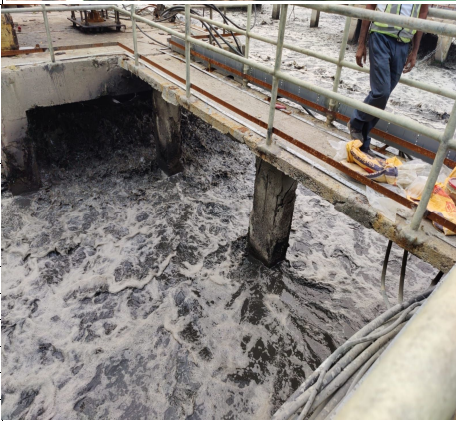
1. KRMPL need to arrange sufficient power backup to operate all aerators. 2.Cracks repairing work done by KRMPL only for outer side of wall. 3.In Aeration Tank platform Slab, where machine is mounted vibrated tremendously, Slab & beam strengthening is required to increase weight of Unit 4.Increasing weight of RCC member's vibration will be controlled. 5.KRMPL instructed to submit the structural strengthening Methodology for Aeration Tank . 6.Aeration Inlet and outlet gates need to be replace . 7. Foundation plate need to be painted. 8. Cable gland need to be fixed in the Pump termination Box. 9. Log Book need to be maintained. 10 KRMPL has supplied 6 nos aerators, 6 nos. gear box on dated 05.07.2022 11. Installation of 6 Nos. of aerators under progress.	01.03.2021		Long Pending

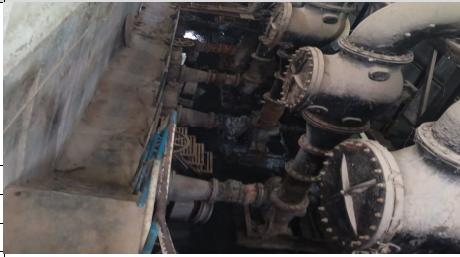
1.New TEPH cum Sump has a;ready been proposed in CA and needs to keep Pump house in working condition till the renovation period. 2.Pump foundation are found in damaged condition. 3.Hand railing to be repaired and installed.	01.03.2021		Long Pending
54	TEPH Pump no.1	Operational

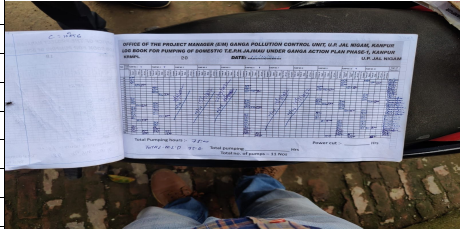
1.All pumps needs to be repaired and get operational. 2. Civil Drawing of pump foundation not submitted by KRMPL for Renovation work. 3.5 nos pumps are in working condition during site visit. 4.2 Nos new pumps has been installed by KRMPL without get any prior approval from UPJN/PE and KRMPL has not submitted any erection procedure as per CA schedule 11. 5. Erection and commissioning of pumps have been done by KRMPL.KRMPL has not complied the compliance raised by PE officials . 6. KRMPL has not been submitted any design and drawings for Valves, NRVs, Dismantling joints etc. 7.Lighting arrangement and Cable to be laid in cable tray. 8.Thermometer and vibration meter should be at site. 9.Railing to be repaired till the renovation period. 10.Motor cover to be arranged. 11.Pressure guage are found in damaged condition and need to be replaced. 12. Concessionaire should maintain lag book of the pumps for proper record maintenance. 13. Leakage has been detected in some pumps which are in operation, and directed to repair the same immediately. 14.LBPS system to be install at site 15. Cable tray need to be painted immediatiatly	01.03.2021		Long Pending

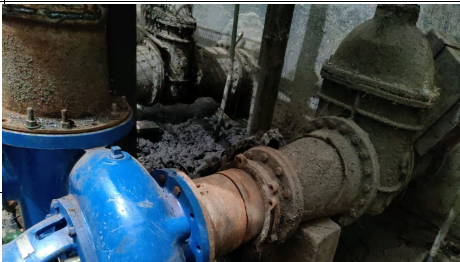
1.Sludge cleaning work done by KRMPL only top of slab. 2. Renovation work done by KRMPL only slab top. 2. KRMPL need to clean sump from bottom of slab.	01.03.2021		Long Pending
66	Return Sludge Pump House (Civil)	Needs rehabilitation

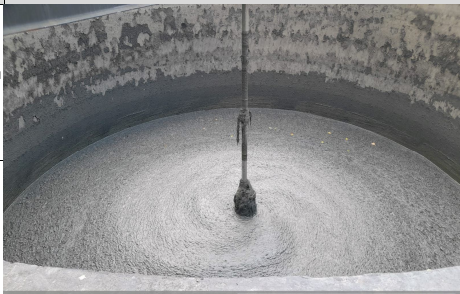
1. Sludge disposal work done from dated 04.02.2022 to 22.02.2022 from common sludge chamber. 2. Belding tank commisioned on 31.05.2022	31.05.2022		
	Blending Tank Agitator	New Replacement as per BEPI					
72	Gravity Sludge Thickeners						
73	Gravity Sludge Thickener no. 1	Operational but non-functional

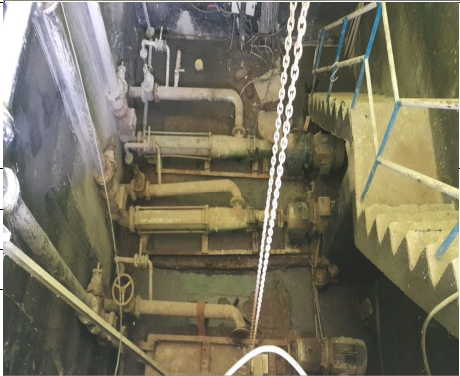
1. Cleaning work of roof slab is in progress by KRMPL. 2. Sump to be clean and rehabilitate. 3. Precast cover slabs of Sump to be replaced . 4. Pump house structure needs plastering and finisihng works. 5. Cracks should be treated with proper technique. 6.Remote system to be installed for TSPH. 7.Cable to be laid in cable tray. 8.All Thickened sludge pumps to be replaced as per CA. 9.Dewatering pump to be installed for removing extra water. 10. EOT crane /lighting /exhaust fan to be inslatlled . 11. Log Book need to be maintained.	10.12.2021		Pending

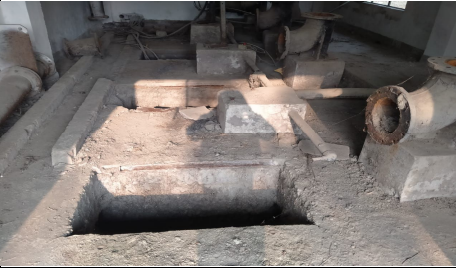
1. Plastering and finishing work of the Centrifuge building and centrate Pump house. 2. Railing and steel ladder to be repaired or replaced as per site condition. 3. Housekeeping to be done. 4. Sign boards are required. 5. No approach road found at site to get on this unit/component. 6. Proper lighting arrangement to be required at site.			
94	Supernatant Pump no.1	Pump already dismantled by KRMPL		As per CA pump to be replaced .	01.03.2021		Long Pending
95	Supernatant Pump no.2	Pump already dismantled by KRMPL		As per CA pump to be replaced .

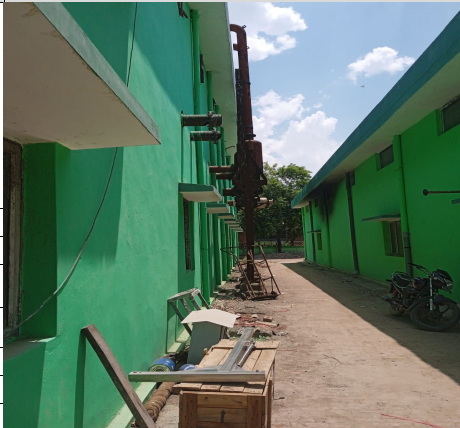
1.Roof slab cleaning work is in progress. 2.KRML is doing surface roof treatment for compressor panel room slab while KRML didn't submit any methodology ,Work process and Work Plan. 3. Outer face plaster work is in progress by KRML with mortar (1:3) cement:sand ratio. 4. Plaster work should be proper thickness, verticality and smoothness but KRML is not doing same as per CA specification. 4. Cracks repairing work in ceiling slab is in progress by KRML. 5. KRML has engaged 9 Nos of labour for civil work.	10.12.2021		Pending
