## SITE INSPECTION REPORT FOR 210 MLD STP BINGAWAN

Location:  
210 MLD STP at BINGAWAN

Inspection  
Date:  
03.10.2022

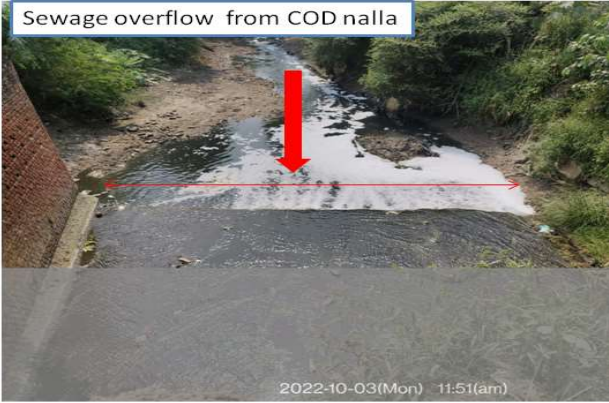
S. No.	Equipment	Assessment of Current Condition	Assessment of Current Condition photo	Corrective Action Required	Corrective Action Completed by KRMPL	Original Date of Issue	Proposed Date to Resolve by KRMPL	Current Status of Compliance
1	COD Nalla	During the UPJN & PE site visit of COD Nala I&D site on 03/10/2022, it was found that sewage flows (Overflow) were diverted to Ganga River.

Required nos. of pumps at MPS need to be operated to tackle the problem of overflow.		03.10.2022		Pending
1A	Bypass Sluice Gate at Bingawan STP Inlet Chamber	During the UPJN & PE site visit of Bingawan STP on 27/05/2022, leakage of sewage flow was found at the bypass sluice gate going to the River. PE had pointed out this issue in previous inspection reports for KRMPL compliance. KRMPL plant incharge confirmed that the issue was rectified but still the same issue was observed which means the issue was not complied earlier and false information is being provided by KRMPL Plant Incharge.

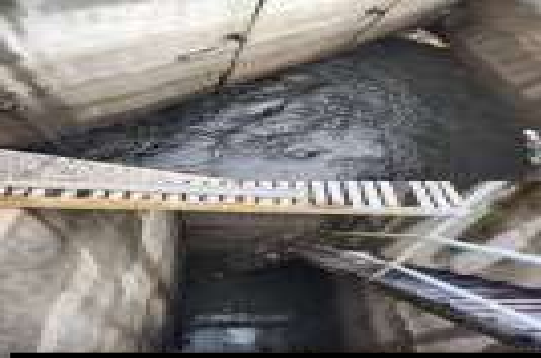
2	Upstream Wetwell of MPS	During the UPJN & PE site visit on 25.08.2022, it was observed that freefall at the inlet of the MPS wet well was not maintained. This situation is very frequent and KRMPL is not taking any corrective measures.

Adequate no. of pumps at MPS need to be operated to tackle the problem of reverse/back flow and free fall at the inlet needs to be maintained at all times.		26.10.2021

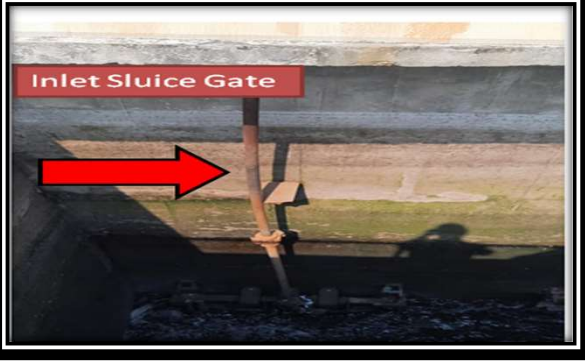
3	Sluice gates at Upstream Wetwell of MPS	Non-Operational

<p>1.Sluice gate pillar/shaft was found in bent condition.Need to be replaced.</p> <p>2.Sluice gate integrated stem guide is broken. Need to be replaced.</p> <p>3.Lubrication of gearbox must be done on regular basis.</p>		03.10.2022			
4	Mechanical Coarse screen (No.01)	Non-operational The rake mechanism is not properly aligned and uneven gap was found between rake teeth and plate/ screen bar.

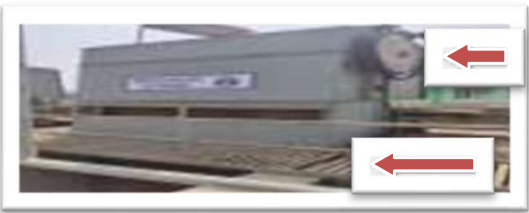
<p>1) Need to be rectified at the earliest.</p> <p>2) Rake mechanism must be aligned properly at the earliest.</p> <p>3) Painting needs to be done properly on the stairs, walkway, handrails etc.</p> <p>4) Chain cover must be provided.</p> <p>5) Log book of mechanical screen must be maintained.</p>		20.08.2022 03.02.2021			Long Pending
5	Mechanical Coarse screen (No.02)	Non-operational The rake mechanism is not properly aligned and uneven gap was found between rake teeth and plate/ screen bar.

<p>1) Need to be rectified at the earliest.</p> <p>2) Rake mechanism must be aligned properly at the earliest.</p> <p>3) Painting needs to be done properly on the stairs, walkway, handrails etc.</p> <p>4) Chain cover must be provided.</p> <p>5) Log book of mechanical screen must be maintained.</p>		18.08.2022 28.06.2022 03.02.2021	30.10.2021		Long Pending

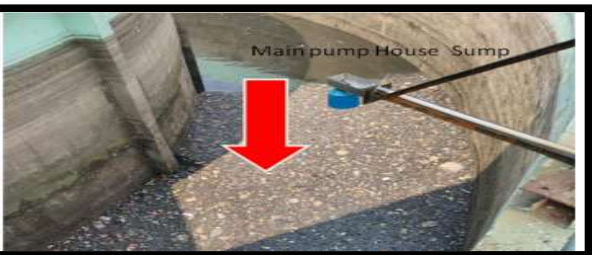
12a	Main Pump Station(MPS) Wetwell	When UPJN & STC team reached the site on 03/10/2022, significant floating material was found in the wetwell.

Floating material needs to be removed from the wetwell. The mechanical screens must be operated regularly to avoid such conditions i.e, garbage carry over.		03.10.2022			Pending
12b		KRMPL has not conducted any cleaning of the Wetwell since the handover. This has caused the MPS pumps to clog and frequently breakdown. Several NRV valves and Sluice valves have also been damaged due to the intake of debris. The failure of mechanical coarse screens are the main reason for accumulation of debris in the wetwell.

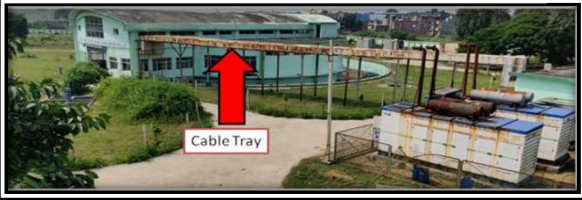
13	MPS Cable tray	Cable tray was found rusted

Needs to be painted/ Replaced	08.07.2019			Long Pending
14	MPS Discharge Header Air Release Valve Chamber (Civil work)	1) Valve Chamber Roof Panels Finishing work is not completed yet. 2) Air Valve Vertical Pipe was found bent. 3) Valve chamber was found filled with mud. 4) Air valves were found non-operational.

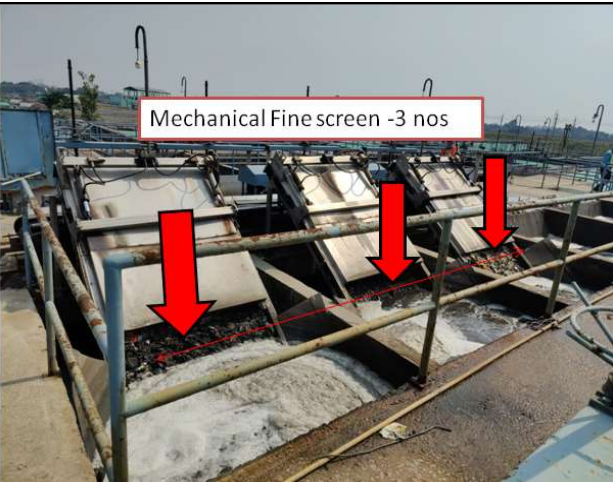
33	Mechanical Fine screen no.01	Non Operational When STC / UP Jal Nigam team reached the site, we found that the screen is still not functioning properly. None of the disposal material is getting removed by the screen and also sewage level in upstream is higher than that of the level at downstream. Screen bars are choked with disposal materials.

Must be Overhauled at the earliest In the meeting dated 11.04.2022, ED (T) NMCG directed KRMPL to rectify the issue till 18.04.2022 but not rectified yet.	28.01.2020	15.11.2021. Next date given is 31.01.2022 Next date given is 31.07.2022	LONG PENDING
34	Mechanical Fine screen no.02	Non Operational

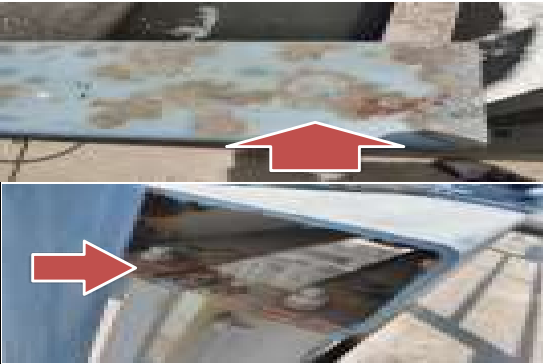
39	Painting works on PTU	<p>When UPJN &amp; PE visited site, it was found that painting work is not done properly on the items on PTU. By scratching through nails only, the painted parts is coming out and the below portion was found rusted.</p> <p>Also various parts which was not painted properly was again get corroded as shown in the pic.</p>

<p>Painting must be done properly and all the rusted parts on PTU needs to be painted. Apart from this, painting procedure needs to be submitted at the earliest.</p> <p>All the parts on which painting is not done by following standard procedure, needs to be repainted properly.</p>		26.11.2021 (Since long back)			Long Pending
40	RTOLMS sampling bucket on PTU			<p>Bucket must be clean and sludge must be removed daily.</p>					
41	Grit removal mechanism- Detritor no.01 Main drive, Classifier drive, Organic pump	<p>Non -operational</p> <p>1) Very less quantity of grit was being removed by the grit classifier.</p> <p>2) No canopy found on motors of equipments.</p>

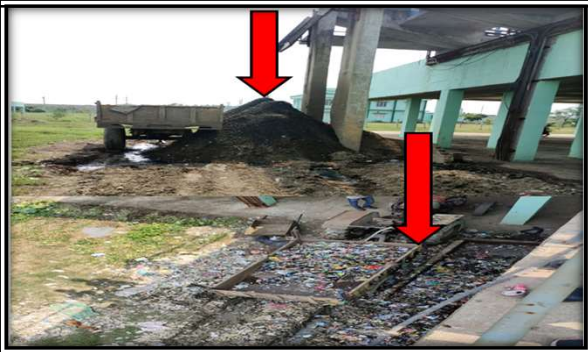
1) Level sensor must be installed at earliest. 2) Scale & chart for flow measurement must be fixed at earliest.		Since Handover 08-07-2019	2) 15.01.2022 new date 30.06.2022 new date 2) 31.07.2022	LONG PENDING
46	Grit Disposal Area	When UPJN & PE visited the site, it was found that no trolley was provided for screening collection and much of the screenings was getting splashed to the nearby locations. Proper drains and CC road below grit tray are still not prepared which is creating pollution & unhygienic environmental condition.

Trolley at every location needs to be provided for collection of Grit from chutes & screenings from conveyor every time as directed by NMCG team and PE also. CC way need to be prepared as required for this area and required drain also needs to be provided.		26.10.2021		LONG PENDING

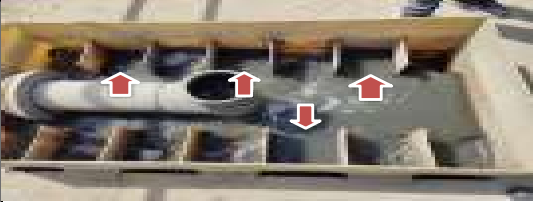
Processing needs to be optimized		23.01.2021		
48	UASB Reactor- no.2	Operational		Processing needs to be optimized		21.04.2021		
49	UASB Reactor- no.3	Operational		Processing needs to be optimized		20.08.2020		
50	UASB Reactor- no.4	Operational		Processing needs to be optimized		23.01.2021		
51	UASB Reactor- no.5	Operational		Processing needs to be optimized		15.03.2021		
52	UASB Reactor- no.6	Operational		Processing needs to be optimized		10.01.2022		
53	UASB Reactor- no.7	Operated but filled with sludge 1) Various downward pipes from the feed box were found choked.

NMCG has directed KRMPL to deploy more team for cleaning of UASB reactors to complete the process with in 3 to 4 week for each reactor.		28.01.2020		LONG PENDING
54	UASB Reactor- no.8	Operational		Processing needs to be optimized		23.01.2021	-

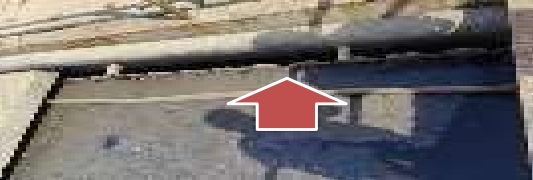
In NMCG meeting dated 11.04.2022, KRMPPL promised and extended the previous date to complete cleaning of reactors till May 2022 but not cleaned yet		28.01.2020	15.02.2022 then 28.02.2022 New Date 15.07.2022	LONG PENDING
61	UASB Reactor- no.15	Under Maintenance since 03.01.2022		In NMCG meeting dated 11.04.2022, KRMPPL promised and extended the previous date to complete cleaning of reactors till May 2022 but not cleaned yet		28.01.2020	31.01.2022 then 31.03.2022 New Date 31.07.2022	LONG PENDING
62	UASB Reactor- no.16	Under Maintenance		In NMCG meeting dated 11.04.2022, KRMPPL promised and extended the previous date to complete cleaning of reactors till May 2022 but not cleaned yet		28.01.2020	15.01.2022 then 15.03.2022 New Date 15.08.2022	LONG PENDING
63	UASB reactors	Some improvement in scum cleaning was observed during site visit.  When UPJN & STC team reached the site, it was found that almost all reactors overflow v-notch was not alignment properly and also the notches were found choked at various places. At various places no overflow was being observed through the v-notch. Apart from this, it has been found that the gates just before UASB reactors were found only little open.

Scum cleaning needs to be done regularly.  1) Alignment and cleaning of v- notches must be done at the earliest so that smooth flow of treated sewage takes place. 2) Gates just before UASB reactors needs to be opened fully.		30.06.2022  25.03.2022 26.07.2022		Long Pending

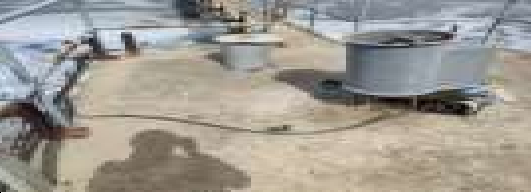
84	Aerator no. 18	Non Operational After approx 3 months since 22.02.2022, it was found operational on 27.05.2022.		Needs to be rectified at the earliest.		03.10.2022		
85	Aerators earthing	When UPJN & PE visited the site, it was found that improper earthing has been provided by connected with thin wire instead of GI strip. All aerators earthing work still found not done.

All aerators earthing GI strip (of required dimension) connection must be done at the earliest which is still pending.		22.01.2022		Long Pending
86	Aeration Lagoon no. 1	1) When STC / UPJN team reached the site, a joint depth measurement for aeration lagoon no. 1 was done at three different points, and sludge was found at an average depth of 0.6m below the top water level, which means 3.4 m approx. sludge is present inside aeration lagoon no. 1 at corners. 2) At the time of visit, no desludging work was found. 3) At the middle portions of the lagoon, sludge was seen above the top water levels also with clearly indicates that the lagoon is completely filled with sludge.

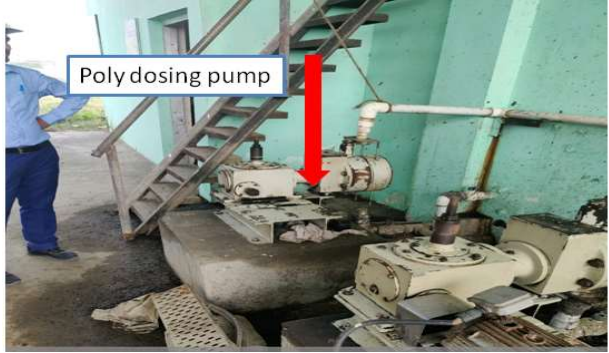
<p>1. Heavy vibration was found. Need to be rectified at the earliest.</p> <p>2. Leakage need to be rectified at the earliest.</p>		03.10.2022		Pending
93	Poly dosing pump No.3	Non Operational

Need to be replaced		07.10.2021	<p>30.10.2021. Next date given 15.02.2022 Next date given 30.06.2022 New date 15.07.2022</p>	LONG PENDING
94	Service water pump No.1 (For BFP)	Operational

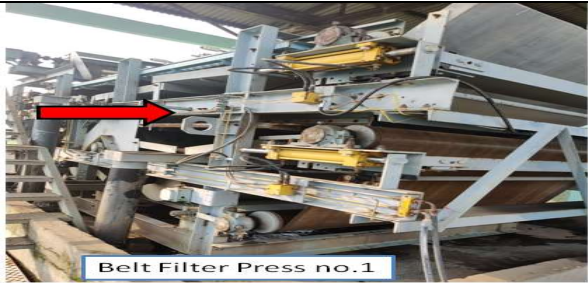
Need to be repaired		Since Handover 08-07-2019	<p>15.11.2021. Next date given 28.02.2022 Next date given 30.06.2022 New date 15.07.2022</p>	LONG PENDING
96	Belt filter Press No. 1	<p>Operational</p> <p>After approx 5 months of non-operational since 23.09.2021, it was found operational on 22.02.2022 and again found non-operational on 27.05.2022, again found operational but no record found at site. No record of non operation of BFP was mentioned in the maintenance register.</p> <p>1) Discharge sludge box was found totally rusted and damaged.</p> <p>2) BFP building shed was found rusted</p>

<p>1) Panel door, ammeter, voltmeter, limit switch, indicator lights need to be repaired / replaced.</p> <p>2) Cable tray need to be painted.</p> <p>3) BFP panel no. 1 buzzer need to be replaced.</p> <p>4) Discharge sludge box must be replaced.</p> <p>5) BFP building shed needs to be epoxy painted by following standard method.</p> <p>6) Maintenance register needs to be maintained properly.</p>		23.09.2021	<p>30.11.2021. Next date given 31.01.2022 Next date given 10.06.2022</p>	LONG PENDING

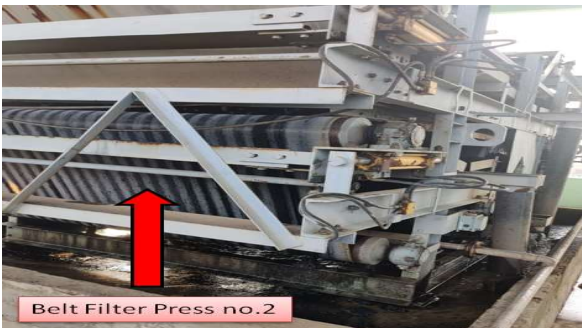
97	Belt filter Press No.2	Operational Discharge sludge box was found totally rusted and damaged.

1) Need to be required lubrication on daily basis 2) Panel door, ammeter, voltmeter, limit switch need to be repaired. 3) Cable tray need to be painted. 4) Discharge sludge box must be replaced.		23.09.2021	30.11.2021 Next date given 31.01.2022 Next date given 31.05.2022	LONG PENDING
98	Belt filter Press No.3	Operational Discharge sludge box was found totally rusted and damaged.

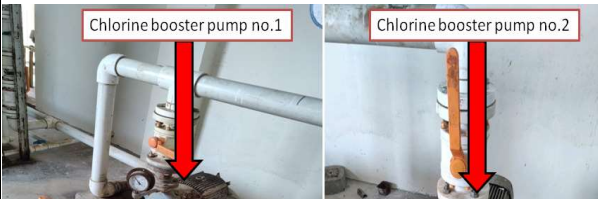
100	Filtrate pump no. 1	Non-Operational		Need to be overhauled at the earliest		10.12.2021		Long Pending A temporary pump is being installed for temporary operation. Pumps needs to be installed on its original arrangements only. False information was provided in KRMLP letter no. 2455 dated 12.05.2022 regarding compliance to PE inspection.
101	Filtrate pump no. 2	Non-Operational		Need to be overhauled at the earliest		10.12.2021		
Chlorination Area								
102	Booster Pump No.1	Operational 1) PG found damaged 2) Leakage found from the Impeller 3) Apart from this, it was found that even after closing the ball valves, water flow was observed from the valves in close position.

1) Pressure gauge must be fixed/ replaced at the earliest 2) Leakages must be fixed at the earliest 3) Ball valves needs to be rectified / replaced.		26.11.2021		Long Pending

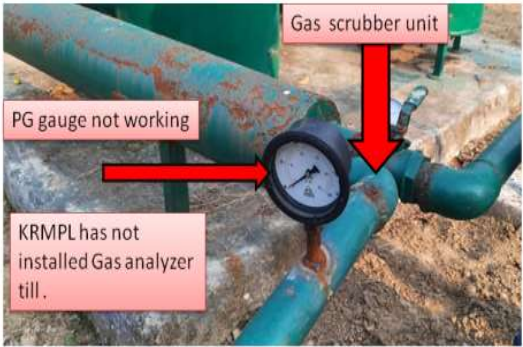
109	Gas scrubber Unit	<p>When UPJN &amp; PE officials visited site, it was found that</p> <ol style="list-style-type: none"> <li>1) PG was not working and KRMPPL was unable to get the pressure checked at the outlet of scrubber unit.</li> <li>2) KRMPPL has not installed any permanent gas analyser yet for checking gas quality.</li> <li>3) KRMPPL is claiming that moisture tapping system has been corrected, scrubber system has been rectified etc which require third party analysis report for checking the performance.</li> </ol>

<ol style="list-style-type: none"> <li>1) Working Pressure gauge must be provided after scrubber.</li> <li>2) Gas analyser must be installed (as per article 8.7 (b) of CA.) so that the scrubbed gas quality could be checked at site.</li> <li>3) Third party analysis of bio gas and scrubbed gas through approved agency from UPJN, needs to be conducted and witnessed by UPJN &amp; PE and report needs to be submitted to check whether operation is corrected or not as claimed by KRMPPL.</li> </ol>	28.01.2020		LONG PENDING

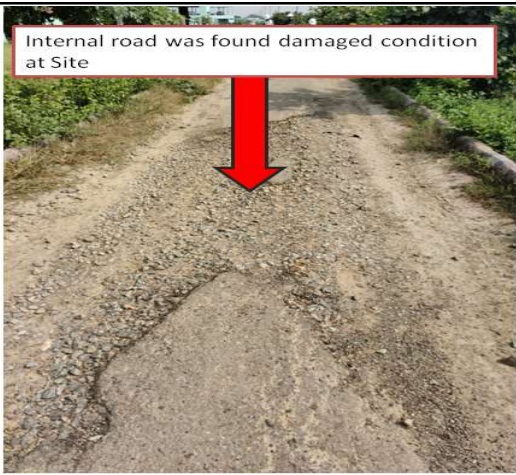
116	Internal Road Restoration	Internal roads were found damaged at various places

Internal road restorational must be started at earliest and should be done on phased manner.		26.10.2021	31.01.2022 New date 30.06.2022	LONG PENDING
117	Marking Equipments	It was found that some markings has been done by KRMPL and some marking on the equipments/ units are still pending which had already been clarified to the plant incharge.		Each equipments / units must be marked (like 1st, 2nd etc) in bold letters so that the equipments/ units can be identified easily.		26.10.2021	28.02.2022	LONG PENDING
118	Laboratory	1) KRMPL lab testing results are not matching with other agency's testing report. 2) Calibration Tests of Lab equipment are not performed. 3) Fecal coliform results is exceeding the permissible limit with a huge margin. 4) List of equipment complete details are not found available at site. 5) It was found that the samples were kept at negative temperature.		1) KRMPL lab testing results are not matching with other agency's testing report. KRMPL must do the testings properly as per standard operating procedure as per CA / CPHEEO manual. 2) Lab. equipments must be calibrated. 3) Fecal Coliform tests need to be validated due to huge variation with the 3rd party lab results. 4) Detailed list of lab equipment with all information must be prepared and made available at site. 5) Temp. regulated fridger must be made available for storing samples.		25.03.2022 26.10.2021		LONG PENDING

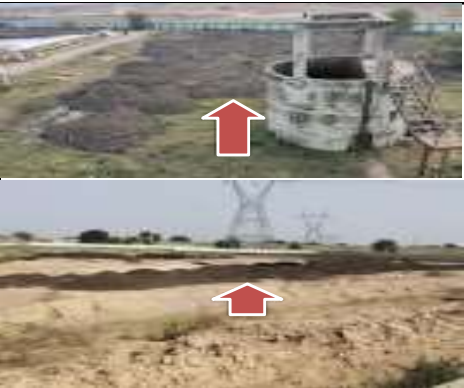
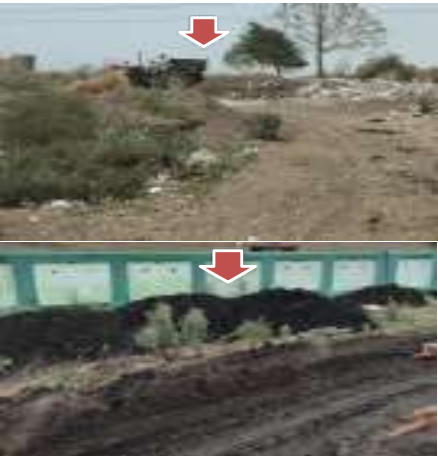
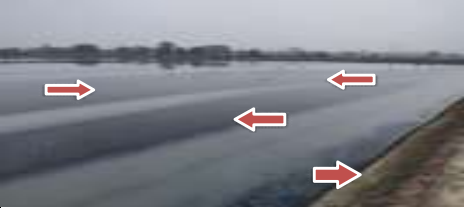
121	Sludge Disposal	<p>When STC / UP Jal Nigam team reached the site, we found that still sludge was being disposed at various locations inside the plant on the ground without any permission. As instructed by ED (Technical) on 08.10.2021 &amp; 11.04.2022 that sludge disposal is to be done as per norms of UPPCB but still KRML is not following</p>

<p>it.</p> <p>UPPCB vide their letter no. 1386/5- 658/21 dated 04.12.2021 also instructed KRML to dispose the sludge as per the norms but still sludge is being disposed on the ground at an inappropriate place.</p>

<p>Still UPPCB norms are not being followed and sludge disposal is being done inside the plant on the muddy ground. Sludge disposal must be done as per UPPCB norms.</p> <p>In the meeting dated 11.04.2022, ED (T) NMCG directed KRML to follow UPPCB norms for sludge disposal &amp; storage inside the plant but KRML still not following the norms.</p>	01.12.2021		LONG PENDING

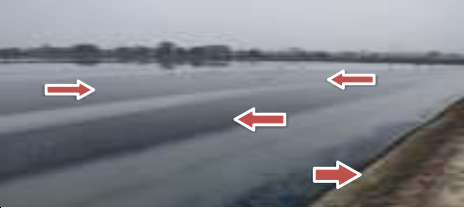
122	Final Polishing Unit 1 & 2	<p>When UPJN &amp; STC officials reached the site, it was found that FPU lagoons are completely filled with sludge</p>

<p>Desludging needs to be done on immediate basis. In the meeting dated 11.04.2022, ED (T) NMCG directed KRML to submit cleaning schedule of final polishing pond (FPU) within 7 days (i.e, 18.04.2022).</p>	22.01.2022 (Since long back)		LONG PENDING
123	Internal Lights, Exhaust fans etc. of Panel rooms	<p>Various lights and exhaust fans inside various panel rooms were found not in working condition</p>		<p>Various lights and exhaust fans must be rectified / replaced at the earliest.</p>	22.01.2022	30.06.2022	Long Pending
124	LT Panel Room	<p>Various indicators, ammeters , voltmeters etc were found not working</p>		<p>All non-working indicators, ammeters, voltmeters etc must be replaced at the earliest.</p>	25.03.2022	30.06.2022	Long Pending

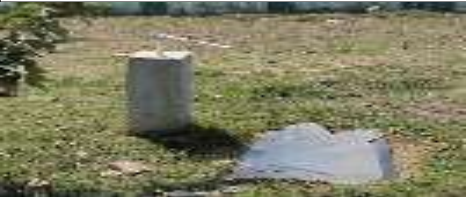
125	Plant External Lights	When UPJN & PE officials visited site, it was found that some of the lights were replaced and various lights are still not working/ not available, which needs to be rectified / replaced. Apart from this, almost all DB of light pole is non-functional.		1) Defective lights needs to be replaced at the earliest. 2) All defective DB needs to be rectified. <b>In the meeting dated 11.04.2022, ED (T) NMCG directed KRMPPL to install all lights within a day (i.e, 13.04.2022) and must ensure its 100% availability/ functioning.</b>		28.01.2020	30.06.2022	LONG PENDING
126	Water taps at various locations inside plant	When UPJN & PE visited the site, it was found that at various locations, the water taps are not working and the civil works are damaged and on some places no foundation and drain line were available.

1) Water taps must be rectified at all places. 2) Civil foundation works must be restored at all places. 3) At the places where civil foundations are not available, construct it. 4) Proper drain line from the water tap area needs to be constructed and conncted to the nearest drain.		22.02.2022		Pending
