SITE INSPECTION REPORT FOR 210 MLD STP BINGAWAN					LOCATION: 210 MLD STP at BINGAWAN	Inspection Date: 14.11.2022	INSPECTED BY: <u>UPJN Team:</u> Sangeet J.R. Chavh <u>STC Team:</u> Mr. Satish Kamranje (Process Expert), Mr. Ajay Kumar Goyal (Support Engrg. Mech) Mr. Divya Mittal (Support Supervisor/Electrical) <u>KRMPL Team:</u> Mr. Abhishek Pandey, Process engineer, KRMPL Mr. Ashwin, Mechanical Engineer, KRMPL

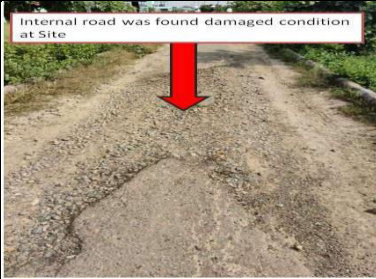
117	Internal Road Restoration	Internal roads were found damaged at various places

Internal road restoration must be started at earliest and should be done on phased manner.	26.10.2021	03.10.2022	Pending
118	Marking Equipments	It was found that some markings has been done by KSMPL and some marking on the equipment carts are still pending which had already been clarified to the plant incharge.		Each equipments / units must be marked (like 1st, 2nd etc) in bold letters so that the equipment/units can be identified easily.	26.10.2021	28.02.2022	LONG PENDING
119	Laboratory	1) KSMPL lab testing results are not matching with other agency's testing report. 2) Calibration Tests of Lab equipment are not performed. 3) Fecal coliform results is exceeding the permissible limit with a huge margin. 4) List of equipment complete details are not found available at site. 5) It was found that the samples were kept at negative temperature.		1) KSMPL lab testing results are not matching with other agency's testing report. KSMPL must do the testings properly as per standard operating procedure as per CIL / CHNEED manual. 2) Lab equipments must be calibrated. 3) Fecal Coliform tests need to be validated due to huge variation with the 3rd party lab results. 4) Detailed list of lab equipment with all information must be prepared and made available at site. 5) Temp. regulated fridge must be made available for storing samples.	20.03.2022 26.10.2021		LONG PENDING

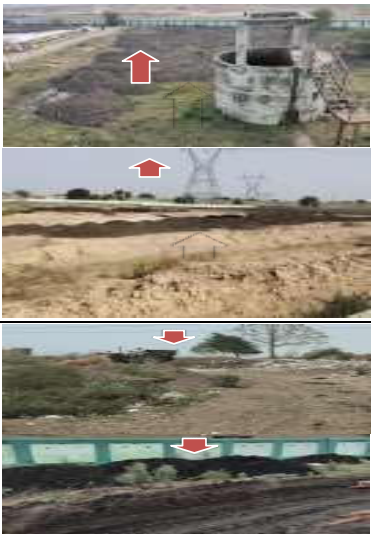
122	Sludge Disposal	<p>When STC / UP Jal Nigam team reached the site, we found that still sludge was being disposed at various locations inside the plant on the ground without any permission.</p> <p>As instructed by EO (Technical) on 08-10-2021 &amp; 11-04-2022 that sludge disposal is to be done as per norms of UPPCB but still KRMPL is not following.</p> <p>UPPCB vide their letter no. 1306/S-608/21 dated 04-12-2021 also instructed KRMPL to dispose the sludge as per the norms but still sludge is being disposed on the ground at an inappropriate place.</p>

<p>SIR UPCCB norms are not being followed and sludge disposal is being done inside the plant on the muddy ground.</p> <p>Sludge disposal must be done as per UPCCB norms.</p> <p>In the meeting dated 11.04.2022, EO (T) NMCO directed KRMPL to follow UPCCB norms for sludge disposal &amp; storage inside the plant but KRMPL still not following the norms.</p>	01.12.2021		LONG PENDING
