<div>STC</div> <div>SITE INSPECTION OF JAJMAU ASSOCIATED IPS REPORT</div>					Nawabganj IPS 32 MLD	Date: 29.11.2022	INSPECTED BY: STC Team 1. Mr Ajay Kumar Goyal, Support Engineer, Mechanical, STC Kanpur 2. Mr. Rahul Sawan, Support engineer, Electrical, STC Kanpur 3. Mrs. Divya Mittal, Support Site Supervisor, STC Kanpur 4. Mr. Karam Veer Singh, Support Site Supervisor, STC Kanpur

<div>STC</div> <div>SITE INSPECTION OF JAJMAU ASSOCIATED IPS REPORT</div>					Parmat IPS	Date: 29.11.2022	INSPECTED BY: STC Team 1. Mr Ajay Kumar Goyal,Support engineer mechanical,STC Kanpur 2. Mr.Rahul Sawan,Support engineer,Electrical,STC Kanpur 3. Mrs. Divya Mittal, Support Site Supervisor, STC Kanpur 4. Mr. Karam Veer Singh, Support Site Supervisor, STC Kanpur

# SITE INSPECTION OF JAJMAU ASSOCIATED IPS REPORT

Baba Ghat -7 MLD

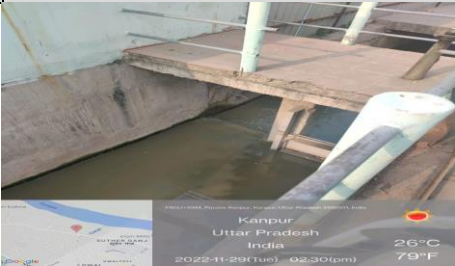
S. No.	Equipment	Assessment of Current Condition	Assessment of Current Condition Photo	Current defects and Corrective Action Suggested by PE	Original Date of Issue	Proposed Date to Resolve by KRMPL	Current Status of Compliance
1	All work						
1	Inlet Over Flow Condition	Overflow condition found since handover

1. During site visit overflow is observed since handover 28.06.2021. 2. No action has been taken by KRMPL despite being informed, several times by NMCG, UPJN and STC representatives. 3. As per renovation plan for IPS Nawabganj , KRMPL should increase adequate pumping to prevent overflow of sewage.	28.06.2021		Long Pending
2	Inlet Chamber	1. Cleaning of inlet chamber needs be done on regular basis. 2. Staircase damaged tile needs to be renovated.		1. Cleaning of inlet chamber needs be done on regular basis. 2. Staircase damaged tile needs to be renovated.	23.11.2021		Long Pending
3	Screen Chamber	1. Garbages has accumulated into screen chamber.		1. Garbage cleaning work should be done on regular basis. 2. Garbage Trolley should be made available at the site.	23.11..2021		Pending

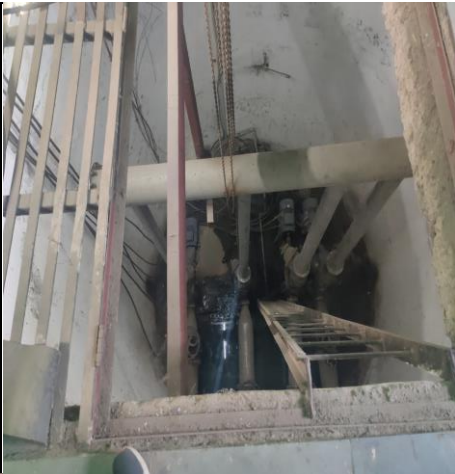
7	Pump House No.2	Civil Structure in unsatisfactory Condition

<ol style="list-style-type: none"> <li>1. All 4 pumps were operational during the inspection.</li> <li>2. Pumps are starting on temporary starters, as existing starters are non operational.</li> <li>3. Exhaust fan was missing in the pump house.</li> <li>4. Indoor switch board work and cable dressing work are pending.</li> <li>5. Dewatering pumps are not installed.</li> </ol>	23.11.2021		Long pending
8	Open Channel and Sluice Gate	Civil Structure in unsatisfactory Condition

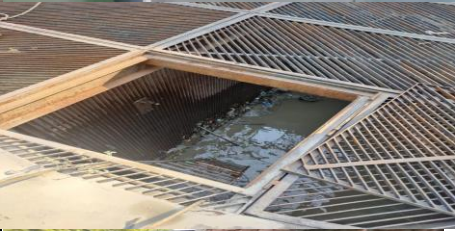
<ol style="list-style-type: none"> <li>1. KRMPL has not submitted approval for fabrication work.</li> <li>2. Sluice gate needs to be replaced under renovation.</li> </ol>	23.11.2021		Long pending
9	Boundary wall, Valve chambers and landscaping area	Civil Structure in unsatisfactory Condition

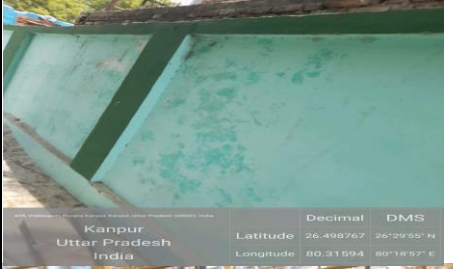
<div data-bbox="491 1057 942 1117"> <div>Kanpur Uttar Pradesh India</div> <div> <div>Decimal</div> <div>DMS</div> </div> <div> <div>Latitude</div> <div>26.498767</div> <div>26°29'55" N</div> </div> <div> <div>Longitude</div> <div>80.31594</div> <div>80°18'52" E</div> </div> </div>	<ol style="list-style-type: none"> <li>1.KRMPL has painted the boundary wall with poor workmanship, This should be reworked.</li> <li>2. Cleaning work of campus area needs to be done by KRMPL.</li> <li>3. Valve chamber should be plastered and covered properly.</li> <li>5. All valves needs to be replaced.</li> </ol>	23.11.2021		Long pending

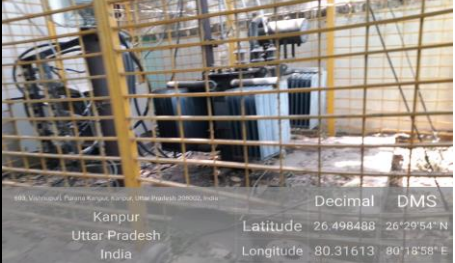
11	Transformer Yard	Civil Structure in satisfactory Condition

<div data-bbox="491 1312 942 1388"> <div>Kanpur Uttar Pradesh India</div> <div> <div>Decimal</div> <div>DMS</div> </div> <div> <div>Latitude</div> <div>26.498488</div> <div>26°29'54" N</div> </div> <div> <div>Longitude</div> <div>80.31613</div> <div>80°18'58" E</div> </div> </div>	<ol style="list-style-type: none"> <li>1. Yard area needs to be cleaned.</li> </ol>	23.11.2021		Long pending

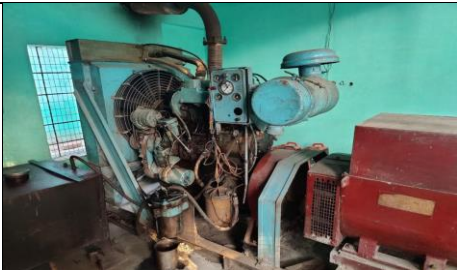
12	DG set room	Civil Structure in satisfactory Condition

<ol style="list-style-type: none"> <li>1. DG set is in working condition.</li> <li>2. Log book of DG set is not maintaining properly by KRML.</li> <li>3. Diesel surplus quantity is not available at site.</li> <li>4. Smog exhaust pipe length is not sufficient as per CPCB/CPHEEO guidelines. Therefore, it must be replaced on urgent basis.</li> </ol>	23.11.2021		Pending
13	Metering Room	Civil Structure in unsatisfactory Condition

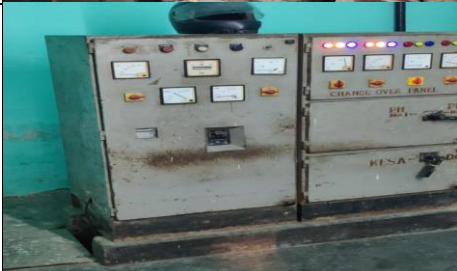
<ol style="list-style-type: none"> <li>1. Seepage was observed on the wall of this room. It should be rectified.</li> <li>2. Panel Volt meters and Ammeters needs to be replaced.</li> <li>3. All Phase Indicators needs to be replaced.</li> </ol>	23.11.2021		Long Pending
14	Logbook	Log book of pump house 01 not maintained by KRML

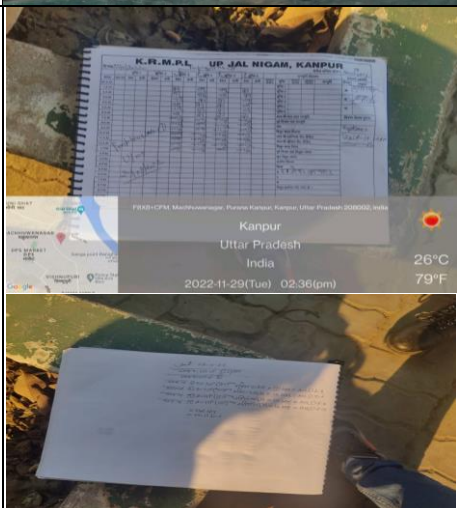
<ol style="list-style-type: none"> <li>1. Security guard should be arranged by KRML.</li> <li>2. Diesel stock log book was not maintained properly by KRML on regular basis.</li> <li>3. Pumps log book was not maintained properly.</li> <li>4. Maintenance records was not available at site for all E&amp;M equipments.</li> <li>5. Arrangement of reliever for Operators and sweepers should be done by KRML.</li> <li>6. DG log book was not maintained properly by KRML.</li> <li>7. Material inward and outward registers need to be maintained properly by KRML.</li> </ol>	28.06.2021		Long Pending

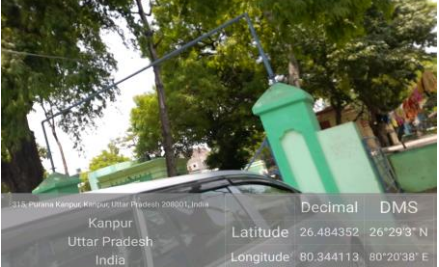
*	Main entry Gate	No informatory sign board for Parmat IPS was available at the entry gate.

1. KRMPL should arrange informatory sign board for Parmat IPS.	07.04.2022		Pending
1	Inlet Chamber	Civil Structure is in satisfactory condition

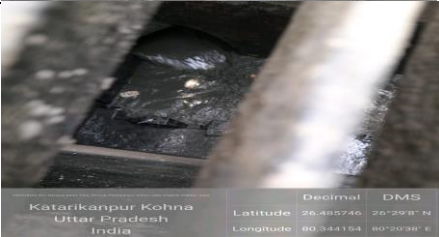
1. All kinds of Renovation work is pending in the inlet chamber. 2. Cleaning and landscaping work needed to be done. 3. KRMPL needs to deploy a security guard for the IPS.	23.11.2021		Pending
2	Screen Chamber	Civil Structure is in satisfactory condition

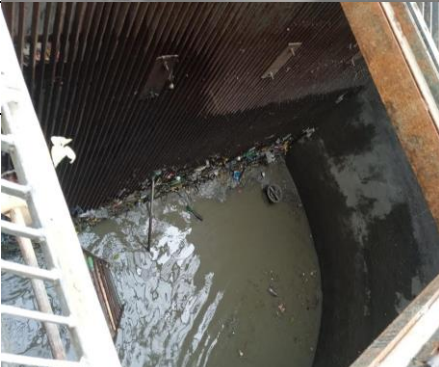
1. Renovation work is required for the inner and outer surface of the chamber. 2. Plaster work needs to be done. 3. Cleaning and landscaping work needs to be done. 4. MS frame cover should be painted.	23.11.2021		Pending
3	Receiving Chamber	Civil Structure is in satisfactory condition

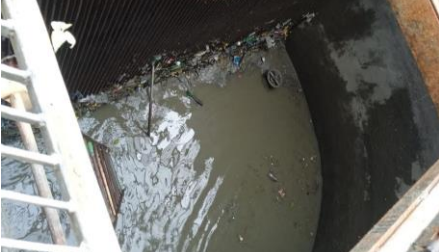
1.Screens should be replaced 2.Garbage material needed to be removed on timely basis. 3. Renovation work is required for inner and outer surface of the Receiving chamber in all respect. 4. Cleaning and landscaping work needed to be done. 5. MS frame cover should be painted.	23.11.2021		Pending

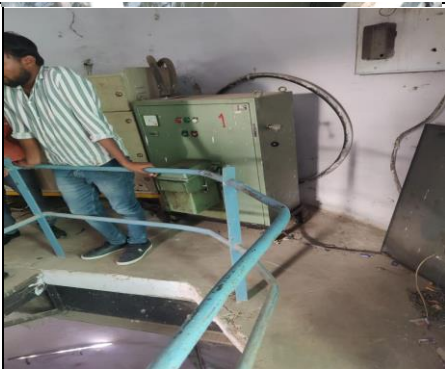
4	Pump house No. 2	Pump house no.2 is in unsatisfactory condition

<ol style="list-style-type: none"> <li>1. All pipelines were found in submergence condition.</li> <li>2. Both pumps were operational. NRV and Sluice gates needs to be replaced.</li> <li>3. All tubelights were not working properly.</li> <li>4. Drain water pump no-2 needs to be replaced.</li> <li>5. Ammeters on the LT panel were not in working condition.</li> <li>6. Motor termination Box cover was not fixed and also cable gland was not fixed.</li> <li>7. DG set for pump house no-1 is not working since handover.</li> <li>8. Dewatering pump needs to be replaced.</li> <li>9. Operators are non technical person. They do not have clear understanding of the Pump Capacity , Flow of Discharge, and Peak Flow. Also records are not maintained properly.</li> </ol>	23.11.2021		Pending
i	Pump No.1( pump capacity =900 m3/hr)	Pump found operational

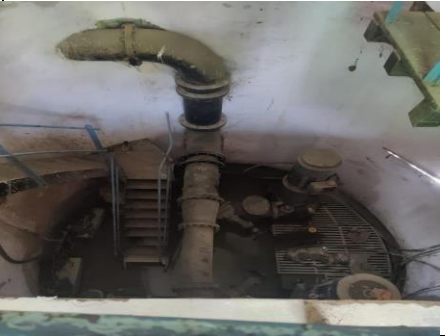
New pump has been installed at 15.03.2022. But installation of new valves, pipeline and fittings are still pending.	23.11.2021		Pending

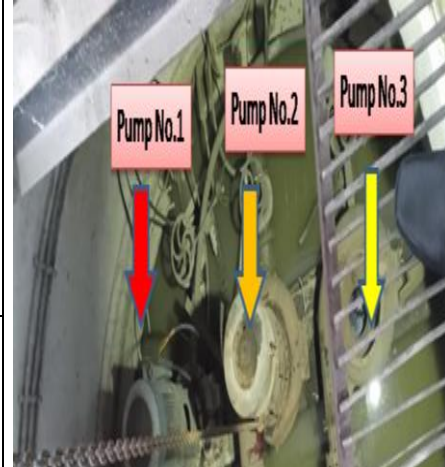
<ol style="list-style-type: none"> <li>1. Starter no-3 was found to be non-functional.</li> <li>2. Cable dressing was not done properly.</li> <li>3. Motor termination cover box was not fixed and cable gland was not fixed.</li> <li>4. No labour was engaged by KRMP for renovation work.</li> <li>5. Cracks needs to be repaired, also damaged door, window, louvers and ventilators needs to be replaced.</li> <li>6. Dewatering pumps need to be replaced.</li> <li>7. Operators are non technical person. They do not have clear understanding of the Pump Capacity , Flow of Discharge, and Peak Flow at the site. Also records are not maintained properly.</li> <li>8. Pipeline and all type valves need to be replaced.</li> </ol>	15.12.2021		Pending

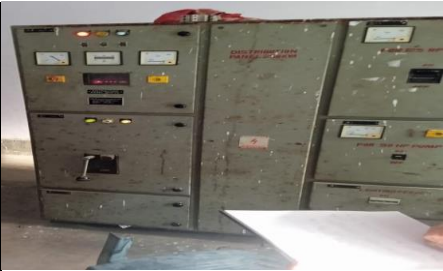
9	Panel Room	Civil Structure is in unsatisfactory condition

<ol style="list-style-type: none"> <li>1. Inside and outside painting work is completed by KRMPL under renovation.</li> <li>2. Damaged Door,window,louvers and ventilators needs to be replaced.</li> <li>2. Panel Volt meters and Ammeters needed to be replaced.</li> <li>3.All Phase Indicator needed to be replaced.</li> </ol>	23.11.2021		Pending
10	Logbook	Log book of pump house 01 and pump house no. 02 has not maintained by KRMPL properly

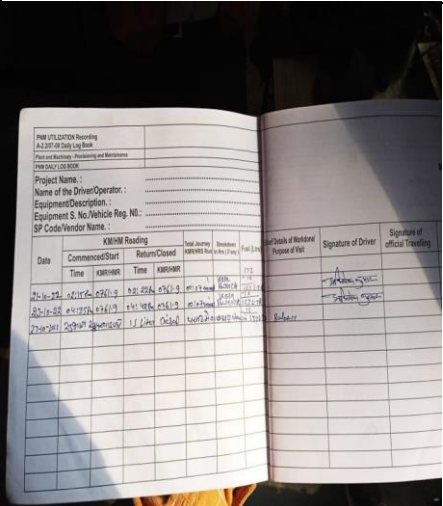
<ol style="list-style-type: none"> <li>1. Logbooks for pumps and DG sets are not properly maintained by KRMPL.</li> <li>2. KRMPL has not arranged adequate number of staff (Operators, Sweepers and relievers) for proper O&amp;M of IPS and attendance register contains manipulated staff details. Operators are non technical person. They do not have clear understanding of the Pump Capacity , Flow of Discharge, and Peak Flow at the site. Also the records are not maintained properly.</li> <li>3. Security guard needs to be deployed at the site.</li> <li>4. No labour available from KRMPL for renovation work.</li> </ol>	23.07.2021		Pending

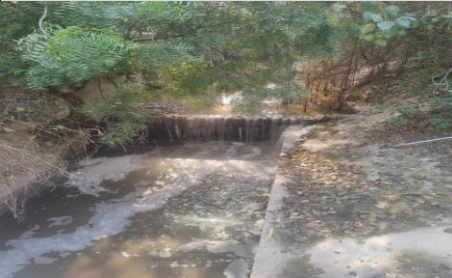
1. During the inspection, No Overflow or Bypass of sewage was observed. 2. Raw sewage by-pass sluice gate need to be replaced. Design, drawing need to be submitted by KRMPL.	4.01.2022		Pending
2	Inlet Chamber (Civil)	Civil Structure is in satisfactory condition

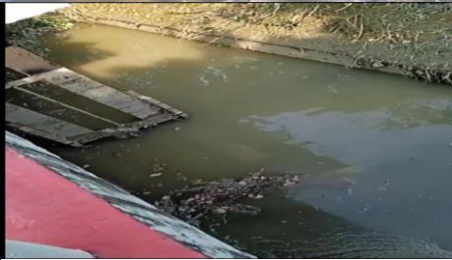
1. All gates needs to be lubricated. 2. Sludge should be removed regularly from inlet parts of IPS. 3. Regular cleaning of the chamber should be done.	23.11.2021		Pending
2A	Inlet Flow Meter	Inlet Flow meter is not available.		Inlet Flow meter is not available.	23.11.2021		Pending
3	Screen Chamber	Civil Structure is in satisfactory condition

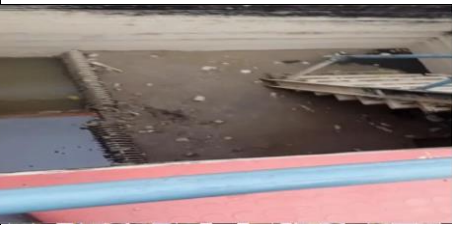
1. No sweeper was present in the screen chamber. 2. Garbage removal work and cleaning of the screen should be done on regular basis. 3. Trolly should be made available at the site for proper disposal of garbages. 4. Durind the inspection it was observed that screen was completly submerged at the site.	23.11.2021		Pending

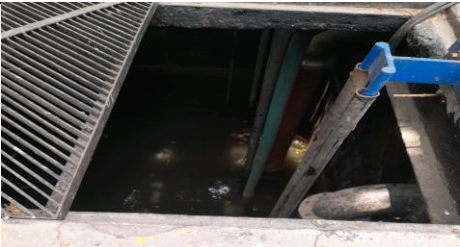
4	Receiving chamber	Civil Structure is unsatisfactory condition.

<ol style="list-style-type: none"> <li>1. Chamber should be cleaned and covered properly.</li> <li>2. All valves should be replaced.</li> <li>3. All stud bolts and gaskets should be replaced.</li> <li>4. Lubrication for valves and pumps ,sluice gates should be done by KRMPL.</li> <li>5. Pressure guage should be provided by KRMPL.</li> </ol>	15.12.2021		Pending
5	Pump House	Civil Structure is in good condition.	 	<ol style="list-style-type: none"> <li>1. Exposure of steel in staircase bottom slab needs to be renovated.</li> <li>2. Inside the pump house, it was observed that light was not working.</li> <li>3. EOT load test required by KRMPL.</li> <li>4. Flow meter need to be installed by KRMPL.</li> <li>5. Log book was not properly maintained by KRMPL staff at site.</li> <li>6. Staircase is in bad condition and needs to be renovated.</li> <li>7. Cable dressing needs to be done properly.</li> <li>8. Operators are non technical person. They do not have clear understanding of the Pump Capacity , Flow of Discharge, and Peak Flow. Also staff does not maintain the records properly.</li> <li>9. Utility water pump is not working since handover.</li> </ol>	23.11.2021		Pending

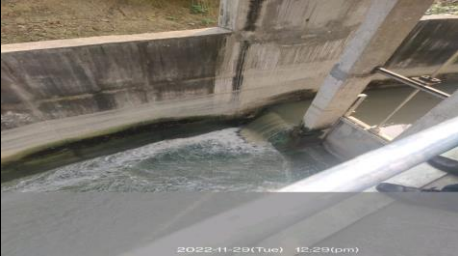
Although income tax gate was closed still, it was found that there was Overflow/Bypass of sewage due to power shutdown on 29.11.2022.	02.03.2022		Pending
2	Inlet Chamber	Civil Work is in satisfactory Condition			15.12.2021		pending
3	Manual bar Screen Chamber	Civil Work is in satisfactory Condition

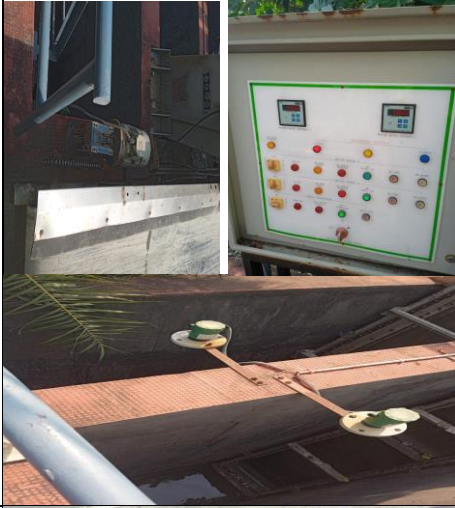
4	<b>Mechanical bar screen Chamber</b>	Civil Work is in satisfactory Condition

<ol style="list-style-type: none"> <li>1. Mechanical Screen No. 1 is damaged since 27.11.2022.</li> <li>2. Conveyor motor should be provided with canopy.</li> <li>3. Both mechanical screen and conveyor belt found non-operational at the time of inspection. It was started when asked by STC representative.</li> <li>4. Mechanical screen no. 1 was not working in auto mode.</li> <li>5. Auto System and level sensor meter were not in working condition.</li> <li>6. Screen panel On/Off main power selector switch was nonoperstional in auto mode.</li> <li>7. Screen No. 2 is in working condition.</li> <li>8. Conveyor belt is in working condition.</li> <li>9. Garbage needed to be removed on regular basis.</li> <li>10. Garbage trolley should be made available at site.</li> <li>11. Both Screen canopy power were not in working condition.</li> <li>12. Conveyor belt was not working in auto mode.</li> <li>13. Cable dressing was not properly done.</li> <li>14. Panel door system not working.</li> <li>15. Earthing was not done properly.</li> </ol>	15.12.2021		pending

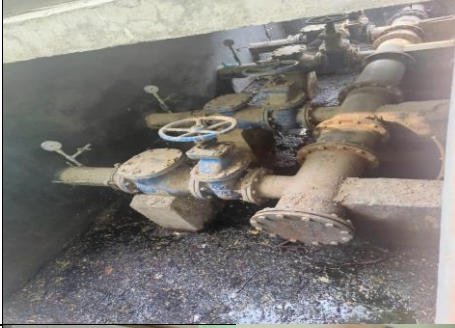
5	<b>Pump House</b>	Civil Work is in satisfactory Condition

<ol style="list-style-type: none"> <li>1. Pump No-4 was not in working condition.</li> <li>2. Starter for Pump No. 2 was not working and it is being operated with stater of Pump No. 4.</li> <li>3. Screen area light no-2 was not in working condition.</li> <li>4. Operators are non technical person. They do not have clear understanding of the Pump Capacity , Flow of Discharge, Peak Flow at the site. Also records are not properly maintained.</li> <li>5. Flow meter was not in working condition.</li> <li>6. 7 out of 9 lights were working.</li> </ol>	23.11.2021		pending
6	<b>Panel room</b>	Civil Work is in satisfactory Condition

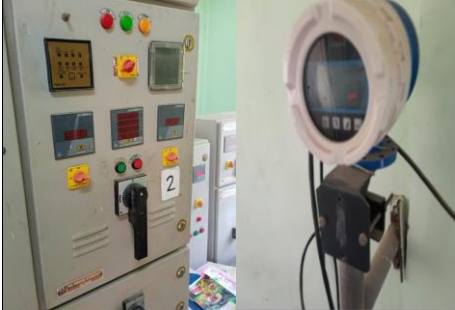
<ol style="list-style-type: none"> <li>1. Pump flow meter is not in woking condition since handover.</li> <li>2. Panel for Pump No. 2 is not working.</li> <li>3. Soft starter for 18.5 kW pump no- 2, 3, 4 were not in working condition.</li> <li>4.Exhaust no-9 and Tubelight no-2 were not in working condition.</li> </ol>	23.11.2021		pending

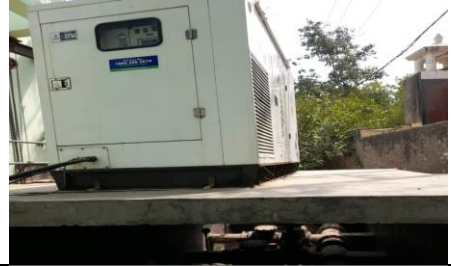
<ol style="list-style-type: none"> <li>1. DG set (125kV) was found to be in the working condition, but DG is getting heated during its operation and therefore was being operated in short intervals.</li> <li>2. Log book of DG set is not maintain by KRMPL properly.</li> <li>3. Smog exhaust pipe length is not sufficient as per CPCB/CPHEEO guidelines. It must be replaced on urgent basis.</li> <li>4. Meter for diesel in the DG SET was not working.</li> <li>5. Diesel stock was observed to be very less.</li> </ol>	23.11.2021		pending
9	<b>Transformer yard</b>	Civil Work is in satisfactory Condition

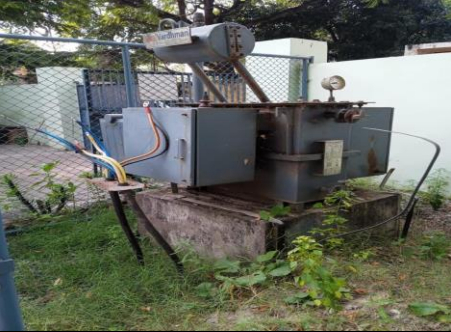
<ol style="list-style-type: none"> <li>1. Transformer no-2 (ACB 400 A) was not in working condition.</li> <li>2. Cable termination work, earthing work, testing and commissioning are pending.</li> </ol>	13.12.2021		pending

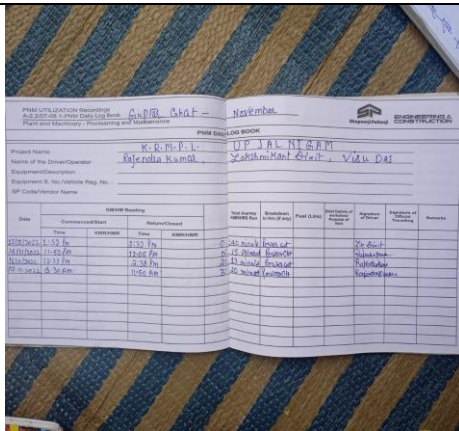
11	Logbook/Records/Documentation	Logbooks are not maintain properly by KRMPL

<div>1. Log book of pumps and DG set are being maintained by KRMPL.</div> <div>2. No entry in the DG log book was observed since 17.11.2022.</div> <div>3. During the inspection only sweeper was answering the questions and showing the progress of the site. Therefore KRMPL must arrange adequate number of staff (Operators, Sweepers and relievers) for proper O&amp;M of IPS. Operators are non technical person. They do not have clear understanding of the Pump Capacity , Flow of Discharge, Peak Flow. The records are also not maintained properly.</div> <div>4. During the inspection it was observed that readings filled in the logbook was found to be manipulated. Due to this, it is difficult to determine the actual hours of operation for pumps. Therefore, hour meter should be installed.</div> <div>5. No labour available by KRMPL for renovation work.</div> <div>6. Safety shoes and jackets for the staff was not available at the site.</div> <div>7. Cleaning material for housekeeping was not available at site.</div>	23.07.2021	Pending
