STC		SITE INSPECTION OF JAMMU ASSOCIATED IPS REPORT				Form No. STC - 001	Date: 26.11.2023	DIRECTOR OF IP STC 1. Mr. Ajay Kumar Goyal (Support Engineer Mechanical) 2. Mr. Ashish (Support Engineer Electrical) 3. Mr. Dhruv Mittal (Support Site Supervisor) 4. Mr. Anant Kumar Singh (Support Site Supervisor)

05.12.2021		Pending
SITE INSPECTION OF JAAMU ASSOCIATED IPS REPORT							05.12.2022	1. Mr. Naga Kumar Goud (Support Engineer-Mechanics) 2. Mr. Naga Support Engineer (Electrical) 3. Mr. Deepa Mittal (Support Site Supervisor) 4. Mr. Anuraag Singh (Support Site Supervisor)
					Shobana IPS- NAG

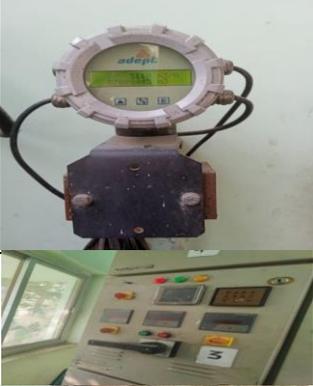
<ul style="list-style-type: none"> 1. Pump No. 4 is present at the site but not installed since 1.1.2021. 2. Pump No. 5 is not working due to not functional starter. 3. All 4 Pumps are working condition. 4. 7 No. Sublight is not working in the left panel room. 5. Collaboration request of the water need to be submitted by AMPL. 6. Log book need to be maintained. 7. Control room need to be installed. 8. Switch board need to be repair. 9. Emergency fire without bucket need to fill by sand. 	15.12.2021		Pending
