INSPECTION REPORT OF 30 MLD STP& IPS FACILITIES AT PANKHA

An Inspection of 30 MLD Pankha STP construction site and associated IPS facilities was jointly conducted by PE and UPJN officials in the presence of KRMPL Representatives, and our findings are noted below.

Dates of Inspection	03/11/2022 & 07/11/2022
Inspection Team	Mr. R. K. Sharma, CE, UPJN, Kanpur Mr. Gyanendra Choudhary, PM-1, UPJN, Kanpur Mr. Rohit Yadav, J.E. Civil, UPJN, Kanpur Dr. Giridhar Prabhukumar, Team Leader, STC Kanpur Mr. Satish Kamaraju, Sr. Process Engineer & Expert, STC Kanpur Mr. Sunil Bastukar, Sr. Mechanical Engineer & Expert, STC Kanpur Mr. Anil Kumar Seth, Sr. Electrical Engineer & Expert, STC Kanpur Mr. Ajay Kumar Goyal, Support Engineer-Mechanical, STC Kanpur Mr. Priyesh Shukla, Supprot Engineer-Civil, STC Kanpur
KRMPL Personnel	Mr. Shawaz, Mechanical Engineer, KRMPL, Kanpur Mr. Raman Kundu, KRMPL, Kanpur Mr. Soumitra Sen, KRMPL Kanpur Mr. Ansari, KRMPL Kanpur
Location	Pankha, ICI Nallah & Sundar Nagar, Kanpur

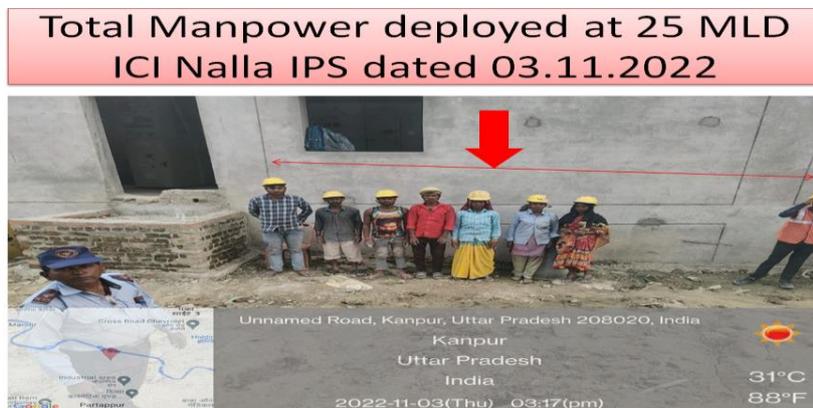
5. Manpower Deployed at the site was found to be low. PE & UPJN Team inspected the site on 03.11.2022, and during site inspection it was observed that only 37 nos. manpower (Civil, E&M) were deployed at the site. It seems that with the present manpower deployed at the site the Concessionaire would not be able to complete the work and meet the target dates noted above. Therefore, it was recommended to increase the manpower for completing the work with all respects and also as per above mentioned schedule.

Total Manpower deployed on 03.11.2022 at 30 MLD STP Pankha	
Civil Manpower	10 nos.
Mechanical manpower	7 nos.
Total Manpower deployed on 03.11.2022 at 25 MLD ICI Nalla IPS	
Civil Manpower	8 nos.
Mechanical manpower	0 nos.
Electrical manpower	0 nos.
Total Manpower deployed on 03.11.2022 at 20 MLD Sundar Nagar IPS	
Civil Manpower	10 nos.
Mechanical manpower	0 nos.
Electrical manpower	0 nos.

Fig 1: Total manpower deployed at ICI Nalla on 03.11.2022

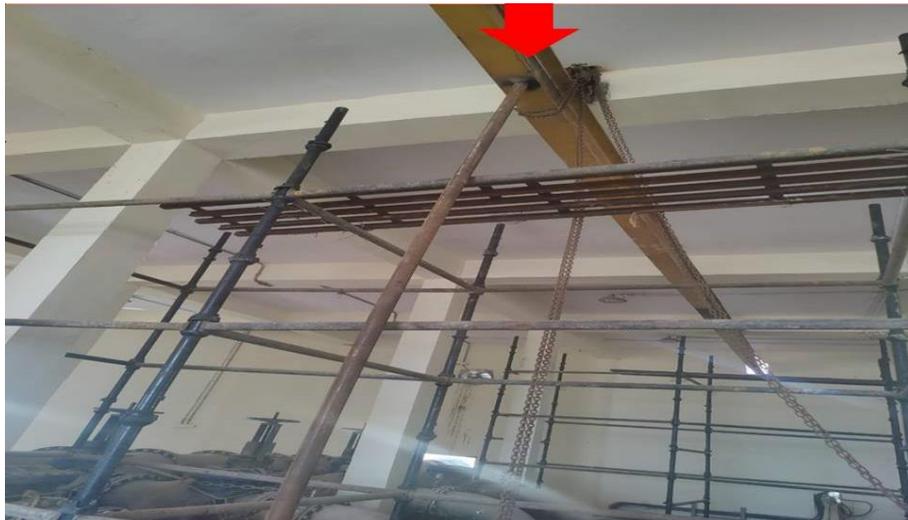
3. Monorail installation work was under progress (Fig 2). Also, its painting work was found pending.
4. Electrical hoist installation is incomplete. It is to be noted, that “shrouded bus bar” has not been installed till date. Both stiffeners should be installed as per approved drawing (Fig 3). Also, trial run of the hoist is required for the electrical hoist as per approved QAP and acceptance certificate of the installation is required from the OEM.

Fig 2: Monorail Installation

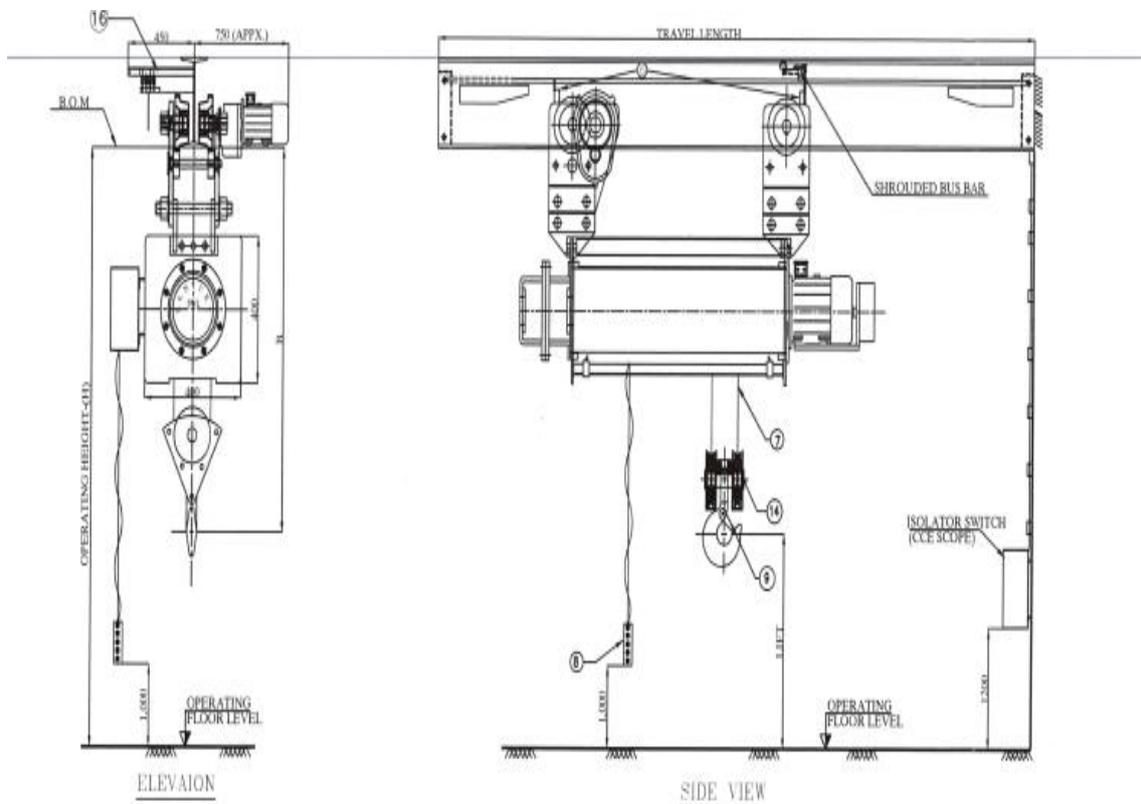
Fig 3: Approved drawing for Electrical hoist

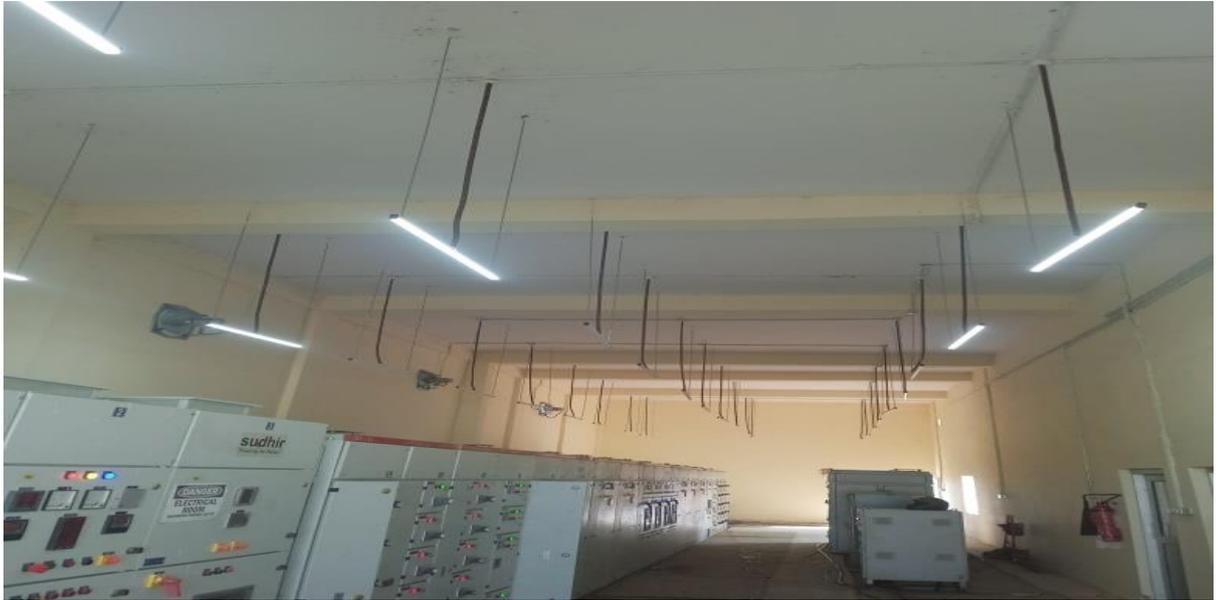
- xii. Final flooring works needs to be done.
- xiii. Panel Room Lighting to be rectified – Lights not working and misaligned (Fig 4).

Fig 4: Panel Room Lighting

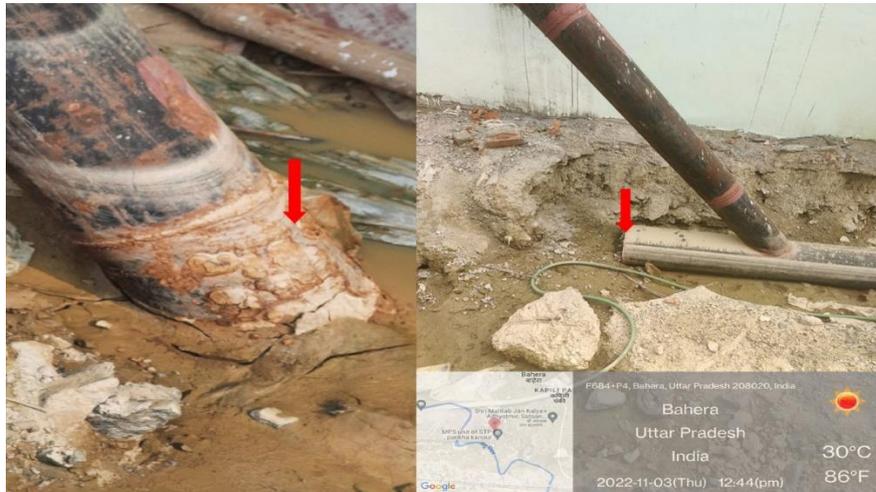
- i. Heavy corrosion (Fig 5) was observed, which has to be sandblasted /surface treatment/repair damaged pipe sections and wrapping coating of underground pipes is still pending and KRMPPL needs to complete as per IS code: 10221 (2008) and as per CA schedule 11. This has been informed many times but still KRMPPL has not taken any action in this regard.
- ii. Temporary endplate needs to be replaced with IS standard Blind Flange. This does not conform with the approved GA drawings of Piping for blower room.

Fig 5: Heavy corrosion in the blower discharge line

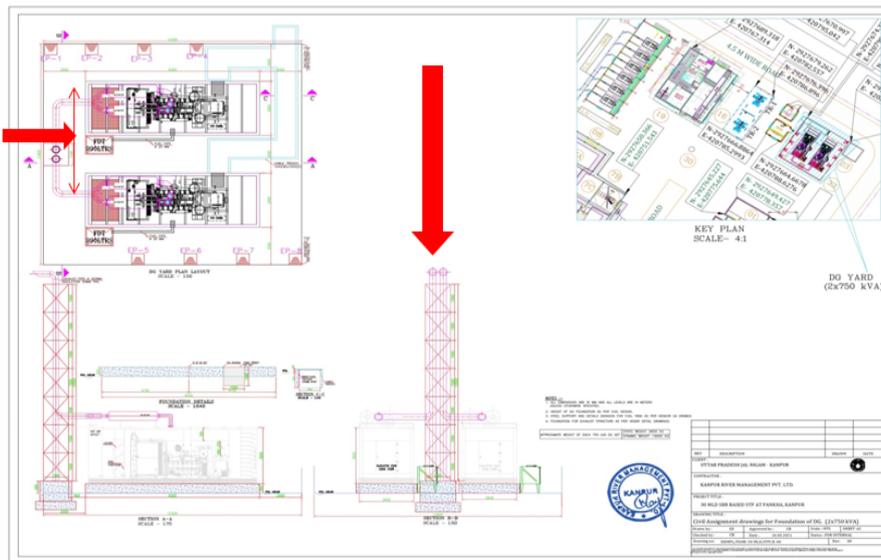
- i. DG isolation panel 1 no. commissioning done
- ii. 2nd DG and isolation panel need to be commissioned.
- iii. Civil foundation & Exhaust chimney installation works are pending for over 1 year. KRMPL has not started the work till date.

Exhaust Chimney & Foundation works Pending at 30 MLD Pankha

Fig 6: Approved drawing for exhaust chimney & Foundation work for DG set

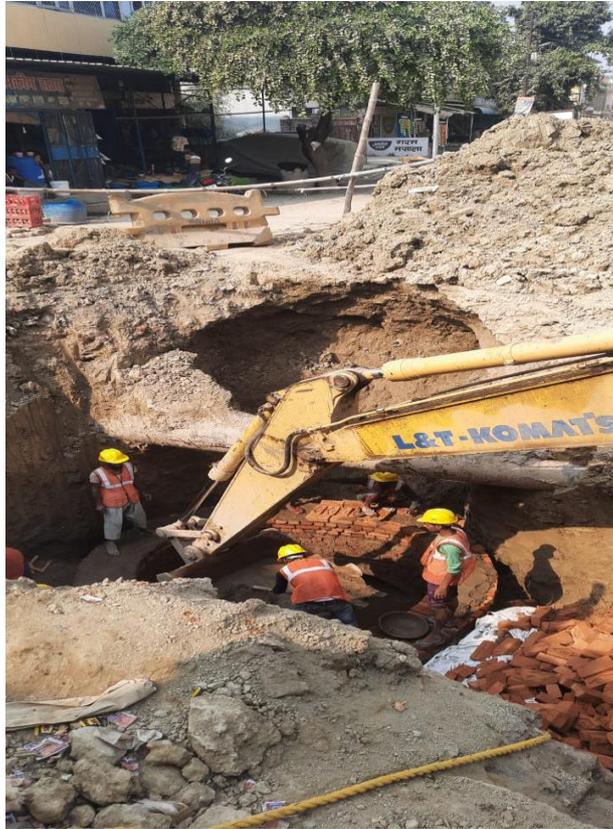
- i. During the joint inspection with CE, KRMPPL was asked to STOP WORK. Proper shoring, barricading was not provided. Excess excavated material was creating safety issues and hinderance to general public were asked to be removed from site before restarting any work at this location (Fig 7).

Fig 7: Manhole construction without safety arrangements (barricading, shoring, etc.) near 4 ATM Tiraha, Gangaganj, Pankhi, Kanpur

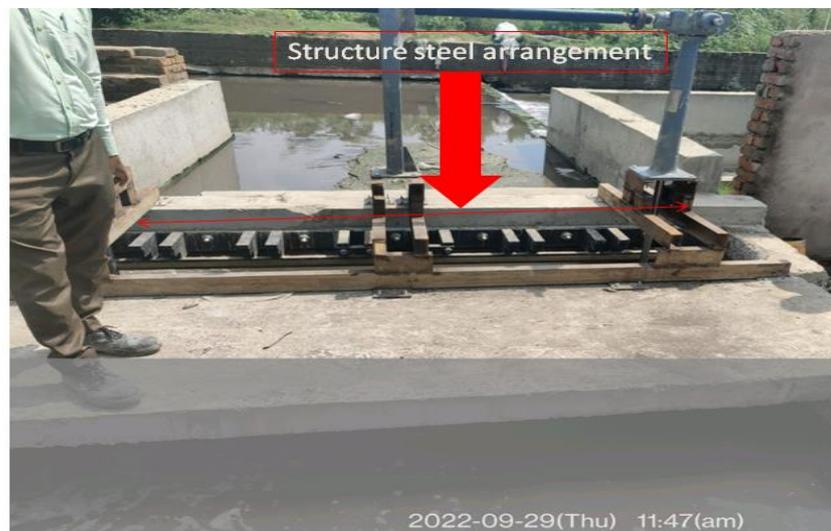
- i. Inlet Weir Sluice Gate (Size 3000mm x 500mm):
 - a. It has not been installed as per approved drawing. It is to be noted that, KRMPL used the structure steel arrangement (Fig: 8) for supporting the connecting pipe support bracket & Pillar of the Sluice Gate. As per approved drawing (Fig 9) RCC structure should be used instead of structure steel arrangement. This indicates the technical negligence from KRMPL's end.
 - b. sluice gate installation & commissioning was not performed in the presence of OEM personnel.
 - c. KRMPL was advised to get the Sluice Gate installation certified by OEM for acceptance.

Fig 8: Weir Sluice gate (Size 3000X500mm)

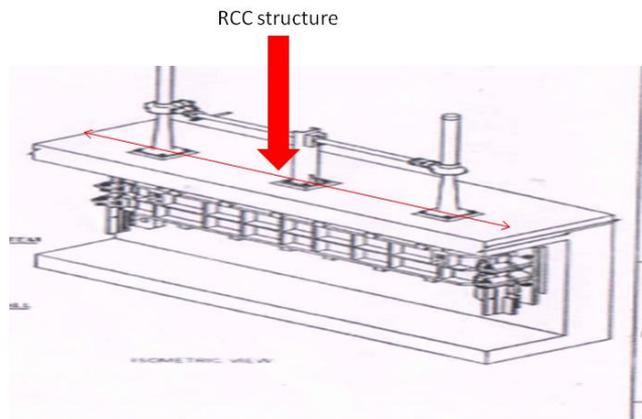
Fig 9: Approved Sluice Gate drawing

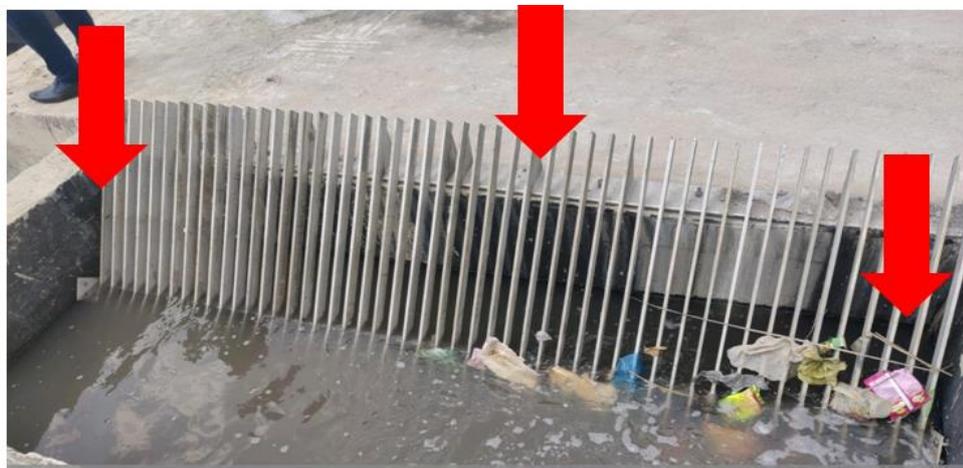
- ii. Manual screen has been installed by KRMPL without fixing anchor fasteners (Fig. 10) as per approved drawing. It should be fixed before taking the raw sewage.
- iii. KRMPL has not completed finishing work at all civil structures.
- iv. KRMPL has started Hydrotesting work of civil structures from 28.09.2022
- v. Approach road, leveling work and landscaping works are pending.

Fig 10: Manual screen

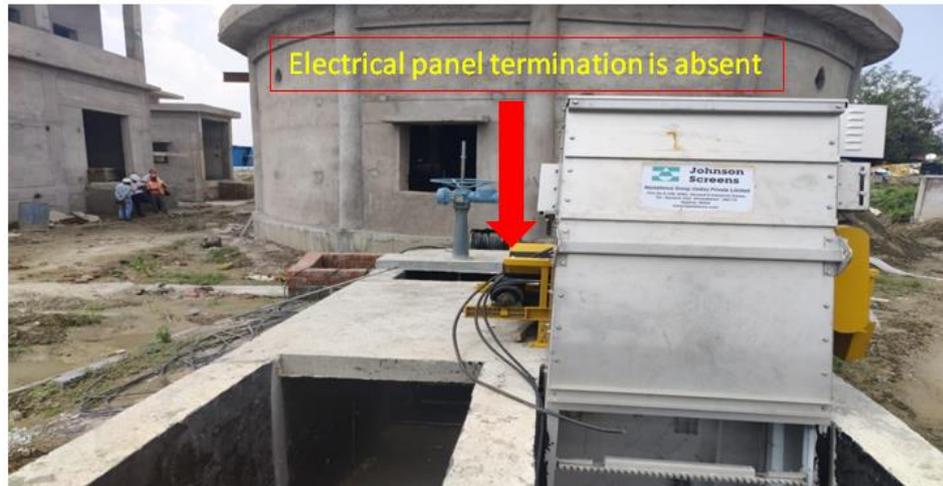
- i. Electrical panel termination for Mechanical coarse screen is pending (Fig 11).
- ii. Differential level meter has not been installed till date.
- iii. Also, Alignment of screen is still pending.

Fig 11: Mechanical screen

Hence, before commissioning the mechanical screen, above mentioned points should be rectified & commissioning should be done in the presence of OEM and certified by the same for acceptance.

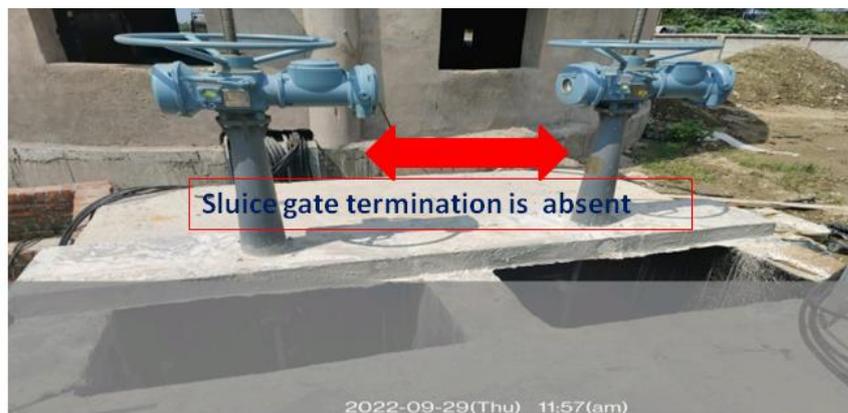
- iv. Termination of Sluice gate is pending and leakage testing has not been performed.
- v. KRMPL has not completed finishing work of the civil work.
- vi. KRMPL has started hydrotesting work of civil structures from 28.09.2022.
- vii. Approach road, leveling work and landscaping works are pending.

Fig 12: Sluice Gate

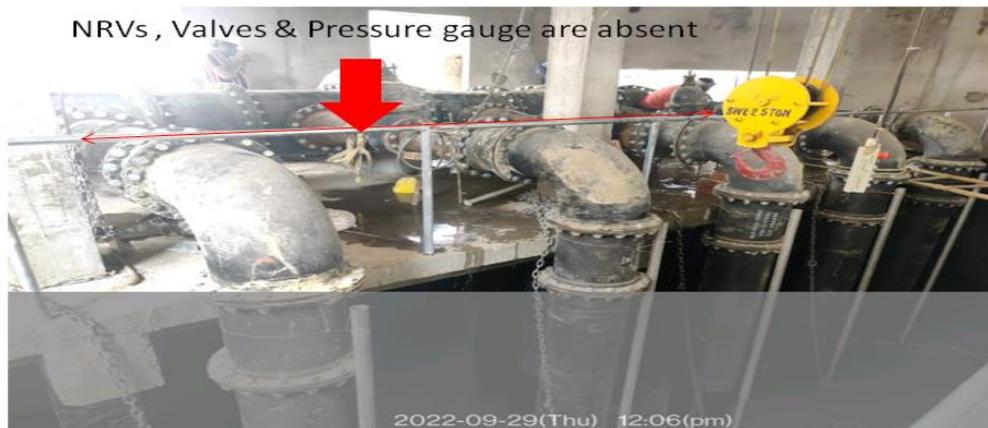
- i. KRMPL is yet to install the following as per approved drawing:
 - a. 5 Nos. Sluice gate valves,
 - b. 5 Nos. NRVs, pressure gauges,
 - c. pipe guide for pump & pipe support
- ii. Blind flange at the end of discharge pipeline was incorrectly installed. It needs to be removed and installed in opposite direction (Fig 13B).
- iii. Block concrete support to be installed in place of the temporary pipe support.
- iv. KRMPL has used unapproved arrangement with temporary spool, wrong size re-used valves (from Jajmau facilities)

Fig 13A: Pump house

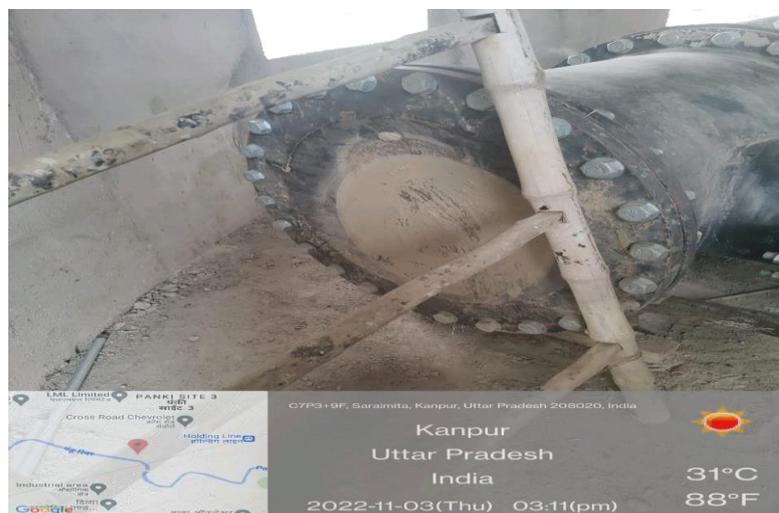
Fig 13B: Discharge pipeline Blind Flange Installed incorrectly at ICI pump house

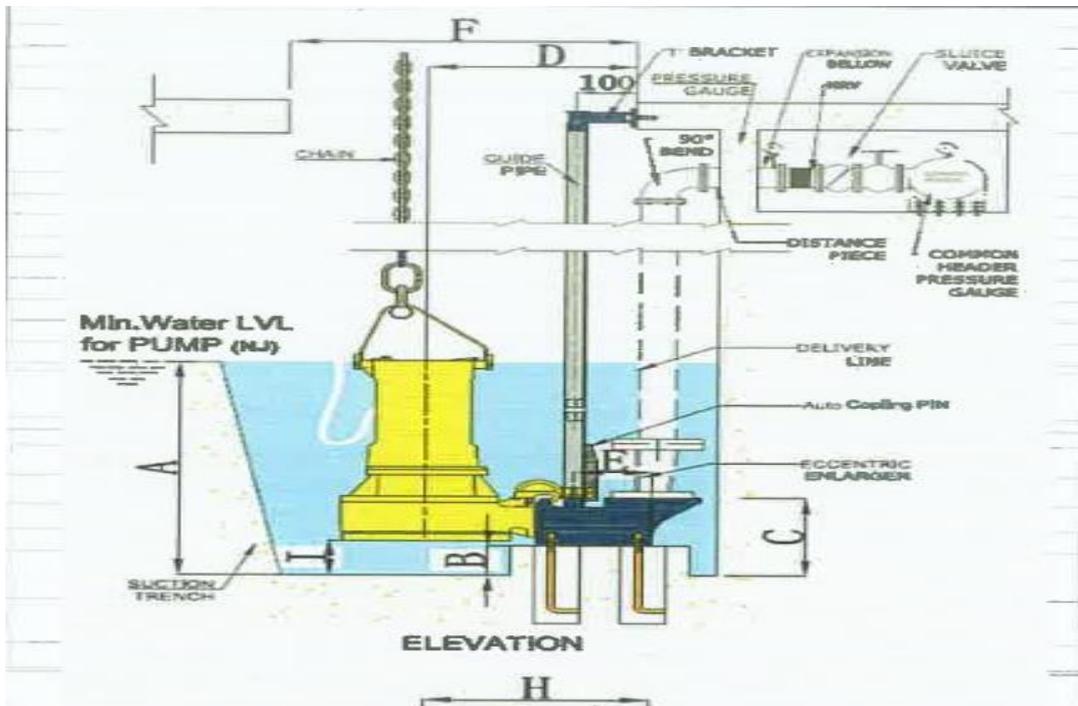
KRMPL has taken the sewage without installing the above-mentioned items (5. (i)). Fig. 14 shows all the pump's accessories needed as per approved technical drawing and the same is to be complied by KRMPL.

Fig 14: Approved pump drawing

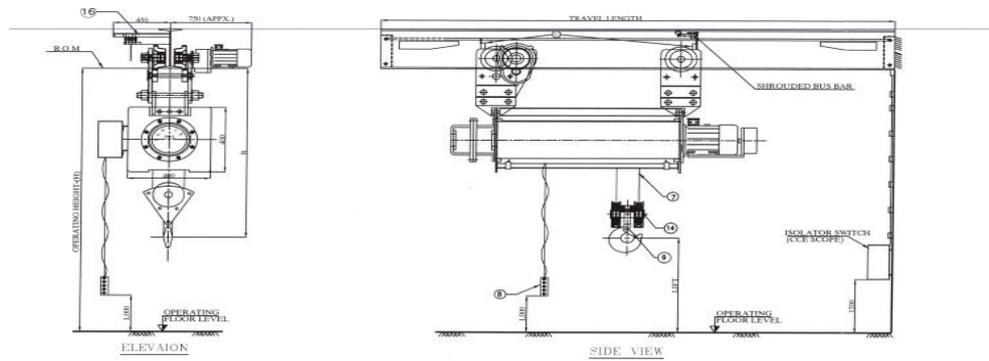
- vi. Electrical hoist installation is incomplete. It is to be noted, that “shrouded bus bar” has not been installed till date. Both stiffeners should be installed as per approved drawing (Fig 16). Also, trial run of the hoist is required for the electrical hoist as per approved QAP (Fig 17)

Fig 16: Approved drawing for Electrical hoist

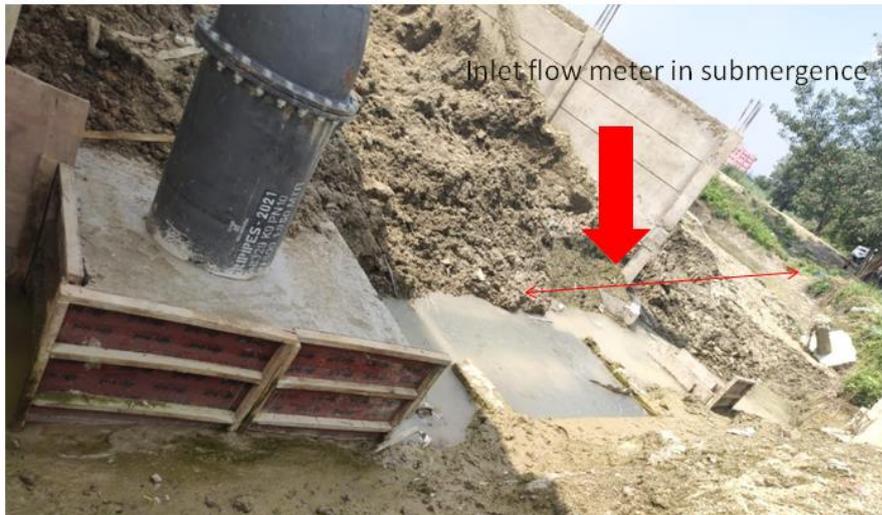
- i. Inlet flowmeter was found to be in submerged condition, this is not acceptable (Fig 18a & 18b).
- ii. Inlet Flowmeter should also be tested, calibrated and certified by the OEM.
- iii. The valve & inlet flowmeter chamber work was ongoing during our inspection and it was found that a brick chamber was being built instead of RCC, considering the high water table condition and below ground structure. **Based on the site conditions, CE, UPJN directed Mr. Manobendra, PM, KRMP to STOP the brick chamber work, remove it and replace with RCC structure immediately.** Flowmeter chamber as shown in Fig 19 shall be casted on urgent basis.

Fig 18a: Inlet Flowmeter – Submerged condition on 03.11.2022

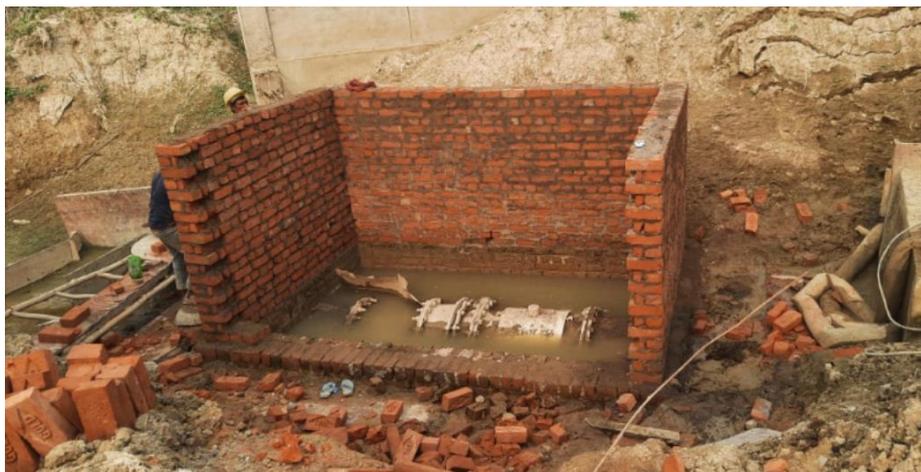
Fig 18b: Inlet Flowmeter – Submerged condition on 07.11.2022 and within unapproved brick chamber under construction

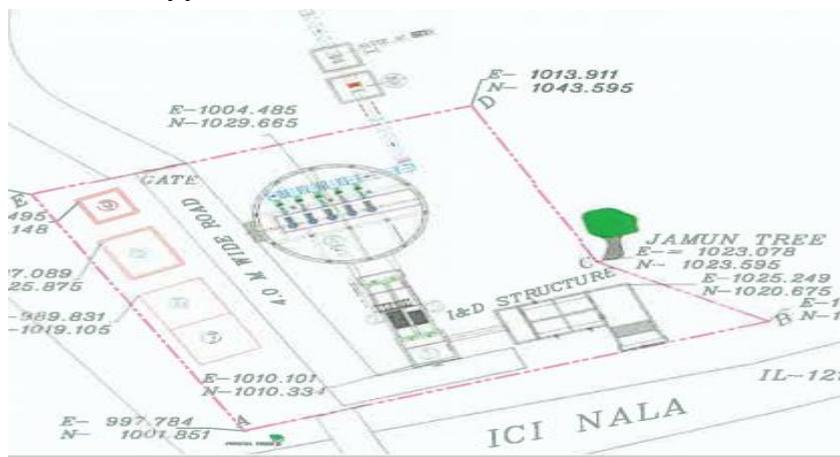
Fig 19: Approved drawing for chamber for inlet flow meter

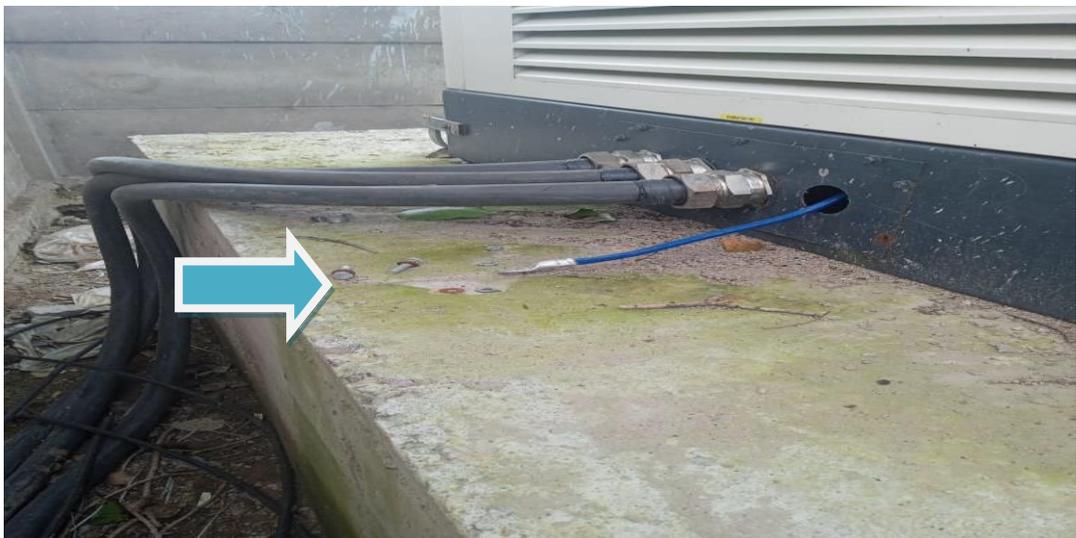
- i. Commissioning work for DG set is complete.
- ii. Cable dressing is not done properly.
- iii. DG set earthing not done properly & earthing pit work is pending

Fig 20: DG set earthing not done properly

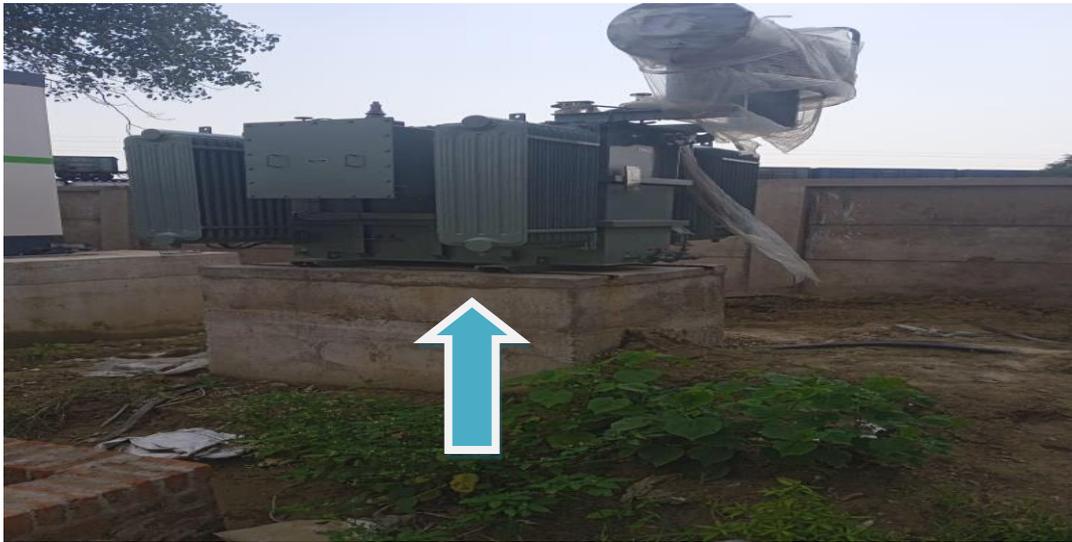
- i. Transformer placement on foundation is not proper.
- ii. Cable termination & cable laying, earthing works are pending.

Fig 21: Transformer placement on foundation is not proper

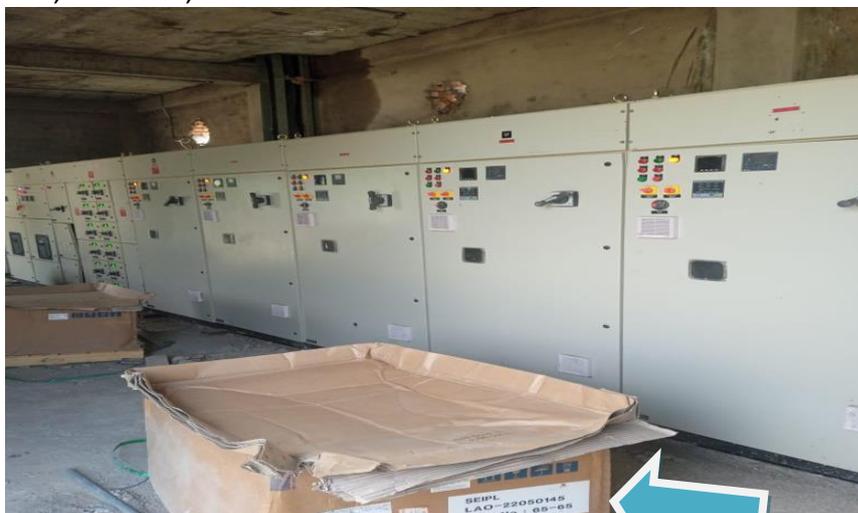
- i. HT VCB Panel installed & commissioning is pending.
- ii. LT Panel charged without VFD starters and control functioning not proper.
- iii. APFC installed & commissioning is pending.
- iv. Internal lighting to be started and outdoor light after leveling work is completed.
- v. Internal electrification & exhaust fan work in progress.
- vi. Plinth protection, surface roof treatment work and fixing of rainwater drainpipe is pending.
- vii. Indoor & Outdoor Painting work is pending
- viii. Handrails need to be fixed by KRMPL.
- ix. Staircase needs to be done by KRMPL.
- x. Doors, windows, ventilator needs to be done.

Fig 22: LT Panel charged without VFD starters and control functioning not proper

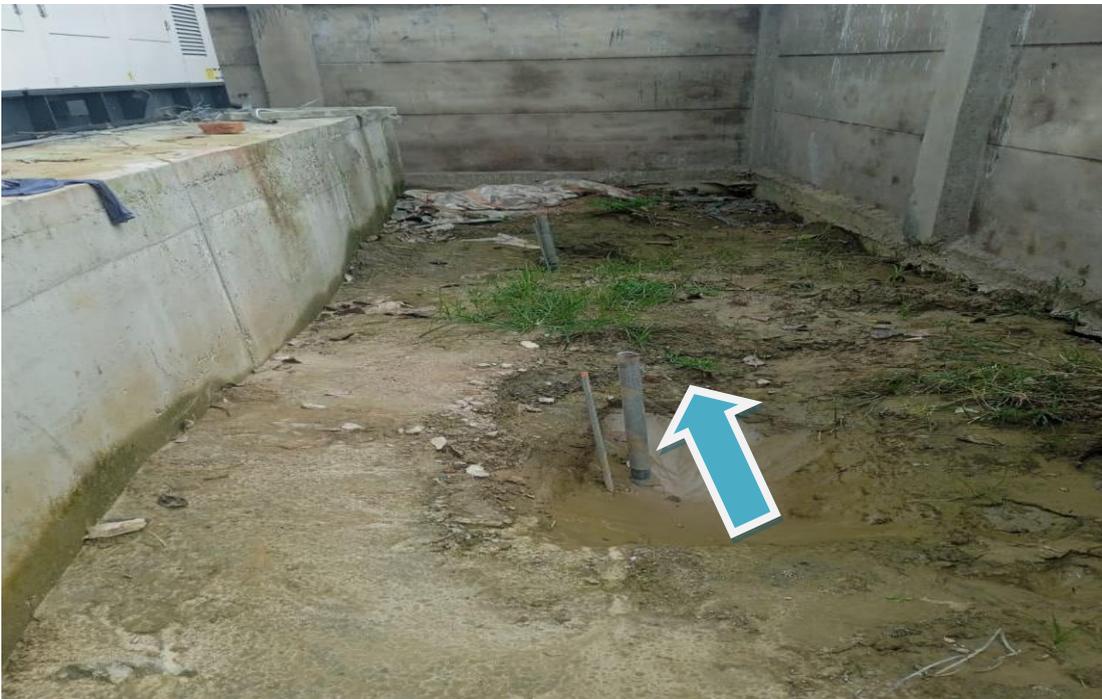
- i. 4 nos. Out OF 6 Nos. grid pipes earthing is done.
- ii. Earthing pit work is pending.

Fig 23: Earthing pit work is pending

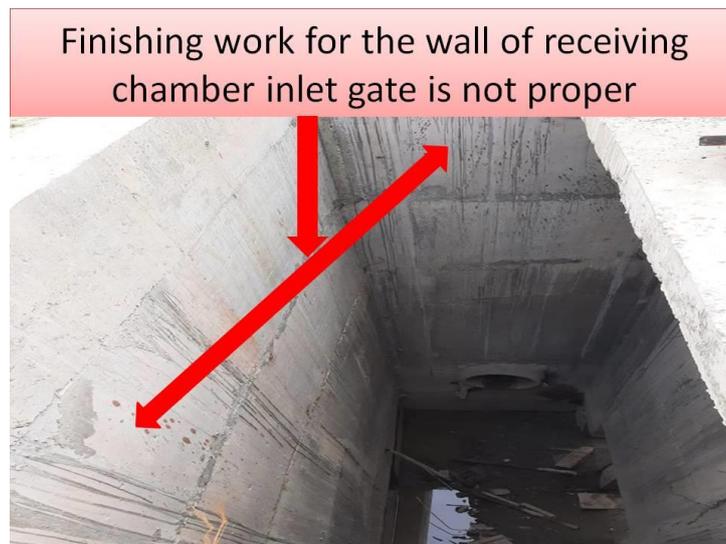
- ii. Walls of receiving chamber inlet gate are not straight and finishing were not proper due to improper shuttering during its concreting work (Fig 24). KRMPL was instructed to do the additional grinding to rectify the defects and coal tar painting in the interiors.

Fig 24: Receiving chamber

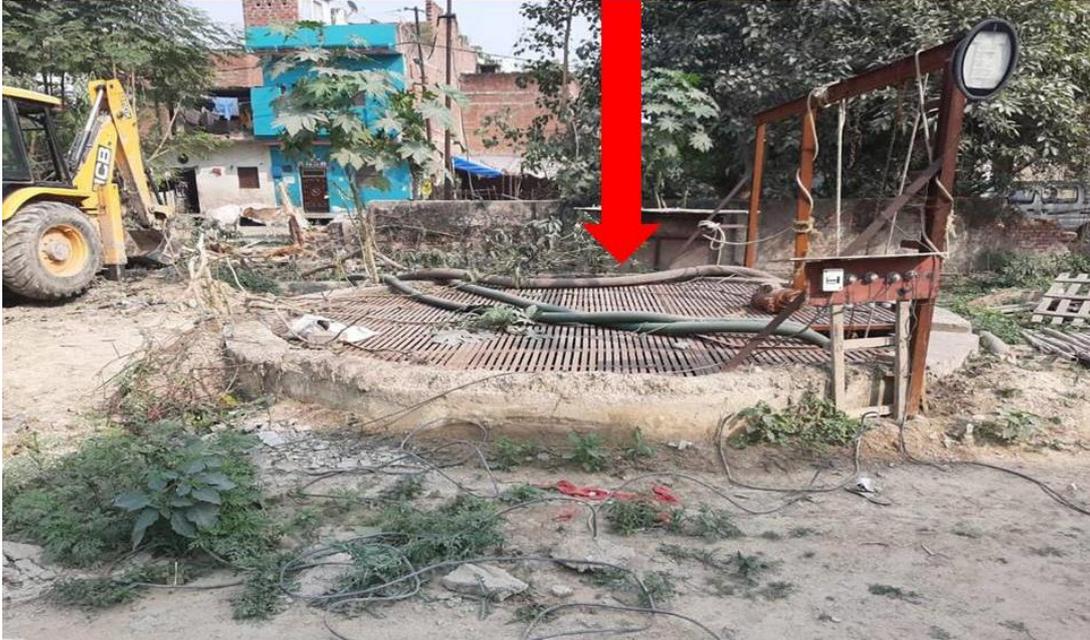
- iii. Existing sump well connection is not done to the new I&D structure. KRMPL was instructed to identify the sump well level as well as nalla invert level and complete the interconnection so that the flow could be diverted to the I&D for screening. CE, UPJN directed KRMPL to complete the work by 15.11.2022.

Existing wet well connection is not done

Fig 25: Existing wetwell at Sundar Nagar
