</div> <div> SITE INSPECTION REPORT </div>					Jajmau STP - 130 MLD		Date: 27.12.2022	INSPECTED BY: UPJIN Team 1. Mr. Rahul, Support Engineer(Ele.) 2. MR. Karm Veer Sing SiteSupervisore -Civil 3. Mrs. Divya Mittal, Site Supervisore - Electrical KRMPL Team 1. Mr Krishna (Plant Incharge) 2. Mr. Akashay Tripathi (Process Engineer)

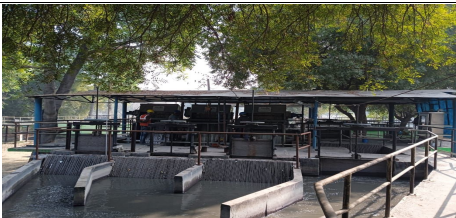
S. No.	Equipment	Assessment of Current Condition	Assessment of Current Condition Photo	Current defects and Corrective Action Suggested by STC, PE	Corrective Action Completed by KRMPL	Original Date of Issue	Proposed Date to Resolve by KRMPL	Current Status of Compliance
A	Collection Chamber			1. All gates to be repalced. 2. Repairing work of free board of this chamber found very poor this must be repaired. 3. Renovation to be completed without getting approval ,testing & commissioning 4. Toe guard to be Provide in hand-railing. 5. TWL marking could be done with paint.		27.11.2021		Pending
1	Inlet Chamber (Civil)	Operational / Needs to be renovated

1. Railing and its foundation needs to be repaired. 2. Reinforced exposed work found repaired. 3. Fininshing work of Inlet chamber chamber need to done properly 4. Toe guard to be Provide in hand-railing. 5. FRP coating need to provide in hand-railing.		27.11.2021		Pending

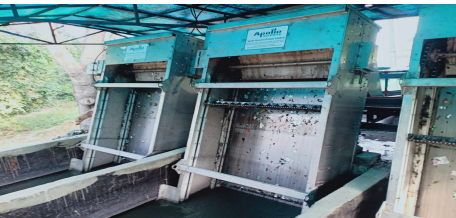
1. Renovation work found not properly. 2. Outer side RCC wall leakages must be grouting under Renovation work. 3. Garbages like Plastic bags, leather pieces, clothes must be removed from Belt conveyor of Screen Chamber regularly. 4. Need to be replaced the gates. 5. Proper Lighting need to be provided at Screen area. 6. Level scale should be properly clean and marking should be clearly visible. 7. MS Fabrication equipment & tools along with MS Shed also corroded & losses its strength. 8. In MS shed pipes are corroded & Colour of shed also worn out. 9. Mechanical Screen not working with auto system and without sensor .Need to be fixed the auto system immediately. 10. New Cables should be laid properly in cable trays 11. FRP coating pending in Hand-railing, screen channel area		27.11.2021		Pending

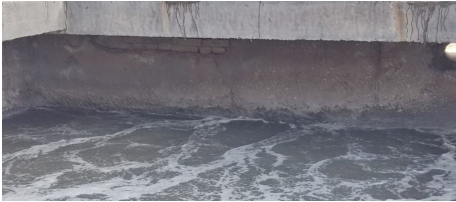
1.Only outer face of distribution chamber for Primary sedimentantion tank partially done by KRMPL. 2. Inside Rcc wall, base and platform required renovation work. 3. Reinforced exposed and need to be repaired 4. Sluice gate need to be replace		27.11.2021		Long Pending
19	Civil works

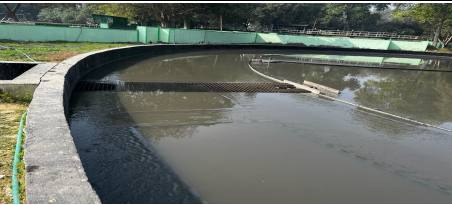
1. Scum Box design need to be changed. 2. Weir plate to be replaced at damaged portion. 3. PST mechanism to be replaced and install. 4. Remote system to be installed for PST-1. 5. Cable to be laid in cable tray. 6. Stair hand-railing need to be provide. 7. TWL marking could be done with paint. 8. Fencing to be provide on Truss platform. 9. LPBS need to be installed as per approved drawing. 10. Torque switches installation done without canopy at all equipment. 11. Hooter is fixed on railing with temporary cable tie, which is not proper and unacceptable. 12. Power supply is given to torque switch & associated equipment from temporally MCB. Permanent supply is to be provided. 13. Torque switch alarm not working properly.		01.03.2021		Long Pending

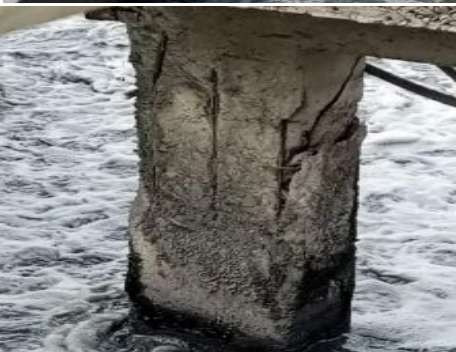
1.Civil structure found in poor condition and need to be rehabilitate. 2.Columns need to be reinforced. 3.Walkway to be strengthen and repaired. 4.New Hand railing need to be installed on walkway. 5.GAD of Hand railing and material certificate of hand railing needs to be furnished. 6.Base plate of Hand railing needs to be blasting and painting after approval from UPJN. Certify the tye of anchors and fasteining. (Nuts/bolts) 7. Jajmau existing Aeration Fountain Tank is very old. It's Concrete & Reinforcement badly deteriorated due to surrounding corrosive atmospheric condition. Concrete cover cracked & inside Steel exposed to corrosive atmosphere which is very dangerous. Most of Columns edges are eroded, damaged & Spalling of concrete appeared. To maintain proper Strength of Concrete & Steel 'Concrete Jacketing' method should be applied for its Strengthening.	Handrailing work in progress	27.11.2021		Long Pending

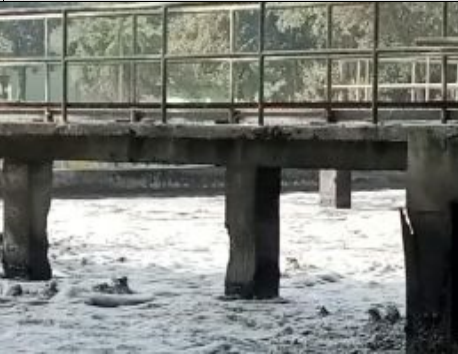
1.Civil structure found in poor condition and need to be rehabilitate. 2.Columns need to be reinforced. 3.Walkway to be strengthen and repaired. 4.New Hand railing need to be installed on walkway. 5.GAD of Hand railing and material certificate of hand railing needs to be furnished. 6.Base plate of Hand railing needs to be blasting and painting after approval from UPJN. 7.Certify the tye of anchors and fasteining. (Nuts/bolts). 8.Cable need to be laid in cable tray. 9.LPBS system to be install at site 10. Jajmau existing Aeration Fountain Tank is very old. It's Concrete & Reinforcement badly deteriorated due to surrounding corrosive atmospheric condition. Concrete cover cracked & inside Steel exposed to corrosive atmosphere which is very dangerous. Most of Columns edges are eroded, damaged & Spalling of concrete appeared. To maintain proper Strength of Concrete & Steel 'Concrete Jacketing' method should be applied for its Strengthening.		27.11.2021		Long Pending

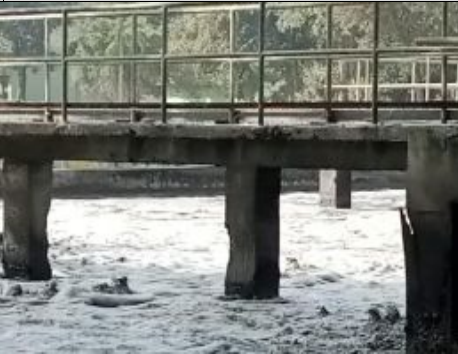
41	Aerator no. 13	Operated

1.Aerators need to be overhaul / replace. 2.Canopies to be installed on the top of motors. 3.Cable need to be laid in cable tray. 4.LPBS system to be install at site		27.11.2021		Long Pending
42	Aerator no. 14								
43	Aerator no. 15								
44	Aerator no. 16								
45	Aerator no. 17								
46	Aerator no. 18								
I	Distribution Chamber -3								
47	Civil works	To be renovated

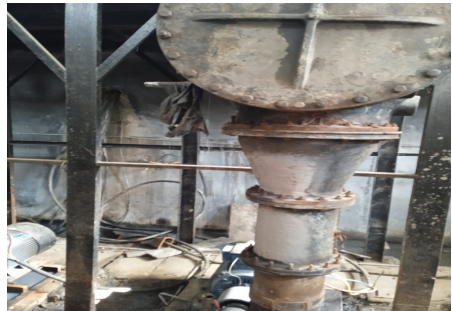
1.All pumps needs to be repaired and get operational. 2. Civil Drawing of pump foundation not submitted by KRMPL for Renovation work. 3.Out of 11 pumps only 4 Nos.pump has been working at site and 4,5,6,7,8,Nos. Pump are not in working condition.. 4.Lighting arrangement and Cable to be laid in cable tray. 5.Thermometer and vibration meter should be at site. 6.Railing to be repaired till the renovation period. 7.Motor cover to be arranged. 8.Pressure guage are found in damaged condition and need to be replaced. 9.Concessionaire should maintain log book of the pumps for proper record maintenance. 10.Leakage has been detected 2 number pump which are in operation, and directed to repair the same immediately. 11.LBPS system to be install at site 12.Cable treay need to be painted immediatly		27.11.2021		Long Pending

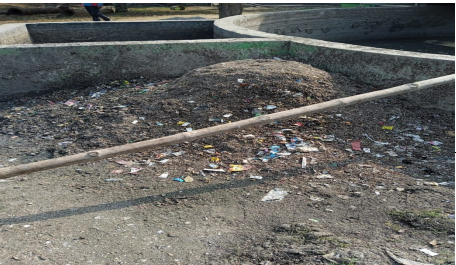
1. Strucutre should be strength and visibide bars to be covered with concrete. 2. Cleaning work need to be done. 3. Interconnection of sludge pipe line for Inlet and Outlet cleaing is pending. 4. Cracks should be treated by Pressure grouting.		27.11.2021		Long Pending
	Blending Tank	Operational		1.For binding tank KRMPL submitted the design for proposed 1 no. agitator. 2.CCTV camra need to be repaire or replace. 3.LPBS system to be install at site		01.03.2021		Long Pending
72	Gravity Sludge Thickeners							
73	Gravity Sludge Thickener no. 1	functional

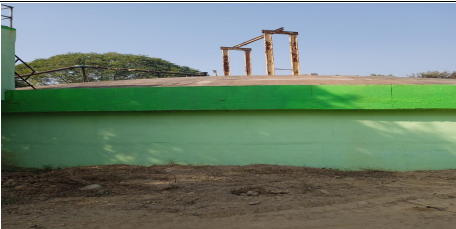
1. Removal of centrally located sludge mixing shaft from Primary Digester 1. 2. Gate to be overhaul 3. Civil Structure of the Digester to be renovate and cracks to be treated. 4. Leakage to be Arrested in the Digester. 5. Installation of the Railing at the boundary of the dome. 6. Finishing work to be done.		27.11.2021		Long Pending

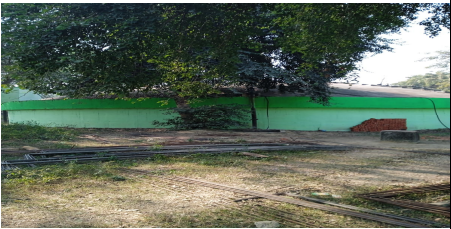
1. Cleaning work of Primary digester done partially. 2. Gate to be overhaul 3. Civil Structure of the Digester to be renovate and cracks to be treated. 4. Leakage to be Arrested in the Digester. 5. Installation of the Railing at the boundary of the dome. 6. Finishing work to be done. 7. Sludge Digester no.2 is under cleaning but no any safety precaution during cleaning. 8. Safety officer not available at site.		27.11.2021		Long Pending
Q	Secondary Sludge Digester							
82	Secondary Sludge Digester	Not operational		1. Strucutre fond in worse condtion and need to be renovate. 2. Gate to be overhaul 3. Civil Structure of the Digester to be renovate and cracks to be treated. 4. Leakage to be Arrested in the Digester. 5. Installation of the Railing at the boundary of the dome. 6. Finishing work to be done.		01.03.2021		Long Pending

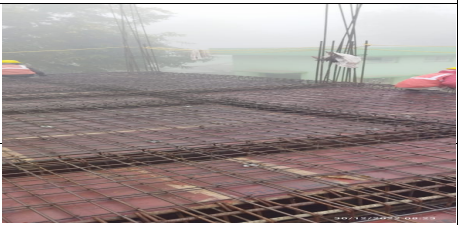
88	Centrifuge Building (Civil Works)	Operational

1. reinforcement of Ground floor roof slab in progress for 4 no of belt filter press 2. Railing and steel ladder to be repaired or replaced as per site condition. 3. Housekeeping to be done. 4. Sign boards are required. 5. No approach road found at site to get on thsi unit/component. 6. Proper lighting arrangement to be required at site. 7.As per CA centrifuge to be repalced. 8. All centrate pump 4 no. to be replace. 9. plinth level, improper Column bar lapping found in Belt filter building. Column Starters steel shifted in one side & Cover for column is not same out at periphery.		01.03.2021		
89	Centrifuge Pump no.1	All centrifuge were in dilapidated condition and dismantling work is completed

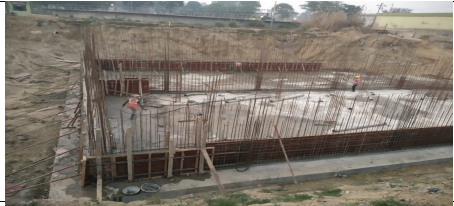
1.Shifting of existing of Utilities at proposed CCT and TEPH area. 2.Site Clearance required. 3. Shuttering and reinforcement of wall is in progress 3. Spacing and Deviopment length not proper 4.				
120	Chlorine Contact tank	To be constructed/ inprogress						
121	Note:-
