## SITE INSPECTION REPORT FOR 210 MLD STP BINGAWAN

Location:  
210 MLD STP at BINGAWAN

Inspection  
Date:  
15.12.2022

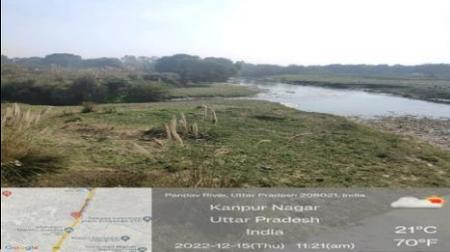
S. No.	Equipment	Assessment of Current Condition	Assessment of Current Condition photo	Corrective Action Required	Corrective Action Completed by KRMPL	Original Date of Issue	Proposed Date to Resolve by KRMPL	Current Status of Compliance
1	COD Nala	During the joint site visit of COD Nala I&D site on 15.12.2022, it was found that sewage flows (Overflow) were diverted to Pandu River.

Required nos. of pumps at MPS need to be operated to tackle the problem of overflow.		03.10.2022		Pending

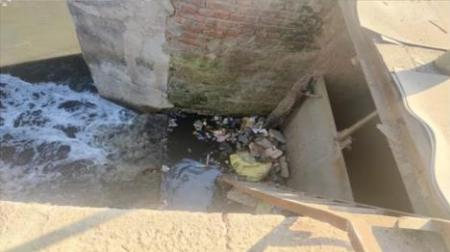
-	COD Nala Gate	During the joint inspection on 15.12.2022, overflow was observed. Also gate was closed.

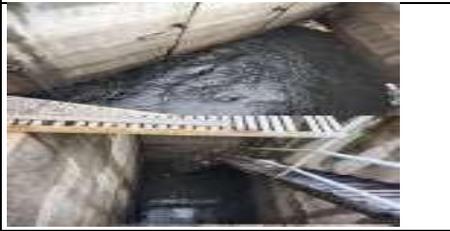
Leakages from the bypass sluice gate must be fixed. During the inspection of UPJN & STC team done on 14.11.2022, it was observed that fine leakage in the bypass is still not attended.		27.05.2022		Pending
2	Upstream Weir of MPS	During the UPJN & PE site visit on 25.08.2022, it was observed that flood at the weir of the MPS was not maintained. This situation is very frequent and KRMPL is not taking any corrective measures.

Adequate no. of pumps at MPS need to be operated to tackle the problem of reverse/back flow and high fall at the weir needs to be maintained at all times.		26.10.2021

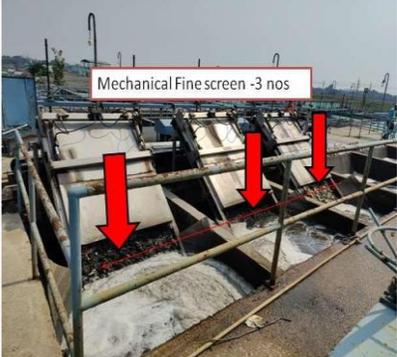
32	M6 pipe to PTU	When LPJN & PE team reached the site, it was found that painting has been done but still some part of the pipes are found rusted and not properly painted.		Needs to do epoxy painting properly by following standard procedure.		25.03.2022		
33	Mechanical Fine screen no.01	Non Operational When STC /LP Jai Nigam team reached the site, we found that the screen is still not functioning properly. None of the disposal material is getting removed by the screen and also sewage level in sump is higher than that of the level at downstream. Screen bars are checked with disposal material.

Must be Overhauled at the earliest In the meeting dated 11.04.2022, ED (T) NMCO directed KRMPL to rectify the Issue till 18.04.2022 but not rectified yet.		28.01.2020	15.11.2021, Next date given is 31.01.2022 Next date given is 31.07.2022	LONG PENDING
34	Mechanical Fine screen no.02	Non Operational		Must be Overhauled at the earliest In the meeting dated 11.04.2022, ED (T) NMCO directed KRMPL to rectify the Issue till 18.04.2022 but not rectified yet.		26.10.2021	31.01.2022 Next date given is 31.07.2022	LONG PENDING

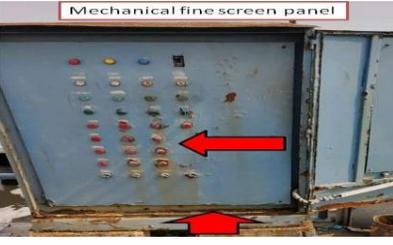
35	Mechanical Fine screen no.03	<p>Non operational</p> <p>When STC /UP Jal Nigam team reached the site, we found that the screen is not functioning properly. None of the disposal material is getting removed by the screen and also sewage level in upstream is higher than that of the level at downstream. Screen bars are checked with disposal materials.</p>

Must be rectified at the earliest In the meeting held 11.04.2022, ED (T) NREGS directed KRMP, to rectify the issue till 18.04.2022 but not rectified yet.	26.10.2021		LONG PENDING
36	Mechanical Fine Screen Panel	<p>1) Various indicators not working</p> <p>2) Cables was found lying on the floor.</p>

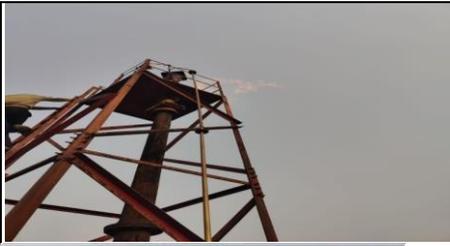
111	Gas Flaring Unit at DG yard	Operational 1) Auto ignition system of the gas flaring system is finally made operational on 14.11.2022. 2) Cable laying was not proper. Temporary cable connection is being used.

Need to be repaired and painted immediately.	29.01.2020	30.06.2022 New Date 31.08.2022	LONG PENDING
112	DFG no. 1	Non-Operational After 3 months of non-operational since 16.12.2021, it was made operational on 12.03.2022. Again, DFG is non-operational since 19.04.2022.

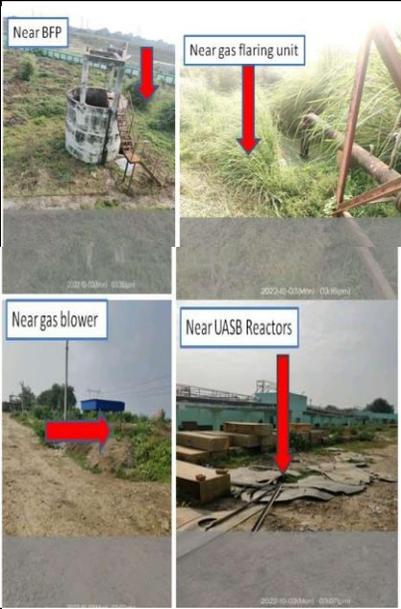
1) The autocharge must be rectified. 2) Needs to be painted 3) Exhaust silencer needs to be overhauled.	03.10.2022		PENDING
114	House Keeping	House Keeping work is found to be in very poor condition. This implies that KRMPPL is not doing house keeping work which is clear from the photographs.

House keeping work of the plant needs to be improved at the earliest and done regularly. Sufficient manpower for house keeping work must be deployed.	03.10.2022		PENDING

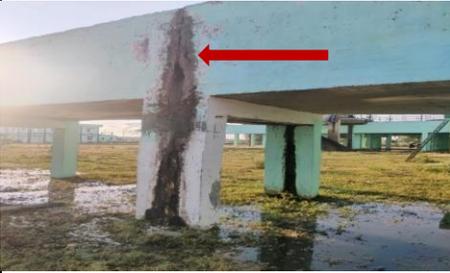
115	Leakage at Civil Unit	When LUPJN & PE visited site, heavy leakage was observed as shown in the picture because of which the area below division channel was filled with sewage. Also leakages from various structures were found.

1. Need to be repaired permanently. 2. Greasing and lubrication for off-line valves is required to be done.	28.01.2020	15.01.2022 New Date 31.08.2022	LONG PENDING
116	Log Books/ Registers	It was found that no record log book or register for mechanical activities, charge pump operation etc were maintained by KRMPPL. Even maintenance register was not found properly maintained at BFP no. It was found operation but no information of BFP was found in the maintenance register. Apart from this, various modification works which the plant incharge is claiming was not found in the maintenance register.		All Log books / registers (i.e. Operation log book of each equipment / process units, DFG log book, collection sump-level transmitter log book, maintenance register, In/out material register, fire and register, attendance register, visit register etc) must be maintained daily and should be available at site at the time.	26.10.2021		LONG PENDING

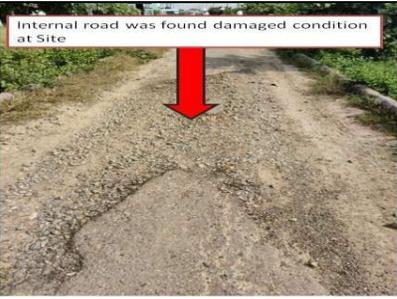
117	Internal Road Restoration	<p>Internal roads were found damaged at various places</p>

Internal road restoration must be started at earliest and should be done on phased manner.	26.10.2021	03.10.2022	Pending
118	Marking Equipments	It was found that some markings has been done by KRMPPL and some marking on the equipments/ units are still pending which had already been clarified to the plant incharge.	Each equipments / units must be marked (like 1st, 2nd etc) in bold letters so that the equipments/ units can be identified easily.	26.10.2021	28.02.2022	LONG PENDING
119	Laboratory	<ol style="list-style-type: none"> <li>1) KRMPPL lab testing results are not matching with other agency's testing report.</li> <li>2) Calibration Tests of Lab equipment are not performed</li> <li>3) Faecal coliform results is exceeding the permissible limit with a huge margin.</li> <li>4) List of equipment complete details are not found available at site.</li> <li>5) It was found that the samples were kept at negative temperature.</li> </ol>	<ol style="list-style-type: none"> <li>1) KRMPPL lab testing results are not matching with other agency's testing report. KRMPPL must do the testing properly as per standard operating procedure as per CA / CPHEEO manual.</li> <li>2) Lab. equipments must be calibrated.</li> <li>3) Faecal Coliform tests need to be validated due to huge variation with the 3rd party lab results.</li> <li>4) Detailed list of lab equipment with all information must be prepared and made available at site.</li> <li>5) Temp. regulated fridge must be made available for storing samples.</li> </ol>	25.03.2022 26.10.2021		LONG PENDING
