SITE INSPECTION REPORT FOR 43 MLD JAJMAU PHASE-II STP

JAJMAU PHASE-II
STP - 43 MLD

Date: 27.12.2022

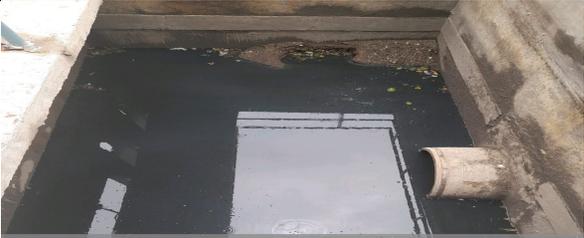
S. No.	Equipment	Assessment of Current Condition	Assessment of Current Condition Photo	Corrective Action Suggested by STC	Original Date of Issue	Proposed Date to Resolve by KRMPL	Current Status of Compliance
A	Inlet Chamber	functional

<div style="display: flex; justify-content: space-between; margin-top: 5px;"> <div style="text-align: center;"> <p>Kanpur Uttar Pradesh India</p> </div> <div style="text-align: center;"> <p>Latitude Longitude</p> </div> <div style="text-align: center;"> <p>Decimal DMS</p> </div> </div> <p style="font-size: small; margin-top: 5px;">26.417689 26°25'3" N 80.418068 80°25'5" E</p>	<ol style="list-style-type: none"> 1. Chamber and hand railing painting work need to be done. 2. Pipe hood to be installed on each rotating wheel. 3. Sluice gate need to be lubricated. 3. Cleaning of inlet chamber need to be done. 	21.09.2021		Pending.
1	Fine Screen No.1(Mecahnical)	functional

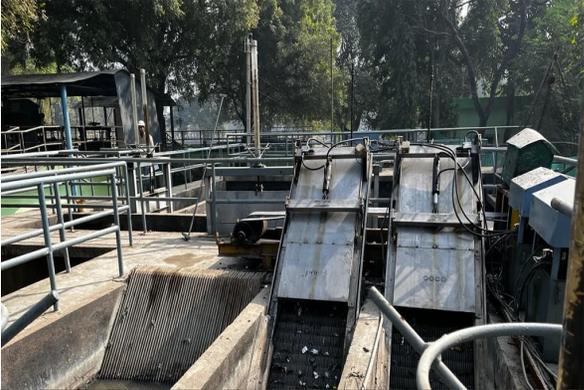
<ol style="list-style-type: none"> 1. Fine Screen need to be cleaning properly. 2. Screen Level Sensor need to be replaced. 3. Screen panel autosystem need to be repaired. 4. Panel stand need to be painted. 5. Cable tray need to be replaced and painted. 6. All light green area need to be replaced. 7. Disposal material need to be removed on regular basis. 8. Manual trolley need to be provided for Disposal material. 9. All motors need to be covered by canopies. 10. Fine screen 2 (mechanical) need to be maintained for proper functional. 	21.09.2021		Pending.

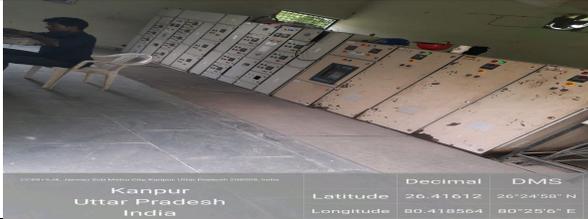
<p>1. Screen panel voltmeter need to be replaced.</p> <p>2. Dosing agitator ammeter need to be replaced .</p>	21.09.2021		Pending
F	Sludge System

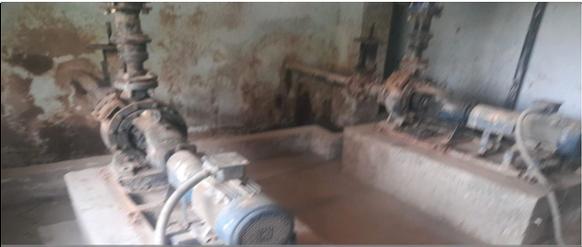
1	Centrifuge feed pump(No.1 &2)	Operational

<ol style="list-style-type: none"> 1. Pump cleaning need to be required. 2. Pump lubrication need to be done on regular basis by KRMPL. 3. Pump RPM need to be increase as per design. 4. Vibration and Temperature need to be measure on regular basis. 5. Pump log book has not maintained by KRMPL. 	21.09.2021		Pending
2	Centrifuge panel	Operational

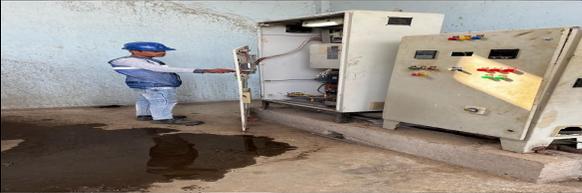
<ol style="list-style-type: none"> 1. Panel no.1 need to be repair. 2. Panel no. 2 voltmeter need to be replaced . 3. Panel door damage need to be repair 4. Panel VFD not working 	21.09.2021		Pending
3	Centrifuge No. 1	Operational

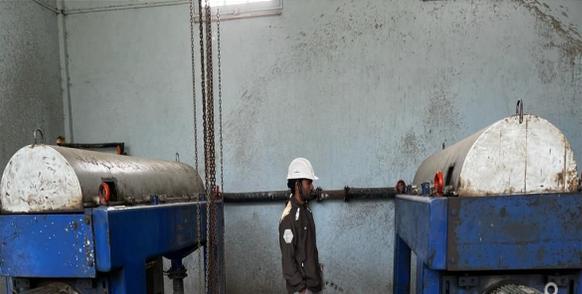
<ol style="list-style-type: none"> 1. Need to be overhauled & servicing. 2. Dosing of PACL in sludge feed line not properly tapping according to design .Therefore dosing line tapping from upword to downward direction.KRMPL has not taken action as same. 3. Pipe support shall be installed properly for sludge feed line and dosing line. 4. Electrical cables need to be lineup properly. 5. 1 CCTV need to be arranged for sludge removal from Trolley on urgent basis. 6. The quality of dewatered sludge is not adequate since liquid is being noticed during site visit. 7. 2 nos centrifuges operated by KRMPL, 12 Hrs.each due to non-availability of VFD, only one at a time operated 	21.09.2021		Pending

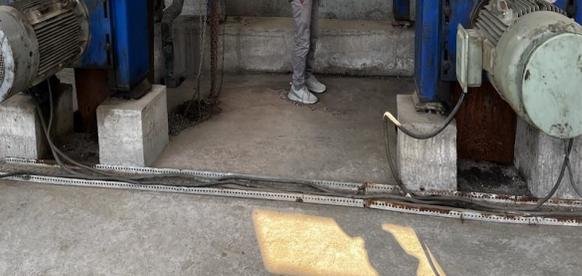
4	Centrifuge No.2	Operational

<ol style="list-style-type: none"> 1. Need to be overhauled & servicing. 2. Dosing of PACL in sludge feed line not properly tapping according to design .Therefore dosing line tapping from upword to downward direction.KRMPL has not taken action as same. 3. Dosing line has not been connected with sludge feed line of centrifuge No 2. 4. Pipe support shall be installed properly for sludge feed line and dosing line. 5 The quality of dewatered sludge is not adequate since liquid is being noticed during site visit. 6. 2 nos centrifuges operated by KRMPL, 12 Hrs.each due to non-availability of VFD, only one at a time operated 	21.09.2021		Pending
5	Centrifuge thickened sludge sump + Agitator 2 Nos.	1 - Operated 1- Operated

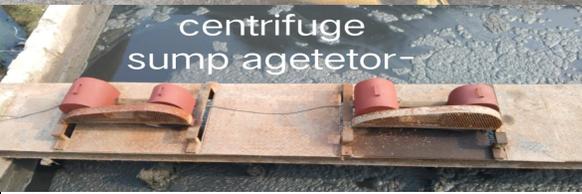
<ol style="list-style-type: none"> 1. Sludge cleaning work need to be done. 2. Need to be overhauled & servicing as required. 3. Log book need to be maintained. 	16.12.2021		Pending

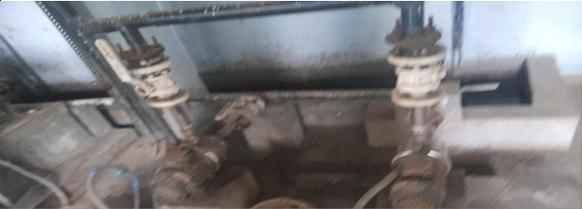
6	Poly Dosing(No.1 & 2)	Pump No.1- Operational Pump No. 2 - damaged

<ol style="list-style-type: none"> 1. Leakage was observed in Pump No. 1 2. Need to be Overhauled & Servicing. 3. Log book need to be maintained. 4. Polymixer was not in operation during site visit. 5. Pump no.2 are not working . 	21.09.2021		Pending

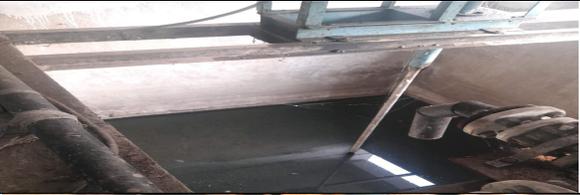
7	Agitator No.1	Operational

<ol style="list-style-type: none"> 1. Need to be rectified. 2. Need to Be cleaned the Sump bottom 3. Needs to be replaced. 4. Cleaning work of tank needs to be done. 	21.09.2021		Pending						
8	Agitator No.2	Operational

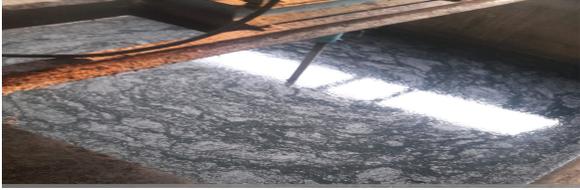
<ol style="list-style-type: none"> 1. Rusted steel Structure need to be replaced. 	21.09.2021		Pending						
9	Digester No.1	Non-operated

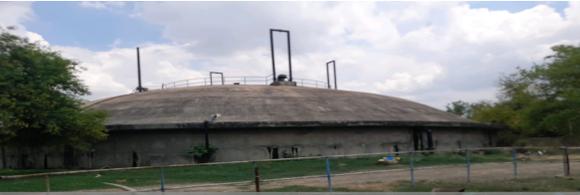
<table border="1" data-bbox="367 618 947 688"> <thead> <tr> <th></th> <th>Decimal</th> <th>DMS</th> </tr> </thead> <tbody> <tr> <td>Kanpur Uttar Pradesh India</td> <td>Latitude 26.41614 Longitude 80.418319</td> <td>26°24'58" N 80°25'5" E</td> </tr> </tbody> </table>		Decimal	DMS	Kanpur Uttar Pradesh India	Latitude 26.41614 Longitude 80.418319	26°24'58" N 80°25'5" E	<ol style="list-style-type: none"> 1. Digster Need to be cleaned. 2. Civil Leakage need to be repaired. 3. Pressure relive valve need to be calibration. 4. All four nos of motors need to be repaired. 5. Canopies need to be replace. 6. HDPE gas pipe line need to be proper support. 7. Sludge digester taken offline since 8 months and it was found that the sludge is being diverted to sludge holding ponds which are already birm. It is very urgent that KRMP address this issue at the highest priority. 	21.09.2021		Pending

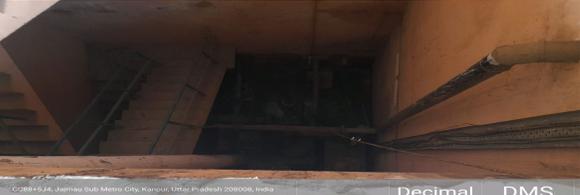
Decimal	DMS											
Kanpur Uttar Pradesh India	Latitude 26.41614 Longitude 80.418319	26°24'58" N 80°25'5" E											
10	Thickened sludge Pump(No.1 & 2)	Both pumps Non-operational

<table border="1" data-bbox="367 883 947 953"> <thead> <tr> <th></th> <th>Decimal</th> <th>DMS</th> </tr> </thead> <tbody> <tr> <td>Kanpur Uttar Pradesh India</td> <td>Latitude 26.416096 Longitude 80.418207</td> <td>26°24'57" N 80°25'5" E</td> </tr> </tbody> </table>		Decimal	DMS	Kanpur Uttar Pradesh India	Latitude 26.416096 Longitude 80.418207	26°24'57" N 80°25'5" E	<ol style="list-style-type: none"> 1. Need to be overhall and servicing. 2. Lubrication of pump need to be done. 	21.09.2021		Pending
	Decimal	DMS											
Kanpur Uttar Pradesh India	Latitude 26.416096 Longitude 80.418207	26°24'57" N 80°25'5" E											
G	Sludge Thickner No.1	Non-Operated

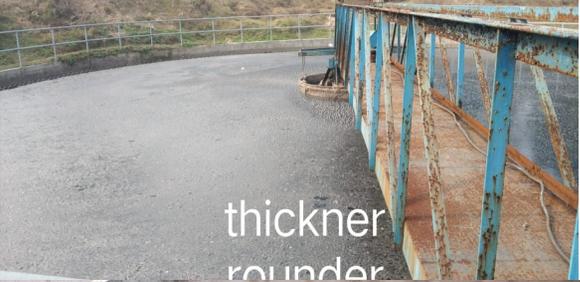
<p style="text-align: center;">thickner rounder</p>	<ol style="list-style-type: none"> 1. Need to be painted. 2. Need to be Clean wier plates. 3. Sludge cleaning need to be done. 4. Need to be Overhaul and servicing. 5. Sludge thickener operation needs immidiate attention since supertananat from the thickener is discharging heavy solids into the PST inlet distribution chambers overloading the PST system. 	21.09.2021		Pending

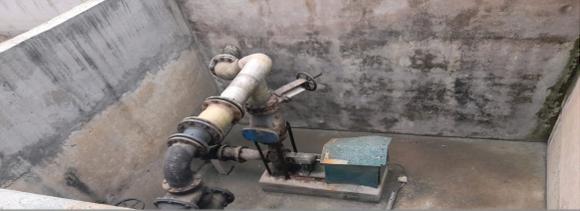
1	Thickened Sludge Sump (Feed pump no 1 & 2)	Operational

<table border="1" data-bbox="367 1446 947 1516"> <thead> <tr> <th></th> <th>Decimal</th> <th>DMS</th> </tr> </thead> <tbody> <tr> <td>Kanpur Uttar Pradesh India</td> <td>Latitude 26.416122 Longitude 80.418369</td> <td>26°24'58" N 80°25'6" E</td> </tr> </tbody> </table>		Decimal	DMS	Kanpur Uttar Pradesh India	Latitude 26.416122 Longitude 80.418369	26°24'58" N 80°25'6" E	<ol style="list-style-type: none"> 1. We have found heavy viberation at Pump no 2 during visit. KRMP need to be repair. 2. Pipe support need to be replace as required . 3. Viberation and Temperature need to be measure on regular basis. 4. Pump log book has not maintained by KRMP. 5. Dewatering from the sump need to be required. 	16.12.2021		Pending
	Decimal	DMS											
Kanpur Uttar Pradesh India	Latitude 26.416122 Longitude 80.418369	26°24'58" N 80°25'6" E

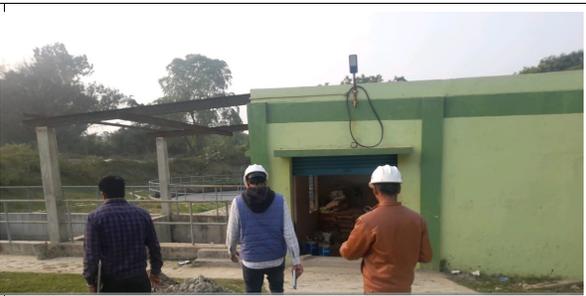
2	Thickened Sludge Pump house	Operational

<ol style="list-style-type: none"> 1. Need to be Overhaul and repair. 2. Cleaning work need to be done. 3. Vibration and Temperature need to be measure on regular basis. 	21.09.2021		Pending
H	Blower Room						
1	Air Blower No.1	Operated

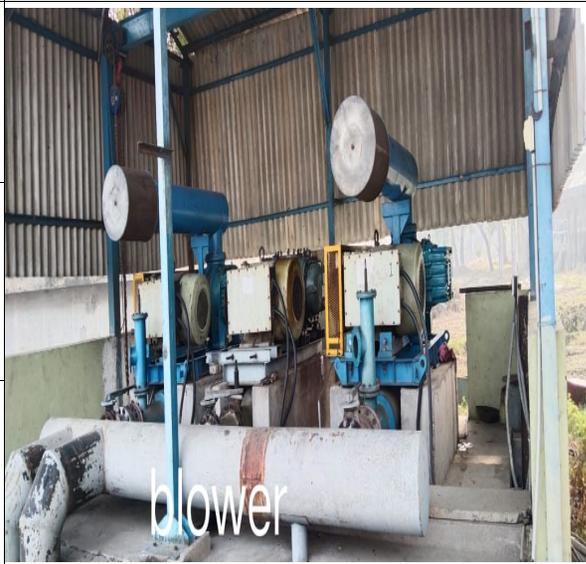
<ol style="list-style-type: none"> 1. Air Blower remote system cable need to dressed properly. 2. Air blower no.1 need to be rectified . 3. Acoustic hood need to be installed . 4. Vibration and Temperature need to be measure on regular basis. 5. Log book need to be maintained. 6. Pressure guages need to be installed. 7. PRV need to be checked. 8. Insulation work in discharge line needs to be done by KRMP. 	21.09.2021		Pending
2	Air Blower No.2	Non-operational since 22.11.2022					
3	Air Blower No.3	Operational since 08.07.2022					
I	Aeration Tank	Operated

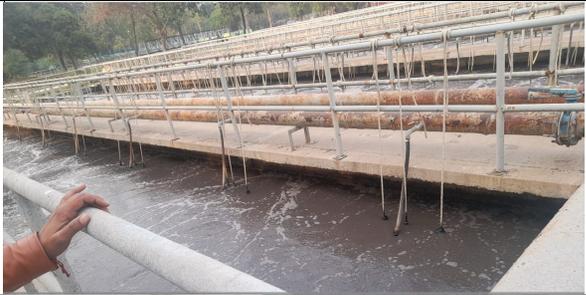
<ol style="list-style-type: none"> 1. Air pipes were observed to be rusted. 2. Pipe lines need to be changed. 3. Valves need to be changed. 4. Handrails need to be painted. 5. Diffuser line need to be Cleaned and mentained records also. 6. Insulation required for discharge line of blower. 7. Rope need to be replaced. 8. 4 Sets of diffuser needs to be repired on urgent basis. 	21.09.2021		Pending

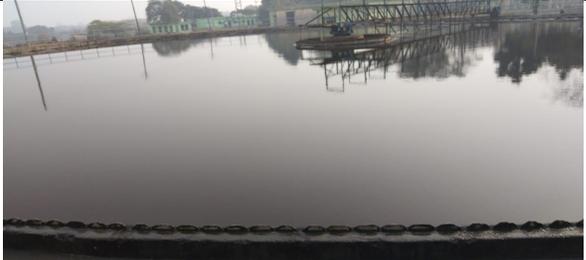
J	Final Sedimentation tank	Operated

<ol style="list-style-type: none"> 1. Cleaning work need to be done. 2. Painiting work need to be done. 3. Alignment of Mechanism need to be rectified. 4. "V" notch need to be replace. 	21.09.2021		Pending

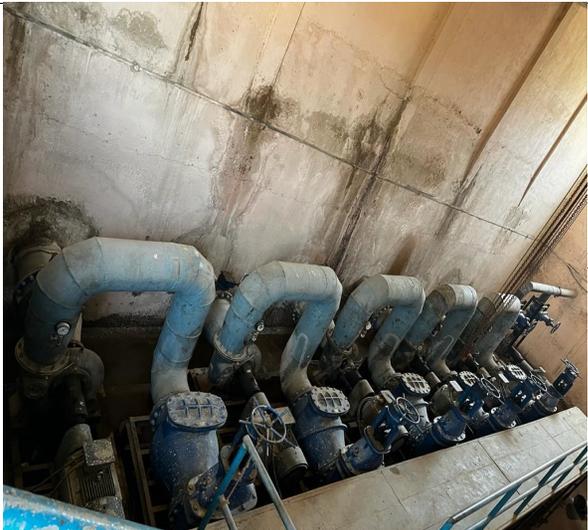
K	43 MLD TEPH(5 Nos Pumps)	Operational

<ol style="list-style-type: none"> 1. Pump No. 2 was non operational. 2. Pressure gauges not working in all pumps. 3. Internal lights were not working. 4. Each pump capacity 900m³/hr. 5. Lubrication of each equipment need to be done. 6. Log book need to be maintain properly. 7. Vibration and Temperature need to be measure on regular basis. 8. Ameter need to be repaired. 	21.09.2021		Pending		
L	RSPH	Operational

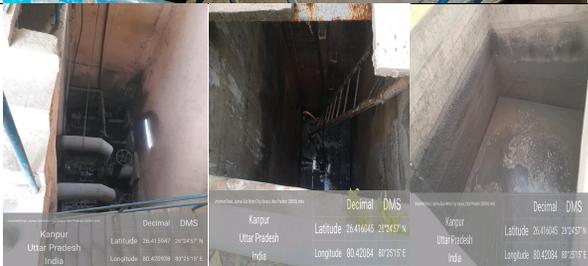
<ol style="list-style-type: none"> 1. 2 Nos. of pumps in Operational(1 W +1 S). 2. Waste activated sludge pump No. 2 is under maintenance since 07.09.2022. 3. Ameter need to be repaired. 4. Wash water pump are not working. 	21.9.2021		Pending		
Remarks:-			<p>Important Note-</p> <ol style="list-style-type: none"> 1. At the time of power failure there are no power backup is available. KRMP has been shutting down the STP which was deteriorated process of the 43 MLD STP plant. 2. CCTV cameras required to installed immediately at centrifuge equipments as agreed by KRMP. 3. Landscaping work need to be done by KRMP. 4. All mechanical, electrical and instrumentation equipments need to be functional properly. 5. Painting work need to be done by KRMP because acceptance criteria not fulfilled yet given below:- <ol style="list-style-type: none"> i) All painted surfaces shall be uniform and pleasing appearance. ii) The colour, textures etc shall match exactly with approved samples. iii) All stains, splashes and splatters of paint shall be removed from surrounding surfaces.
