SITE INSPECTION OF JAJMAU ASSOCIATED IPS REPORT

Nawabganj IPS 32
MLD

Date: 29.12.2022

Parmat IPS

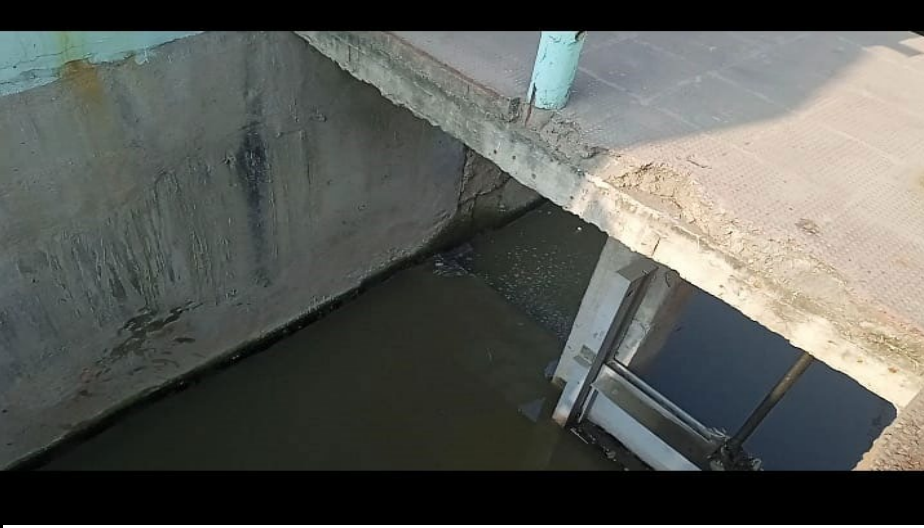
S. No.	Equipment	Assessment of Current Condition	Assessment of Current Condition Photo	Current defects and Corrective Action Suggested by PE	Original Date of Issue	Proposed Date to Resolve by KRMPL	Current Status of Compliance
1	All work						
1	Inlet Over Flow Condition	Overflow condition found since handover

1. During site visit overflow is observed since handover 28.06.2021. 2. No action has been taken by KRMPL despite being informed, several times by NMCG, UPJN and STC representatives. 3. As per renovation plan for IPS Nawabganj , KRMPL should increase adequate pumping to prevent overflow of sewage.	28.06.2021		Long Pending
2	Inlet Chamber	1. Cleaning of inlet chamber needs be done on regular basis. 2. Staircase damaged tile needs to be renovated.		1. Cleaning of inlet chamber needs be done on regular basis. 2. Staircase damaged tile needs to be renovated.	23.11.2021		Long Pending
3	Screen Chamber	1. Garbages has accumulated into screen chamber.

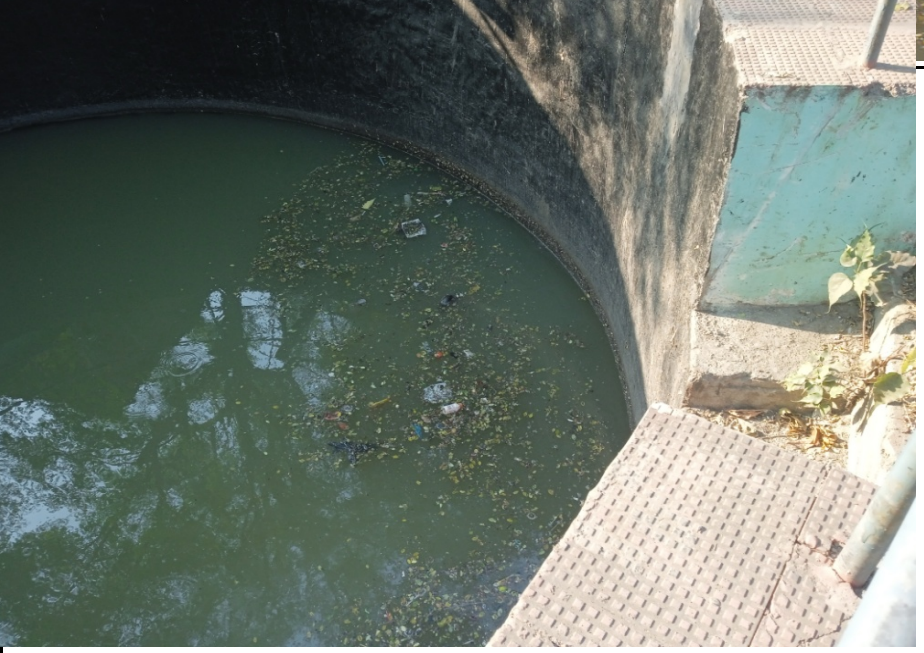
<p>1. For Receiving Chamber 02, the sludge removal work has not been done.</p> <p>2. Repairing work needs to be done by KRMPL.</p>	28.06.2021		Long Pending
6	Pump House No.1	Civil Structure in unsatisfactory Condition		<p>1. Pump House no-1 is non operational since date 29.08.2022. All pumps were non operational.</p> <p>2. During the inspection, all pumps and motors were observed to be in submergence condition.</p> <p>3. Chain pulley, LT panels, Cable tray and cable dressing were damaged.</p> <p>4. 2 Nos Exhaust Fan were not working.</p> <p>5. Dewatering pumps are not installed.</p> <p>6. Log book is not maintaining properly by KRMPL staff as per prescribed format.</p>	23.11.2021		Long Pending

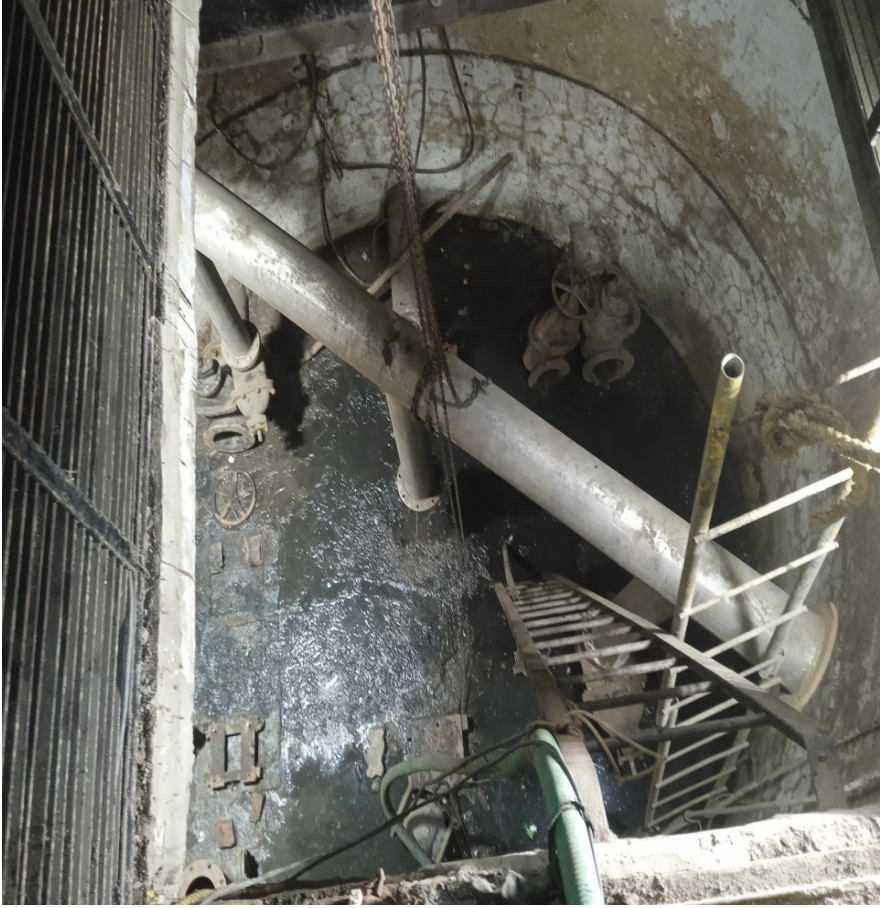
i	Pump no.1 (Capacity =297 m3/hr)	Non-Operational

Need to be raplaced as per Rennovation Plan	23.11.2021		Long Pending
ii	Pump no.2 (Capacity =156 m3/hr)	Non-Operational		Need to be raplaced as per Rennovation Plan	23.11.2021		Long Pending
iii	Pump no.3 (Capacity =297m3/hr)	Non-Operational		Pump no. 3 found non-operational since 27.05.2022. KRMPL needs to repair it on urgent basis.	23.11.2021		Long Pending

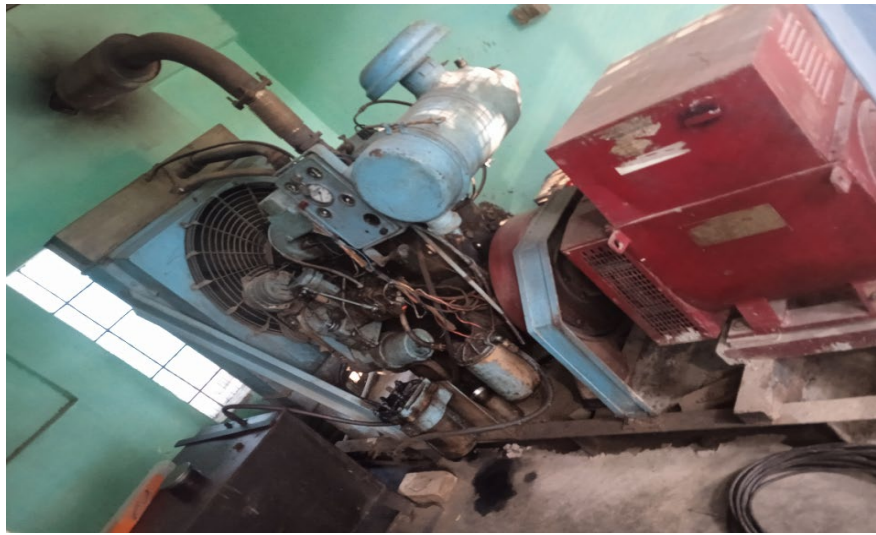
12	DG set room	Civil Structure in satisfactory Condition

<div>1. DG set is in working condition.</div> <div>2. Log book of DG set is not maintaining properly by KRML.</div> <div>3. Diesel surplus quantity is not available at site.</div> <div>4. Smog exhaust pipe length is not sufficient as per CPCB/CPHEEO guidelines. Therefore, it must be replaced on urgent basis.</div>	23.11.2021		Pending
13	Metering Room	Civil Structure in unsatisfactory Condition

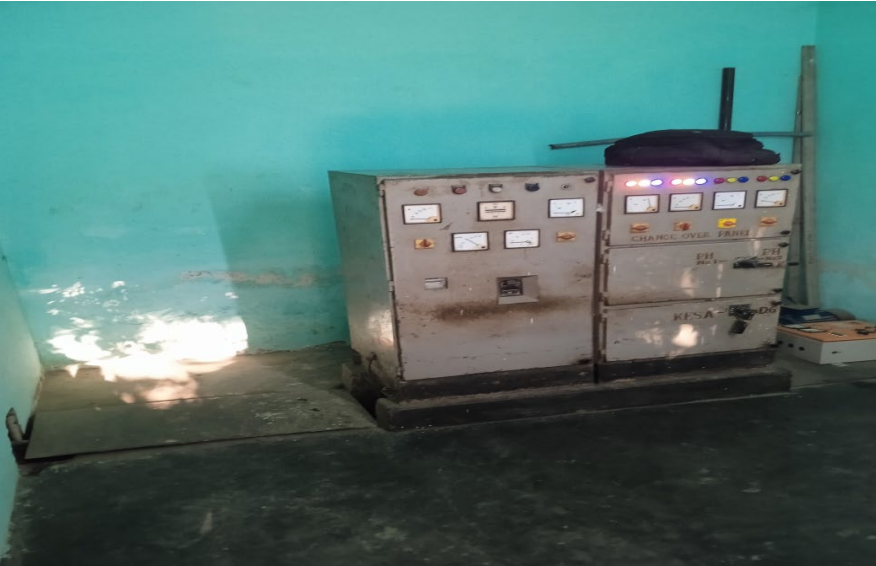
<div>1. Seepage was observed on the wall of this room. It should be rectified.</div> <div>2. Panel Volt meters and Ammeters needs to be replaced.</div> <div>3. All Phase Indicators needs to be replaced.</div>	23.11.2021		Long Pending
14	Logbook	Log book of pump house 01 not maintained by KRML

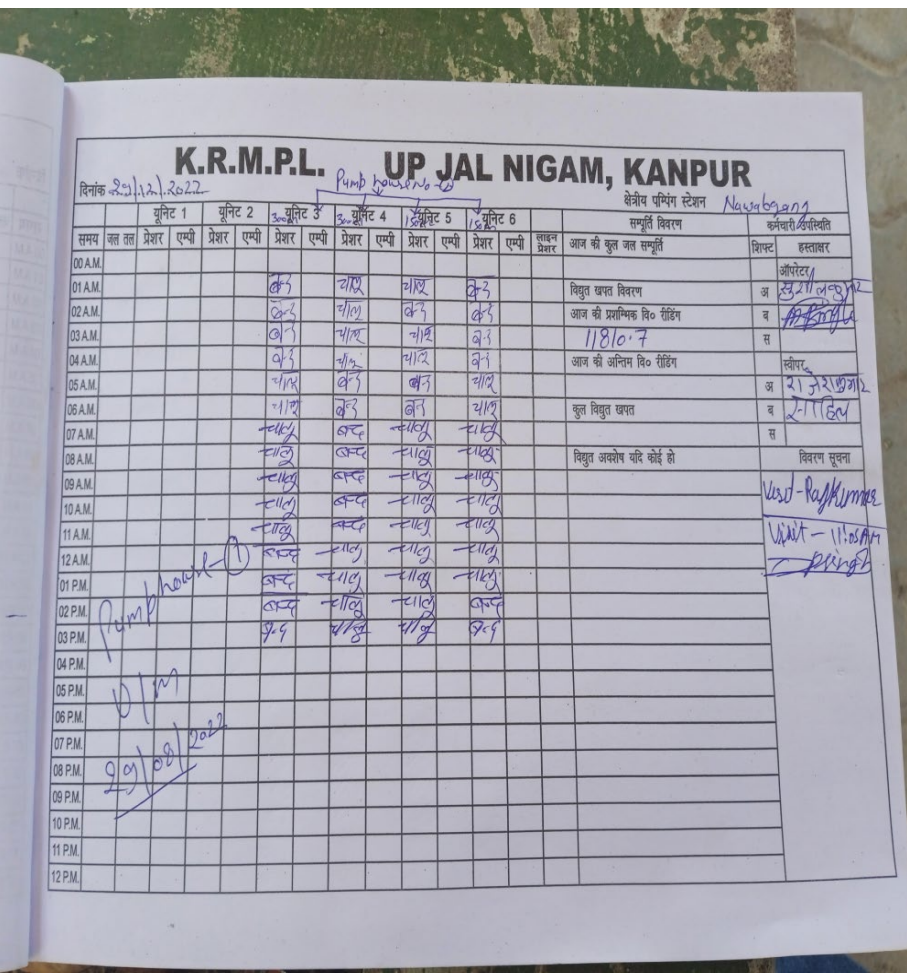
<div>1. Security guard should be arranged by KRML.</div> <div>2. Diesel stock log book was not maintained properly by KRML on regular basis.</div> <div>3. Pumps log book was not maintained properly.</div> <div>4. Maintenance records was not available at site for all E&M equipments.</div> <div>5. Arrangement of reliever for Operators and sweepers should be done by KRML.</div> <div>6. DG log book was not maintained properly by KRML.</div> <div>7. Material inward and outward registers need to be maintained properly by KRML.</div>	28.06.2021		Long Pending

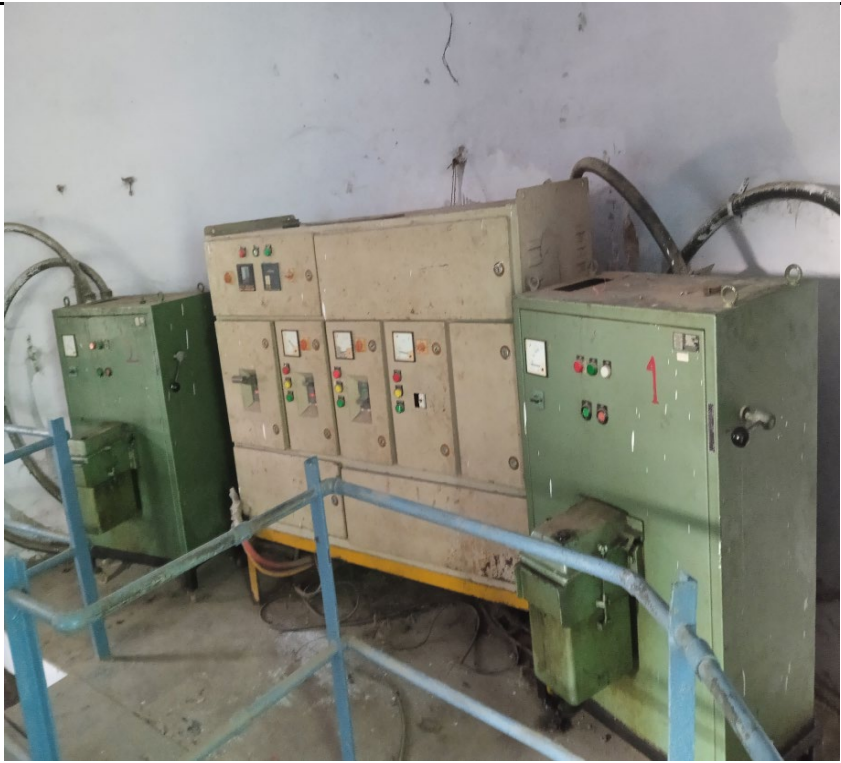
4	Pump house No. 2	Pump house no.2is in unsatisfactory condition

<ol style="list-style-type: none"> 1. All pipelines were found in submergence condition. 2. Both pumps were operational. NRV and Sluice gates needs to be replaced. 3. All tubelights were not working properly. 4. Drain water pump no-2 needs to be replaced. 5. Ammeters on the LT panel were not in working condition. 6. Motor termination Box cover was not fixed and also cable gland was not fixed. 7. DG set for pump house no-1 is not working since handover. 8. Dewatering pump needs to be replaced. 9. Operators are non technical person. They do not have clear understanding of the Pump Capacity , Flow of Discharge, and Peak Flow. Also records are not maintained properly. 	23.11.2021		Pending
i	Pump No.1(pump capacity =900 m3/hr)	Pump found operational

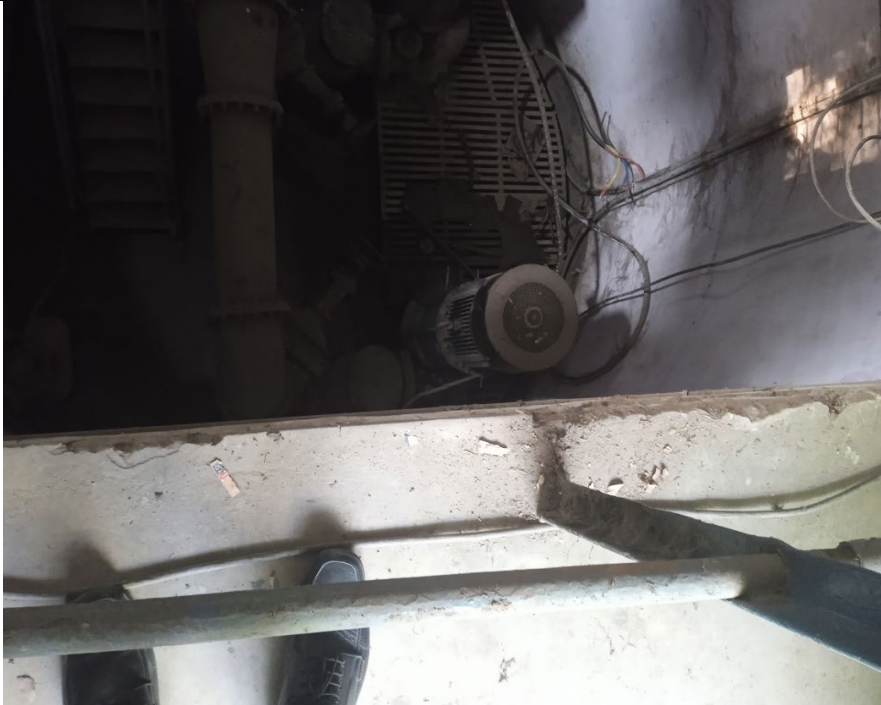
New pump has been installed at 15.03.2022. But installation of new valves, pipeline and fittings are still pending.	23.11.2021		Pending

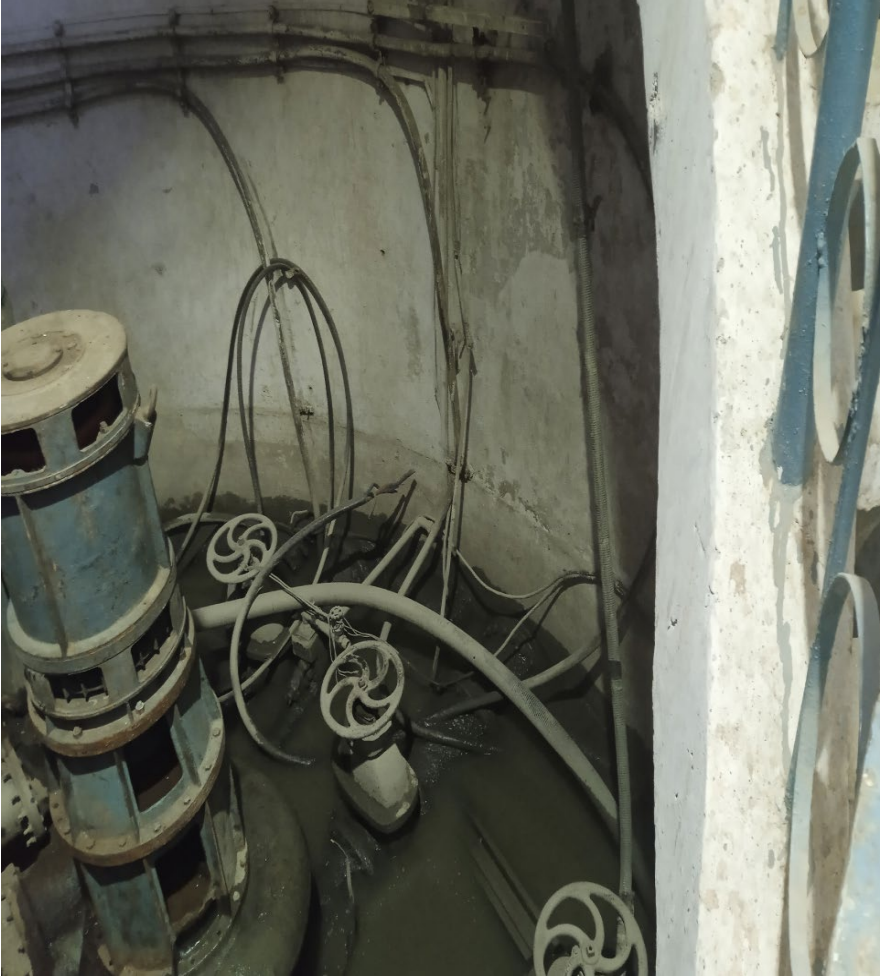
<ol style="list-style-type: none"> 1. Starter no-3 was found to be non-functional. 2. Cable dressing was not done properly. 3. Motor termination cover box was not fixed and cable gland was not fixed. 4. No labour was engaged by KRMPL for renovation work. 5. Cracks needs to be repaired, also damaged door, window, louvers and ventilators needs to be replaced. 6. Dewatering pumps need to be replaced. 7. Operators are non technical person. They do not have clear understanding of the Pump Capacity , Flow of Discharge, and Peak Flow at the site. Also records are not maintained properly. 8. Pipeline and all type valves need to be replaced. 	15.12.2021		Pending
i	Pump No.1(pump capacity =1320 m3/hr)	Operational		<ol style="list-style-type: none"> 1. During site visit it was found that pump no 1 was not in working condition since handover of this IPS. 2. Need to be replaced as per Renovation Plan 	23.11.2021		Pending

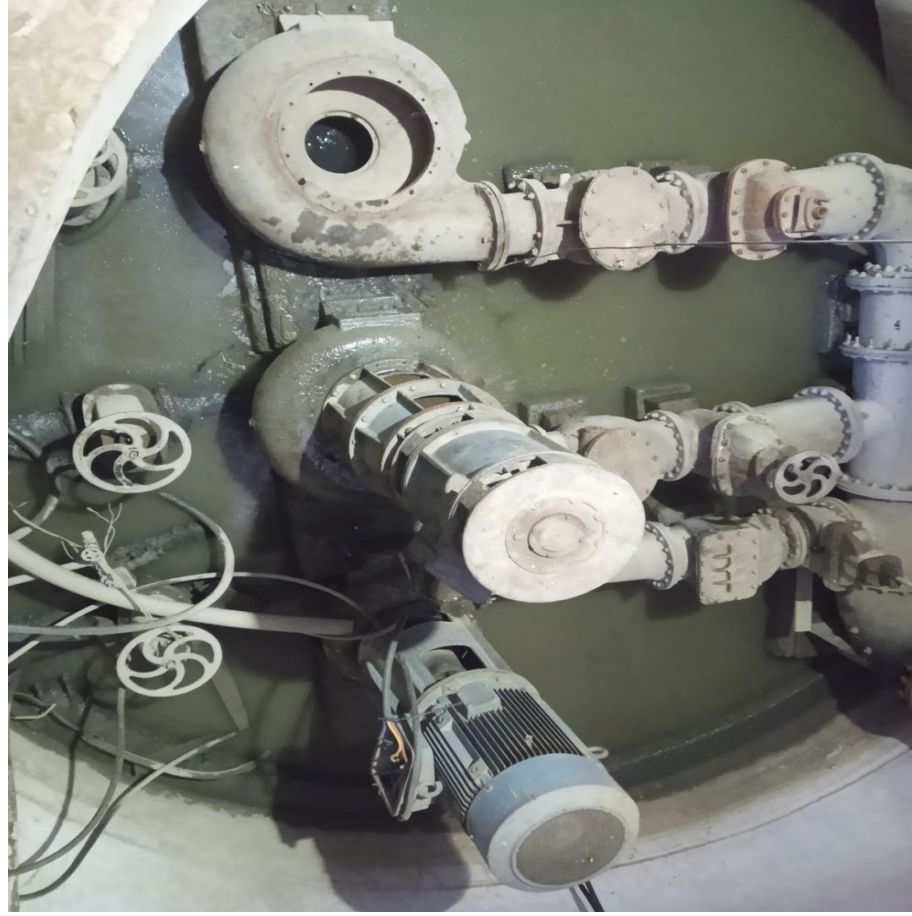
ii	Pump No.2(pump capacity =1320 m3/hr)	Non Operational

Pump no-2 is not working since date 30.09.2022.	23.11.2021		Pending
iii	Pump No.3(pump capacity =1320 m3/hr)	Non operational Pump no-3 is not availble since handover.	 	1. Pump no.3 & valves ,NRV etc need to be replaced as per construction plan	23.11.2021		Pending
6	Pump House No. 3	Civil Structure is in unsatisfactory condition

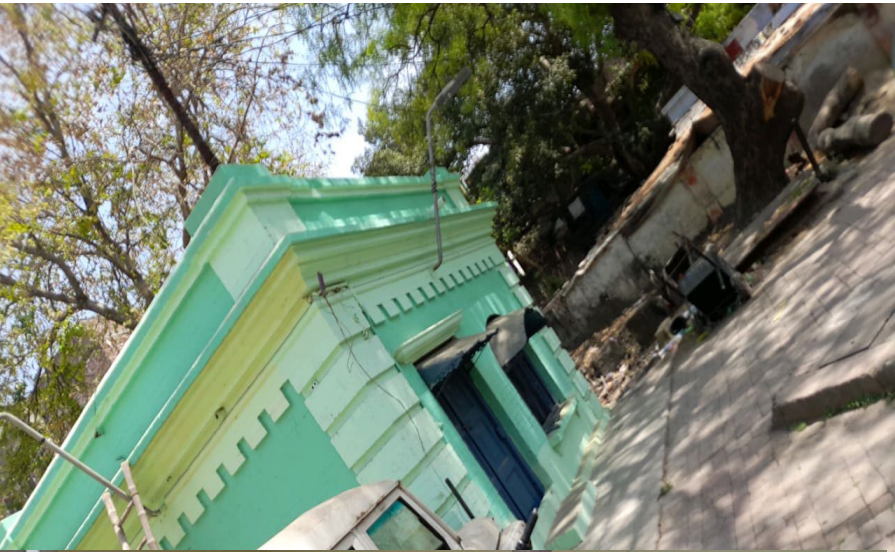
1.Pump house no-3 is defunct since handover. 2. Renovation work are pending from KRMPL's end. 3. Cracks needs to be repaired, and damaged door>window,louvers and ventilators needs to be replaced.	23.11.2021		Pending
7	DG room	Civil Structure is in unsatisfactory condition

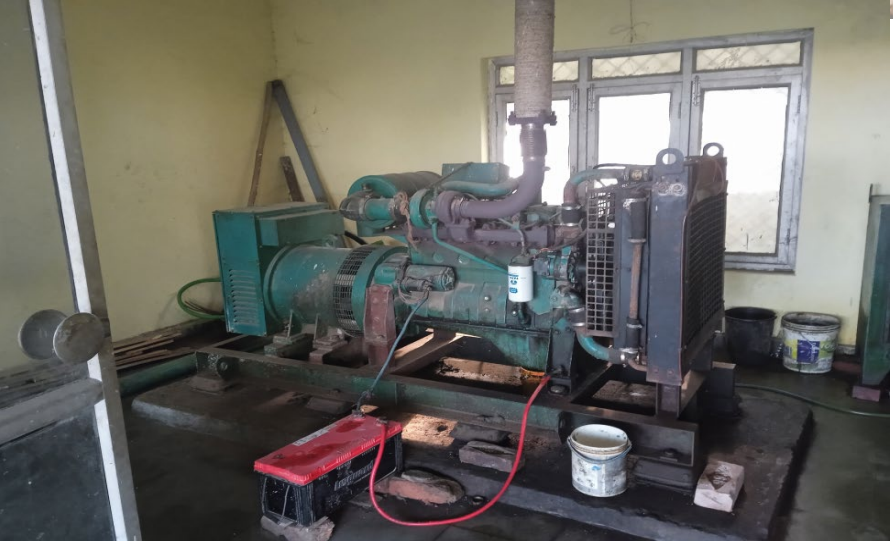
1. Voltmeters, Ammeters were not in working condition. 2. According to the DG logbook, diesel was not availbale at the site. 3.DG set for Pump House no-1 was non operational. 4. Cracks needs to be repaired, and damaged door>window,louvers and ventilators needs to be replaced. 5. DG logbook is not maintained properly. 6. Smog exhaust pipe length was not suffficienr as per CPCB/CPHEEO guidelines. Therefore, it must be replaced on urgent basis.	23.11.2021		Pending

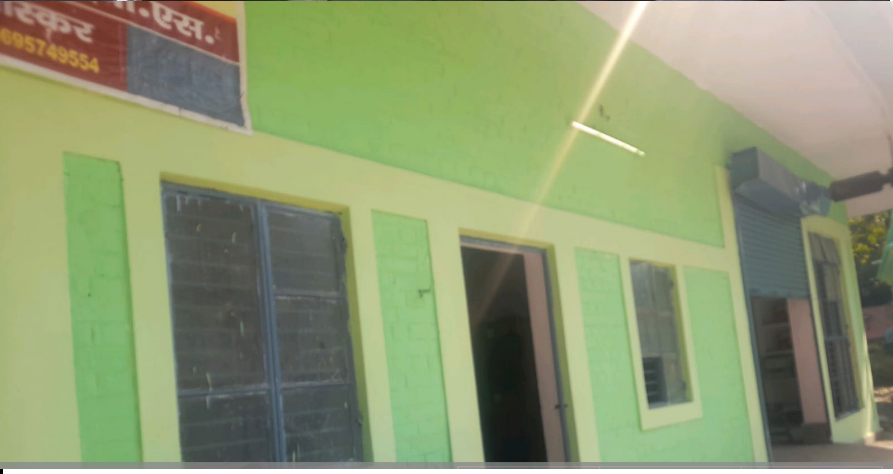
8	Metering room	Civil Structure is in unsatisfactory condition

1.Inside and outside painitng work completed by KRMPL under renovation. 2. Replacement of damaged Door>window,louvers and ventilators is pending. 3. Flooring work needs to be renovated.	23.11.2021		Pending

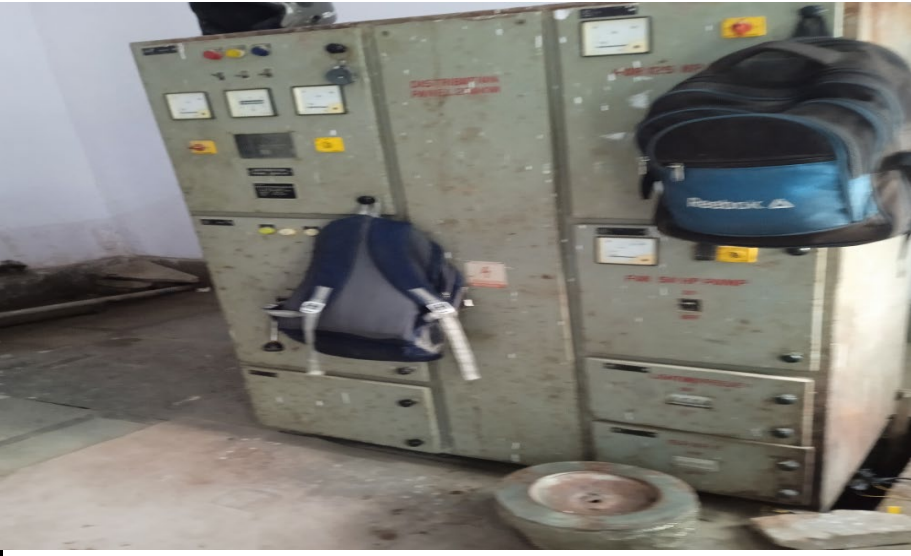
9	Panel Room	Civil Structure is in unsatisfactory condition

<div>1. Inside and outside painting work is completed by KRMPPL under renovation.</div> <div>2. Damaged Door,window,louvers and ventilators needs to be replaced.</div> <div>2. Panel Volt meters and Ammeters needed to be replaced.</div> <div>3.All Phase Indicator needed to be replaced.</div>	23.11.2021		Pending
10	Logbook	Log book of pump house 01 and pump house no. 02 has not maintained by KRMPPL properly

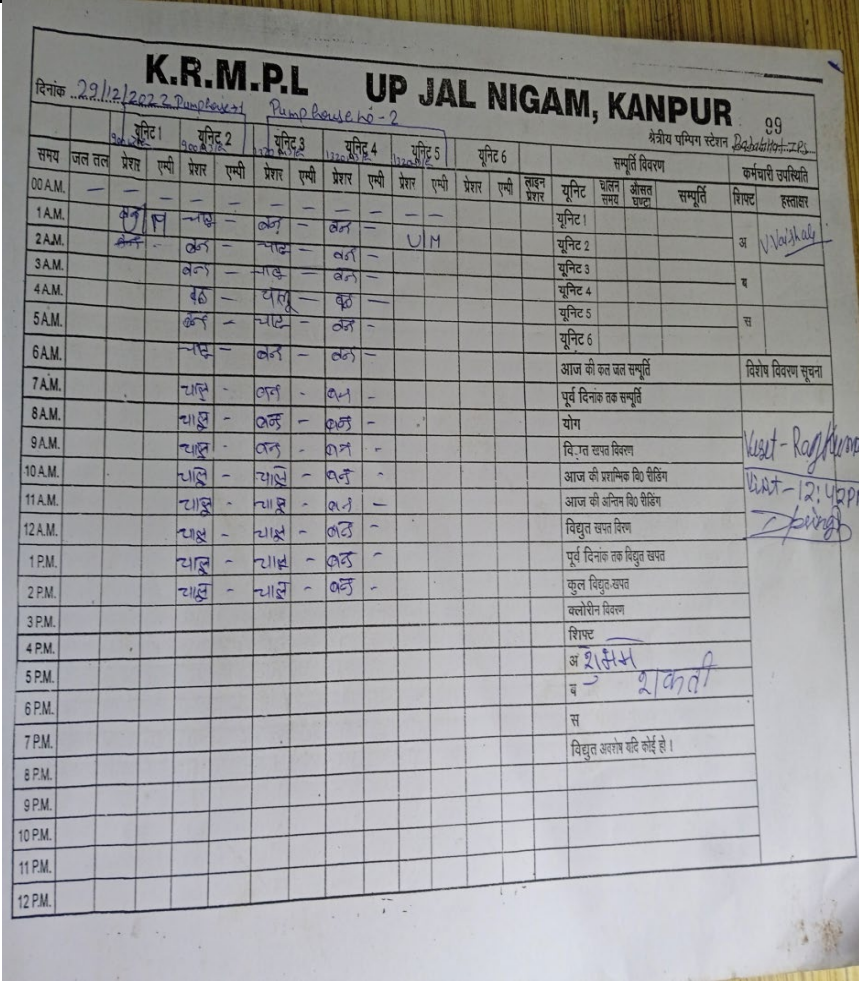
<div>1. Logbooks for pumps and DG sets are not properly maintained by KRMPPL.</div> <div>2. KRMPPL has not arranged adequate number of staff (Operators, Sweepers and relievers) for proper O&M of IPS and attendance register contains manipulated staff details. Operators are non technical person. They do not have clear understanding of the Pump Capacity , Flow of Discharge, and Peak Flow at the site. Also the records are not maintained properly.</div> <div>3. Security guard needs to be deployed at the site.</div> <div>4. No labour available from KRMPPL for renovation work.</div>	23.07.2021		Pending

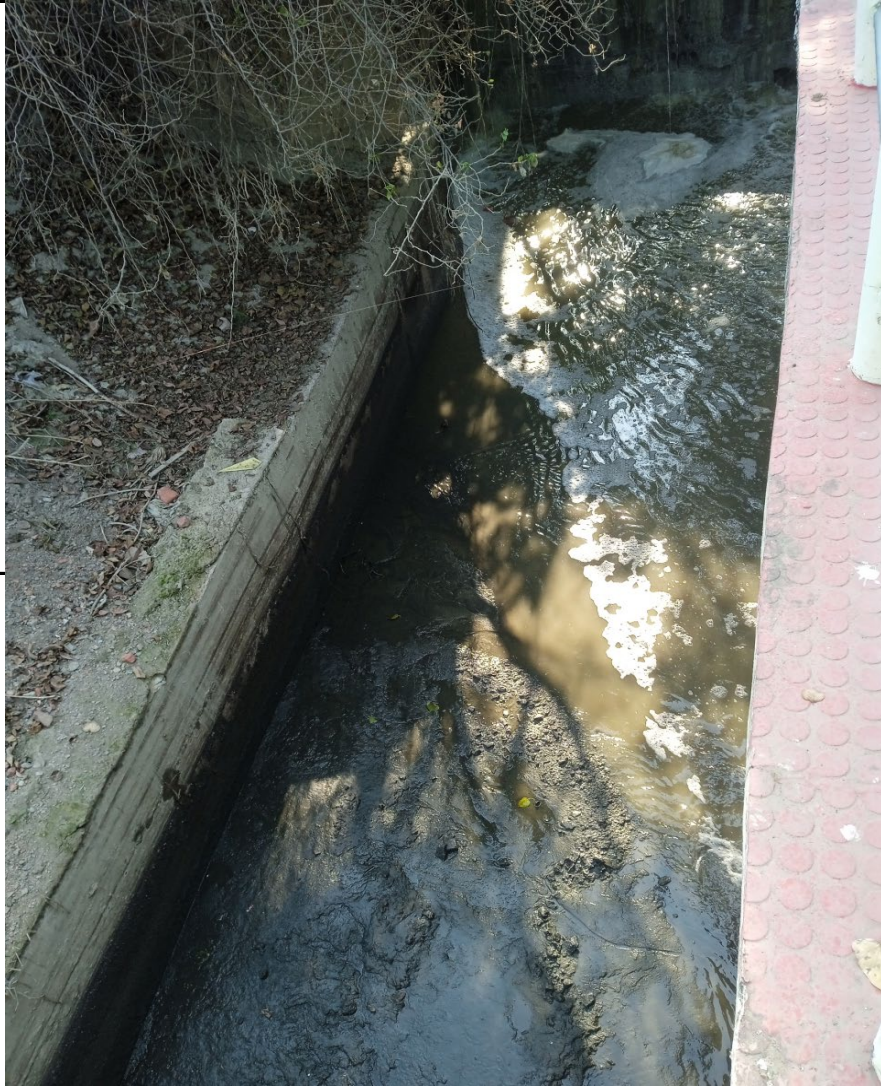
1. During the inspection, No Overflow or Bypass of sewage was observed. 2. Raw sewage by-pass sluice gate need to be replaced. Design,drawing need to be submitted by KRMPL.	4.01.2022		Pending
2	Inlet Chamber (Civil)	Civil Structure is in satisfactory condition		1. All gates needs to be lubricated. 2.Sludge should be removed regularly from inlet parts of IPS. 3. Regular cleaning of the chamber should be done.	23.11.2021		Pending
2A	Inlet Flow Meter	Inlet Flow meter is not available.		Inlet Flow meter is not available.	23.11.2021		Pending
3	Screen Chamber	Civil Structure is in satisfactory condition

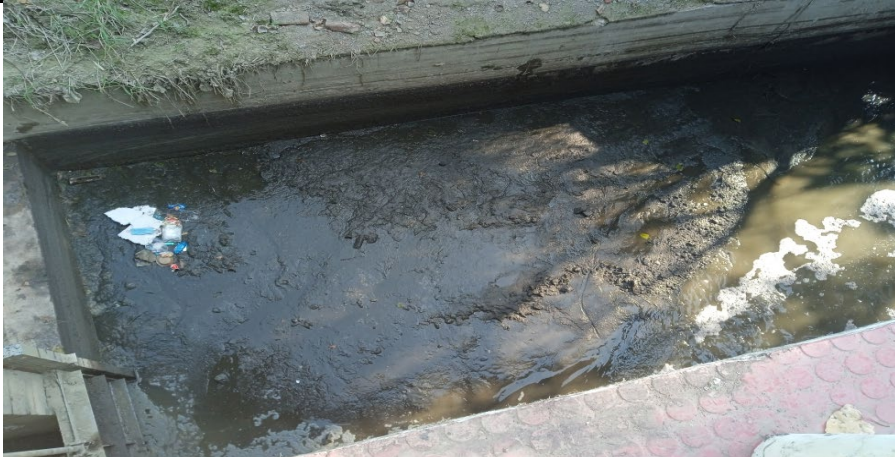
1. No sweeper was present in the screen chamber. 2. Garbage removal work and cleaning of the screen should be done on regular basis. 3. Trolly should be made available at the site for proper disposal of garbages. 4. Durind the inspection it was observed that screen was completly submerged at the site.	23.11.2021		Pending

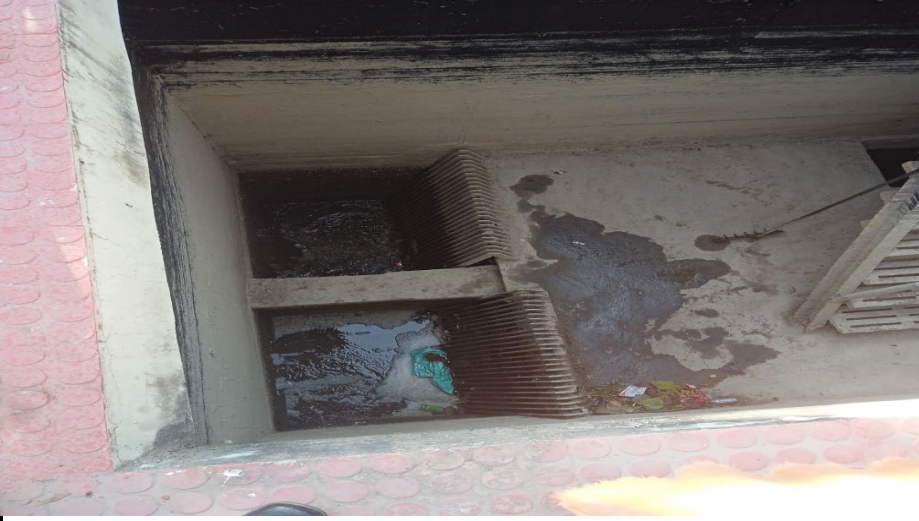
4	Receiving chamber	Civil Structure is unsatisfactory condition.

<ol style="list-style-type: none"> 1. Chamber should be cleaned and covered properly. 2. All valves should be replaced. 3. All stud bolts and gaskets should be replaced. 4. Lubrication for valves and pumps ,sluice gates should be done by KRMPL. 5. Pressure guage should be provided by KRMPL. 	15.12.2021		Pending
5	Pump House	Civil Structure is in good condition.

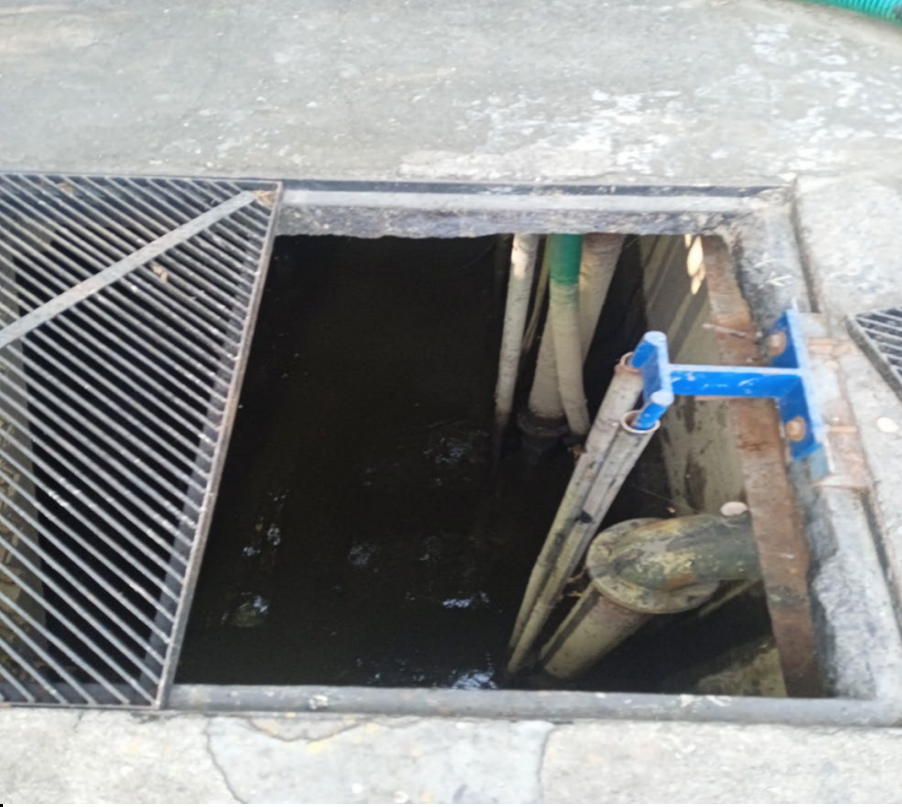
<ol style="list-style-type: none"> 1. Exposure of steel in staircase bottom slab needs to be renovated. 2. Inside the pump house, it was observed that light was not working. 3. EOT load test required by KRMPL. 4. Flow meter need to be installed by KRMPL. 5. Log book was not properly maintained by KRMPL staff at site. 6. Staircase is in bad condition and needs to be renovated. 7. Cable dressing needs to be done properly. 8. Operators are non technical person. They do not have clear understanding of the Pump Capacity , Flow of Discharge, and Peak Flow. Also staff does not maintain the records properly. 9. Utility water pump is not working since handover. 	23.11.2021		Pending

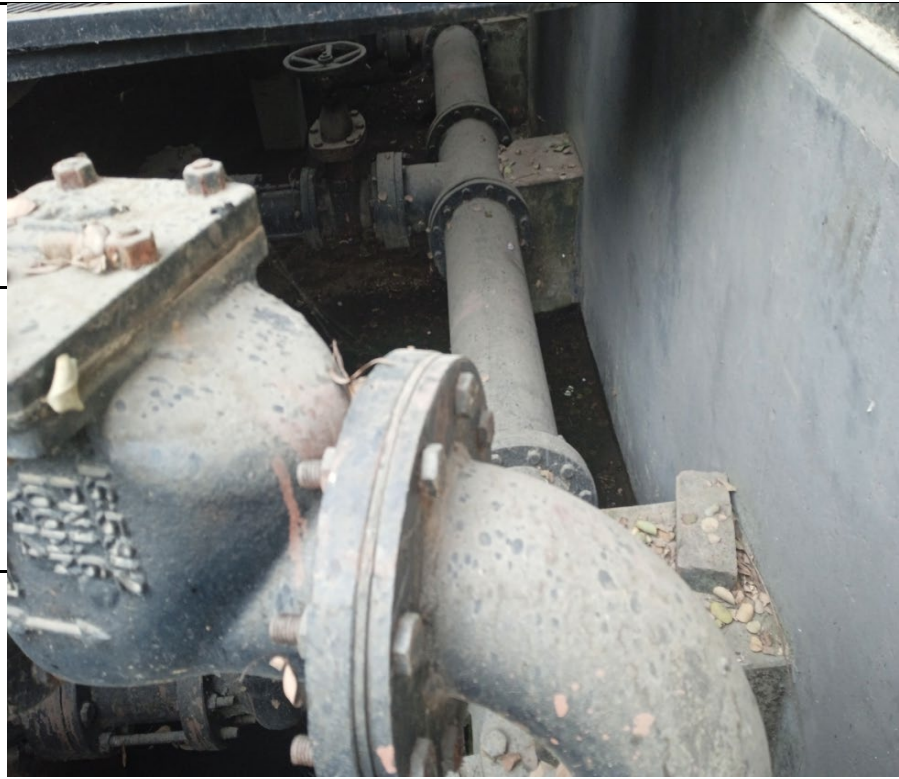
i	Pump no.1(Capacity=309cum/hr)	Operatioal

<ol style="list-style-type: none"> 1. New pump has been installed at 14.03.2022 to 20.03.2022. 2. KRMPL has not submitted any RFI during installation of new pumps. 3. Pump no. 01 found damaged from 02.06.2022,KRMPL needs to be reapir on urgent basis 	15.12.2021		Pending
ii	Pump no.2(Capacity=309cum/hr)	Operational		<p>New pump has been installed at 14.03.2022 to 20.03.2022. KRMPL has not submitted any RFI during installation of new pumps.</p>	23.11.2021		Pending
iii	Pump no.3(Capacity=168 cum/hr)	Non-Operational		<p>The pump is not in working conditin since 31.08.2022</p>	23.11.2021		Pending
6	Boundary wall and landscaping area	Civil Structure is in good condition.

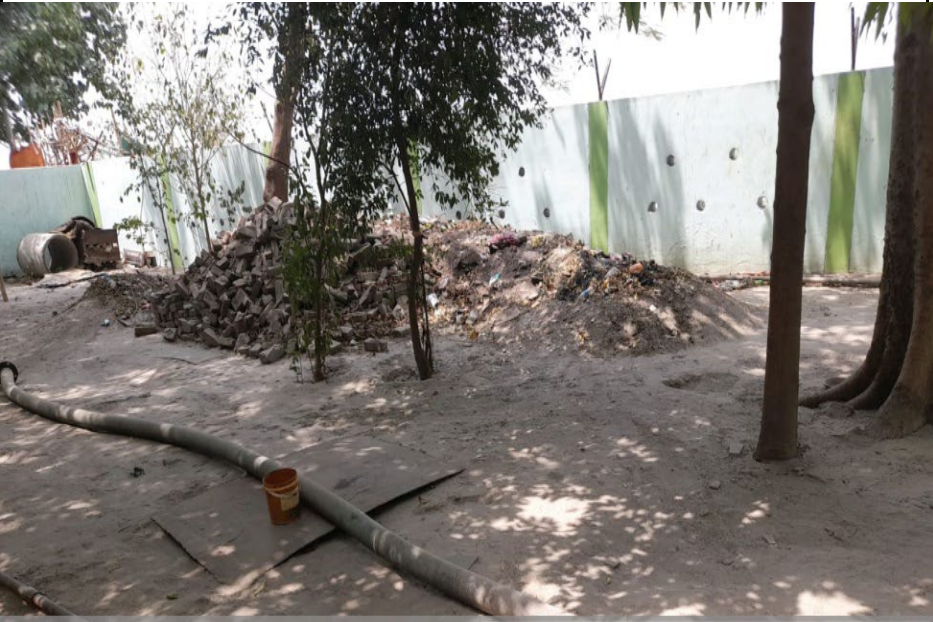
<ol style="list-style-type: none"> 1. Fencing work is pending. 2.Security guard should be arranged by KRMPL. 3. Cleaning work needs to be carried out by KRMPL. 	23.11.2021		Pending

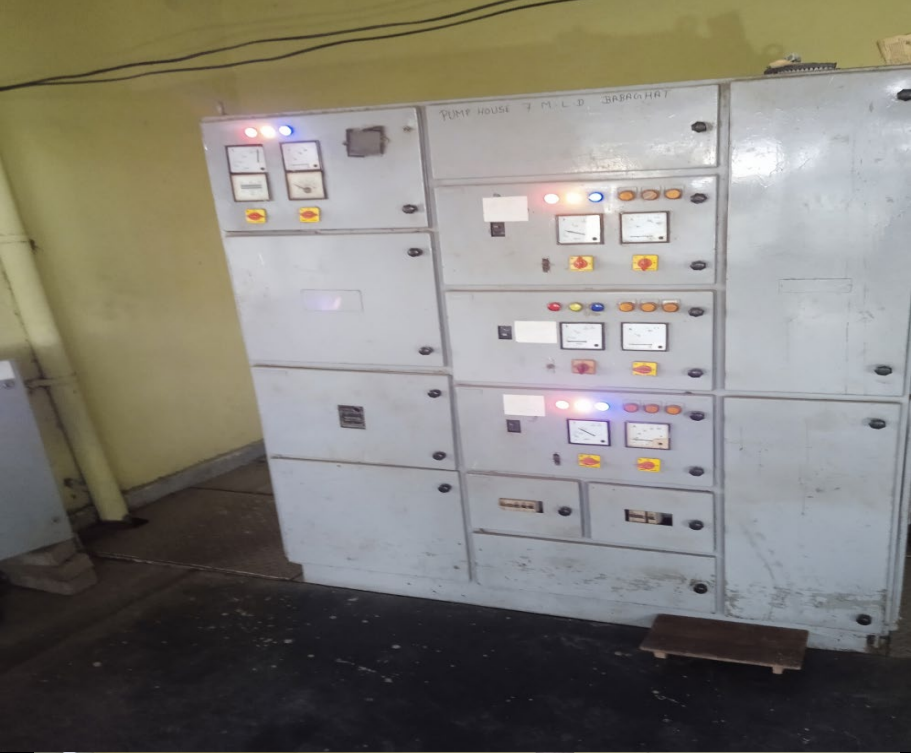
7	Panel Room	Structure is in unsatisfactory condition

<ol style="list-style-type: none"> 1. Voltmeters and Ammeters of the LT panels were not in working condition. 2. All tubelights, ceiling fans, exhaust fans were not in working condition. 3. During the inspection it was observed that the pumps were working on the temporary starters, as all the existing starters were non functional at the site. 4. Cable dressing was not properly done at the panel room. 	23.11.2021		Pending
8	DG Room	Civil Structure is in good condition.

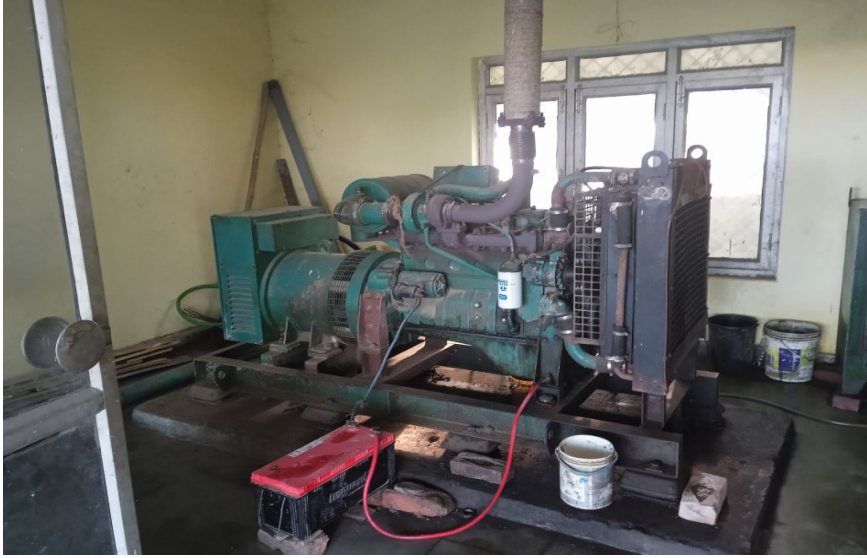
<ol style="list-style-type: none"> 1. DG is not working since 19.11.2022. 2. No exhaust fan was supplied in the DG room. 2. Aerial light no-3 was not in working condition. 2. KRMPL is not properly maintaining the log book for DG set. 3. Smog exhaust pipe length is not sufficient as per CPCB/CPHEEO guidelines. It must be replaced on urgent basis. 	23.11.2021		Pending

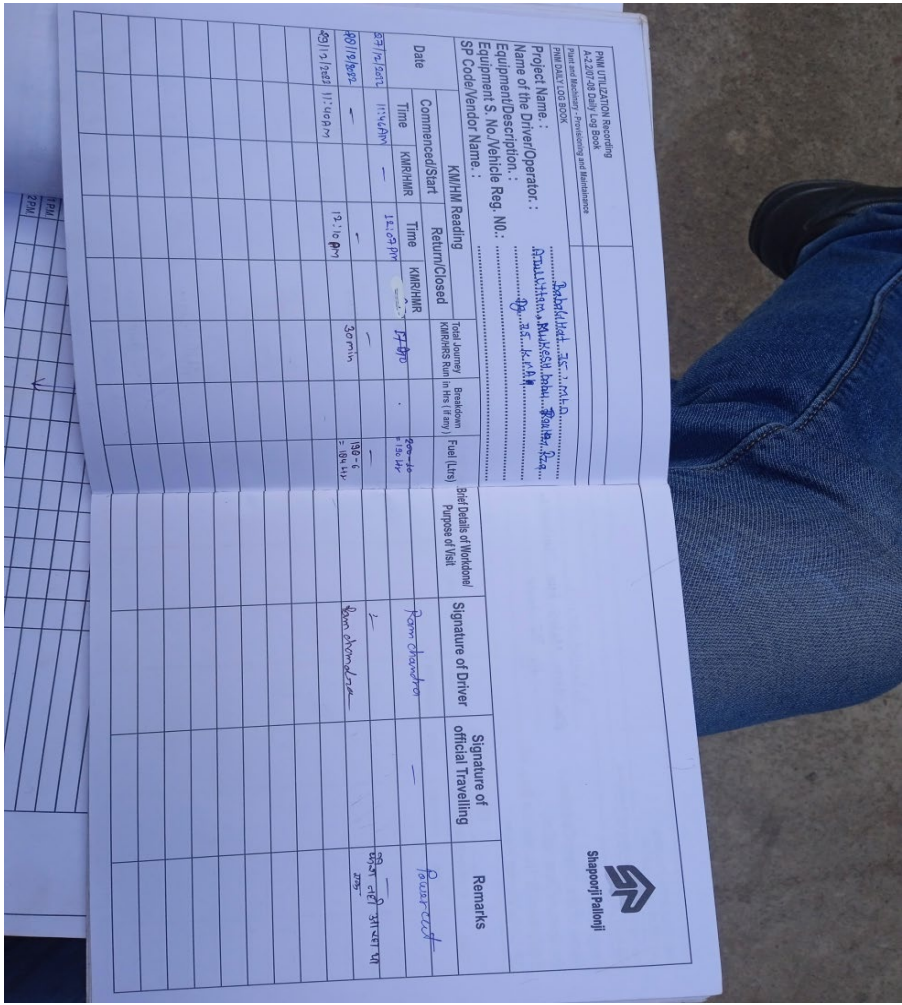
<ol style="list-style-type: none"> 1. Log book of pumps and DG set are not properly maintained by KRMPL. 2. Supervisor Mohammad, told STC team that KRMPL was earlier informed regarding limited diesel supply for the site and also raised the request to increase the diesel supply. But no action has been taken by KRMPL in this regard for Baba Ghat IPS. 4. KRMPL has not arranged adequate number of staff (Operators, Sweepers and relievers) for proper O&M of IPS. Operators are non technical person. They do not have clear understanding of the Pump Capacity, Flow of Discharge, and Peak Flow. Also records are not maintained properly. 5. KRMPL needs to maintain Visitor Register. 6. Security guard needs to be deployed. 7. No labour was available from KRMPL for renovation work. 	28.06.2022		Pending

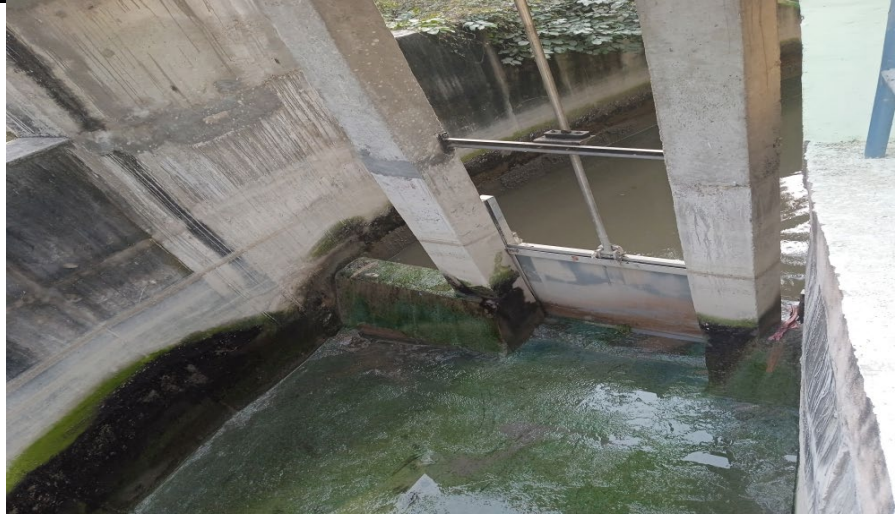
Although income tax gate was closed still, it was found that there was no Overflow/Bypass at the time of inspection	29.12.2022		Pending
2	Inlet Chamber	Civil Work is in satisfactory Condition			15.12.2021		pending
3	Manual bar Screen Chamber	Civil Work is in satisfactory Condition

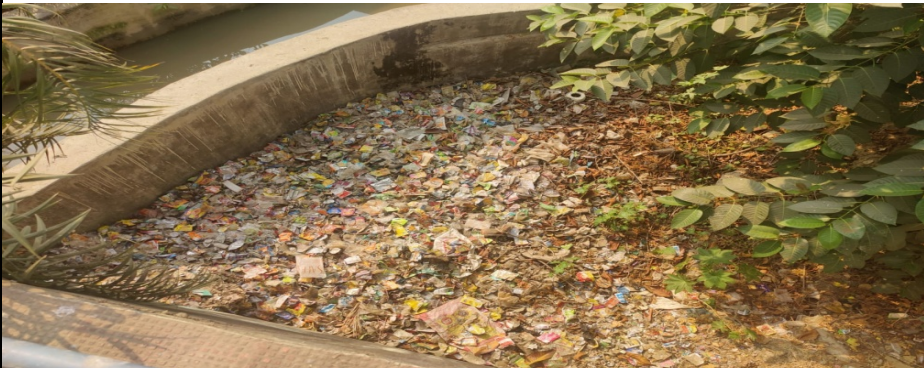
1. Garbages needed to be removed on regular basis. 2. Garbage trolley should be made available at the site.	23.11.2021		pending

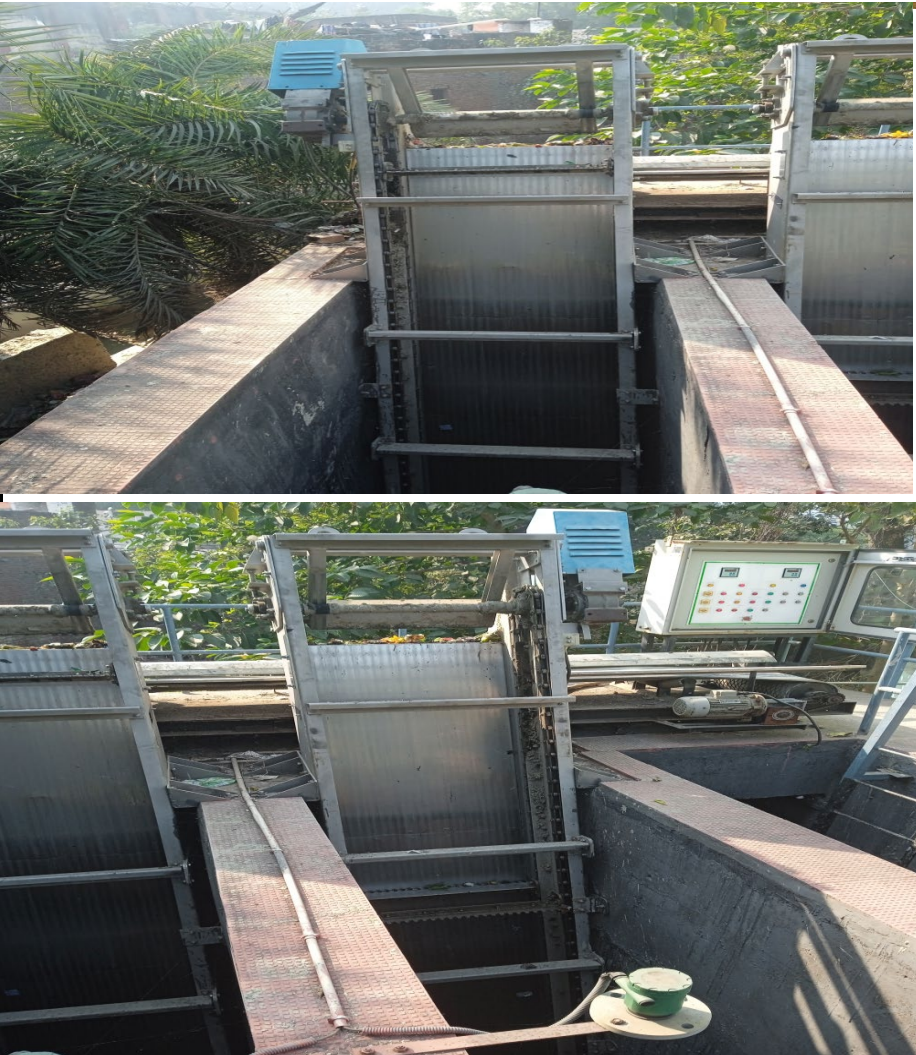
4	Mechanical bar screen Chamber	Civil Work is in satisfactory Condition

<ol style="list-style-type: none">1. Mechanical Screen No. 1 is damaged since 27.11.2022.2. Conveyor motor should be provided with canopy.3. Both mechanical screen and conveyor belt found non-operational at the time of inspection. It was started when asked by STC representative.4. Mechanical screen no. 1 was not working in auto mode.5. Auto System and level sensor meter were not in working condition.6. Screen panel On/Off main power selector switch was nonoperstional in auto mode.7. Screen No. 2 is in working condition.8. Conveyor belt is in working condition.9. Garbage needed to be removed on regular basis.10. Garbage trolley should be made available at site.11. Both Screen canopy power were not in working condition.12. Conveyor belt was not working in auto mode.13. Cable dressing was not properly done.14. Panel door system not working.15. Earthing was not done properly.16. Level sensor not working in screen chanel area, Level sensor Need to replace.	15.12.2021		pending

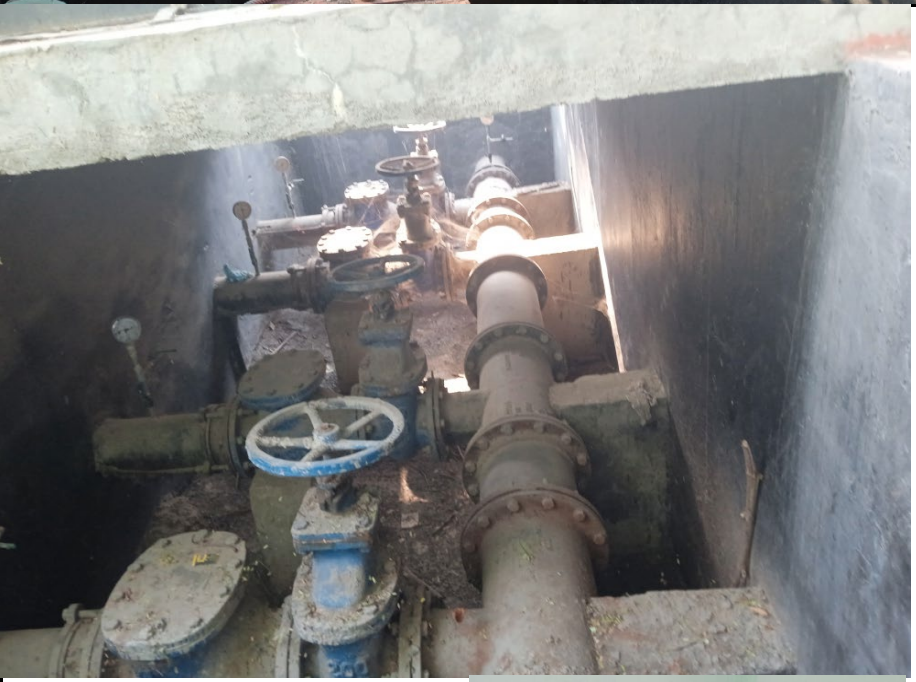
5	Pump House	Civil Work is in satisfactory Condition

<ol style="list-style-type: none">1. Pump No-4 was not in working condition.2. Starter for Pump No. 2 was not working and it is being operated with stater of Pump No. 4.3. Screen area light no-2 was not in working condition.4. Operators are non technical person. They do not have clear understanding of the Pump Capacity , Flow of Discharge, Peak Flow at the site. Also records are not properly maintained.5. Flow meter was not in working condition.6. 7 out of 9 lights were working.	23.11.2021		pending
6	Panel room	Civil Work is in satisfactory Condition

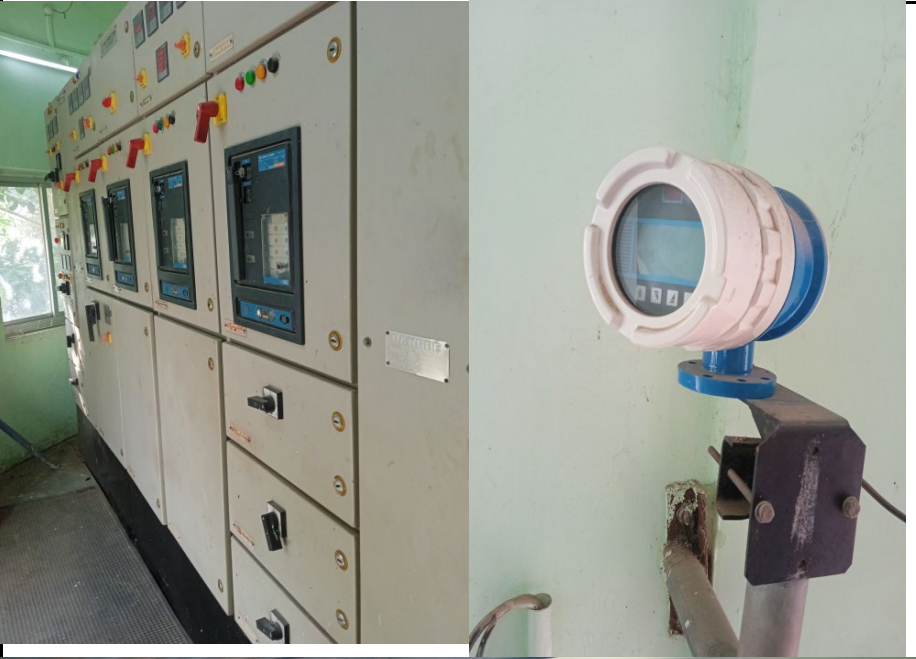
<ol style="list-style-type: none">1. Pump flow meter is not in woking condition since handover.2. Panel for Pump No. 2 is not working.3. Soft starter for 18.5 kW pump no- 2, 3, 4 were not in working condition.4.Exhaust no-9 and Tubelight no-2 were not in working condition.	23.11.2021		pending
