SITE INSPECTION OF JAJMAU ASSOCIATED IPS REPORT

Nawabganj IPS 32
MLD

Date: 29.12.2022

Parmat IPS

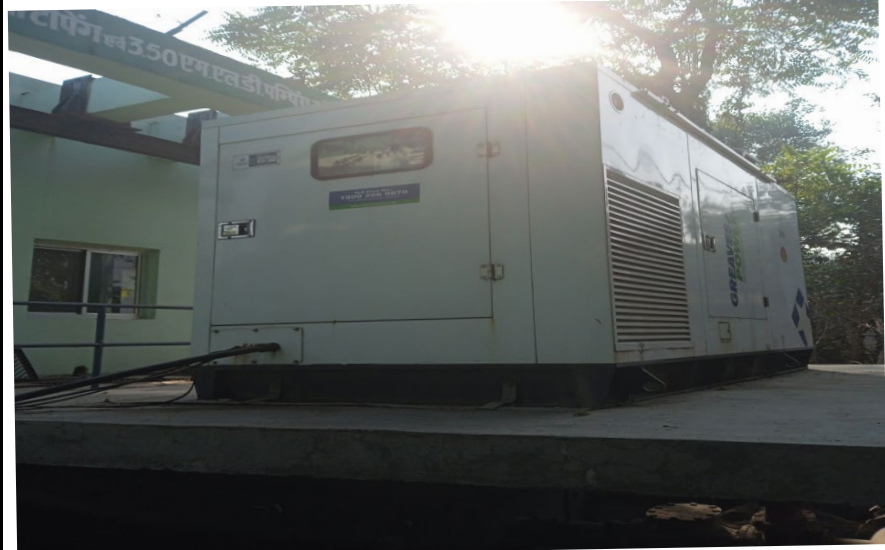
<ol style="list-style-type: none"> 1. DG set (125kV) was found to be in the working condition, but DG is getting heated during its operation and therefore was being operated in short intervals. 2. Log book of DG set is not maintain by KRMPL properly. 3. Smog exhaust pipe length is not sufficienttr as per CPCB/CPHEEO guidelines.It must be replaced on urgent basis. 4. Meter for diesel in the DG SET was not working. 5. Diesel stock was observed to be very less. 	23.11.2021		pending
9	Transformer yard	Civil Work is in satisfactory Condition

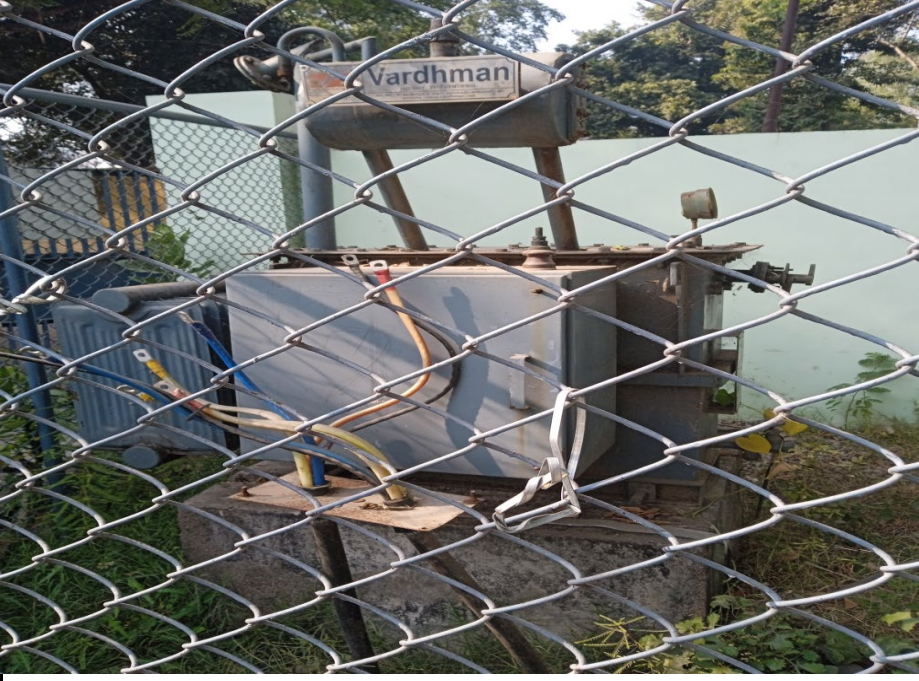
<ol style="list-style-type: none"> 1. Transformer no-2 (ACB 400 A) was not in working condition. 2. Cable termination work, earthing work, testing and commissioning are pending. 	13.12.2021		pending
10	Handrailng work	satisfactory Condition		<ol style="list-style-type: none"> 1. Installation of handrails needs to be done by KRMPL properly. 2. Security guard should be arranged by KRMPL. 	23.11.2021		pending

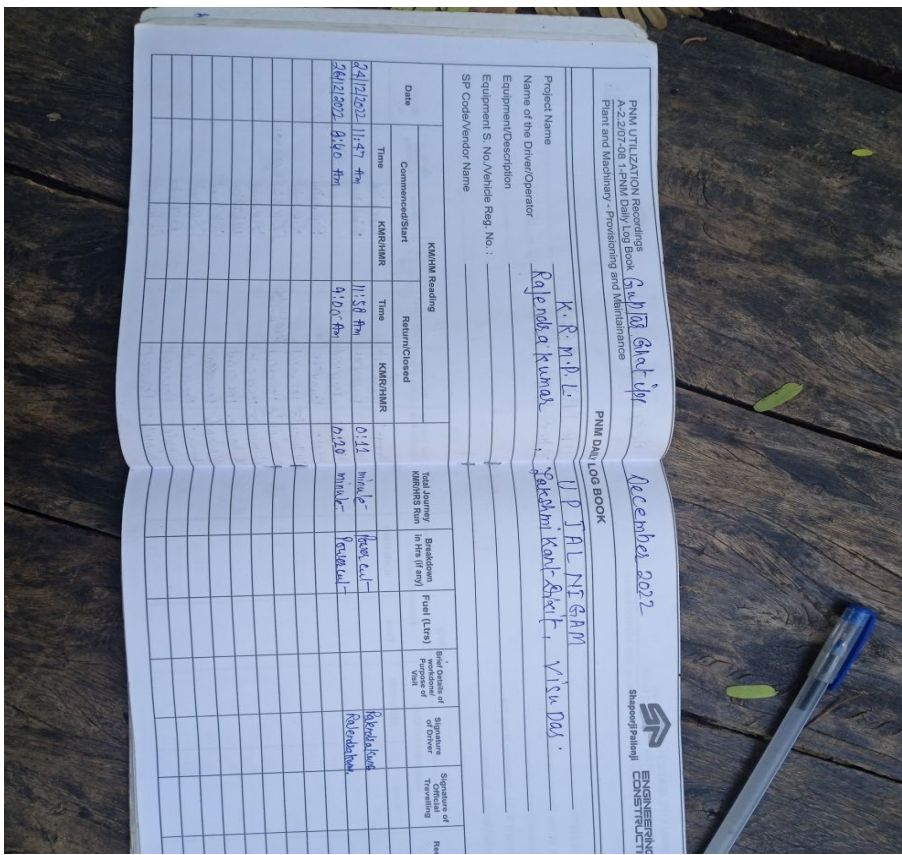
11	Logbook/Records/Documentation	Logbooks are not maintain properly by KRMPL

<p>1. Log book of pumps and DG set are being maintained by KRMPL. 2. No entry in the DG log book was observed since 17.11.2022.</p> <p>3. During the inspection only sweeper was answering the questions and showing the progress of the site. Therefore KRMPL must arrange adequate number of staff (Operators, Sweepers and relievers) for proper O&M of IPS. Operators are non technical person. They do not have clear understanding of the Pump Capacity , Flow of Discharge, Peak Flow. The records are also not maintained properly.</p> <p>4. During the inspection it was observed that readings filled in the logbook was found to be manipulated. Due to this, it is difficult to determine the actual hours of operation for pumps. Therefore, hour meter should be installed.</p> <p>5. No labour available by KRMPL for renovation work.</p> <p>6. Safety shoes and jackets for the staff was not available at the site.</p> <p>7. Cleaning material for housekeeping was not available at site.</p>	23.07.2021		Pending
