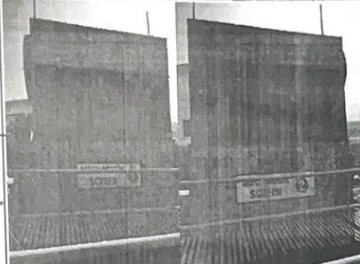
1. Screen gate mechanism was found to be in best condition. Needs to be replaced. 2. Screen gate alignment door gate is broken. Needs to be replaced. 3. Lubrication of gate mechanism was not properly done.	05.10.2022			
4	Mechanical Screen screen No 201	Non-Operational The rope mechanism is not properly aligned and screen gate was found between rope teeth and plate screen bar

1) Need to be installed at the worktop. 2) Rope mechanism must be aligned properly at the worktop. 3) Fixing needs to be done properly on the work, worktop, worktable etc. 4) Chain cover must be provided. 5) Long beam of mechanical screen must be replaced. 6) Cable drawing to be done.	20.08.2022 03.10.2022			Long Pending
5	Mechanical Screen screen No 202	Operational The rope mechanism is not properly aligned and screen gate was found between rope teeth and plate screen bar

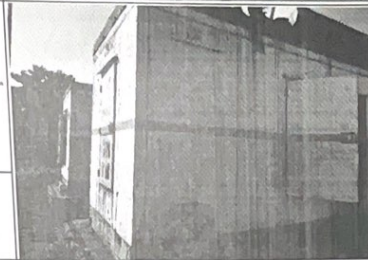
Need to be repaired and painted immediately.	28.01.2023	10.04.2023 New Date: 31.08.2023	LONG PENDING
109	SPD no. 1	Operational After 2 months of non-operational since 18.12.2021. It was made operational on 13.03.2022 Again, SPD is non-operational since 18.04.2022

1) Need to be modified at the worktop 2) Needs to be painted	10.04.2022 18.12.2021	21.08.2022 New Date: 31.07.2023 New Date: 18.07.2023	LONG PENDING
110	SPD no. 2	Operational		1) The subcharge must be modified 2) Needs to be painted 3) Subcharge element needs to be overhauled	03.10.2022		PENDING
111	House Flaming	House flaming work is found to be in very poor condition. This makes that BFP, is not doing house flaming work which is clear from the photographs

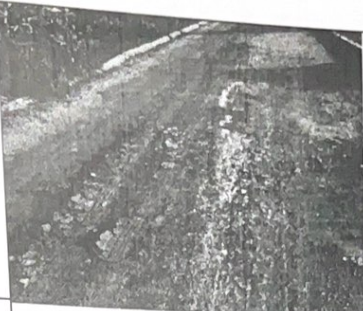
Internal roads were found damaged at various places

Internal road rehabilitation must be started at earliest and should be done in phased manner	28.11.2021	03.12.2021	Pending
Assembling Equipments	It was found that some equipments have been done by KSRAP, and some, relating to the experimental units are still pending which had already been specified to the donor exchange		Each equipment's status must be reported (the 1st, 2nd etc) in total where so that the equipments units can be identified easily	28.11.2021	28.02.2022	LONG PENDING
Laboratory	1) KSRAP's lab testing results are not matching with other agency's testing report. 2) Calibration Tests of Lab equipment are not performed. 3) Final culture results is exceeding the permissible limit with a huge margin. 4) Lab of equipment complete details are not found accessible at site. 5) It was found that the samples were kept at negative temperatures.		1) KSRAP's lab testing results are not matching with other agency's testing report. KSRAP must do the testing properly as per standard operating procedures as per CAP-1 (PHASE) manual. 2) Lab equipment must be calibrated. 3) Final Culture tests must to be validated due to huge variation with the 3rd party lab results. 4) Complete list of lab equipment with all information must be prepared and made available at site. 5) Temperature ranges must be made available for storing samples.	28.03.2022 28.12.2021		LONG PENDING
