National Mission for Clean Ganga- Development,
Rehabilitation with Operation & Maintenance of STPs at
Kanpur under Hybrid Annuity based PPP mode

Sub: HAM KANPUR: Inspection Report of 130 MLD STP Jajmau facilities, inspection done on 01.02.2023, 04.02.2023, 13.02.2023, and 15.02.2023.

SITE INSPECTION REPORT

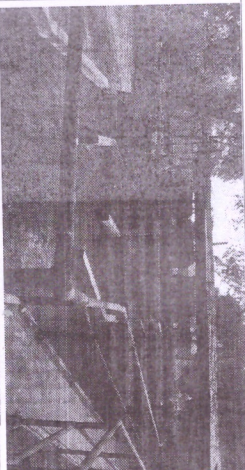
1. Railing and its foundation needs to be repaired. 2. Reinforced concrete work found required. 3. Formwork work of inlet chamber chamber need to be done properly. 4. Toe guard to be provided in hand railing. 5. RPP coating done in hand railing.		27.11.2021		Pending

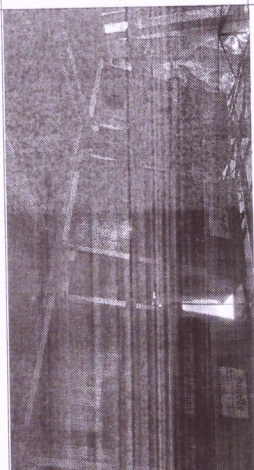
3	Screen Chamber (CWI)	Need Renovation

1. Renovation work found not properly. 2. Garbage, like Plastic bags, leather pieces, clothes must be removed from Belt conveyor of Screen Chamber regularly. 3. Need to be replaced the gates. 4. Proper Lighting need to be provided at Screen area. 5. Level scale should be properly clean and marking should be clearly visible. 6. MS Fabrication equipment & tools along with MS Shed also corroded & losses its strength. 7. In MS shed pipes are corroded & Colour of shed also worn out. 8. Mechanical Screen not working with auto system and without sensor. Need to be fixed the auto system immediately. 9. New cables should be laid properly in cable trays. 10. RPP coating done in Hand railing, screen channel area. 11. Maximum gap in bar screen should be fill.		27.11.2021		Pending
4	Mechanical Fine Screen no. 1	Operational

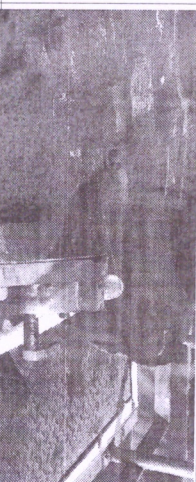
1. Renovation work found satisfactory. 2. Organic pump need to be installed as per approved drawing. 3. Cable need to be layed at Cable tray as per approved drawing. 4. IPBS need to be installed as per approved drawing. 5. Mobil leakage in grit no 1, KRMPL need to be fix it. 6. KNOF Houser not working. 7. TWT marking should be done with paint. 8. ORP non operational		27.11.2021		Pending

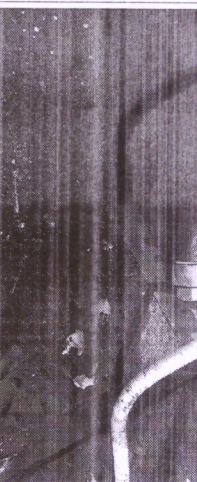
10	Grit Mechanism-2	Operated

1. Renovation work found satisfactory. 2. Organic pump need to be installed as per approved drawing. 3. Cable need to be layed at Cable tray as per approved drawing. 4. IPBS need to be installed as per approved drawing. 5. Torque switches installation done without canopy at all equipment. 6. Power supply is given to torque switch & associated equipment from temporarily MCB. Permanent supply is to be provided		27.11.2021		Pending	
11	Grit Mechanism-3	Operated

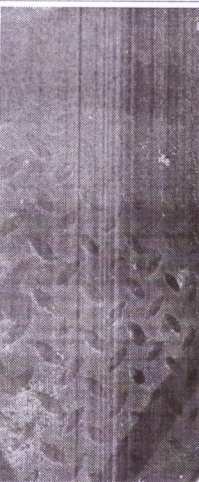
1. Repairing of Grit chamber done as per schedule. 2. Contractor is instructed to fill the water for hydrotest work on Grit Chamber 03 3. Renovation in screw conveyor channel is pending. 4. Grit Mechanism No. 3 torque switch was not in working condition. 5. Cable dressing not done properly. 6. Tonguard need to be provide in handdrilling		27.11.2021		Pending	
12	Grit Classifier-1	operational

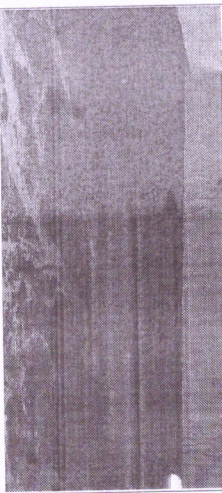
1. Only outer face of distribution chamber for primary sedimentation tank partially done by KRMPL. 2. Inside Rec wall, base and platform required renovation work. 3. Reinforced exposed and need to be repaired. 4. Source gate need to be replaced.		27.11.2021		Long Pending

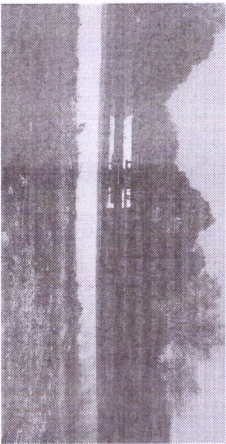
F	Primary Sedimentation tank								
21	Primary Sedimentation tank-1	Operated/ found in overflow condition

1. Scum Box design need to be changed. 2. Weir plate to be replaced at damaged portion. 3. PST mechanism to be replaced and install. 4. Remote system to be installed for PST-1. 5. Cable to be laid in cable tray. 6. Stair hand-railing need to be provide. 7. TML markingdone with paint. 8. Fencing to be provide on Truss platform. 9. LPS need to be installed as per approved drawing. 10. Torque switches installation done without canopy at all equipment. 11. Hoover is fixed on railing with temporary cable tie, which is not proper and unacceptable. 12. Power supply is given to torque switch & associated equipment from temporarily MCCB. Permanent supply is to be provided. 13. Torque switch alarm not working properly. 14. Torque switch not showing reading.		01.03.2021			Long Pending
22	Primary Sedimentation tank-2	Operated/ found in overflow condition

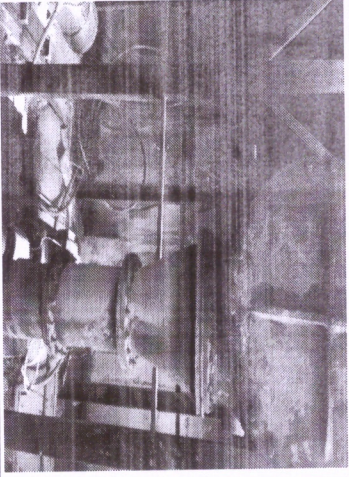
1. All pumps needs to be repaired and get operational. 2. Civil Drawing of pump foundation not submitted by RMCG for Renovation work. 3. Out of 11 pumps only 4 Nos pump has been working at site and 4,5,6,7,8 Nos. Pump are not in working condition. 4. Lighting arrangement and Cable to be laid in cable tray. 5. Thermometer and vibration meter should be at site. 6. Bearing to be repaired till the renovation period. 7. Motor cover to be repaired. 8. All pumps are found in damaged condition and need to be replaced. 9. Concessions should maintain log book of the pumps for proper record maintenance. 10. Leakage has been detected 2 number pump which are in operation and directed to repair the same immediately. 11. LIPS system to be install at site 12. Cable tray need to be painted immediately		27.11.2021		Long Pending

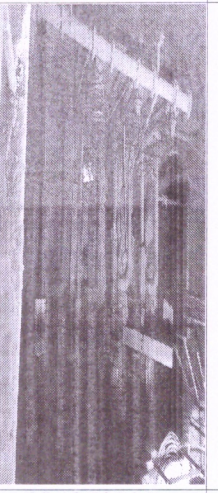
O	Thickened Sludge Pump House

1. Pump house structure plastering and finishing work should be proper. 2. Cracks should be treated with proper technique. 3. Remote system to be installed for TSPI. 4. Cable to be laid in cable tray. 5. All the equipment to be replaced as per CA. 6. Dewatering pump to be installed for dewatering extra water. 7. EOT crane lifting Exhaust fan to be installed. 8. Window need to be replaced. 9. Civil Renovation work required in RCC Slab.		27.11.2021		Long Pending

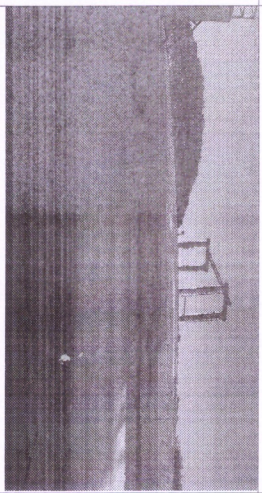
1. New pump installation work ongoing. 2. New valves & pipe line need to be installed	Jagannath SVP - JSD MID	01.02.2023, 04.02.2023, 13.02.2023, and 15.02.2023	INSPECTED BY: 1. Mr. Nishu Dwevedi, NMCB 2. Mr. Gyanendra Choudhary, PM1, UPIN 3. Mr. Shivakish Upal, AE, UPIN 4. Mr. Vishu Pal, JE, UPIN 5. Mr. Anil Kumar Sethi, Team leader, SITC Kanpur 6. Mr. Ajay Kumar Goyal, Support Engineer (Mechanical), SITC Kanpur 7. Mr. Manish Saxena, Support Engineer (Electrical), SITC Kanpur 8. Mr. Indar Dev Pandey, Support Engineer (Civil), SITC Kanpur 9. Mr. Karam Veer Singh, Site Supervisor (Civil), SITC Kanpur 10. Mr. Dhruv Mittal, Site Supervisor (Electrical), SITC Kanpur 11. Mr. Krishna Prasad (in charge), KRMPL

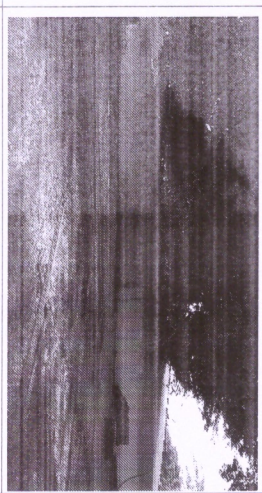
1. Removal of centrally located sludge mixing shaft from Primary Digester 1. 2. Gate to be overhaul 3. Civil Structure of the Digester to be renovate and cracks to be treated. 4. Leakage to be Arrested in the Digester. 5. Installation of the Railing at the boundary of the dome. 6. Finishing work to be done.	27.11.2021	27.11.2021	Long Pending

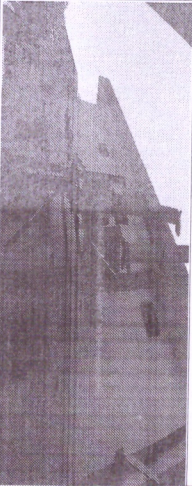
As per CA, Gas Flaring to be replaced.		01.03.2021			Long Pending
X		Bio gas Compressor								
105		Bogas Compressor Building					01.03.2021			
106		Bio gas Compressor no.1	Dismantling done by KRMPL

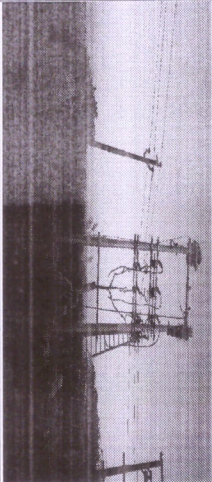
1. DP structure erection work not as per approved drawing, need to be installed as per approved drawing. 2. DP pipe earthing work in not done, need to be earthed immediately. 3. Pole foundation need to done properly.				pending
