<div>STC</div> <div>SITE INSPECTION OF JAJMAU ASSOCIATED IPS REPORT</div>					Nawabganj IPS 32 MLD	Date: 22.02.2023	INSPECTED BY: STC Team 1. Mr Ajay Kumar Goyal, Support Engineer, Mechanical, STC Kanpur 2. Mr. Karam Veer Singh, Support Site Supervisor, STC Kanpur

<div>STC</div> <div>SITE INSPECTION OF JAJMAU ASSOCIATED IPS REPORT</div>					Parmat IPS	Date: 22.02.2023	INSPECTED BY: STC Team 1. Mr Ajay Kumar Goyal, Support Engineer, Mechanical, STC Kanpur 2. Mr. Karam Veer Singh, Support Site Supervisor, STC Kanpur

<div> <div>STC</div> <div> <div></div> <div>SITE INSPECTION OF JAJMAU ASSOCIATED IPS REPORT</div> </div> </div>					Baba Ghat -7 MLD	Date: 29.11.2022	INSPECTED BY: STC Team 1. Mr Ajay Kumar Goyal,Support Engineer, Mechanical, STC Kanpur 2. Mr. Karam Veer Singh, Support Site Supervisor, STC Kanpur

<div> <div>STC</div> <div> <div></div> <div>SITE INSPECTION OF JAJMAU ASSOCIATED IPS REPORT</div> </div> </div>					Guptar Ghat	Date: 22.02.2023	INSPECTED BY: STC Team 1. Mr Ajay Kumar Goyal,Support Engineer, Mechanical, STC Kanpur 2. Mr. Karam Veer Singh, Support Site Supervisor, STC Kanpur

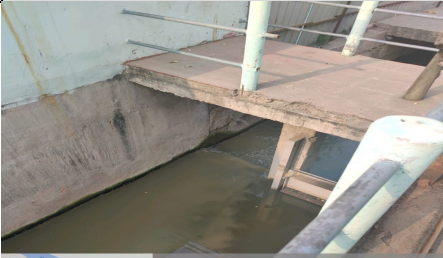
S. No.	Equipment	Assessment of Current Condition	Assessment of Current Condition Photo	Current defects and Corrective Action Suggested by PE	Original Date of Issue	Proposed Date to Resolve by KRMPL	Current Status of Compliance
1	All work						
1	Inlet Over Flow Condition	Overflow condition found since handover

1. During site visit overflow is observed since handover 28.06.2021. 2. No action has been taken by KRMPL despite being informed, several times by NMCG, UPJN and STC representatives. 3. As per renovation plan for IPS Nawabganj , KRMPL should increase adequate pumping to prevent overflow of sewage.	28.06.2021		Long Pending
2	Inlet Chamber	1. Cleaning of inlet chamber needs be done on regular basis. 2. Staircase damaged tile needs to be renovated.		1. Cleaning of inlet chamber needs be done on regular basis. 2. Staircase damaged tile needs to be renovated.	23.11.2021		Long Pending
3	Screen Chamber	1. Garbages has accumulated into screen chamber.		1. Garbage cleaning work should be done on regular basis. 2. Garbage Trolley should be made available at the site.	23.11..2021		Pending

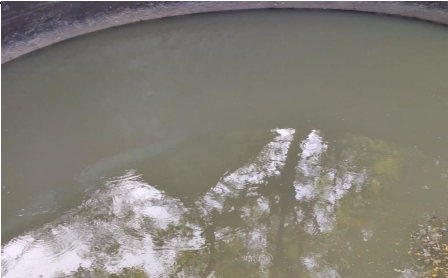
4	Receiving Chamber 1	Non-Operational

<ol style="list-style-type: none"> 1. Proper pumping arrangement should be maintained by KRMPL. 2. Receiving chamber must be cleaned on regular basis. 3. Manual screen needs to be installed as per renovation plan. 4. KRMPL must ensure that after completing cleaning work of the chamber, the renovation work should begin. 	28.06.2021		Long Pending
5	Receiving Chamber 2	Operational	 	<ol style="list-style-type: none"> 1. For Receiving Chamber 02, the sludge removal work has been done. 2. Repairing work needs to be done by KRMPL. 	28.06.2021		Long Pending
6	Pump House No.1	Civil Structure in unsatisfactory Condition

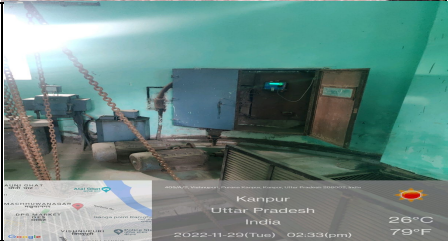
<ol style="list-style-type: none"> 1. Pump House no-1 is non operational since date 29.08.2022. All pumps were non operational. 2. During the inspection, all pumps and motors were observed to be in submergence condition. 3. Chain pulley, LT panels, Cable tray and cable dressing were damaged. 4. 2 Nos Exhaust Fan were not working. 5. Dewatering pumps are not installed. 6. Log book is not maintaining properly by KRMPL staff as per prescribed format. 	23.11.2021		Long Pending

i	Pump no.1 (Capacity =297 m3/hr)	Non-Operational		Need to be replaced as per Renovation Plan	23.11.2021		Long Pending
ii	Pump no.2 (Capacity =156 m3/hr)	Non-Operational		Need to be replaced as per Renovation Plan	23.11.2021		Long Pending
iii	Pump no.3 (Capacity =297m3/hr)	Non-Operational		Pump no. 3 found non-operational since 27.05.2022. KRMPL needs to repair it on urgent basis.	23.11.2021		Long Pending

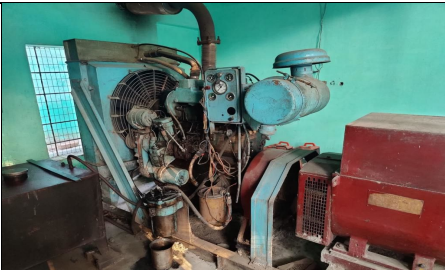
12	DG set room	Civil Structure in satisfactory Condition

<ol style="list-style-type: none"> 1. DG set is in working condition. 2. Log book of DG set is not maintaining properly by KRMPL. 3. Diesel surplus quantity is not available at site. 4. Smog exhaust pipe length is not sufficient as per CPCB/CPHEEO guidelines. Therefore, it must be replaced on urgent basis. 	23.11.2021		Pending
13	Metering Room	Civil Structure in unsatisfactory Condition

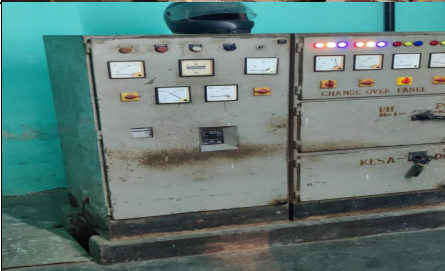
<ol style="list-style-type: none"> 1. Seepage was observed on the wall of this room. It should be rectified. 2. Panel Volt meters and Ammeters needs to be replaced. 3. All Phase Indicators needs to be replaced. 	23.11.2021		Long Pending
14	Logbook	Log book of pump house 01 not maintained by KRMPL

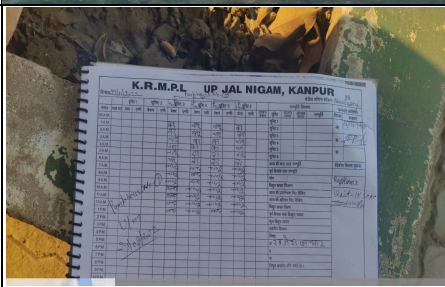
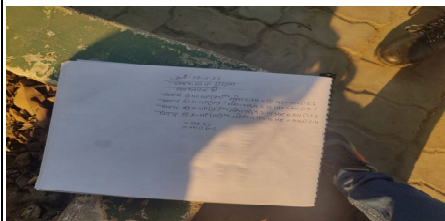
<ol style="list-style-type: none"> 1. Security guard should be arranged by KRMPL. 2. Diesel stock log book was not maintained properly by KRMPL on regular basis. 3. Pumps log book was not maintained properly. 4. Maintenance records was not available at site for all E&M equipments. 5. Arrangement of reliever for Operators and sweepers should be done by KRMPL. 6. DG log book was not maintained properly by KRMPL. 7. Material inward and outward registers need to be maintained properly by KRMPL. 	28.06.2021		Long Pending

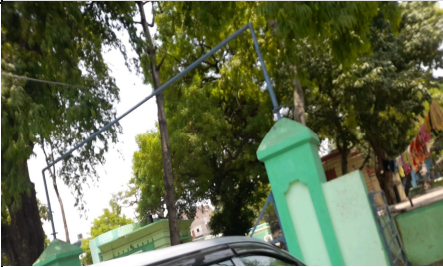
*	Main entry Gate	No informatory sign board for Parmat IPS was available at the entry gate.

1. KRMPL should arrange informatory sign board for Parmat IPS.	07.04.2022		Pending
1	Inlet Chamber	Civil Structure is in unsatisfactory condition

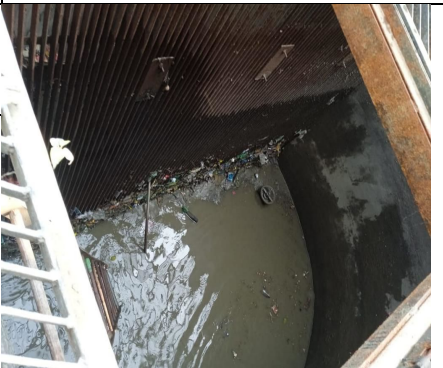
1. Renovation work is required for the inner and outer surface of the chamber. 2. Plaster work needs to be done. 3. Cleaning and landscaping work needs to be done. 4. MS frame cover should be painted.	23.11.2021		Pending
3	Receiving Chamber	Civil Structure is in satisfactory condition		1. Screens should be replaced 2. Garbage material needed to be removed on a timely basis. 3. Renovation work is required for inner and outer surface of the receiving chamber in all respects. 4. Cleaning and landscaping work needed to be done. 5. MS frame cover should be painted.	23.11.2021		Pending

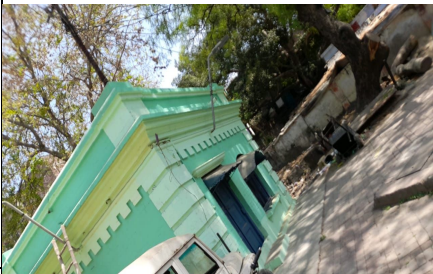
1.Pump house no-3 is defunct since handover. 2. Renovation work are pending from KRMPL's end. 3. Cracks needs to be repaired, and damaged door,window,louvers and ventilators needs to be replaced.	23.11.2021		Pending
7	DG room	Civil Structure is in unsatisfactory condition

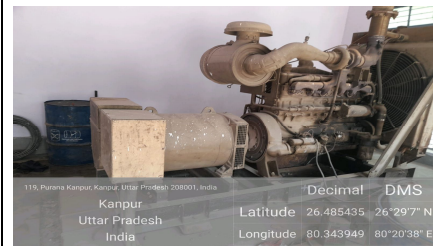
1. Voltmeters, Ammeters were not in working condition. 2. According to the DG logbook, diesel was not available at the site. 3. DG set for Pump House no-1 was non operational. 4. Cracks needs to be repaired, and damaged door,window,louvers and ventilators needs to be replaced. 5. DG logbook is not maintained properly. 6. Smog exhaust pipe length was not sufficientr as per CPCB/CPHEEO guidelines. Therefore, it must be replaced on urgent basis.	23.11.2021		Pending

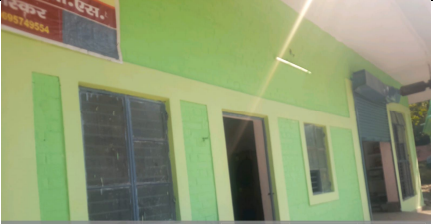
8	Metering room	Civil Structure is in unsatisfactory condition

1.Inside and outside painitng work completed by KRMPL under renovation. 2. Replacement of damaged Door,window,louvers and ventilators is pending. 3. Flooring work needs to be renovated.	23.11.2021		Pending

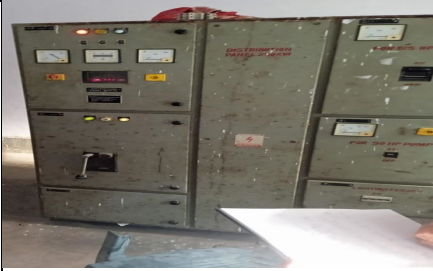
9	Panel Room	Civil Structure is in unsatisfactory condition

<p>1. Inside and outside painting work is completed by KRMPL under renovation.</p> <p>2. Damaged Door,window,louvers and ventilators needs to be replaced.</p> <p>2. Panel Volt meters and Ammeters needed to be replaced.</p> <p>3.All Phase Indicator needed to be replaced.</p>	23.11.2021		Pending
10	Logbook	Log book of pump house 01 and pump house no. 02 has not maintained by KRMPL properly

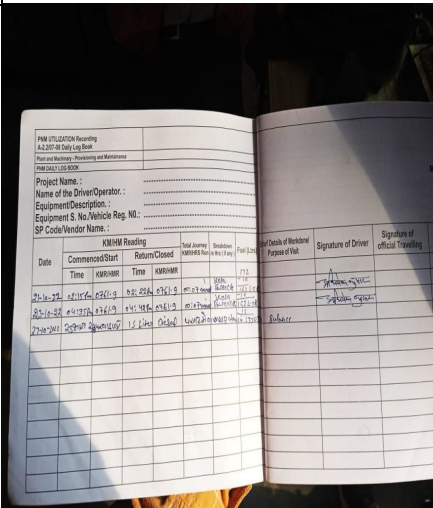
<p>1. Logbooks for pumps and DG sets are not properly maintained by KRMPL.</p> <p>2. KRMPL has not arranged adequate number of staff (Operators, Sweepers and relievers) for proper O&M of IPS and attendance register contains manipulated staff details. Operators are non technical person. They do not have clear understanding of the Pump Capacity , Flow of Discharge, and Peak Flow at the site. Also the records are not maintained properly.</p> <p>3. Security guard needs to be deployed at the site.</p> <p>4. No labour available from KRMPL for renovation work.</p>	23.07.2021		Pending

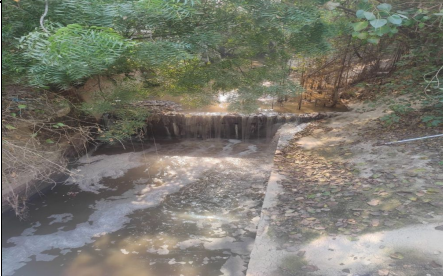
S. No.	Equipment	Assessment of Current Condition	Assessment of Current Condition Photo	Current defects and Corrective Action Suggested by STC	Original Date of Issue	Proposed Date to Resolve by KRMPL	Current Status of Compliance
A	All work						
1	Inlet Over Flow Condition	During site visit No Overflow or Bypass of sewage was observed.

1. During the inspection, No Overflow or Bypass of sewage was observed. 2. Raw sewage by-pass sluice gate need to be replaced. Design,drawing need to be submitted by KRMPL.	4.01.2022		Pending
2	Inlet Chamber (Civil)	Civil Structure is in satisfactory condition

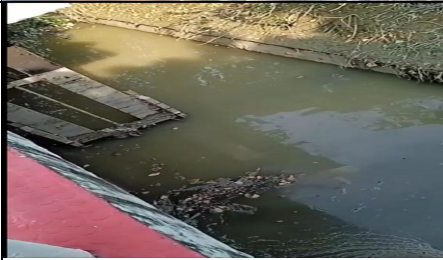
1. All gates needs to be lubricated. 2.Sludge should be removed regularly from inlet parts of IPS. 3. Regular cleaning of the chamber should be done.	23.11.2021		Pending
2A	Inlet Flow Meter	Inlet Flow meter is not available.		Inlet Flow meter is not available.	23.11.2021		Pending
3	Screen Chamber	Civil Structure is in satisfactory condition

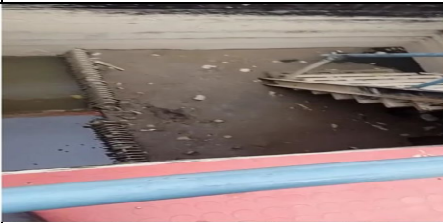
1. No sweeper was present in the screen chamber. 2. Garbage removal work and cleaning of the screen should be done on regular basis. 3. Trolly should be made available at the site for proper disposal of garbages. 4. Durind the inspection it was observed that screen was completely submerged at the site.	23.11.2021		Pending

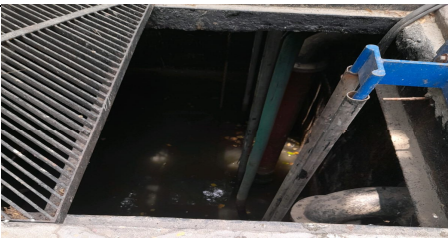
4	Receiving chamber	Civil Structure is unsatisfactory condition.

<ol style="list-style-type: none"> 1. Chamber should be cleaned and covered properly. 2. All valves should be replaced. 3. All stud bolts and gaskets should be replaced. 4. Lubrication for valves and pumps ,sluice gates should be done by KRMPL. 5. Pressure guage should be provided by KRMPL. 	15.12.2021		Pending
5	Pump House	Civil Structure is in good condition.

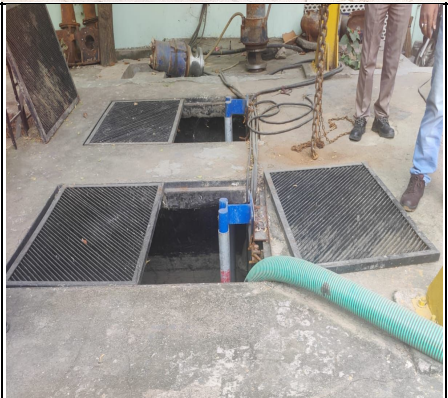
<ol style="list-style-type: none"> 1. Exposure of steel in staircase bottom slab needs to be renovated. 2. Inside the pump house, it was observed that light was not working. 3. EOT load test required by KRMPL. 4. Flow meter need to be installed by KRMPL. 5. Log book was not properly maintained by KRMPL staff at site. 6. Staircase is in bad condition and needs to be renovated. 7. Cable dressing needs to be done properly. 8. Operators are non technical person. They do not have clear understanding of the Pump Capacity , Flow of Discharge, and Peak Flow. Also staff does not maintain the records properly. 9. Utility water pump is not working since handover. 	23.11.2021		Pending

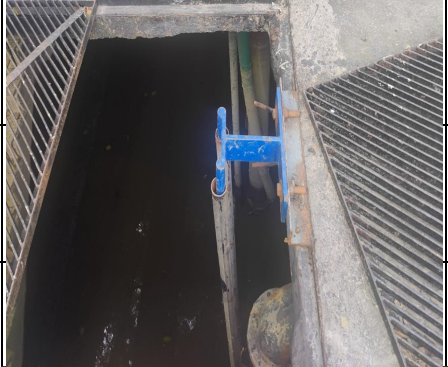
i	Pump no.1(Capacity=309cum/hr)	Operational

<ol style="list-style-type: none"> 1. New pump has been installed at 14.03.2022 to 20.03.2022. 2. KRMPL has not submitted any RFI during installation of new pumps. 3. Pump no. 01 found damaged from 02.06.2022,KRMPL needs to be reapiro n urgent basis 	15.12.2021		Pending
ii	Pump no.2(Capacity=309cum/hr)	Operational		<p>New pump has been installed at 14.03.2022 to 20.03.2022. KRMPL has not submitted any RFI during installation of new pumps.</p>	23.11.2021		Pending
iii	Pump no.3(Capacity=168 cum/hr)	Non-Operational		<p>The pump is not in working conditin since 31.08.2022</p>	23.11.2021		Pending
6	Boundary wall and landscaping area	Civil Structure is in good condition.

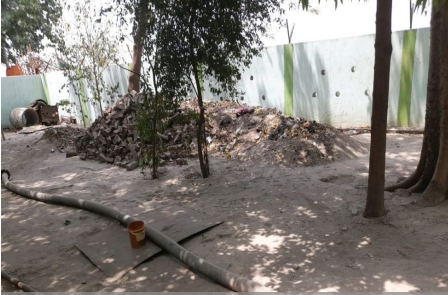
<ol style="list-style-type: none"> 1. Fencing work is pending. 2.Security guard should be arranged by KRMPL. 3. Cleaning work needs to be carried out by KRMPL. 	23.11.2021		Pending

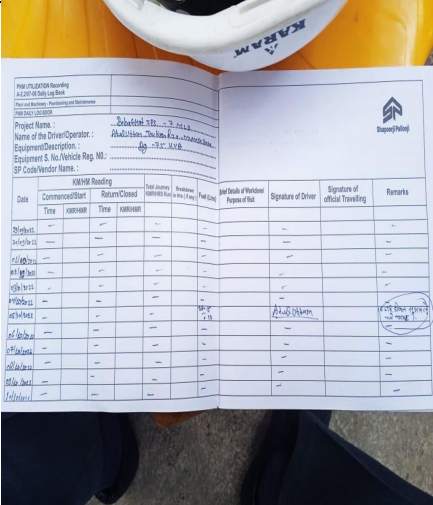
10	Logbook	Logbooks are not maintained properly by KRMPL

<p>1. Log book of pumps and DG set are not properly maintained by KRMPL.</p> <p>2. According to logbook, power was not supplied to the site on date 05.10.2022 from 1:30 pm to 4:50 pm. Supervisor Mohammad told STC team that, power cut was due to fault at Parmat Ghat IPS. But according to DG logbook, diesel was not available at the site from date 26.09.2022 to 26.10.2022. This indicates shortage of diesel supply at the site.</p> <p>3. Supervisor Mohammad, told STC team that KRMPL was earlier informed regarding limited diesel supply for the site and also raised the request to increase the diesel supply. But no action has been taken by KRMPL in this regard for Baba Ghat IPS.</p> <p>4. KRMPL has not arranged adequate number of staff (Operators, Sweepers and relievers) for proper O&M of IPS. Operators are non technical person. They do not have clear understanding of the Pump Capacity, Flow of Discharge, and Peak Flow. Also records are not maintained properly.</p> <p>5. KRMPL needs to maintain Visitor Register.</p> <p>6. Security guard needs to be deployed.</p> <p>7. No labour was available from KRMPL for renovation work.</p>	28.06.2022		Pending

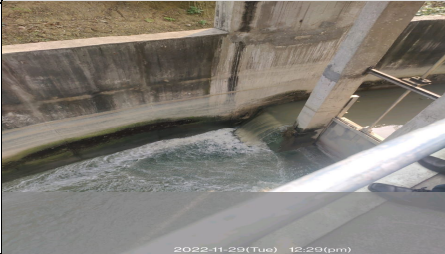
S. No.	Equipment	Assessment of Current Condition	Assessment of Current Condition Photo	Current defects and Corrective Action Suggested by STC	Original Date of Issue	Proposed Date to Resolve by KRMPL	Current Status of Compliance
A	All work						
1	Inlet Over Flow Condition	Over flow was observed

Although income tax gate was closed still, it was found that there was Overflow/Bypass of sewage due to power not open inlet gate on 22.02.2023.	22.02.2023		Pending
2	Inlet Chamber	Civil Work is in satisfactory Condition			15.12.2021		pending
3	Manual bar Screen Chamber	Civil Work is in satisfactory Condition

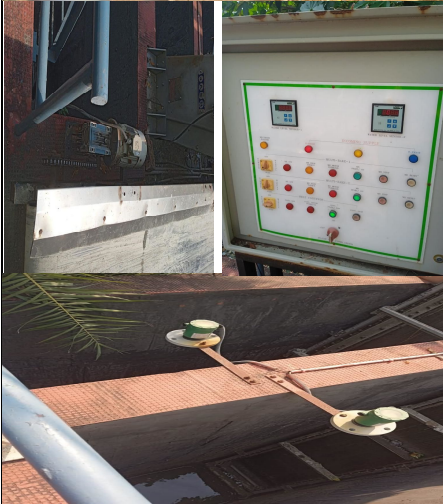
4	Mechanical bar screen Chamber	Civil Work is in satisfactory Condition

<ol style="list-style-type: none"> 1. Mechanical Screen No. 1 is damaged since 27.11.2022. 2. Conveyor motor should be provided with canopy. 3. Both mechanical screen and conveyor belt found non-operational at the time of inspection. It was started when asked by STC representative. 4. Mechanical screen no. 1 was not working in auto mode. 5. Auto System and level sensor meter were not in working condition. 6. Screen panel On/Off main power selector switch was nonoperstional in auto mode. 7. Screen No. 2 is in working condition. 8. Conveyor belt is in working condition. 9. Garbage needed to be removed on regular basis. 10. Garbage trolley should be made available at site. 11. Both Screen canopy power were not in working condition. 12. Conveyor belt was not working in auto mode. 13. Cable dressing was not properly done. 14. Panel door system not working. 15. Earthing was not done properly. 	15.12.2021		pending

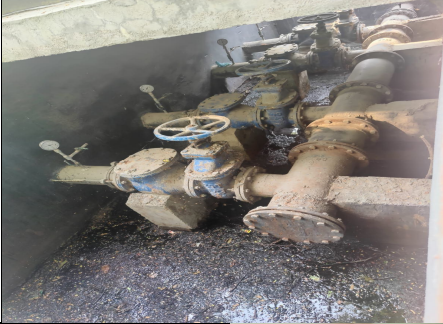
5	Pump House	Civil Work is in satisfactory Condition

<ol style="list-style-type: none"> 1. Pump No-4 was not in working condition. 2. Starter for Pump No. 2 was not working and it is being operated with stater of Pump No. 4. 3. Screen area light no-2 was not in working condition. 4. Operators are non technical person. They do not have clear understanding of the Pump Capacity , Flow of Discharge, Peak Flow at the site. Also records are not properly maintained. 5. Flow meter was not in working condition. 6. 7 out of 9 lights were working. 	23.11.2021		pending
6	Panel room	Civil Work is in satisfactory Condition

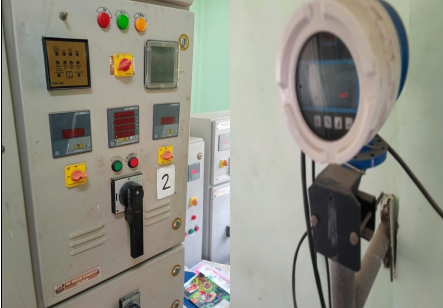
<ol style="list-style-type: none"> 1. Pump flow meter is not in woking condition since handover. 2. Panel for Pump No. 2 is not working. 3. Soft starter for 18.5 kW pump no- 2, 3, 4 were not in working condition. 4.Exhaust no-9 and Tubelight no-2 were not in working condition. 	23.11.2021		pending

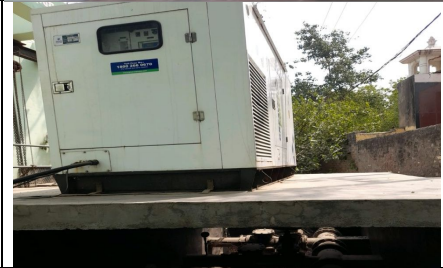
<ol style="list-style-type: none"> 1. DG set (125kv) was found to be in the working condition, but DG is getting heated during its operation and therefore was being operated in short intervals. 2. Log book of DG set is not maintain by KRMPL properly. 3. Smog exhaust pipe length is not sufficient as per CPCB/CPHEEO guidelines. It must be replaced on urgent basis. 4. Meter for diesel in the DG SET was not working. 5. Diesel stock was observed to be very less. 	23.11.2021		pending
9	Transformer yard	Civil Work is in satisfactory Condition

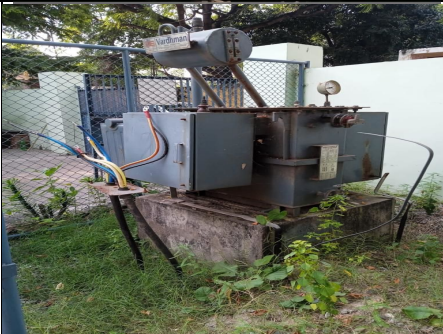
<ol style="list-style-type: none"> 1. Transformer no-2 (ACB 400 A) was not in working condition. 2. Cable termination work, earthing work, testing and commissioning are pending. 	13.12.2021		pending
10	Handrailing work	satisfactory Condition		<ol style="list-style-type: none"> 1. Installation of handrails needs to be done by KRMPL properly. 2. Security guard should be arranged by KRMPL. 	23.11.2021		pending

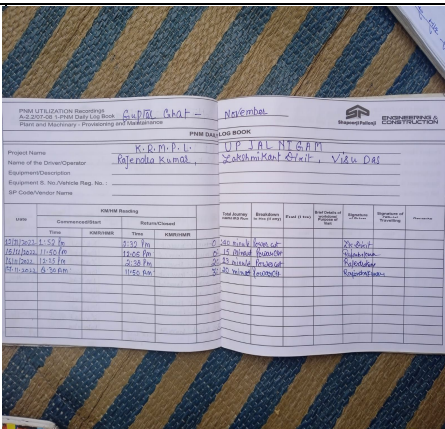
11	Logbook/Records/Documentation	Logbooks are not maintained properly by KRMPL

<p>1. Log book of pumps and DG set are being maintained by KRMPL.</p> <p>2. No entry in the DG log book was observed since 17.11.2022.</p> <p>3. During the inspection only sweeper was answering the questions and showing the progress of the site. Therefore KRMPL must arrange adequate number of staff (Operators, Sweepers and relievers) for proper O&M of IPS. Operators are non technical person. They do not have clear understanding of the Pump Capacity , Flow of Discharge, Peak Flow. The records are also not maintained properly.</p> <p>4. During the inspection it was observed that readings filled in the logbook was found to be manipulated. Due to this, it is difficult to determine the actual hours of operation for pumps. Therefore, hour meter should be installed.</p> <p>5. No labour available by KRMPL for renovation work.</p> <p>6. Safety shoes and jackets for the staff was not available at the site.</p> <p>7. Cleaning material for housekeeping was not available at site.</p>	23.07.2021		Pending
