National Mission for Clean Ganga- Development, Rehabilitation with
Operation & Maintenance of STPs at Kanpur under Hybrid Annuity based PPP mode

Sub: HAM KANPUR: Inspection Report of 43 MLD STP Jajmau facilities, Inspection done on
10.02.2023

SITE INSPECTION REPORT FOR 43 MLD JAJMAU PHASE-II STP

JAJMAU PHASE-II
STP - 43 MLD

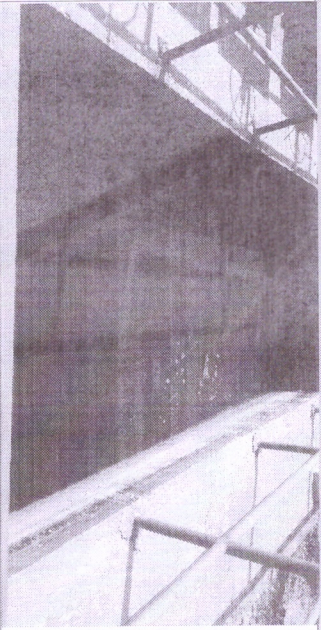
1. Chamber and hand railing painting work done. 2. Pipe hood to be installed on each rotating wheel. 3. Sluice gate need to be lubricated. 3. Cleaning of inlet chamber need to be done.	21.09.2021		Pending.
1	Fine Screen No. 1 (Mechanical)				21.09.2021		Pending.
2	Fine Screen No. 2 (Mechanical)

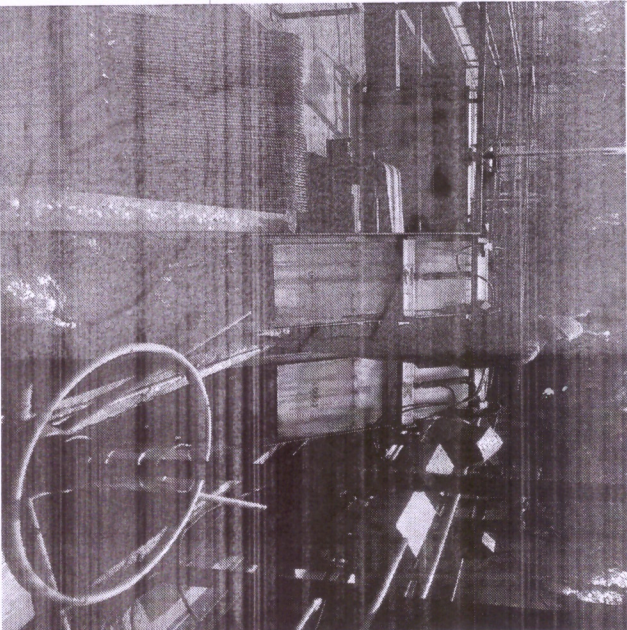
1. Fine Screen need to be cleaning properly. 2. Screen Level Sensor need to be replaced. 3. Screen panel auto/system need to be repaired. 4. Panel stand need to be painted. 5. Cable tray need to be replaced and painted. 6. All light in the screen area areed to be replaced. 7. Disposal material need to be removed on regular basis. 8. Manual trolly need to be provided for Disposal material. 9. All motors need to be covered by canopies. 10. Fine screen 2 (mechanical) need to maintenance for proper functional.	21.09.2021		Pending.

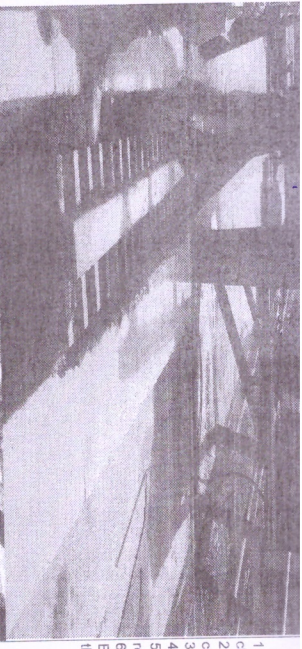
1	Grit chamber-1 1)Organic pump withMotor 2)Scraper 3)Classifier Mechanism	During site visit it was found that KRMP.L has taken shutdown sluice gate so during site visit it was found non-functional since 11.07.2022

<ol style="list-style-type: none"> Grit removal system is functional and classifier system is functional. Painting needs to be done to equipment / covers wherever rusting. Alignment of classifier found non-functional. Cable tray need to be painted. All E&M equipments shall be lubricate on regular basis and maintain the log book at site. Log book need to be maintained. Baffle plates are found to be corroded and therefore need to be replaced. 	30.09.2021		Pending
C	Inlet flow meter	During the visit it was found operational.

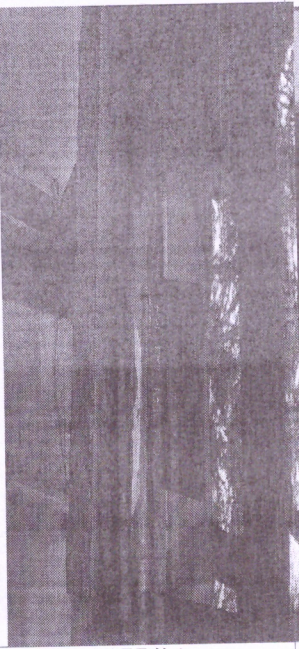
<ol style="list-style-type: none"> Log book need to be maintained. At the time of power failure there are no powerbackup is available for flow meter, So KRMP.L has to provided power backup facility. Level scale needs to be painted. 	21.09.2021		Pending

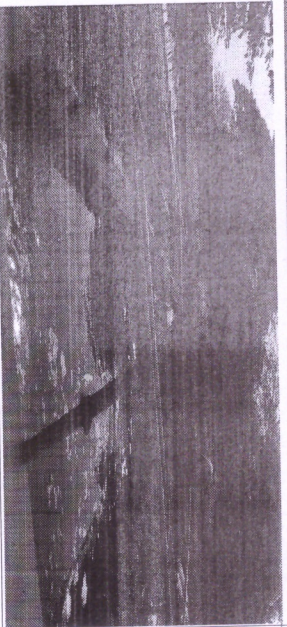
Open Channel	Operational

<ol style="list-style-type: none"> Open channel need to be cover with frame cover. Repairing and Painting work need to be done. 	16.12.2021		Pending
D	Primary Unit						
1	Primary sedimentation tank	Primary sedimentation tank found operational.

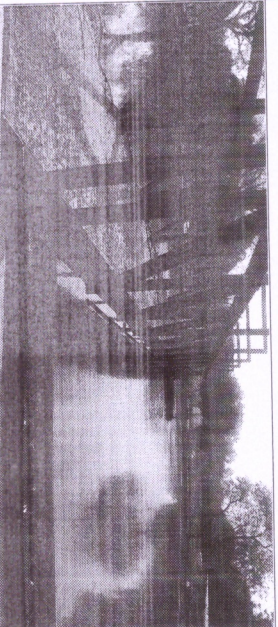
<ol style="list-style-type: none"> Cleaning work done of PST. Painting work need to be done. "V" notch need to be replaced. Handrailing work need to be paint. Alignment need to be rectified for PST. Log book need to be maintained. Scum chamber need to be clean. loose concrete work need to be cleaned and track should be proper groud. Housekeeping need to be done. Need to Cleaning of sludge. 	21.09.2021		Pending
E	Panel room	Operational

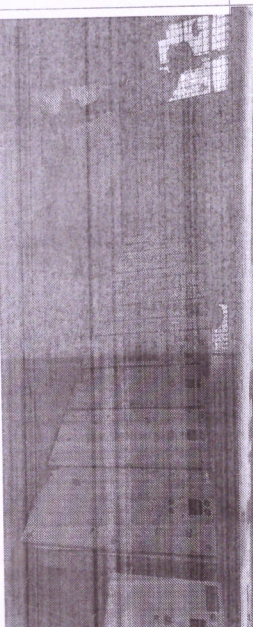
<ol style="list-style-type: none"> Screen panel voltmeter need to be replaced. Dosing agitator ammeter need to be replaced. 	21.09.2021		Pending

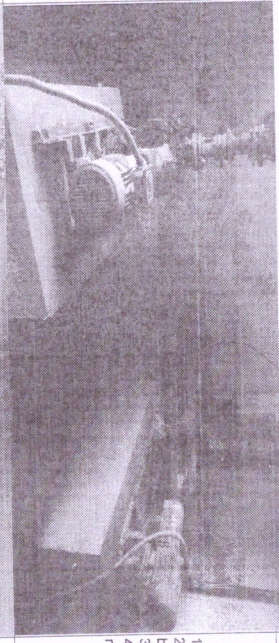
F	Sludge System						
1	Centrifuge feed pump (No. 1 & 2)	Operational

<ol style="list-style-type: none"> 1. Pump cleaning need to be required. 2. Pump lubrication need to be done on regular basis by KRMPL. 3. Pump RPM need to be increase as per design. 4. Vibration and Temperature need to be measure on regular basis. 	21.09.2021		Pending
2	Centrifuge panel	Operational

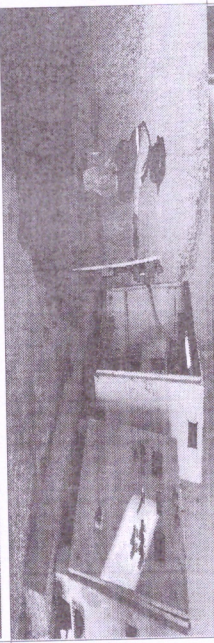
<ol style="list-style-type: none"> 1. Panel no. 1 need to be repaired. 2. Panel no. 2 voltmeter need to be replaced. 3. Panel door damage need to be repair. 	21.09.2021		Pending
3	Centrifuge No. 1	Operational

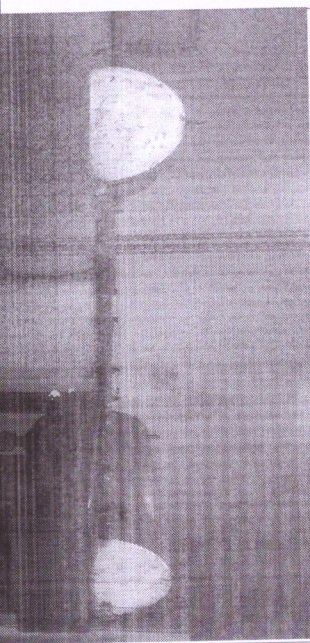
<ol style="list-style-type: none"> 1. Need to be overhauled & servicing. 2. Dosing of PACL in sludge feed line not properly tapping according to design. Therefore dosing line tapping from upward to downward direction. KRMPL has not taken action as same. 3. Pipe support shall be installed properly for sludge feed line and dosing line. 4. Electrical cables need to be lineup properly. 5. 1 CCTV need to be arranged for sludge removal from Trolley on urgent basis. 6. The quality of dewatered sludge is not adequate since liquid is being noticed during site visit. 7. 2 nos centrifuges operated by KRMPL, 12 Hrs each due to non-availability of VFD only one at a time operated. 	21.09.2021		Pending

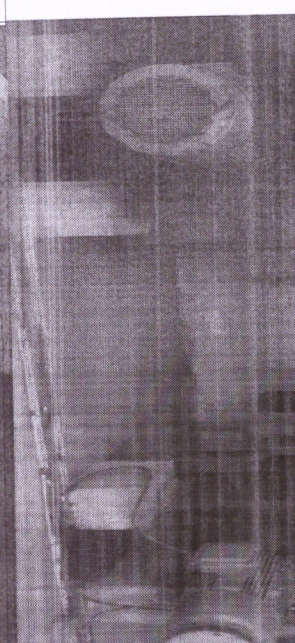
4	Centrifuge No. 2	Operational

<ol style="list-style-type: none"> 1. Need to be overhauled & servicing. 2. Dosing of PACL in sludge feed line not properly tapping according to design. Therefore dosing line tapping from upward to downward direction. KRMPL has not taken action as same. 3. Dosing line has not been connected with sludge feed line of centrifuge No. 2. 4. Pipe support shall be installed properly for sludge feed line and dosing line. 5. The quality of dewatered sludge is not adequate since liquid is being noticed during site visit. 6. 2 nos centrifuges operated by KRMPL, 12 Hrs each due to non-availability of VFD only one at a time operated. 	21.09.2021		Pending
5	Centrifuge thickener sludge sump + Agitator 2 Nos.	1 - Operated 1 - Operated

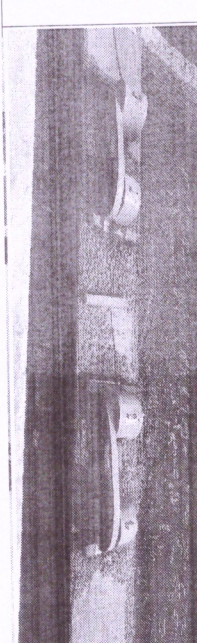
<ol style="list-style-type: none"> 1. Sludge cleaning work need to be done. 2. Need to be overhauled & servicing as required. 3. Log book need to be maintained. 	16.12.2021		Pending

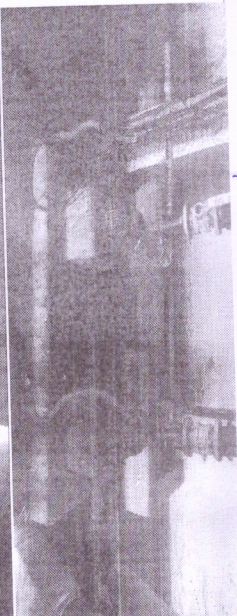
6	Poly Dosing(No.1 & 2)	Operational

<ol style="list-style-type: none"> 1. Leakage was observed in Pump No. 1 2. Need to be Overhauled & Servicing. 3. Log book need to be maintained. 4. Polymixer was not in operation during site visit. 	21.09.2021		Pending
7	Agitator No. 1	Non-Operational

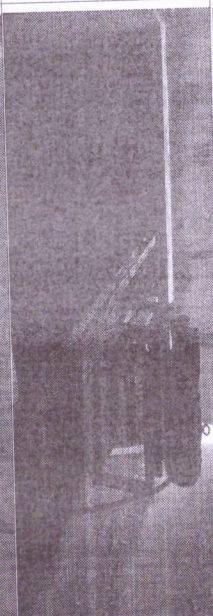
<ol style="list-style-type: none"> 1. Need to be rectified 2. Need to Be cleaned the Sump bottom 3. Needs to be replaced 4. Cleaning work of tank needs to be done 	21.09.2021		Pending
8	Agitator No. 2	Operational

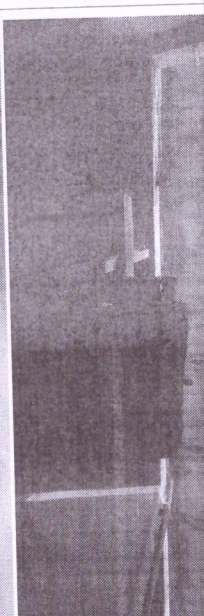
<ol style="list-style-type: none"> 1. Rusted steel Structure need to be replaced. 	21.09.2021		Pending
9	Digester No. 1	Non-operated

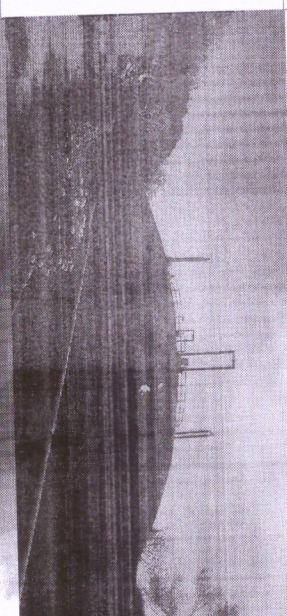
<ol style="list-style-type: none"> 1. Digster Need to be cleaned. 2. Civil Leakage need to be repaired. 3. Pressure relieve valve need to be calibration. 4. All four nos of motors need to be repaired. 5. Canopies need to be replace. 6. HDPE gas pipe line need to be proper support. 7. Sludge digester taken offline since 8 months and it was found that the sludge is being diverted to sludge holding ponds which are already brim. It is very urgent that KRMPL address this issue at the highest priority. 	21.09.2021		Pending

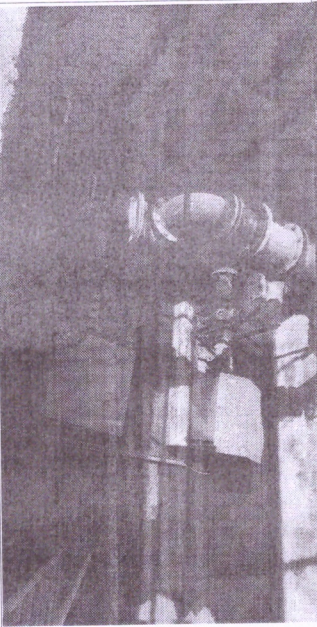
<ul style="list-style-type: none"> 1. We have found some vibration at Pump no 2 during visit KRMPL, need to be repair. 2. Pipe support need to be replace as required. 3. Vibration and Temperature need to be measure on regular basis. 4. Dewatering from the sump need to be required. 	16.12.2021		Pending
	Thickened Sludge Pump house	Operational

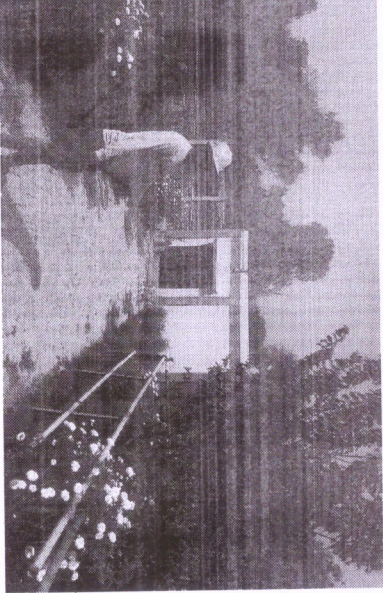
<ul style="list-style-type: none"> 1. Need to be Overhaul and repair. 2. Cleaning work need to be done. 3. Vibration and Temperature need to be measure on regular basis. 	21.09.2021		Pending
H	Blower Room						
	Air Blower No. 1	Operated

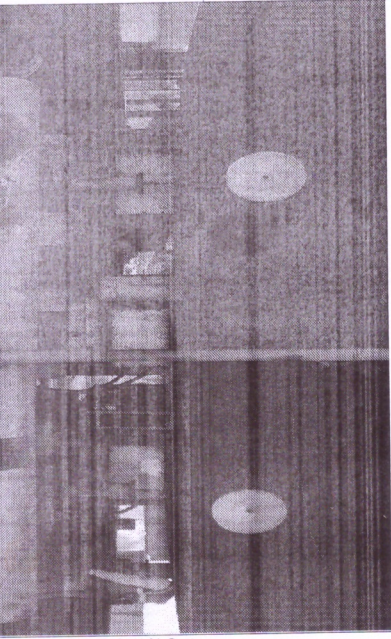
<ul style="list-style-type: none"> 1. Air Blower remote system cable need to dressed properly. 2. Air blower no 1 need to be rectified. 3. Acoustic hood need to be installed. 4. Vibration and Temperature need to be measure on regular basis. 5. Log book need to be maintained. 6. Pressure gauges need to be installed. 7. PRV need to be checked. 8. Insulation work in discharge line needs to be done by KRMPL. 	21.09.2021		Pending

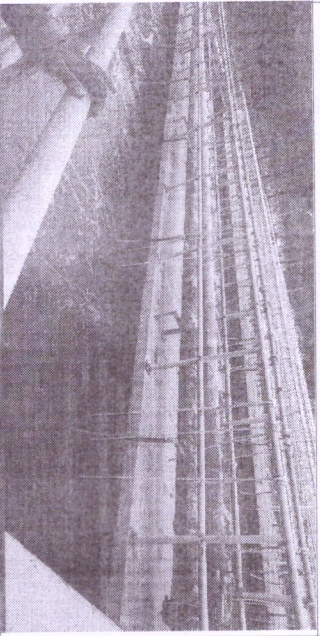
<p>1. Air pipes were observed to be rusted. 2. Pipe lines need to be changed. 3. Valves need to be changed. 4. Handrails need to be painted. 5. Diffuser line need to be Cleaned and maintained records also. 6. Insulation required for discharge line of blower. 7. Rope need to be replaced. 8. 4 Sets of diffuser needs to be repired on urgent basis. 9. Blower nos3 NRV leakage need to repair</p>	21.09.2021	Pending
J	Final Sedimentation tank	Operated

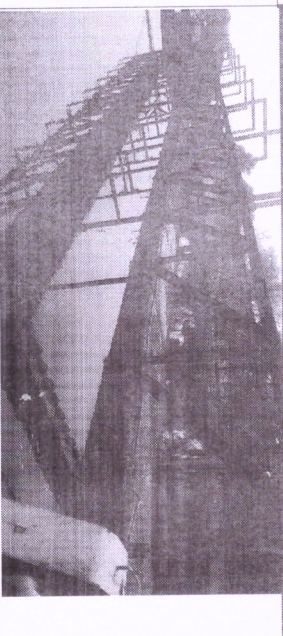
<p>1. Cleaning work need to be done. 2. Painting work need to be done. 3. Alignment of Mechanism need to be rectified. 4. "V" notch need to be replace.</p>	21.09.2021	Pending
K	43 MLD TEPH5 Nos Pumps)	Operational

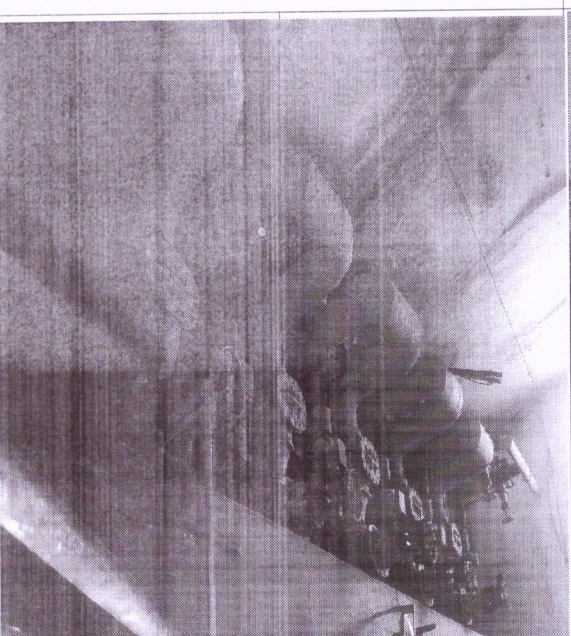
<p>1. Pump No. 2 was non operational. 2. Pressure gauges not working in all pumps. 3. Internal lights were not working. 4. Each pump capacity 900m3/hr. 5. Lubrication of each equipment need to be done. 6. Log book need to be maintain properly. 7. Vibration and Temperature need to be measure on regular basis. 8. Ammeter need to be repaired.</p>	21.09.2021	Pending
