<div>SITE INSPECTION REPORT</div> </div>					Jajmau STP - 130 MLD		s	INSPECTED BY: 1. Bipin Pal (APE UPJN) 2. MR. Indra Deo Pandey , Suupport Engg.-Civil STC KRMPL Team 1. Mr Krishna (Plant Incharge)

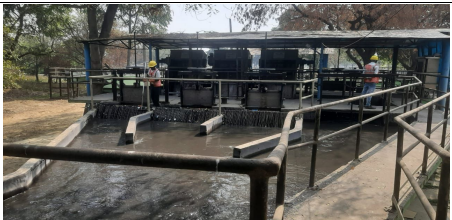
1. Railing and its foundation needs to be repaired. 2. Reinforced exposed work found repaired. 3. Fininshing work of inlet chamber chamber need to done properly 4. Toe guard to be Provide in handrailing. 5. FRP coating done in hand railing		27.11.2021			Pending
2	Gates /Valves and Covering Shed	Need Overhauling / Replacement

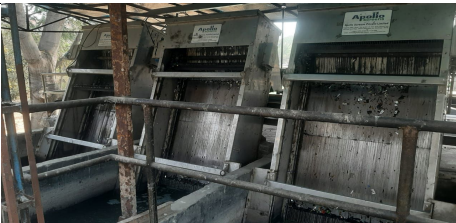
B	Fine Screen Chamber (Mechanical / Manual)								
3	Screen Chamber (Civil)	Need Renovation

1. Renovation work found not properly. 2. Garbages like Plastic bags, leather pieces, clothes must be removed from Belt conveyer of Screen Chamber regularly. 3. Need to be replaced the gates. 4. Proper Lighting need to be provided at Screen area. 5. Level scale should be properly clean and marking should be clearly visible. 6. MS Fabrication equipment & tools along with MS Shed also corroded & losses its strength. 7. In MS shed pipes are corroded & Colour of shed also worn out. 8. Mechanical Screen not working with auto system and without sensor .Need to be fixed the auto system immediately. 9. New Cables should be laid properly in cable trays 11. FRP coating done in Hand-railing, screen channel area. 12. Maximum gap in bar screen should be fill.		27.11.2021			Pending
4	Mechanical Fine Screen no. 1	Operational

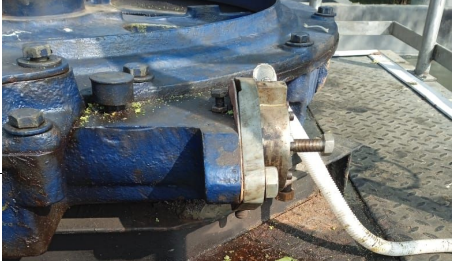
1.Renovation work found satisfactory. 2. Organic pump need to be installed as per approved drawing. 3.Cable need to be layed at Cable tray as per approved drawing. 4.LPBS need to be installed as per approved drawing. 5. Mobil leakage in grit no 1, KRMPL need to be fix it. 6. KNOP Houter not working. 7.TWI marking could be done with paint. 8. ORP non operational		27.11.2021		Pending

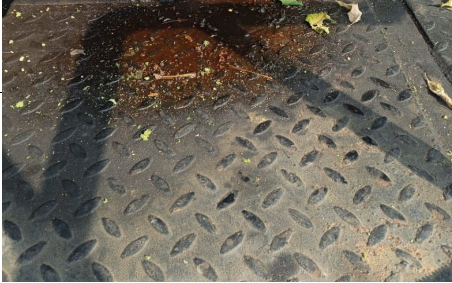
10	Grit Mechanism-2	Operated

1.Renovation work found satisfactory. 2. Organic pump need to be installed as per approved drawing. 3.Cable need to be layed at Cable tray as per approved drawing. 4.LPBS need to be installed as per approved drawing. 5.Torque switches installation done without canopy at all equipment. 6.Hooter is fixed on railing with temporary cable tie, which is not proper and unacceptable. 7.Power supply is given to torque switch & associated equipment from temporally MCB. Permanent supply is to be provided.		27.11.2021		Pending
11	Grit Mechanism-3	Operated

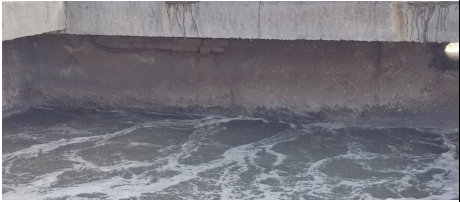
1.Only outer face of distribution chamber for Primary sedimentation tank partially done by KRMPL. 2.Inside Rcc wall, base and platform required renovation work. 3. Reinforced exposed and need to be repaired 4. Sluice gate need to be replace		27.11.2021		Long Pending
19	Civil works

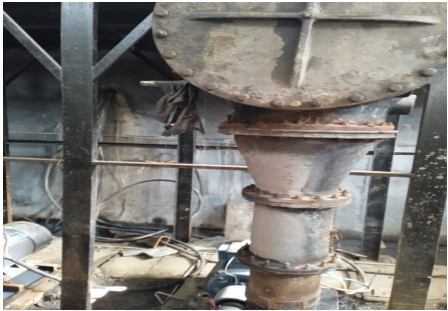
1.All pumps needs to be repaired and get operational. 2. Civil Drawing of pump foundation not submitted by KRMPL for Renovation work. 3.Out of 11 pumps only 4 Nos.pump has been working at site and 4,5,6,7 8,Nos. Pump are not in working condition.. 4.Lighting arrangement and Cable to be laid in cable tray. 5.Thermometer and vibration meter should be at site. 6.Railing to be repaired till the renovation period. 7.Motor cover to be arranged. 8.Pressure guage are found in damaged condition and need to be replaced. 9.Concessionaire should maintain log book of the pumps for proper record maintenance. 10.Leakage has been detected 2 number pump which are in operation, and directed to repair the same immediately. 11.LPBS system to be install at site 12.Cable tray need to be painted immediatly		27.11.2021		Long Pending
