National Mission for Clean Ganga- Development, Rehabilitation with
Operation & Maintenance of STPs at Kanpur under Hybrid Annuity based PPP mode
Shah Technical Consultants Private Limited

Sub: **HAM Kanpur: PE Inspection Report for 5 MLD STP Shuklaganj**

SITE INSPECTION REPORT - 05 MLD STP AT SHUKLAGANJ

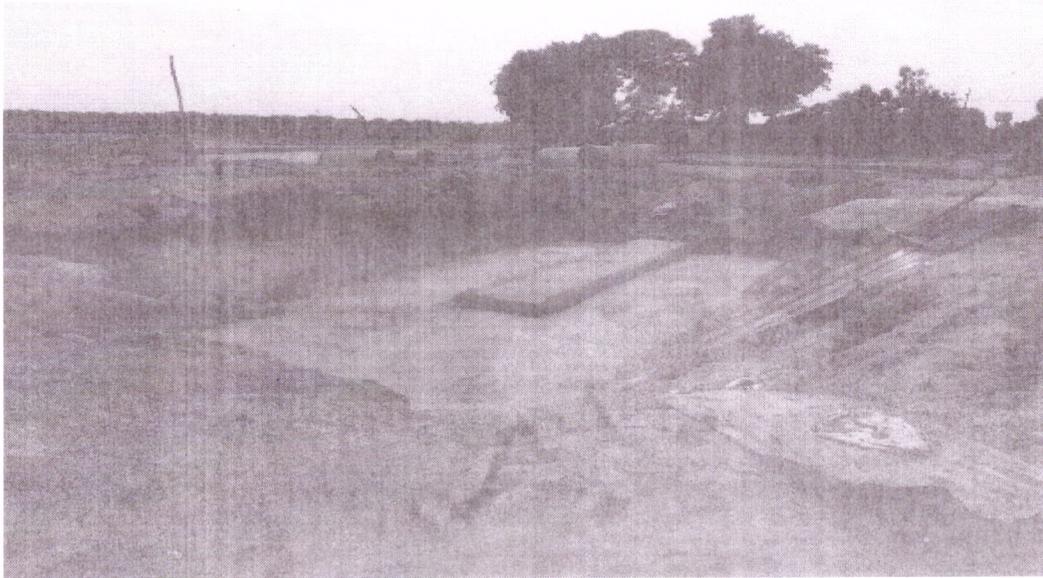
I&D Structure Location

- i. **I&D Structure:** Work of I&D is very slow. Till date only excavation and PCC work has been done. It is to be noted that safety precautions are not followed by KRMPL. Excavated sites should be fully covered by hard barricading.

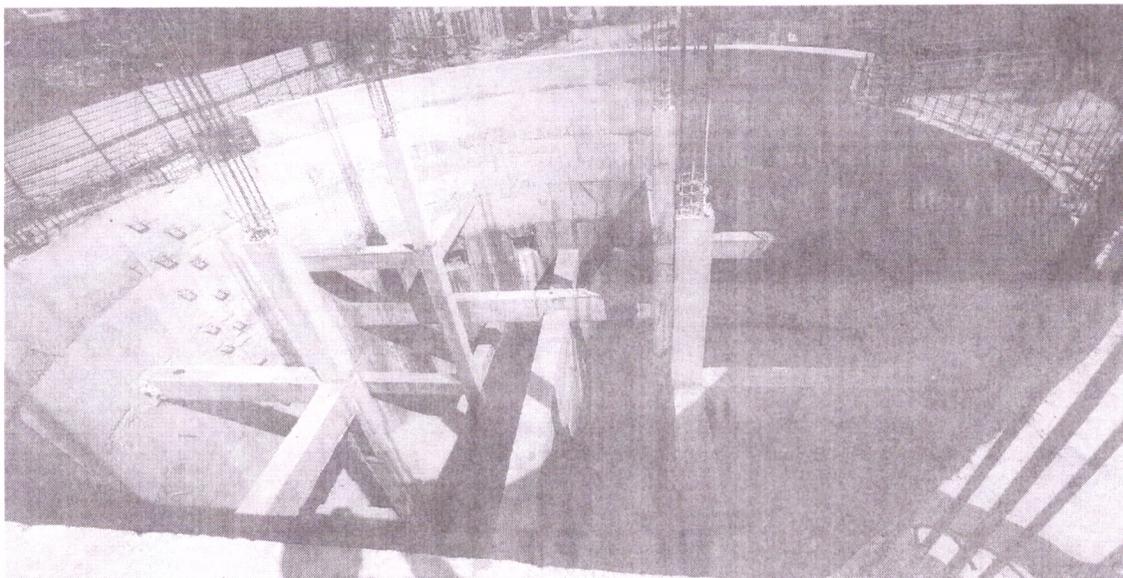
- ii. **Sewer System:** KRMPL (900mm dia) 85% laid out of sewer line without Approval Drawing and design, Ref letter STC letter no 1652 and UPJN letter.
- iii. **Main Pumping Station (MPS):** At inlet chamber, step arrangement and proper footrest have not been provided. MPS wall casting up to base slab done and cleaning in progress. KRMPL needs to do hydro testing with clear water as per CEPHEEO MANUAL and IS code 3370 in presence of UPJN & STC, before grinding and tar coal epoxy work.

MPS wall casting work done

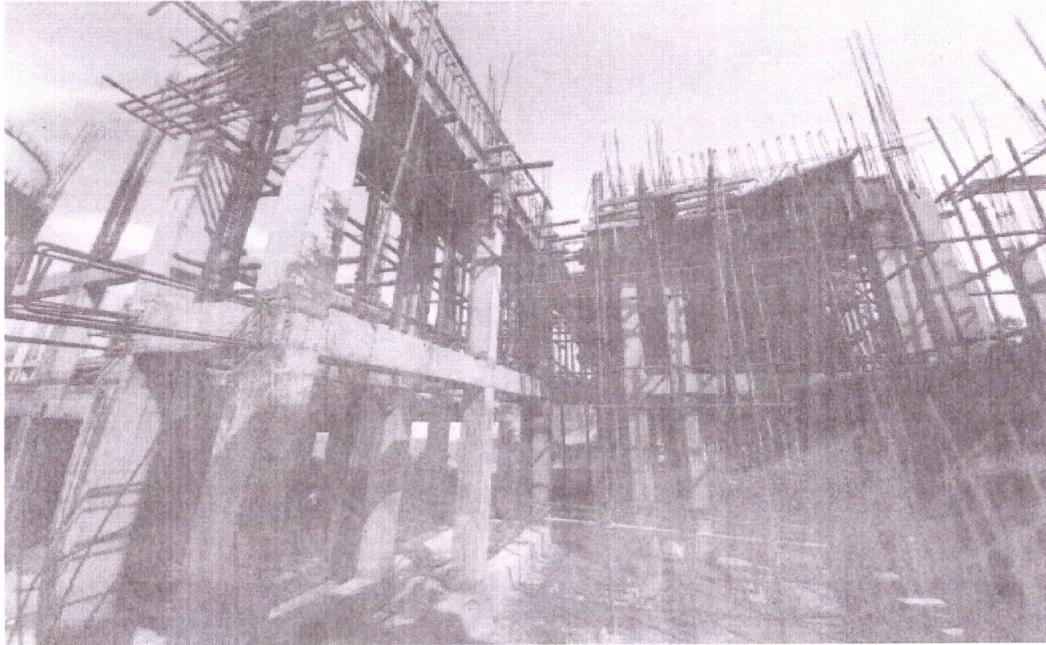
- iv. **Primary treatment unit (PTU):** Alignment of most of the Columns is not straight, bulged twisted & not in Plum bob, improper covers provided, top of Column wrongly smoothly finished & Column edges bend. Most of Steel is corroded. PTU, Column work completed and slab shuttering and reinforcement work in progress.

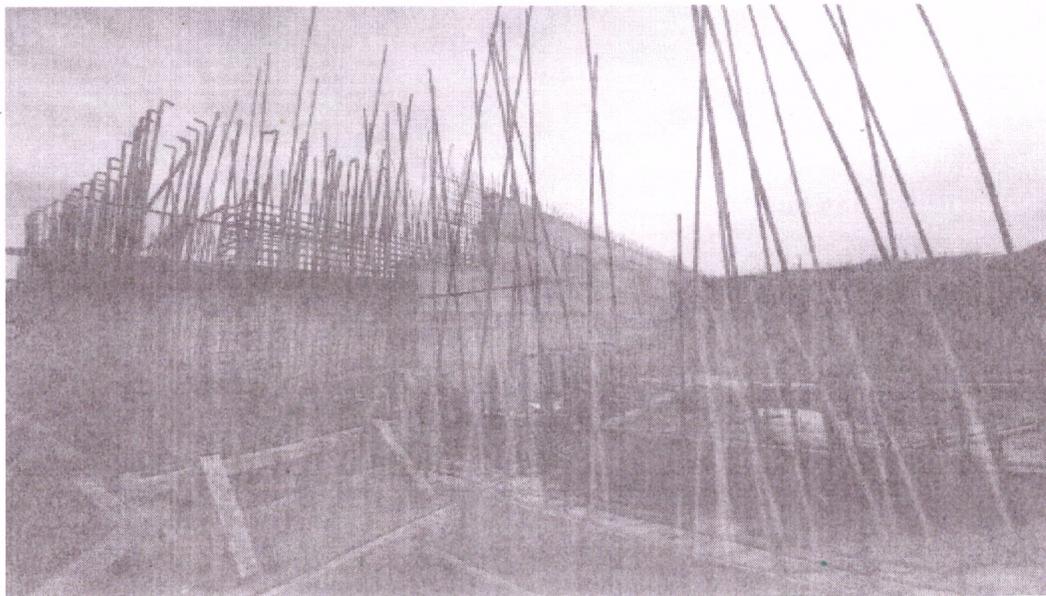
- v. **Sequence batch reactor (SBR):** SBR wall has not been done properly. KRMPL has not provided develop length (L_d), $50d$ according to Design in SBR Wall. KRMPL has not used proper shuttering arrangement. Clear cover is not exactly as per design. Due to use of wide range of cover blocks casting of wall by the Concessionaire is not proper. KRMPL also do not use vibrator frequently at the time of casting due to which at some locations honey combing occurred. KRMPL has been instructed to rectify these issues and use vibrator in regular practice.

SBR - North side wall, reinforcement and shuttering work in progress

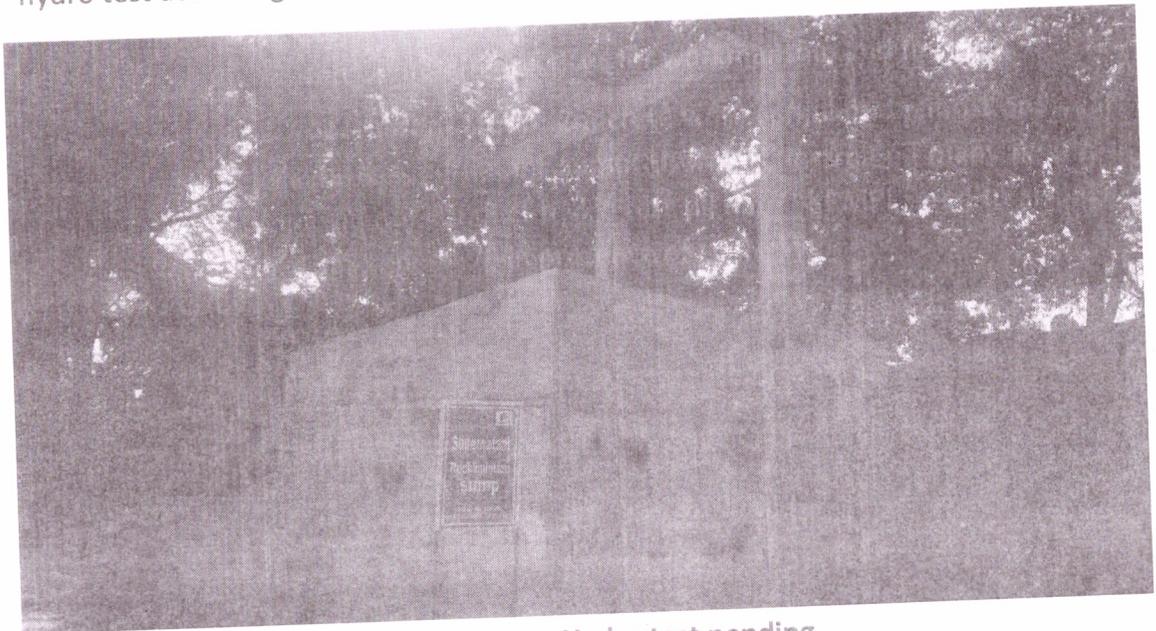
Supernatant Sump, Hydro test pending

- vii. **Administration Building cum Air blower:** In Admin building cum Air blower shuttering work of column and slab works are in progress. Most of the Column's alignment is not straight, bulged twisted & not in Plum bob. Improper covers provided, top of Column wrongly finished & Column edges are found bend. Most of the Steel is corroded. KRMPL has been instructed to rectify these issues without delay and comply with the standard practices for workmanship and finishing.
- viii. **Sludge Thickener & Supernatant Sump:** Concrete work completed almost one year ago for Sludge thickener & supernatant Sump. UPJN/STC instructed many time for Hydro test but KRMPL did not conduct hydro test till date. KRMPL need to arrange hydro test according to IS code 3370 in presence of UPJN/STC.
