**Project:** “Development of Sewerage Treatment Plants on Hybrid Annuity PPP basis at Kanpur, UP”.  
**Subject:** Site visit report of 30 MLD STP and associated IPS & 130 MLD STP at Jajmau

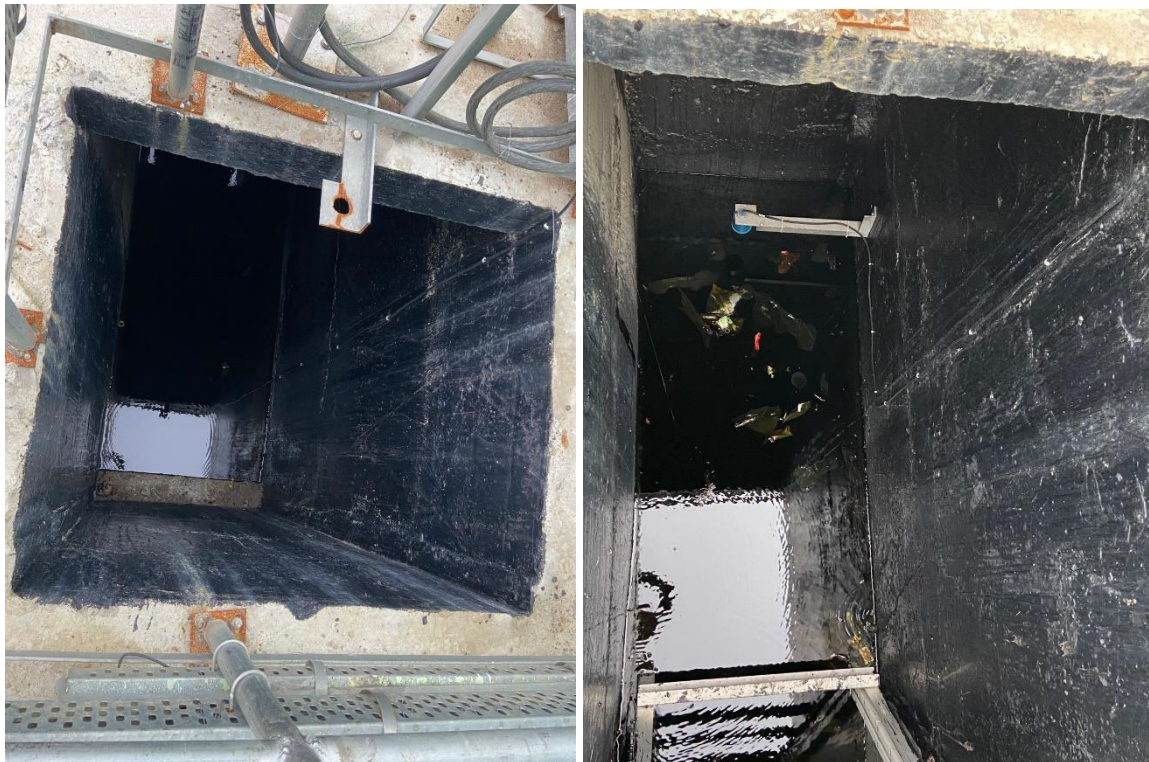
- The Differential level transmitter at the screens has been installed below the High Flood level, consequently, the sensors are submerged as evident from the pictures below:

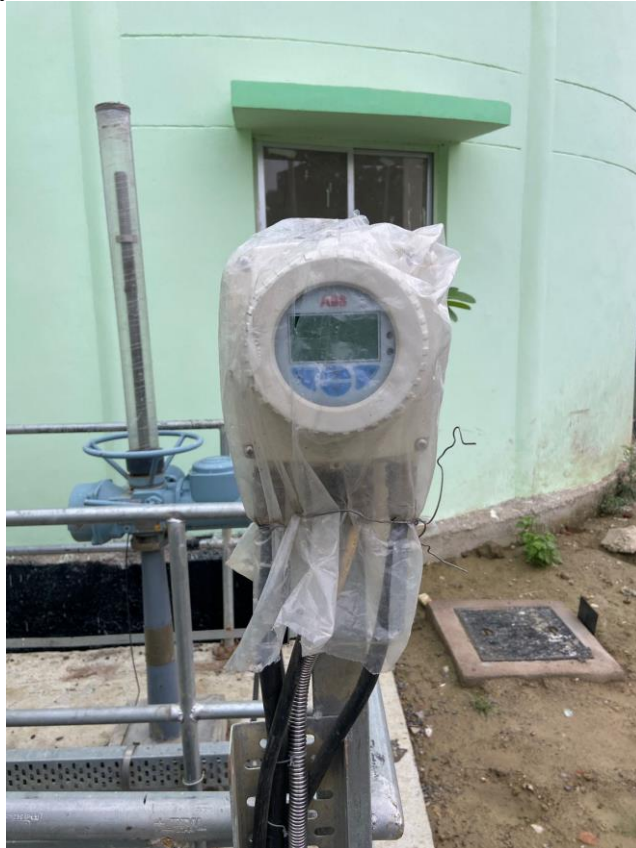
- The concessionaire has been instructed several times during the site visits, but still the Canopy for weather protection of field instruments has not yet been provided. The instruments have been covered with polythene.

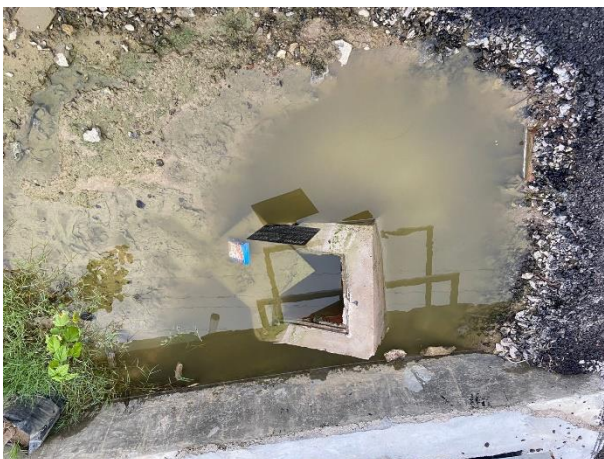
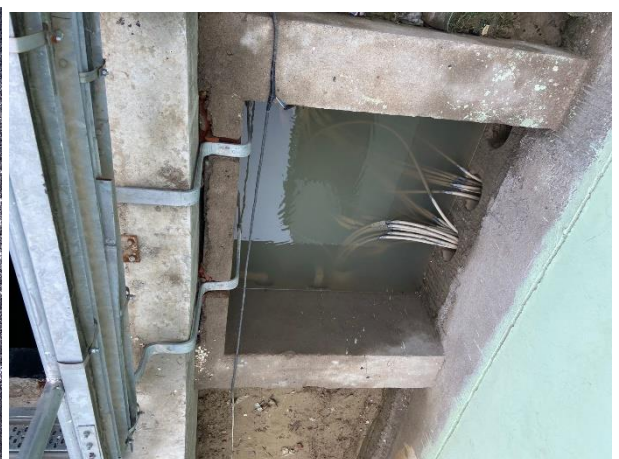
- The earth pits have collapsed due to flooding and the cable have drowned in water in the cable pull pits. The concessionaire has been instructed to drain the water using the portable drain pumps and rectify the defects in the earthing pit.

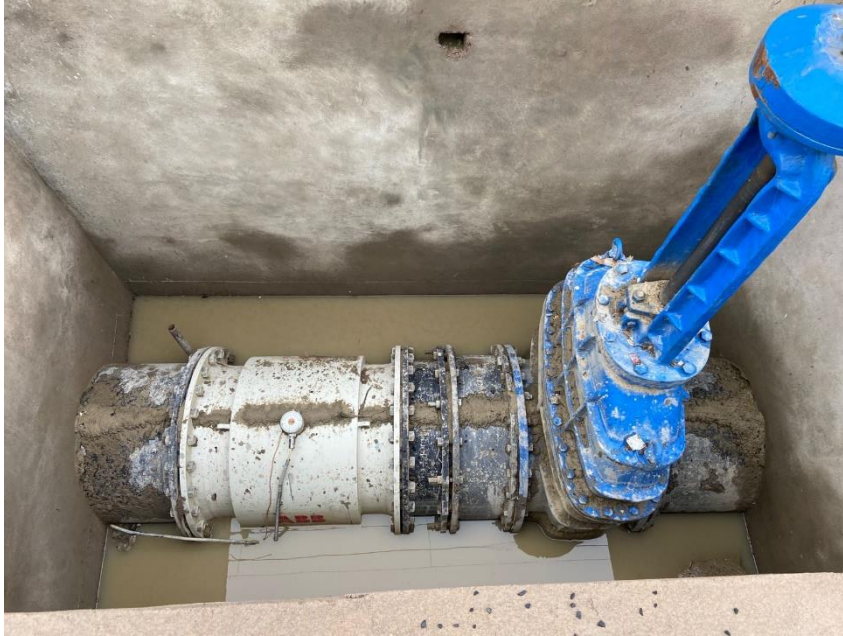
- The concessionaire has not maintained the required distances for installation of flow meter at the common discharge of pumps as per the manufacturer recommendations, which might result in inaccurate flow values at later stage.

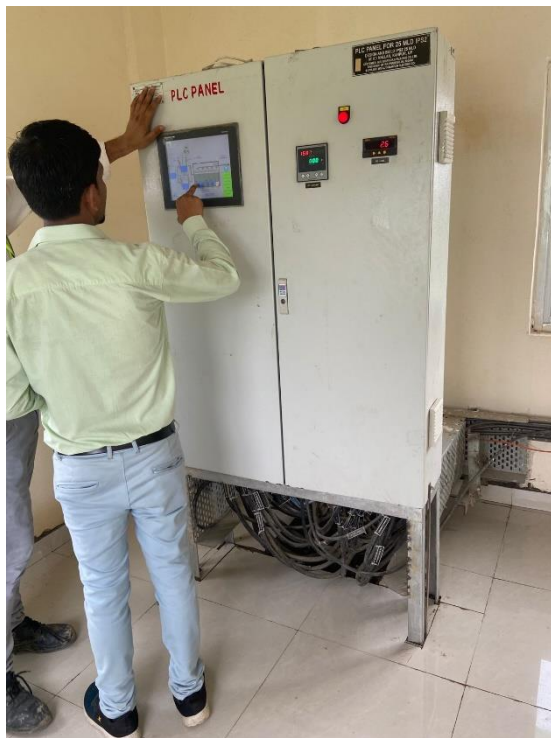
- PLC panel has been raised by 500 mm above the finished floor level, but the cable termination below the panel has not yet been covered.

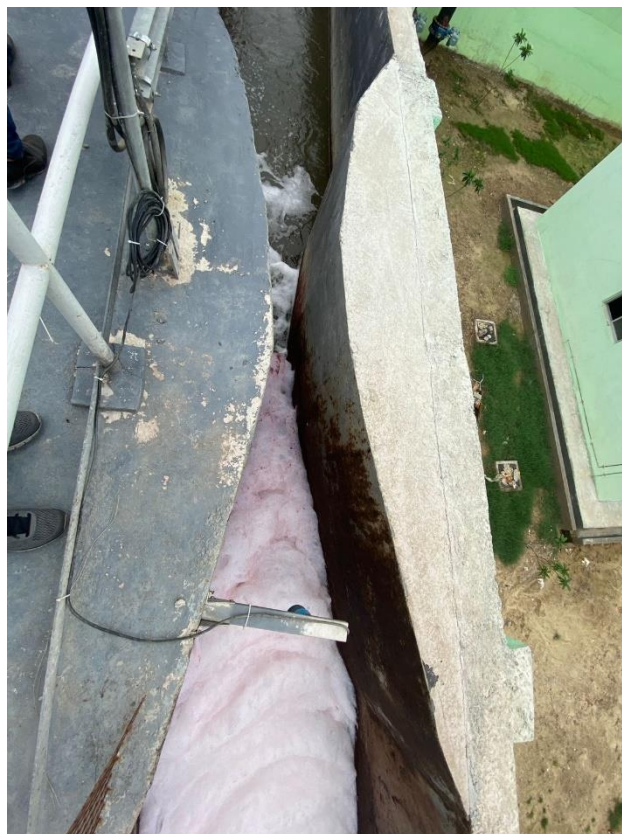
- The concessionaire has not provided any cable route markers for identification of cables in the plant. The concessionaire has been instructed to provide the cable route markers for all the buried cables in the plant.
- The foaming in the Parshall flume is affecting the flow measurement at the plant inlet. The concessionaire has been instructed to provide remedial measures to arrest the foaming at the units affecting the field instrument measurements. The concessionaire has been advised to provide de-foaming agent dosing at the inlet to the plant and affected units.

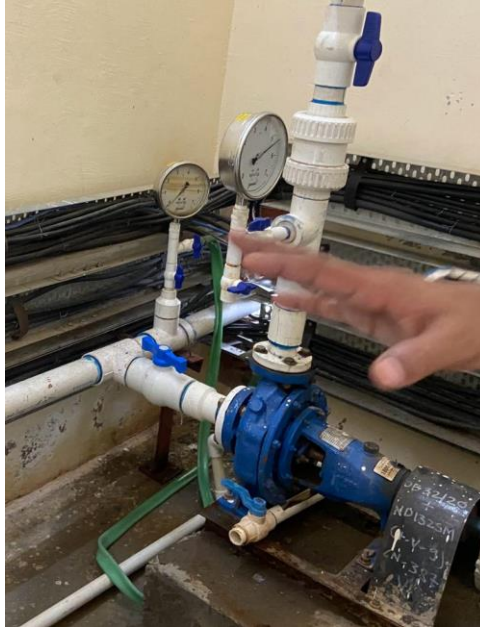
- The Pressure transmitters installed at the pumping station need to be calibrated as erratic readings of pressure have been observed during visit.
- The pressure gauges installed at the chlorinators are not functioning properly and need to be attended for rectification. Further the leakage of glycerin is observed in some of the pressure gauges.

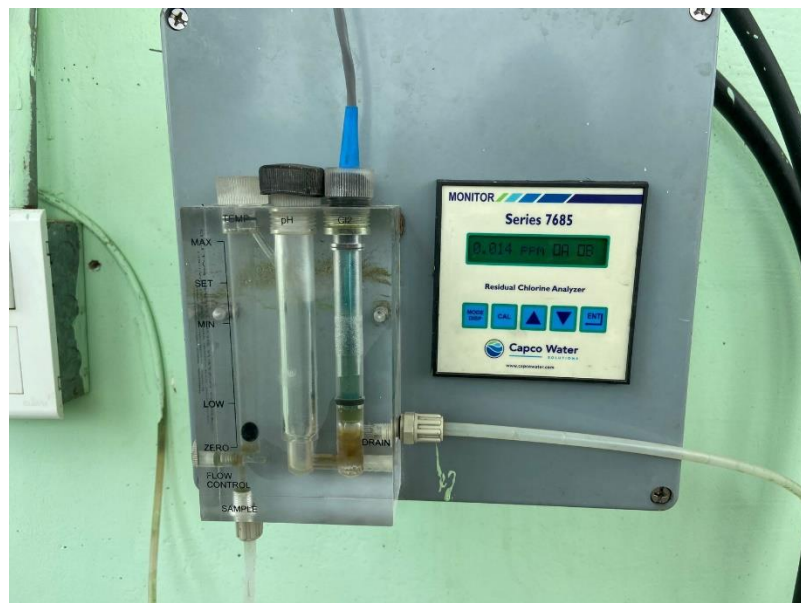
- The On-line Chlorine Analyzer does not show the correct residual chlorine values. The values were also checked using reagent but the values do not match. The analyzer needs to be calibrated.
