SITE INSPECTION REPORT					Jajmau STP - 130 MLD		INSPECTED BY:(22/06/23) 1. Mr. A.K. Seth Team Leader STC 2. Mr. Bipin Pal (APE UPJN) 3. Mr. Indra Deo Pandey,Suupport Engg STC 4. Mr. Rahul Support Engg. STC KRMPL Team 1. Mr Krishna (Plant Incharge) 2. Mr. Avjit Dutta Mechanical.

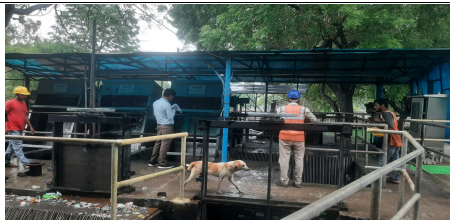
1. Railing and its foundation needs to be repaired. 2. Reinforced exposed work found repaired. 3. Finishing work of inlet chamber chamber need to done properly 4. Toe guard to be Provide in handrailing. 5. FRP coating done in hand railing 6. Staff working without ppe. 7. Panel connection are not done as per approval drawing or tagging in panel room. 8. Cable trench renovation work pending in panel room.		27.11.2021		Pending

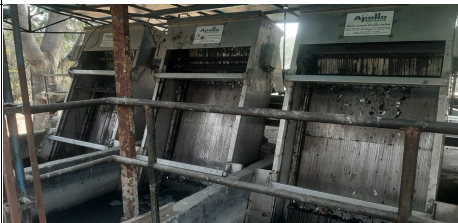
1. Renovation work found not properly. 2. Garbages like Plastic bags,leather pieces, clothes must be removed from Belt conveyor of Screen Chamber regularly. 3. Need to be replaced the gates. 4. Proper Lighting need to be provided at Screen area. 5. Level scale should be properly clean and marking should be clearly visible. 6. MS Fabrication equipment & tools along with MS Shed also corroded & losses its strength. 7. In MS shed pipes are corroded & Colour of shed also worn out. 8. Mechanical Screen not working with auto system and without sensor .Need to be fixed the auto system immediately. 9. New Cables should be laid properly in cable trays 11. FRP coating done in Hand-railing, screen channel area. 12. Maximum gap in bar screen should be fill.		27.11.2021		Pending

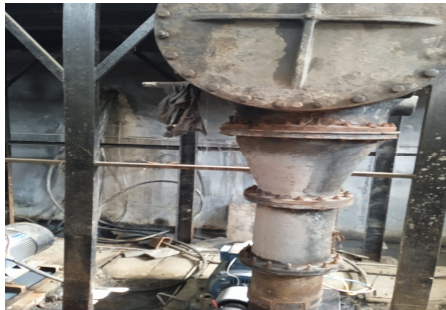
1.All pumps needs to be repaired and get operational. 2. Civil Drawing of pump foundation not submitted by KRMPL for Renovation work. 3.Out of 11 pumps only 3 Nos.pump has been working at site and 7, 8,10 Nos. Pump are not in working condition.. 4.Lighting arrangement and Cable to be laid in cable tray. 5.Thermometer and vibration meter should be at site. 6.Railing to be repaired till the renovation period. 7.Motor cover to be arranged. 8.Pressure guage are found in damaged condition and need to be replaced. 9.Concessionaire should maintain log book of the pumps for proper record maintenance. 10.Leakage has been detected 2 number pump which are in operation, and directed to repair the same immediately. 11.LBPS system to be install at site 12.Cable treay need to be painted immediatly		27.11.2021		Long Pending

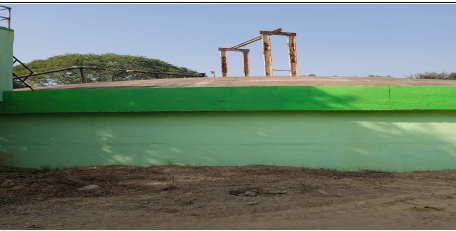
1. Removal of centrally located sludge mixing shaft from Primary Digester 1. 2. Gate to be overhauled 3. Civil Structure of the Digester to be renovate and cracks to be treated. 4. Leakage to be Arrested in the Digester. 5. Installation of the Railing at the boundary of the dome. 6. Finishing work to be done.		27.11.2021		Long Pending

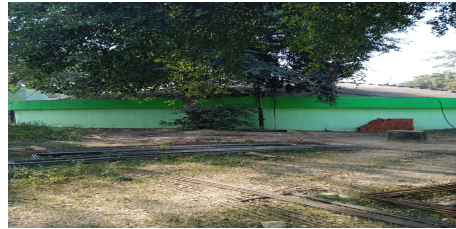
81	Primary Sludge Digester no. 2	Not operational

1. Cleaning work of Primary digester done partially. 2. Gate to be overhauled 3. Civil Structure of the Digester to be renovate and cracks to be treated. 4. Leakage to be Arrested in the Digester. 5. Installation of the Railing at the boundary of the dome. 6. Finishing work to be done. 7. Sludge Digester no.2 is under cleaning but no any safety precaution during cleaning. 8. Safety officer not available at site.		27.11.2021		Long Pending
Q	Secondary Sludge Digester							
82	Secondary Sludge Digester	Not operational		1. Structure found in worse condition and need to be renovate. 2. Gate to be overhauled 3. Civil Structure of the Digester to be renovate and cracks to be treated. 4. Leakage to be Arrested in the Digester. 5. Installation of the Railing at the boundary of the dome. 6. Finishing work to be done.		01.03.2021		Long Pending
R	Digested Sludge Pump House

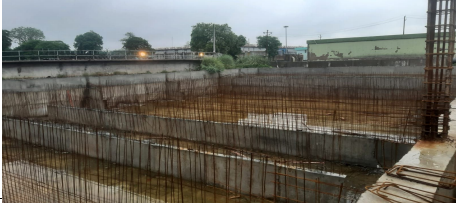
1.Shifting of existing of Utilities at proposed CCT and TEPH area. 2.Site Clearance required. 3. 30% work still pending of CCT-TEPH and chlorination building plinth beam work done.				
120	Chlorine Contact tank	To be constructed						
121	Note:-			1.The Slude removal is still not be done properly . from temporary pond not done daily. O&M no any arrangement for boundary wall	2.Sludge withdrwal 3 . Safety & Security of facility under
