Ref. STC/ PE/ KNP/2117 / Shuklaganj**Date:** 25/10/2023**To,**Superintending Engineer
3rd Circle
UP Jal Nigam (Rural)
Lucknow**Sub:** **HAM Kanpur:** PE Inspection Report dated 25/10/2023 for 5 MLD STP Shuklaganj

SITE INSPECTION REPORT - 05 MLD STP AT SHUKLAGANJ

| Date of site Inspection | 23/09/2023 |

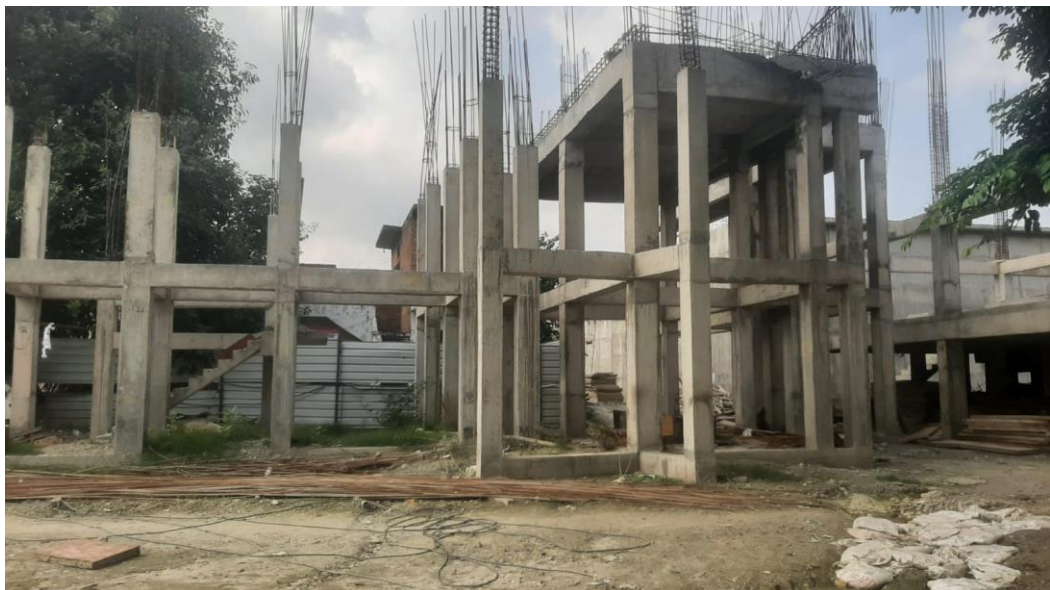
- iv. **Primary treatment unit (PTU):** Alignment of most of the Columns is not straight, bulged twisted & not in Plum bob, improper covers provided, top of Column wrongly smoothly finished & Column edges bend. Most of Steel is corroded. PTU, Column work completed and slab shuttering and reinforcement work in progress.

Slab Shuttering work – 60%

Grit Chamber – 100%

Channel Slab - 90%
