National Mission for Clean Ganga- Development, Rehabilitation with  
Operation & Maintenance of STPs at Kanpur under Hybrid Annuity based PPP mode

**Sub: HAM Kanpur:** PE Inspection Report dated 23/09/2023 for 5 MLD STP Shuklaganj

## SITE INSPECTION REPORT - 05 MLD STP AT SHUKLAGANJ

Date of site Inspection	23/09/2023
STC Site Inspection team	Mr. Anil Kr. Seth – TL (I/c) STC Kanpur Mr. Indra Deo pandey - Supp. Engg. STC Kanpur
KRMPL Personal	Mr. Pankaj Supervisor KRMPL Mr. Vimlendu bhushan Safety KRMPL

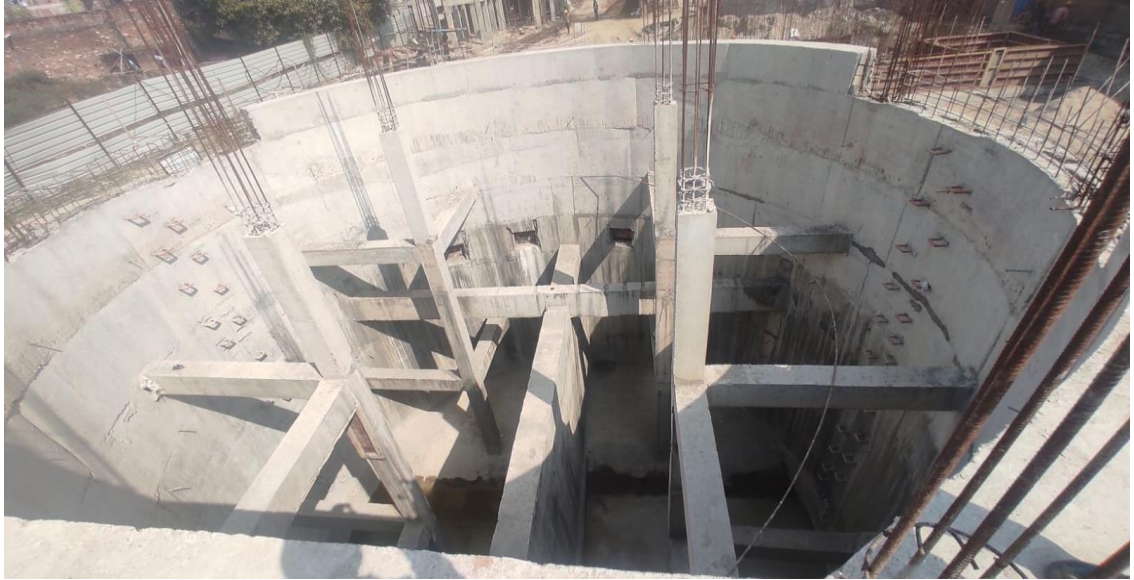
- iii. **Main Pumping Station (MPS):** At inlet chamber, step arrangement and proper footrest have not been provided. MPS wall casting up to base slab done and cleaning in progress. KRMPL needs to do hydro testing with clear water as per CEPHEO MANUAL and IS code 3370 in presence of UPJN & STC, before grinding and tar coal epoxy work.

**MPS wall casting work done**

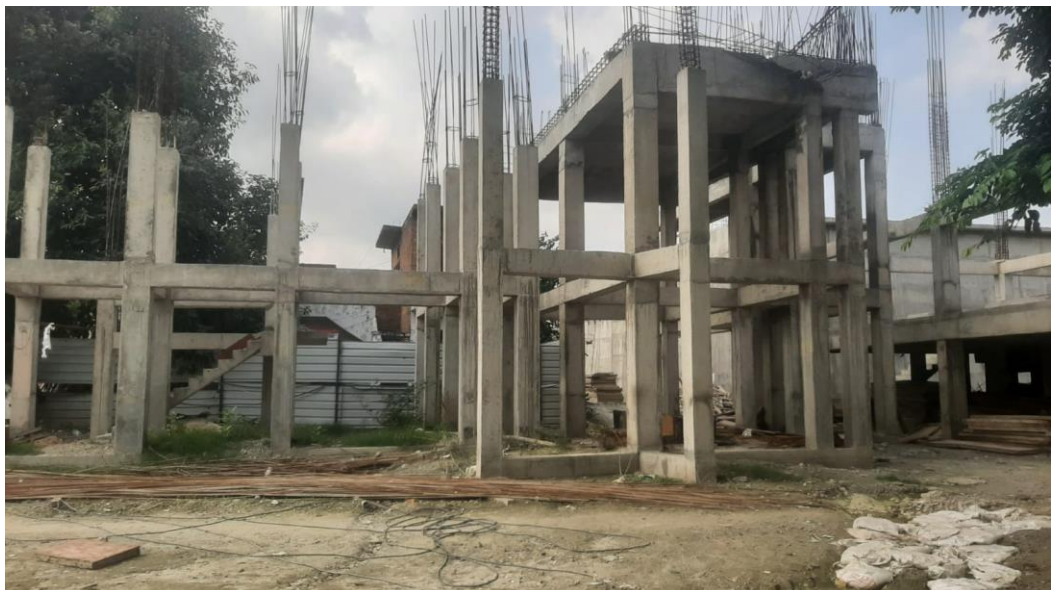
- iv. **Primary treatment unit (PTU):** Alignment of most of the Columns is not straight, bulged twisted & not in Plum bob, improper covers provided, top of Column wrongly smoothly finished & Column edges bend. Most of Steel is corroded. PTU, Column work completed and slab shuttering and reinforcement work in progress.

Slab Shuttering work – 60%

Grit Chamber – 100%

Channel Slab - 90%

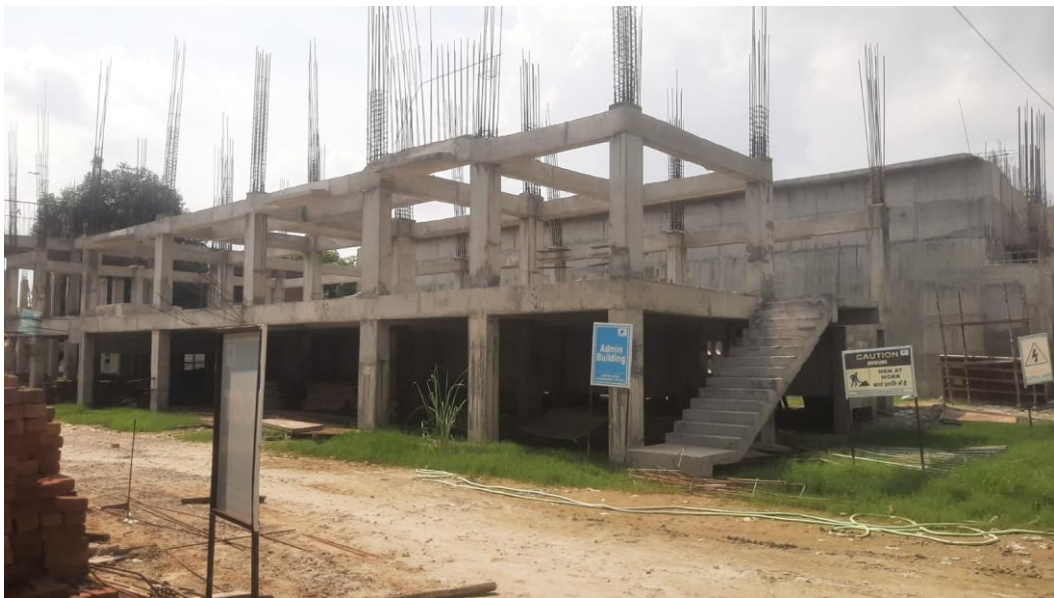
- SBR outlet channel wall casting completed.
- Slab shuttering works R/F work completed, casting pending;
- Walkway one side completed, casting is in progress.
- SBR wall has not been done properly. KRMPL has not provided develop length (Ld), 50d according to Design in SBR Wall. KRMPL has not used proper shuttering arrangement. Clear cover is not exactly as per design. Due to use of wide range of cover blocks casting of wall by the Concessionaire is not proper. KRMPL also do not use vibrator frequently at the time of casting due to which at some locations honey combing occurred. KRMPL has been instructed to rectify these issues and use vibrator in regular practice.

**SBR and Admin building cum blower room**

- In Admin building cum Air blower foundation completed.
- Slab for first floor staging material arrived at plant.
- Most of the Column's alignment is not straight, bulged twisted & not in Plum bob. Improper covers provided, top of Column wrongly finished & Column edges are found bend. Most of the Steel is corroded. KRMPL has been instructed to rectify these issues without delay and comply with the standard practices for workmanship and finishing.

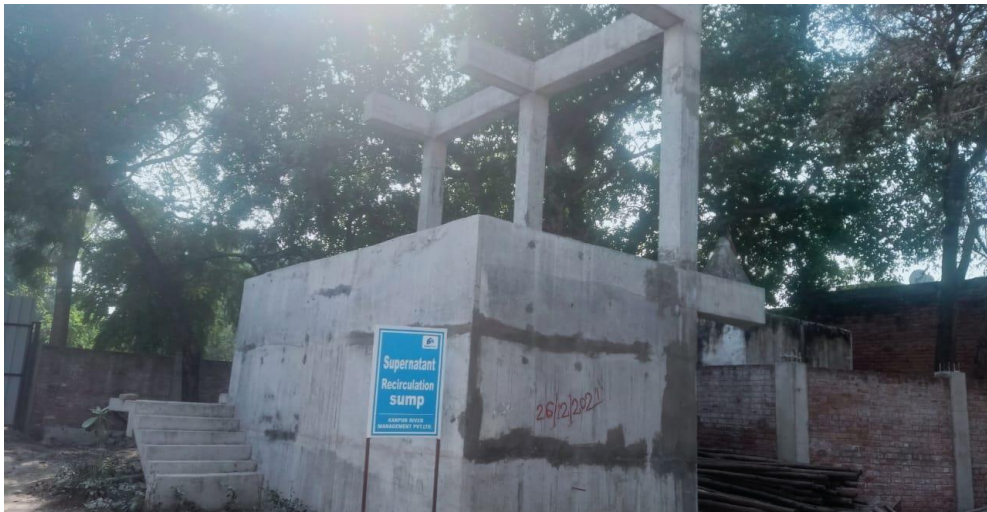
**viii. Sludge Thickener & Supernatant Sump:** Concrete work completed almost one year

ago for Sludge thickener & supernatant Sump. UPJN/STC instructed many time for Hydro test but KRMPL did not conduct hydro test till date. KRMPL need to arrange hydro test according to IS code 3370 in presence of UPJN/STC.

**Supernatant Sump, Hydro test pending**

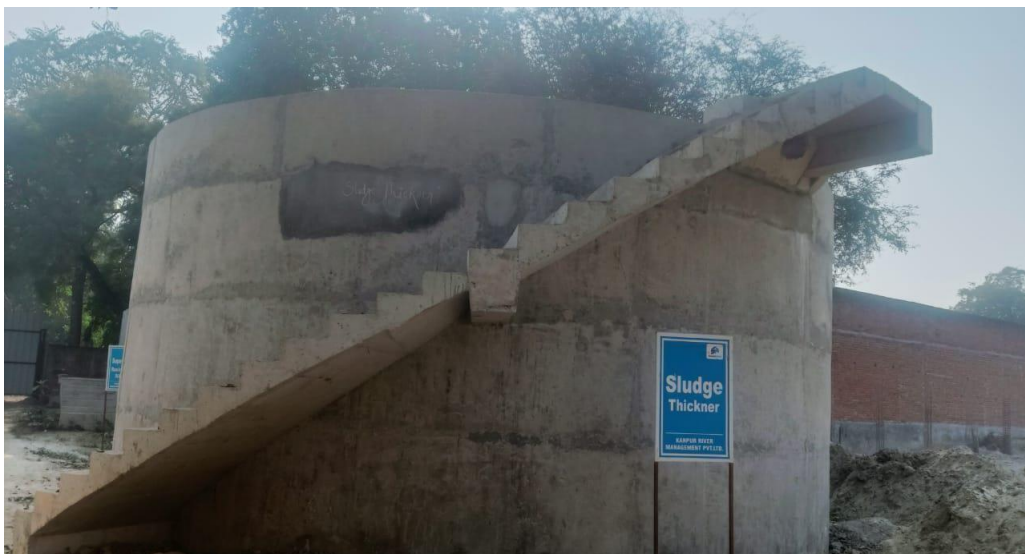
**Sludge Thickener, Hydro test pending**
