SITE INSPECTION REPORT-05MLD STPATSHUKLAGANJ

Date of site inspection	30/12/2023
STC Site Inspection team	Mr. Anil Kr. Seth – TL(I/c) STC Kanpur Mr. Indra Deopandey – Supp. Engg. STC Kanpur
KRMPL Personal	Mr. Vijay Jadhav – Construction Manager KRMPL Mr. Vimlendu Bhushan – Safety KRMPL

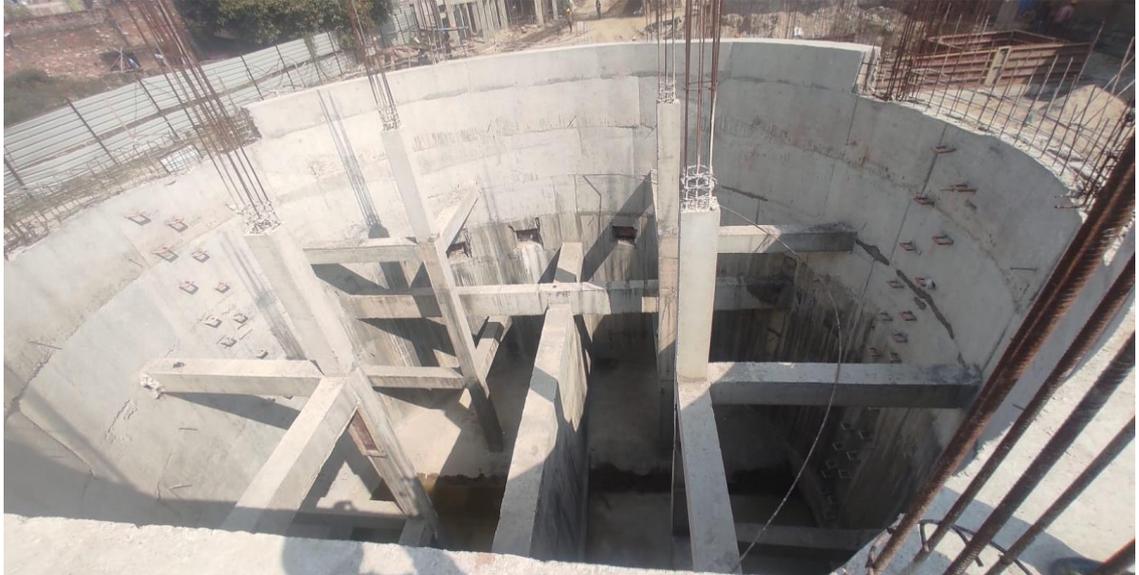
- iii. **Main Pumping Station (MPS):** At inlet chamber, step arrangement and proper footrest have not been provided. MPS wall casting up to base slab done and cleaning in progress. KRMPL needs to do hydro testing with clear water as per CEPHEEO MANUAL and IS code 3370 in presence of UPJN & STC, before grinding and tar coal epoxy work.

MPS wall casting work done

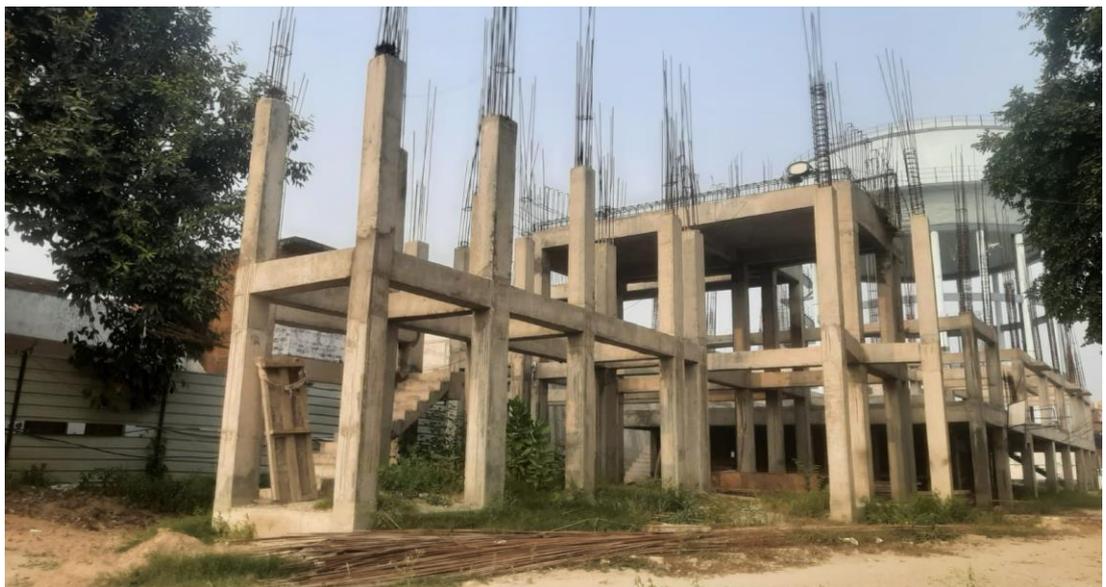
- iv. **Primary treatment unit (PTU):** Alignment of most of the Columns is not straight, bulged, twisted & not in Plum bob, improper covers provided, top of Column wrongly smoothly finished & Column edges bend. Most of Steel is corroded. PTU, Column work completed and slab shuttering and reinforcement work in progress.

Slab Shuttering work – 60%

Grit Chamber – 100%

Channel Slab - 90%

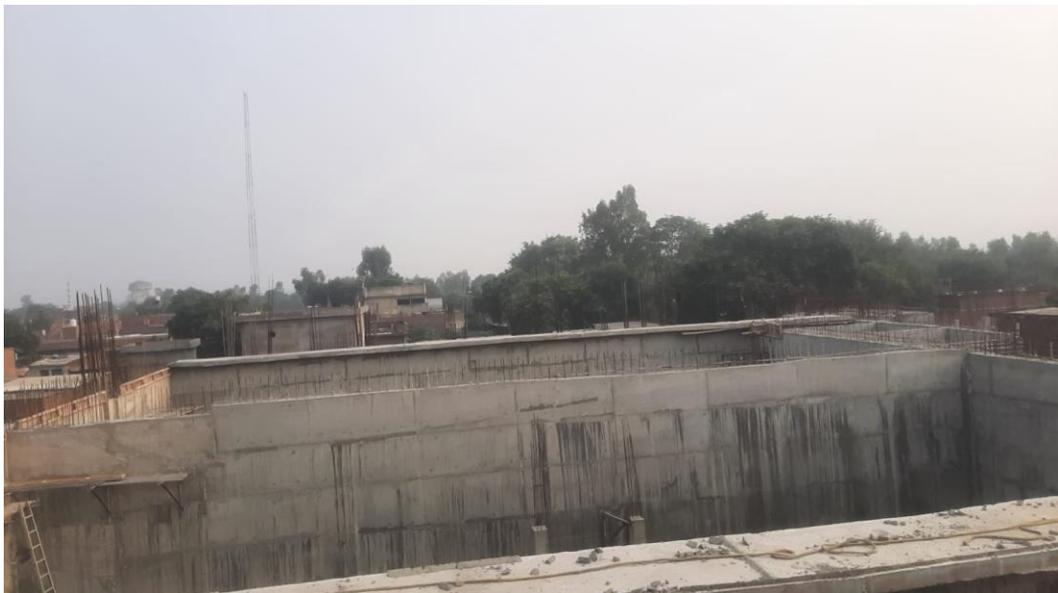
- SBRoutletchannelwallcastingcompleted.
- SlabshutteringworksR/Fworkcompleted,castingpending;
- Walkwayonesidecompleted,onesidepending.
- KRMPL has not used proper shutteringarrangement. Clear cover is not exactly as per design. Due to use of wide range of cover blocks casting of wall by the Concessionaire is not proper. KRMPL also do not use vibrator frequently at the timeof casting dueto which at some locations honey combing occurred. KRMPL has been instructed to rectify these issues and use vibrator in regular practice.

SBRandAdminbuildingcumblowerroom

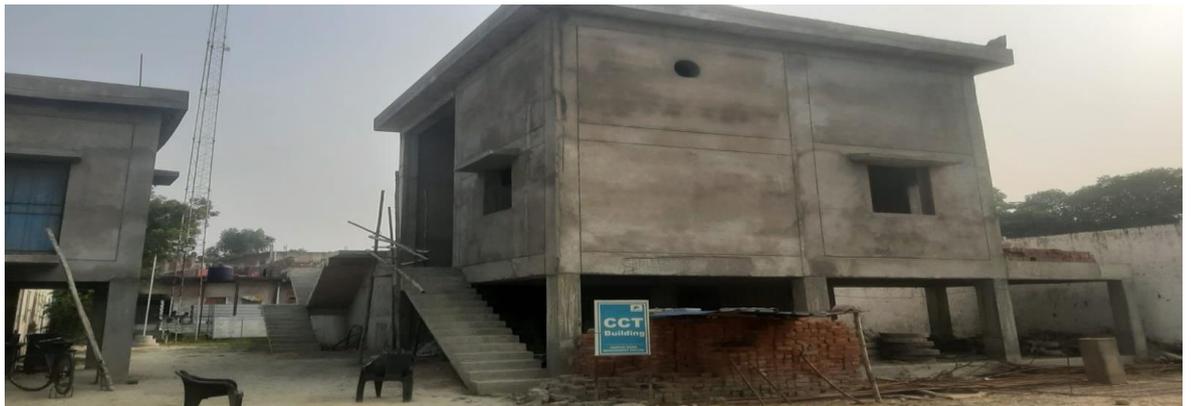
- vi. CCT & Building:** Brick work and plaster is almost completed in Chlorination building and finishing work is pending.

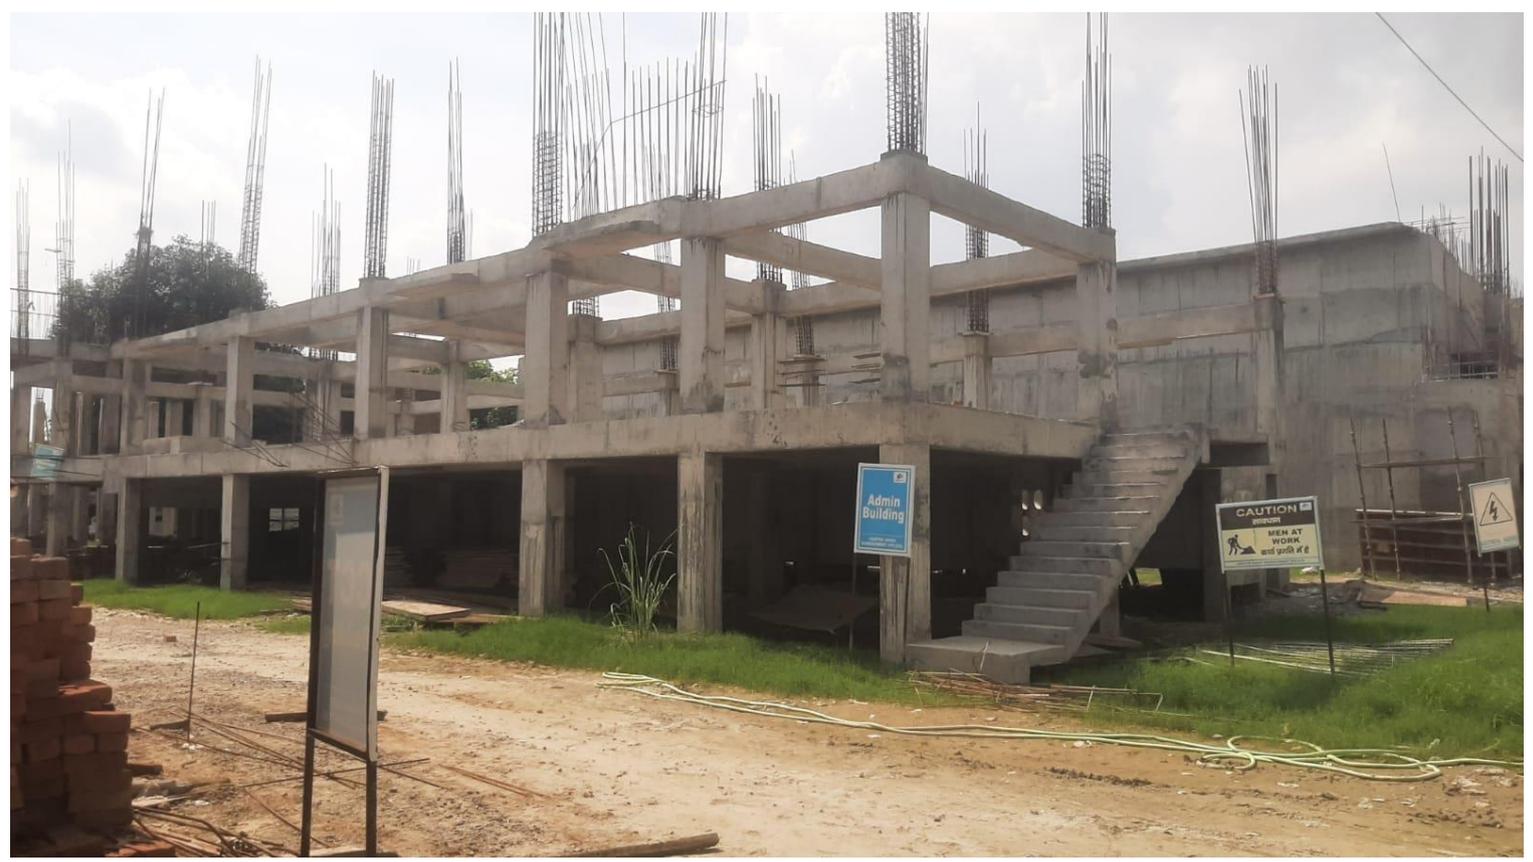
- InAdminbuildingcumAirblowerfoundationcompleted.
- Slabforfirstfloorstagingmaterialarrivedatplant.
- Most of the Column's alignment is not straight, bulged twisted & not in Plum bob.Impropercoversprovided,topofColumnwronglyfinished&Columnedges arefoundbend.MostoftheSteeliscorroded.KRMPLhasbeeninstructedto

rectify these issues without delay and comply with the standard practices for workmanship and finishing.

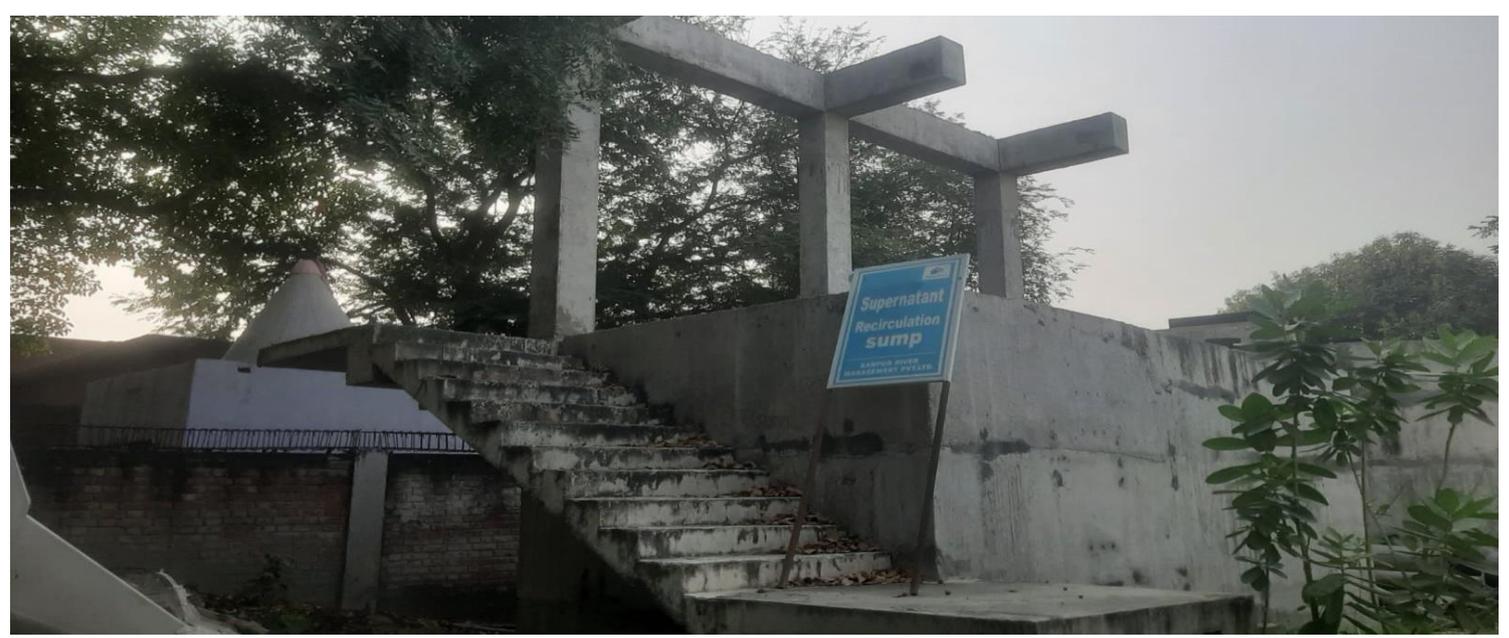
Sludge Thickener & Supernatant Sump: Concrete work completed almost one year ago for Sludge thickener & supernatant Sump. UPJN/STC instructed many time for Hydro test but KRMPL did not conduct hydro test till date. KRMPL need to arrange hydro test according to IS code 3370 in presence of UPJN/STC.

Supernatant Sump, Hydro test pending

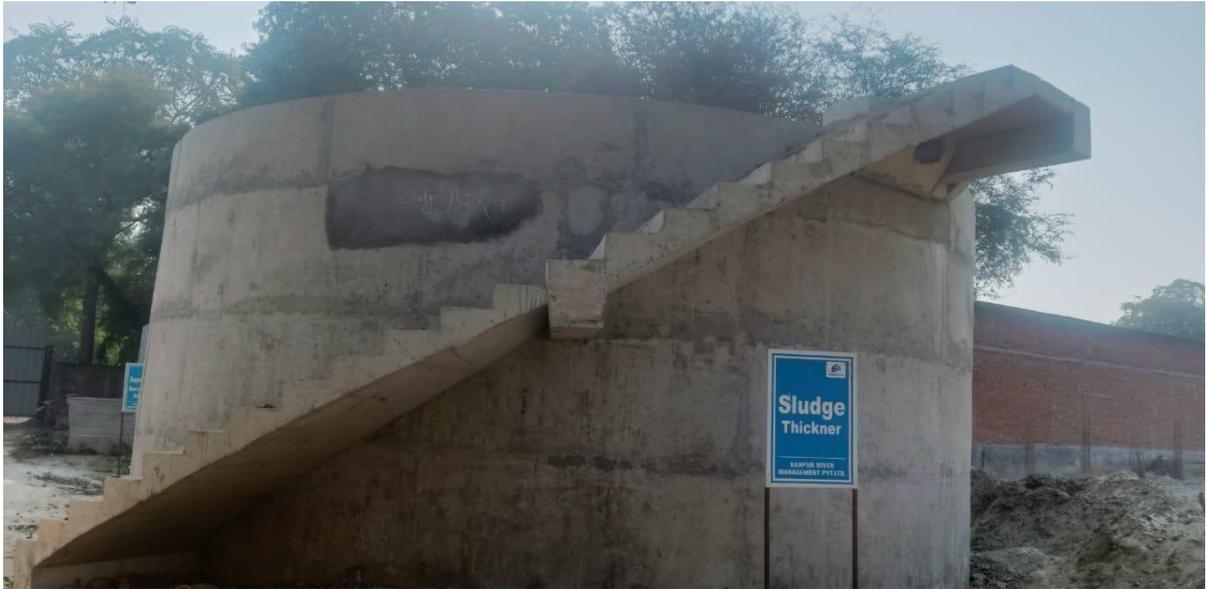
Sludge Thickener, Hydrotest pending

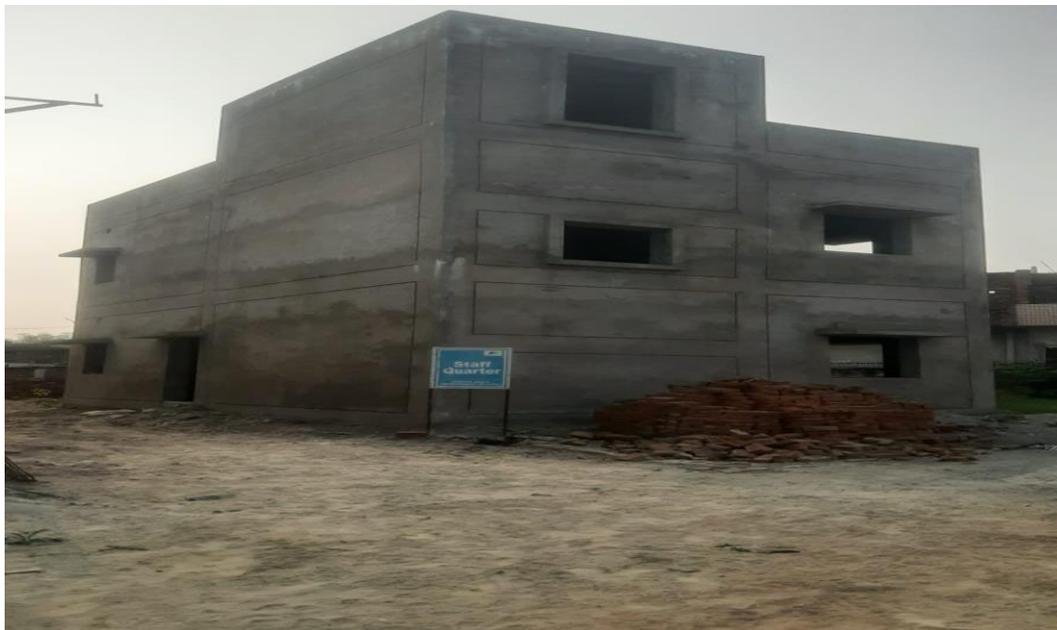
viii. Staff Quarter: Plaster work completed finishing and painting work pending.

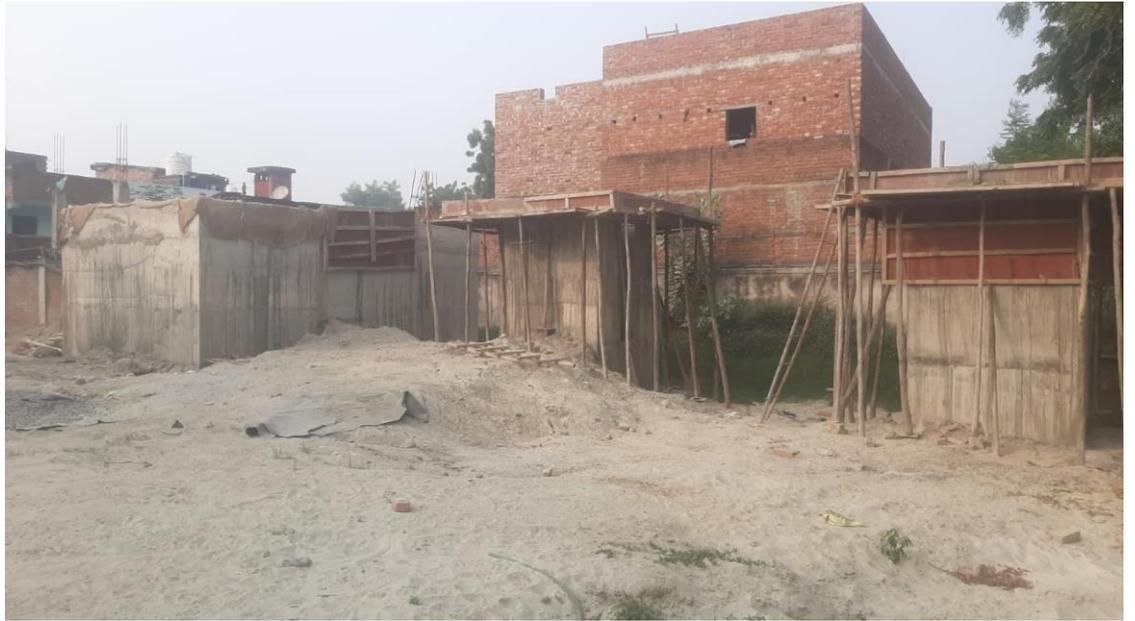
ix. DG set Foundation, Transformer area & VCB Panel room:

- RCC work is completed for DG and transformer foundation finishing works pending.
