**Ref.** STC/ PE/ KNP/2154 / Shuklaganj**Date:** 22/01/2024**To,**Superintending Engineer  
3<sup>rd</sup> Circle  
UP Jal Nigam (Rural)  
Lucknow**Sub:** **HAM Kanpur:** PE Inspection Report dated 06/01/2024 for 5 MLD STP Shuklaganj

## SITE INSPECTION REPORT - 05 MLD STP AT SHUKLAGANJ

Date of site Inspection	06/01/2024
STC Site Inspection team	Mr. Anil Kr. Seth – TL (I/C) STC Kanpur Mr. Indra Deo pandey - Supp. Engg. STC Kanpur
KRMPL Personal	Mr. Rajpal Singh Construction Manager KRMPL Mr. Avanish Tripathi QA/QC KRMPL

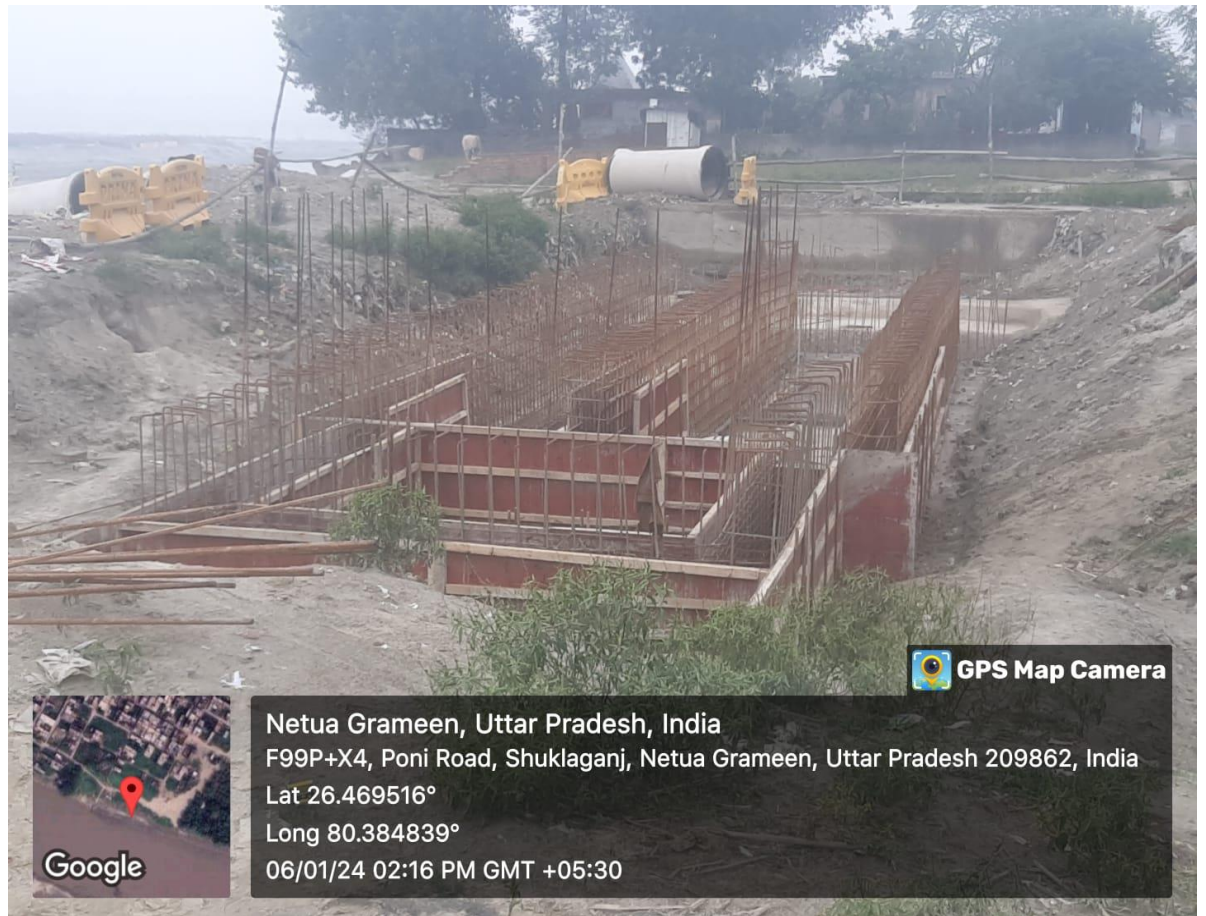
- i. **I&D Structure:** Work of I&D is very slow. Till date only PCC and raft work has been done, reinforcement work of wall in progress. It is to be noted that safety precautions are not followed by KRMPL. Excavated sites should be fully covered by hard barricading.

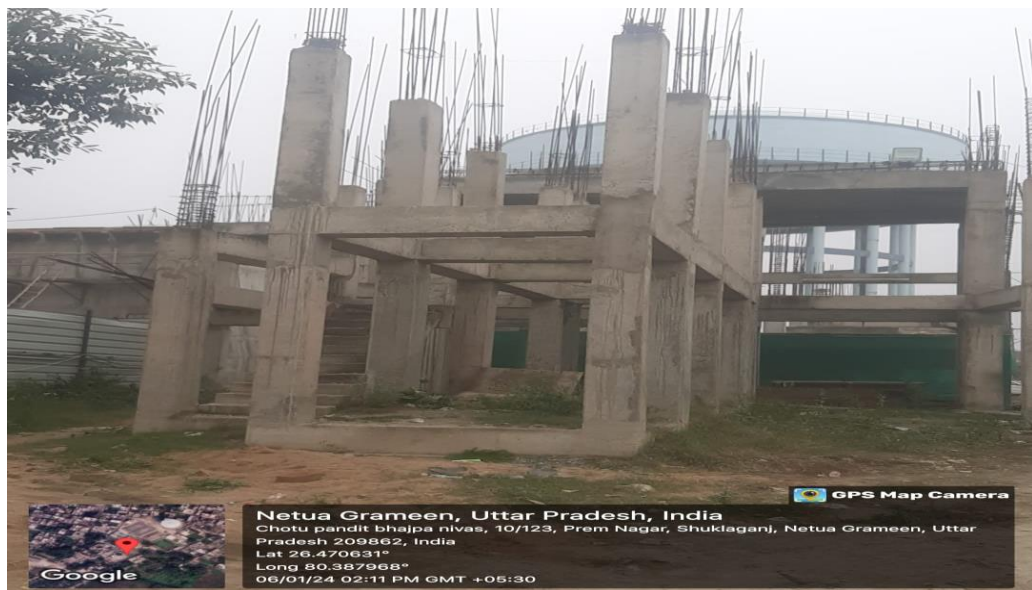
- iv. **Primary treatment unit (PTU):** Alignment of most of the Columns is not straight, bulged twisted & not in Plum bob, improper covers provided, top of Column wrongly smoothly finished & Column edges bend. Most of Steel is corroded. PTU, Column work completed and slab shuttering and reinforcement work in progress.

Slab Shuttering work – 60%

Grit Chamber – 100%

Channel Slab - 90%

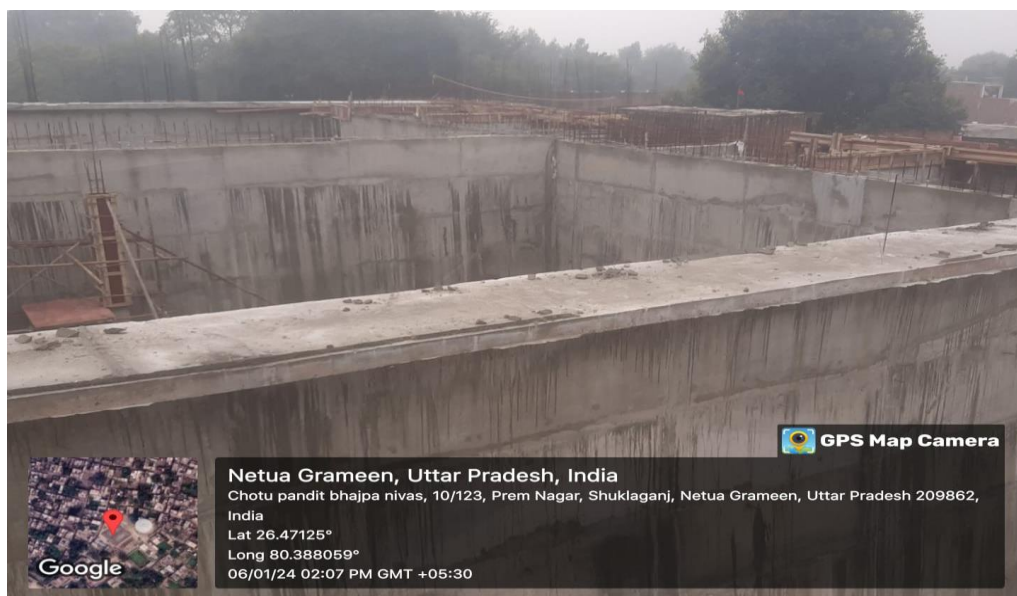
**SBR and Admin building cum blower room**

- SBR outlet channel wall casting completed.
- Slab shuttering works R/F work completed, casting pending;
- Walkway one side completed, one side pending.
- Connecting channel balance
- Decanter foundations are pending.
- Column and beam pending for RAS and SAS pumps.
- KRMPL has not used proper shuttering arrangement. Clear cover is not exactly as per design. Due to use of wide range of cover blocks casting of wall by the Concessionaire is not proper. KRMPL also do not use vibrator frequently at the time of casting due to which at some locations honey combing occurred. KRMPL has been instructed to rectify these issues and use vibrator in regular practice.

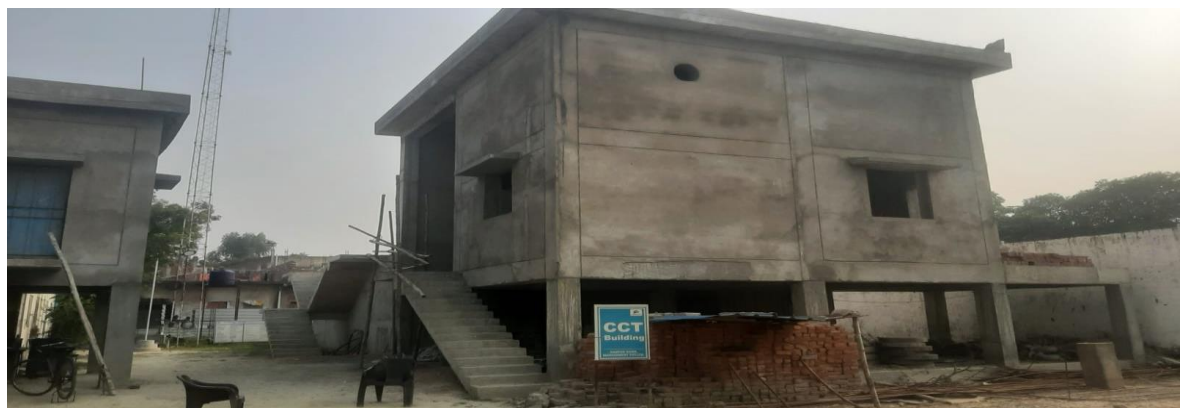
- vi. CCT & Building:** Brick work and plaster is almost completed in Chlorination building and finishing work is pending.

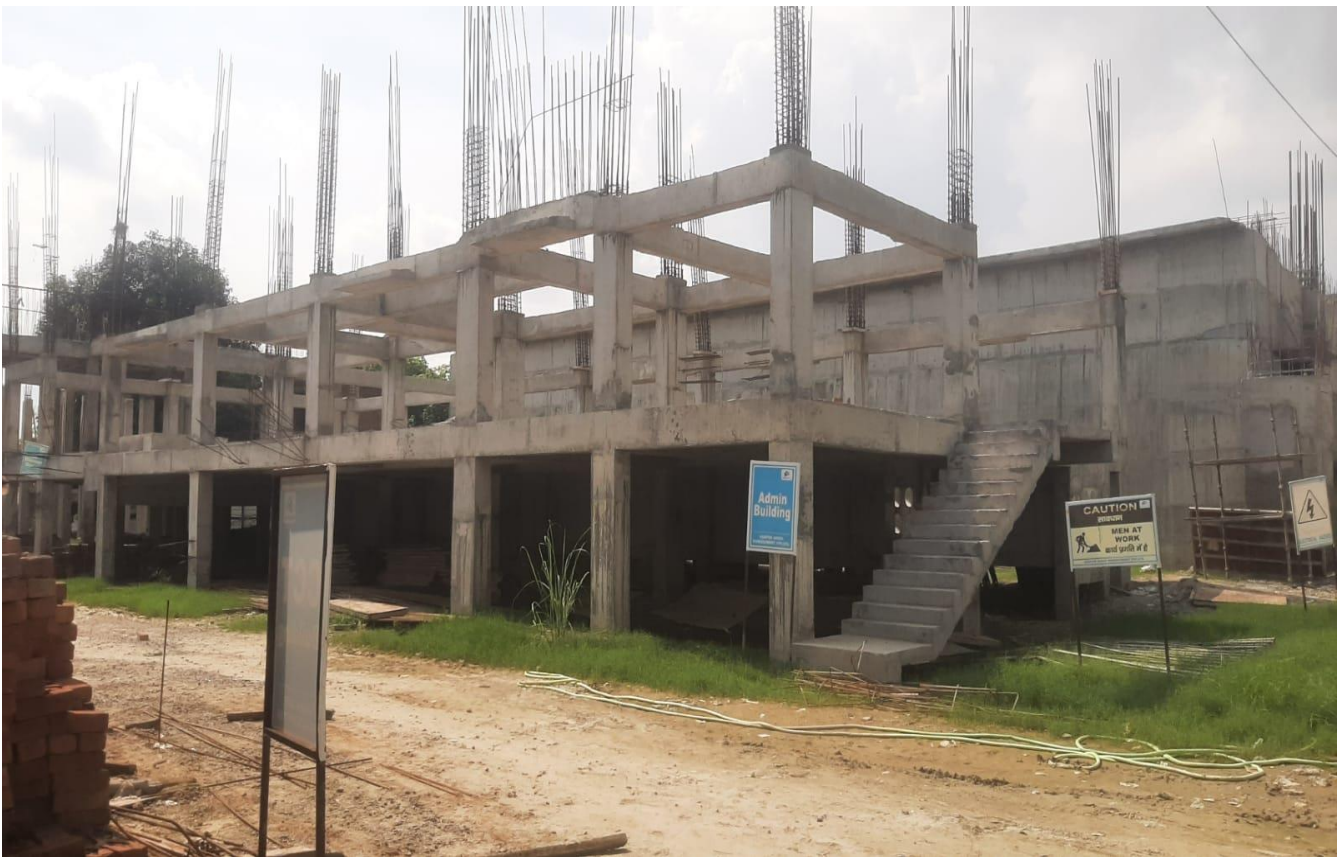
**Administration Building cum Air blower**

- In Admin building cum Air blower foundation completed.
- Hand railing work in progress.
- Slab for first floor staging material arrived at plant.
- Most of the Column's alignment is not straight, bulged twisted & not in Plum bob. Improper covers provided, top of Column wrongly finished & Column edges are found bend. Most of the Steel is corroded. KRMPL has been instructed to rectify these issues without delay and comply with the standard practices for workmanship and finishing.

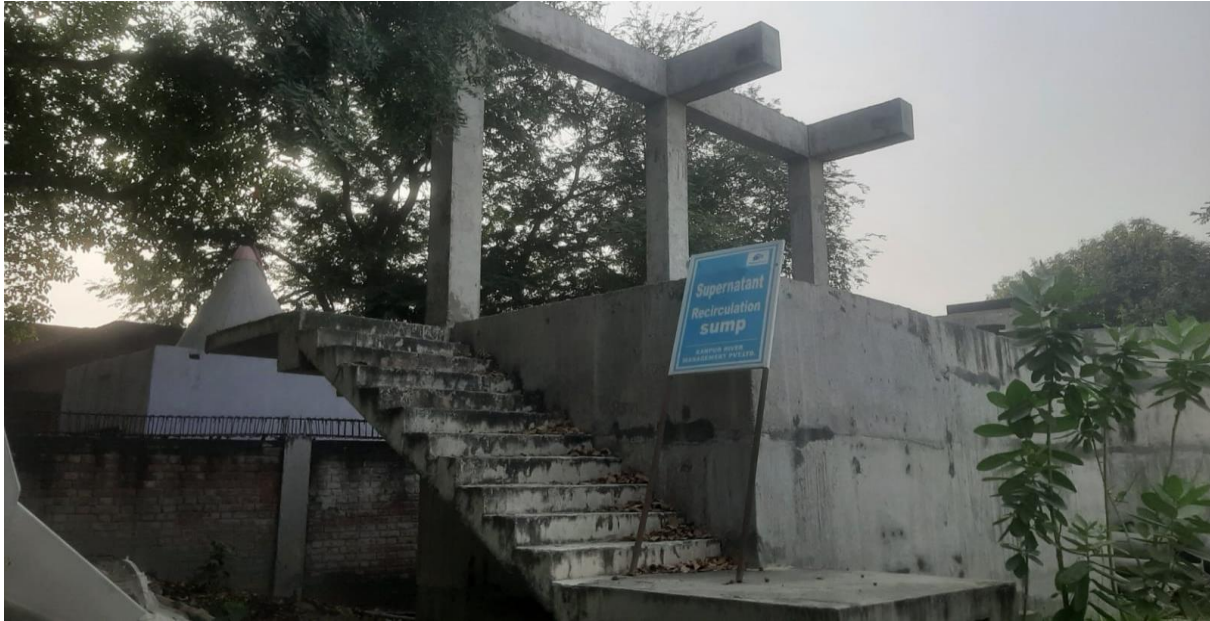
**Sludge Thickener & Supernatant Sump:** Concrete work completed almost one year ago for Sludge thickener & supernatant Sump. UPJN/STC instructed many time for Hydro test but KRMPL did not conduct hydro test till date. KRMPL need to arrange hydro test according to IS code 3370 in presence of UPJN/STC. There is no manpower.

**Supernatant Sump, Hydro test pending**

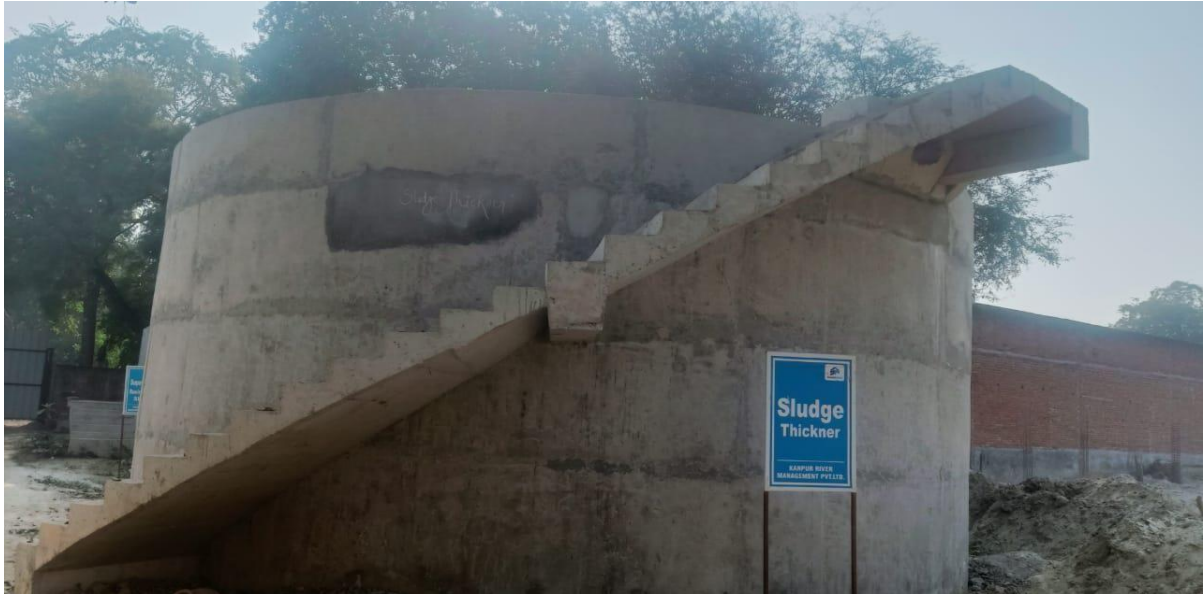
**Sludge Thickener, Hydro test pending**

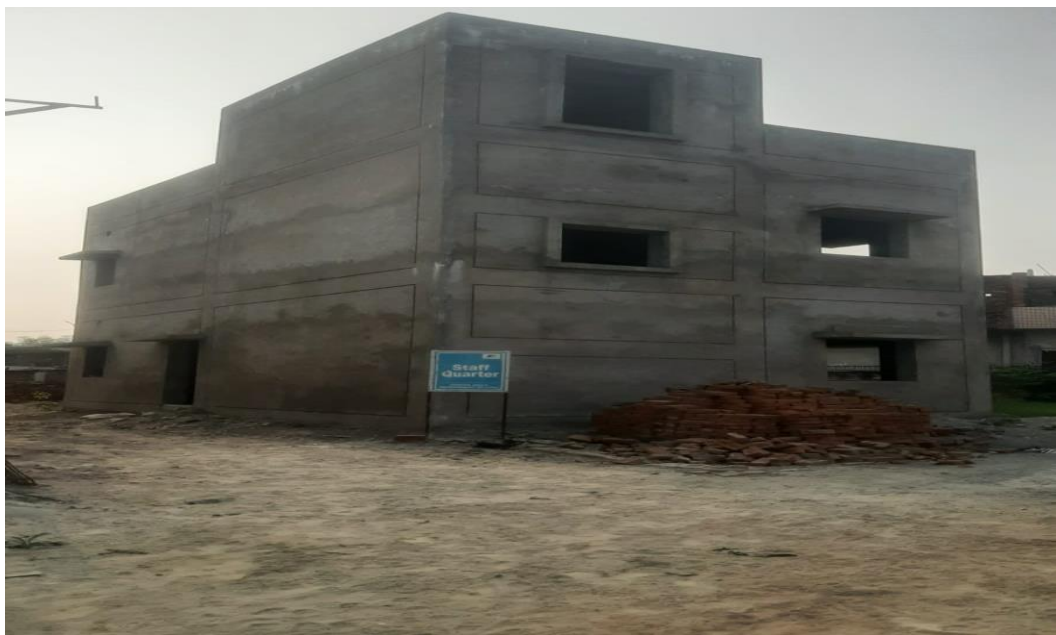
**viii. Staff Quarter:** Plaster work completed finishing and painting work pending.

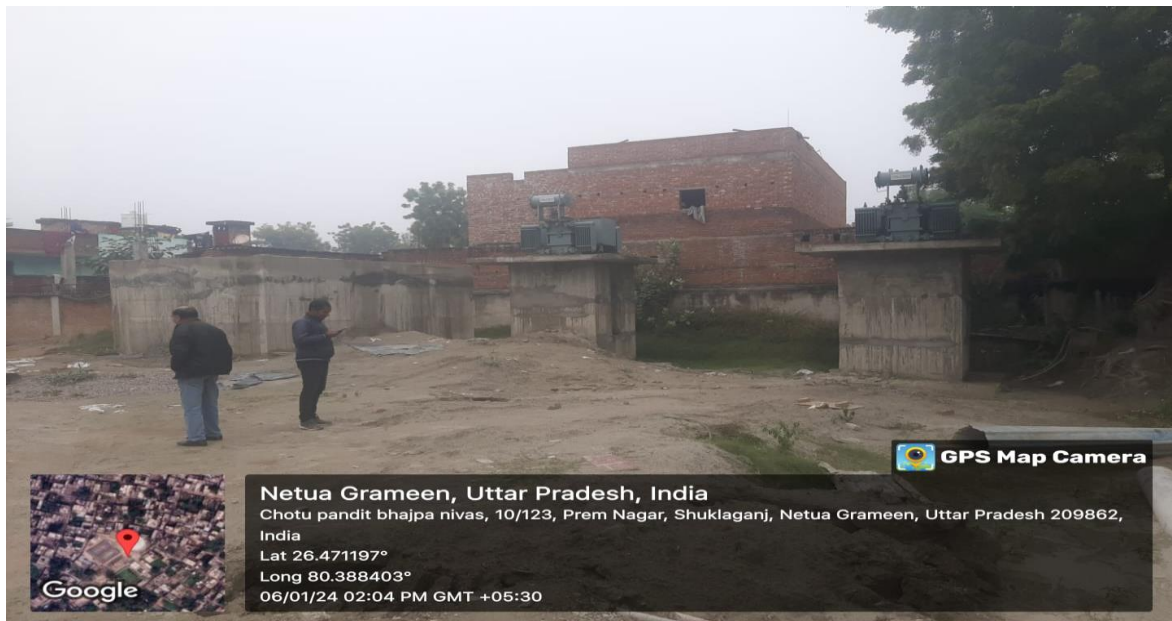
**ix. DG set Foundation, Transformer area & VCB Panel room:**

- RCC work completed for DG and transformer foundation finishing works pending.
