Joint Site Inspection Report of 5 MLD Shuklaganj

Date of Inspection	14/06/2024
STP Site inspection Team	Mr. Anil Kumar seth Mr. Subhash A.E. UPJN Mr. Ankur Saxena J.E. UPJN Mr. Indra Deo Pandey- Support Engineer
KRMPL Personal	Mr. Saket Singh Mr. Soham vishwas.

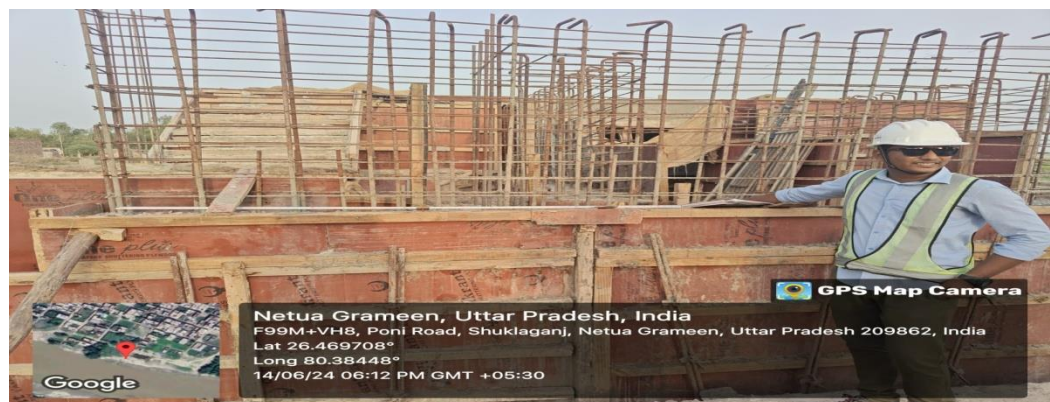
A. I&D Structure-

- i. Work of I&D structure is in progress. Reinforcement & shuttering work of wall in progress. The casting of the all lift of the wall was done without informing UPJN and STC. In Approach channel, inlet channel and screen channel finishing and hydro test is pending. KRMPL.

- ii. KRMPL has not used proper Clear cover exactly as per design. Due to use of wide range of cover blocks casting of wall by the Concessionaire is not proper.

- iii. Joint inspection conducted by Uttar Pradesh Jal Nigam and PE STC on 14th June 2024, it was found that the quality of steel being used in the I&D structure was rusted, for which KRMPL has been instructed several times by UPJN & STC through **letters 4088/WS-97/253 dated 30/12/23, 240/WS-97/19 dated 18/01/24, 373/WS-97/27 dated 08/02/24, 508/WS-97/27 dated 08/02/24, 547/WS-97/28 dated 12/02/24, 609/WS-97/29 dated 18/02/24, 1084/WS-97/44 dated 20/03/24, STC/PE/KNP/2166 dated 15/03/24 and STC/PE/KNP dated 2168** to replace it, but KRMPL is not taking action to replace the steel and using the same steel, earlier instructions were given to KRMPL to work as per the approved drawing, but non compliance is being done continuously, which is not appropriate, in such a situation, it will not be possible to measure and make payment for the said work done by KRMPL.

- iv. During the inspection honeycombs and cracks were found at many places in the stairs and wall.
- v. In the third lift of the vertical wall of I&D the lap should be 50 D, which should be 400 mm c/c, which was found 10 mm and 25 mm.

- vi. In the third lift of vertical wall, the thickness of the third steel bar from the bottom was measured by means of vernier caliper and found to be 7 mm and 8 mm respectively.

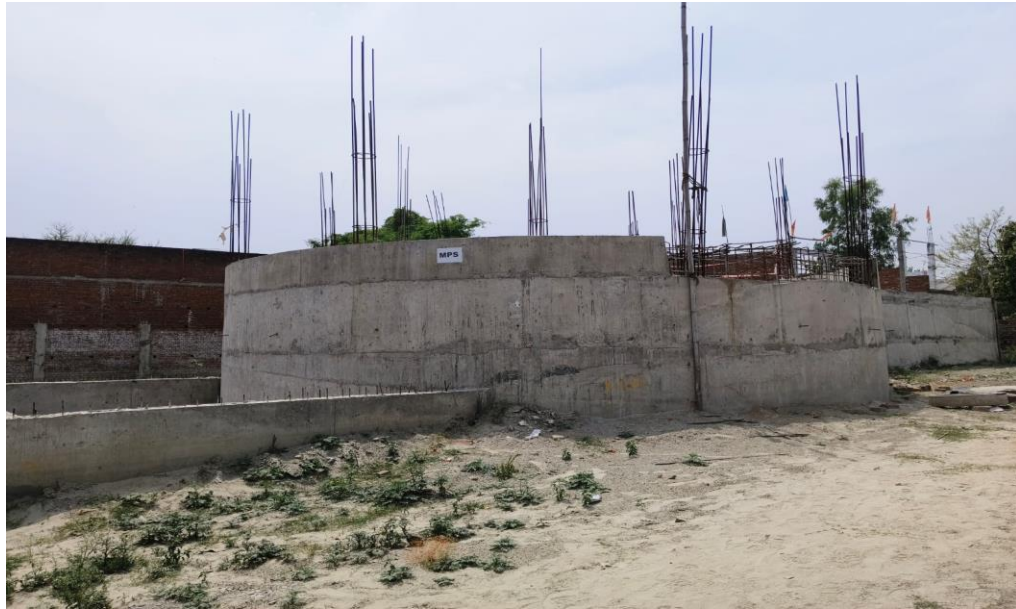
- B. MPS-** At inlet chamber step arrangement and proper footrest have not been provided. Column, beam and slab work is still pending. KRMPL needs to do hydro testing with clear water as per CEPHEEO MANUAL and IS code 3370 in presence of UPJN & STC, before grinding and tar coal epoxy work. During inspection there is no manpower on MPS.

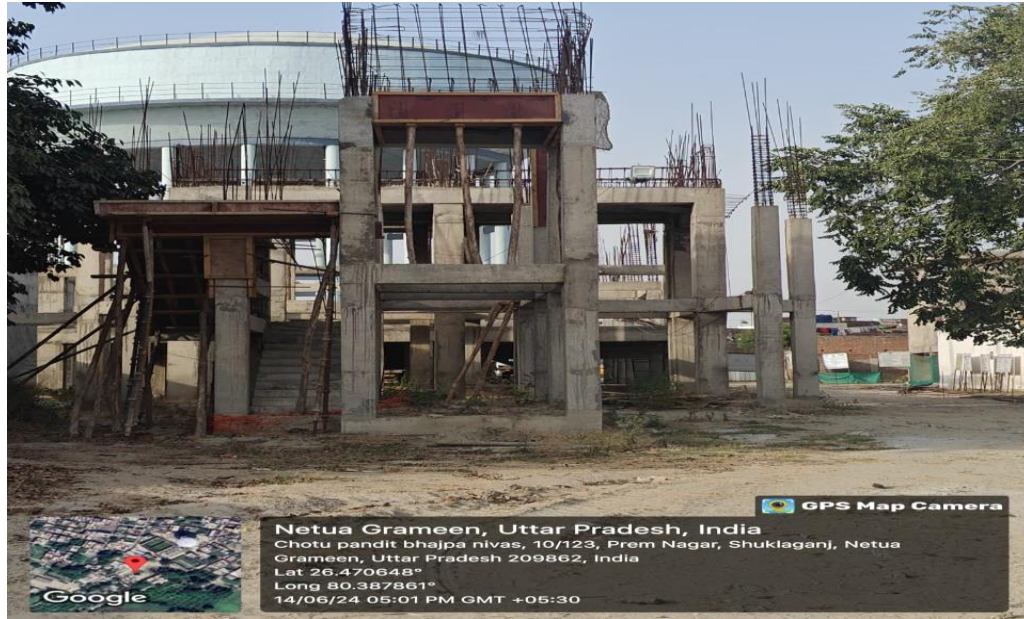
- C. PTU-** Most of Steel found corroded. PTU, Column work completed and slab shuttering and reinforcement work is in progress. In Inlet chamber area finishing work, hydro test is pending. In Grit chamber and parshall flume RCC wall & slab, walk way, platform and hydro test pending.

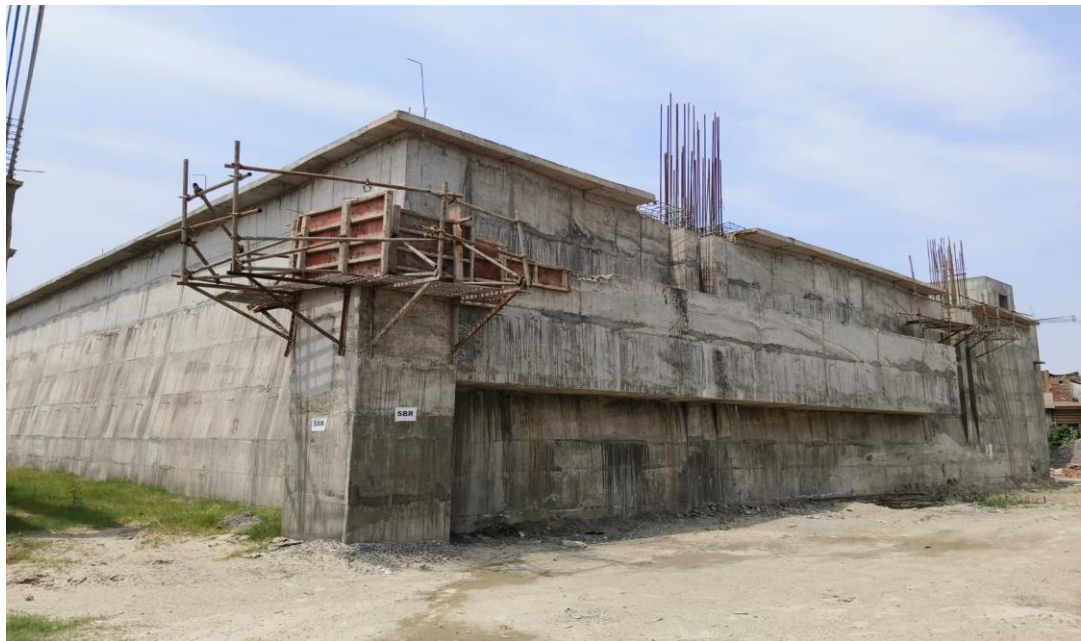
- D. SBR-** In SBR connecting channel, supporting column, walkway platform, RAS & WAS pump platform column, decanter foundation, finishing hydro test are pending. There is no manpower on SBR during inspection.

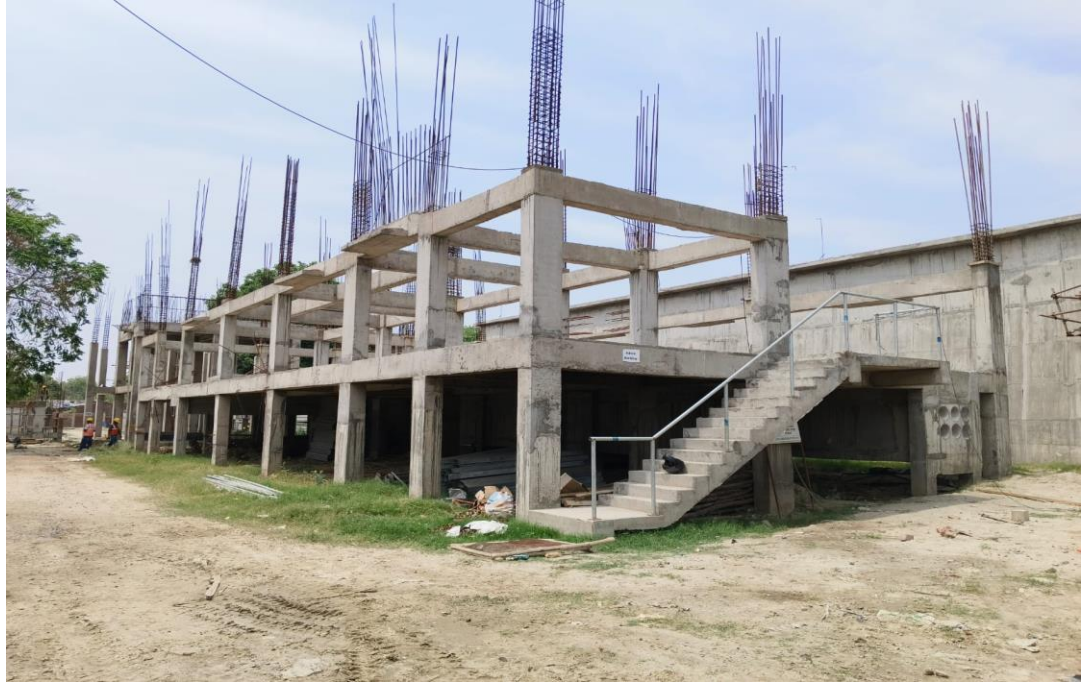
- E. Admin building cum Blower room-** In admin building room first floor and second floor slab work pending, brick work IPS flooring, electrification, sanitary fitting & plumbing, beam, column works are pending. In blower room roof slab, brick work, IPS flooring, roof treatment & finishing works are pending.

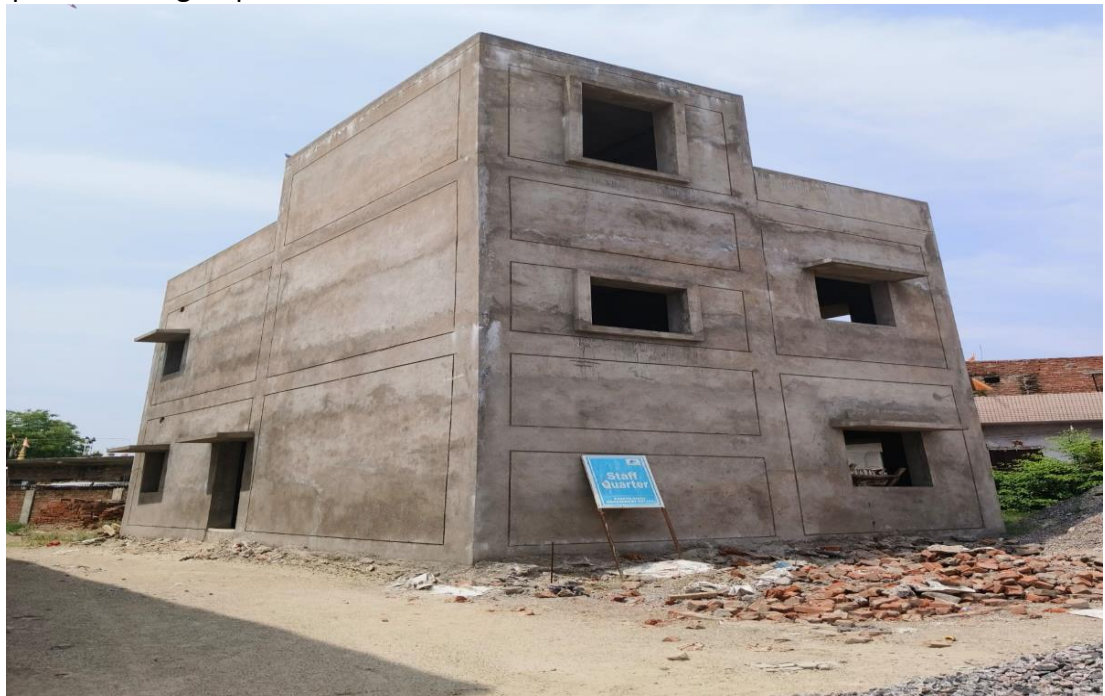
- F. Staff quarter-** Electric work, plumbing, sanitary fittings, floor, roof treatment, drainage, finishing and painting works are pending. There is no manpower on staff quarter during inspection.

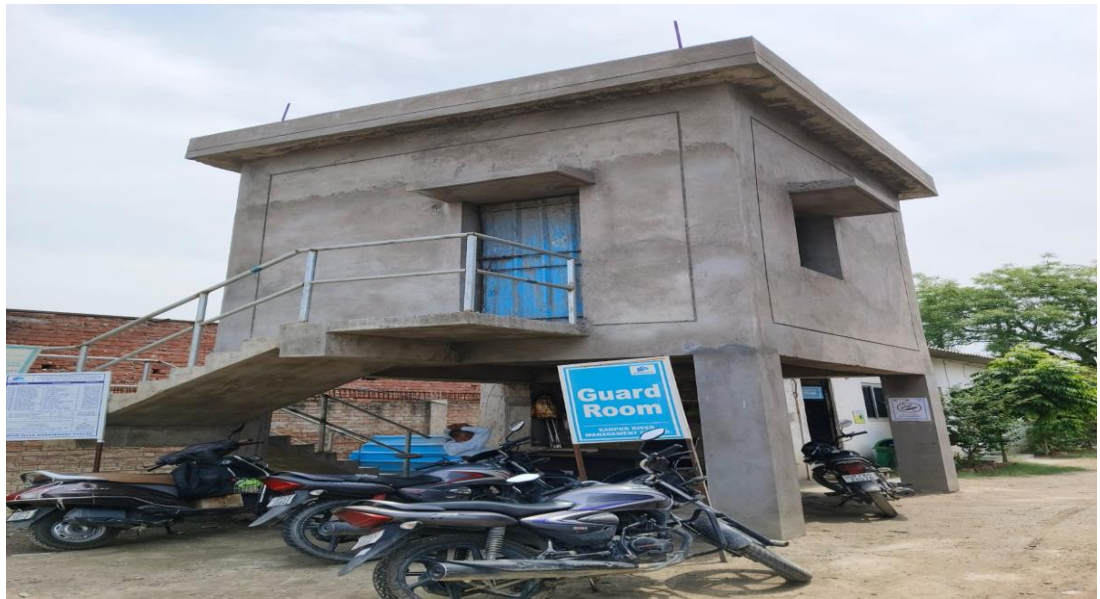
- G. Guard Room-** Electric work, plumbing, sanitary fittings, floor, roof treatment, drainage, finishing and painting works are pending. There is no manpower on staff quarter during inspection.

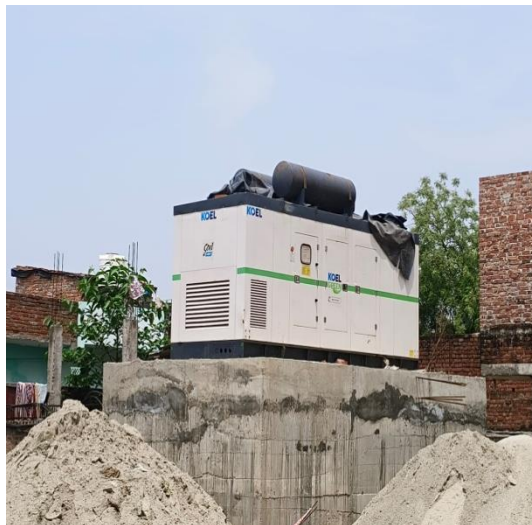
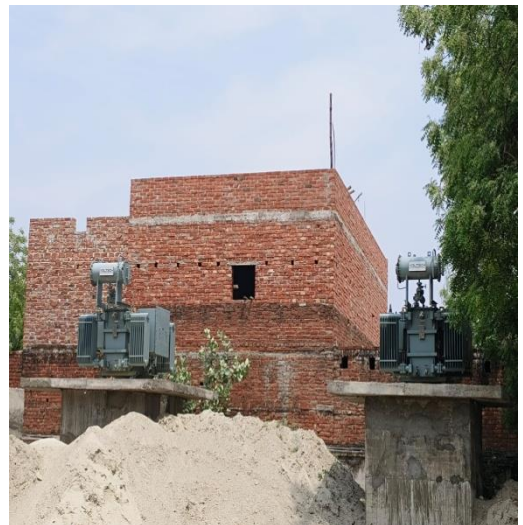
- H. Transformer & DG Yard-** Staircase, finishing, approach and painting works are pending.

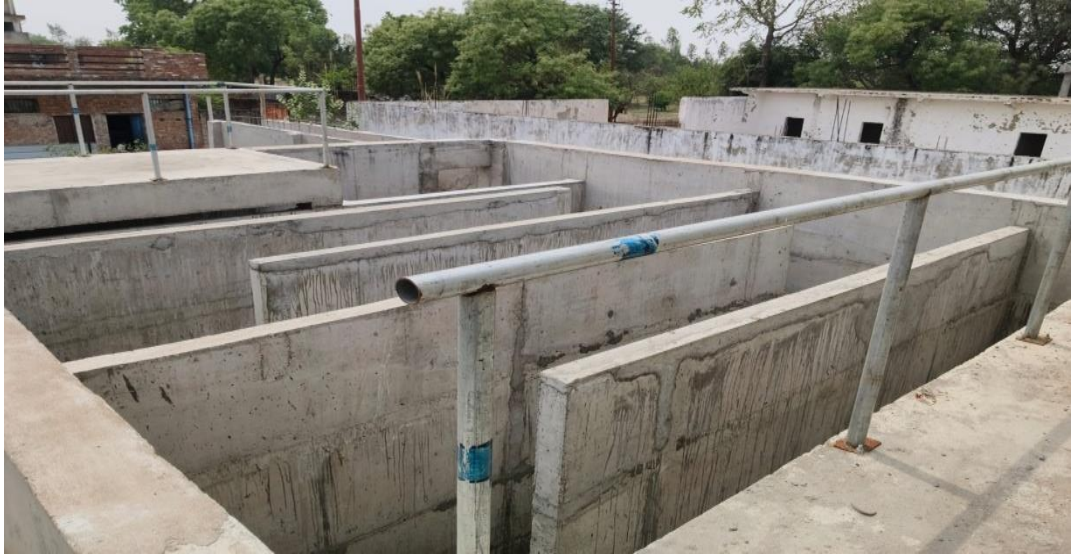
- I. CCT & Chlorination building** - In CCT outlet channel work, finishing of outlet chamber, grinding, finishing and painting works are pending. In building foundation of tonner, Electric work, plumbing, floor, finishing and painting works are pending. Booster pump and fitting pump can be install. During inspection there is no manpower on chlorination building & CCT.

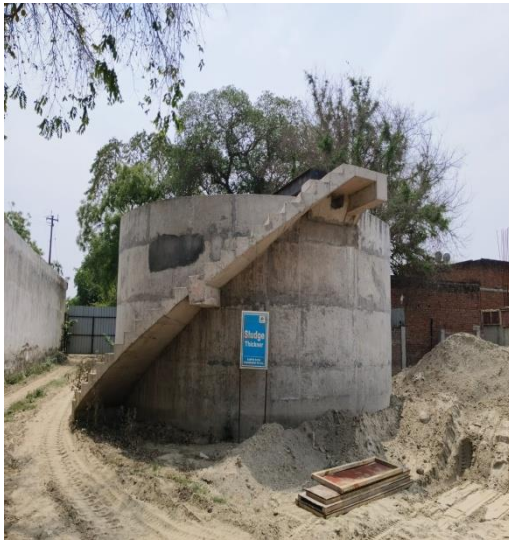
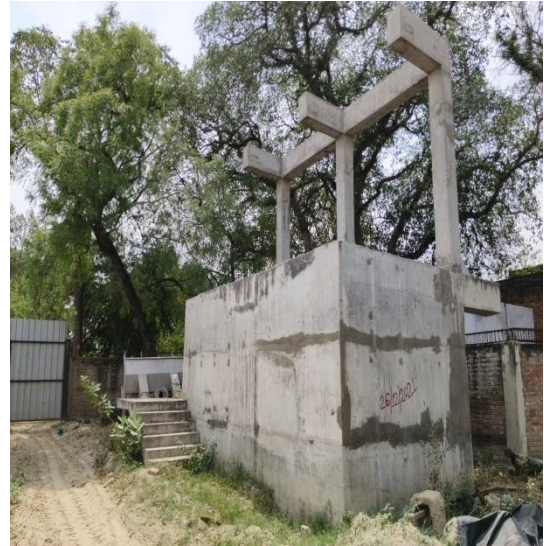
- J. Sludge Thickner & Supernatant Pump-** finishing, painting and hydro testing are pending. Scraper in thickener and pump in supernatant can be install as there is no hindrance.

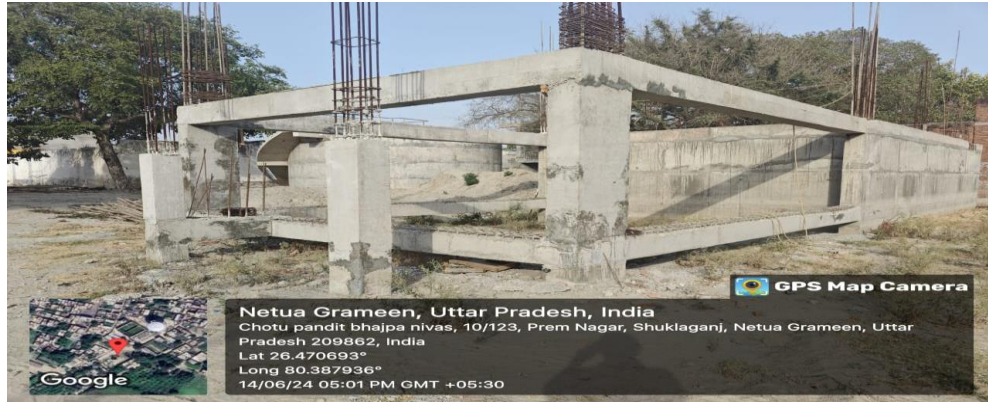
- K. Centrifuge Building-** First and second floor slab work is pending, column and beam work is in progress. Cracks found in the beam.

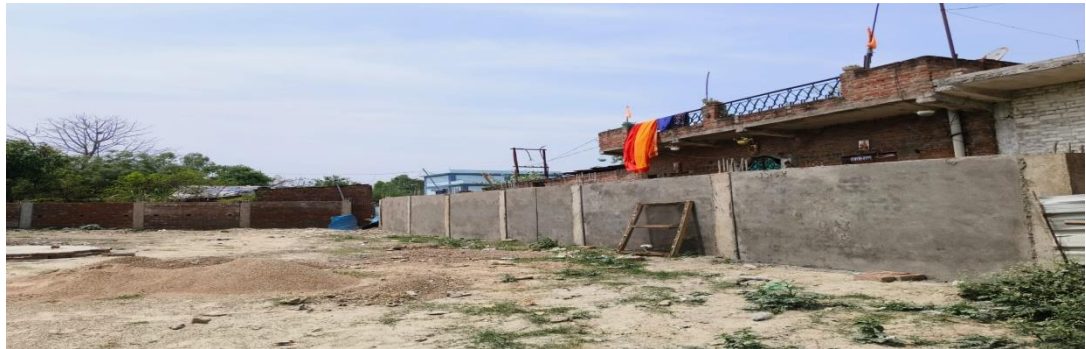
- L. Boundary wall-** 60% work of boundary wall completed. Plaster work of boundary wall is in progress.

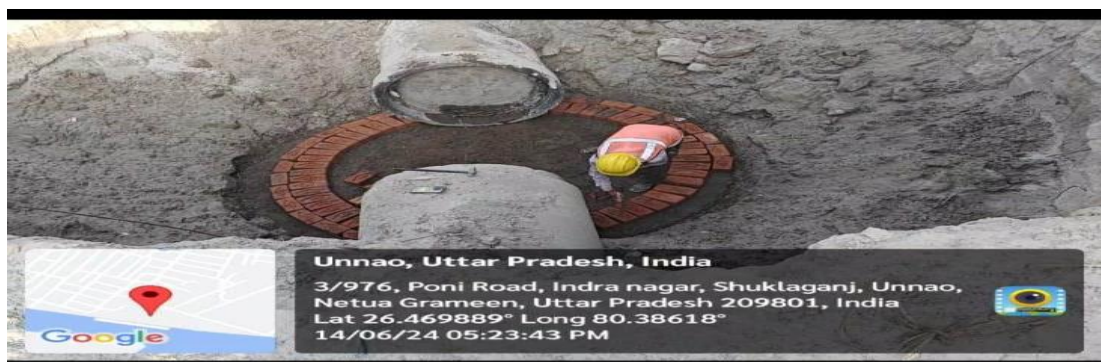
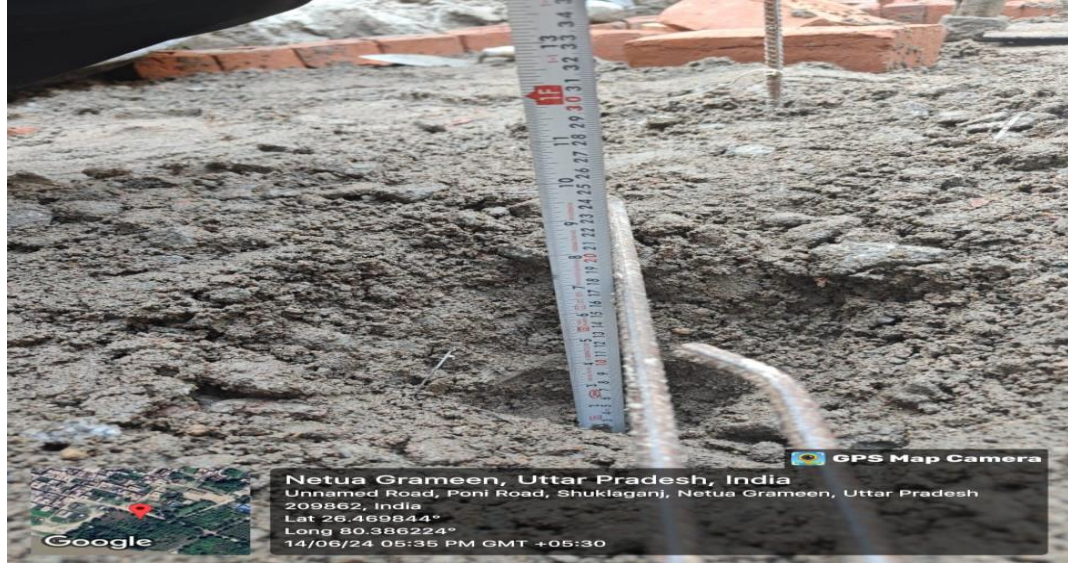
- M. Manhole-** During inspection it was found that the manhole work was being done without information to UPJN & STC and without approved drawings, in which the quality of bricks being used was found to be very poor which is not appropriate in the interest of work. In such a situation it would not be possible to measure and make payment for the work done by KRMPL and in view of the quality of the said work, it was also informed through letter **STC/PE/2165/Shuklaganj dated 11/03/24**, despite this KRMPL is getting the work done arbitrarily.

During the inspection it was found that the manhole raft was to be constructed using M 30 grade concrete but it was found that M 30 grade concrete was being used in the raft without Ajax and concrete mixer, using a simple mixer and without cubes test or setting the raft, which is not as per standard. In which the thickness of the raft was found to be 19 cm instead of 30 cm.

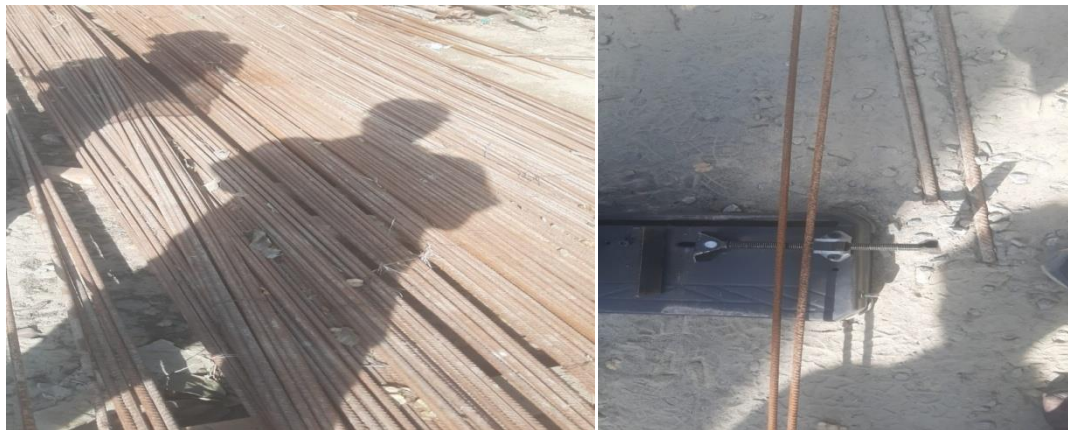
- P. **Note-** During the joint inspection, it was found that the steel used in grade chamber, collection chamber, screen chamber, approach channel and inlet chamber on the I&D structure is not as per the approved drawing design and the concerned Site Engineer Mr. Sohan Vishwas are making aware of the fact that KRMPL does not have the availability of steel as per the approved design and drawing. KRMPL is not ensuring the availability of material in the execution of the works of the proposed scheme under an important program like Namami Gange, whereas KRMPL is also provided price acceleration money in relation to the invoice to complete the works with quality, in such a situation also not being able to complete the works as per the approved design and drawing shows negligence and indifference towards the works. In such a situation, it will not be possible to measure and make payment for the said work done by KRMPL.
