National Mission for Clean Ganga- Development, Rehabilitation with  
Operation & Maintenance of STPs at Kanpur under Hybrid Annuity based PPP mode

Ref STC / PE / KNP /2188/Jajmau Phase 1

Date: 10/05/2024

**Sub: HAM KANPUR: Joint inspection report of Jajmau phase 1 Facilities**

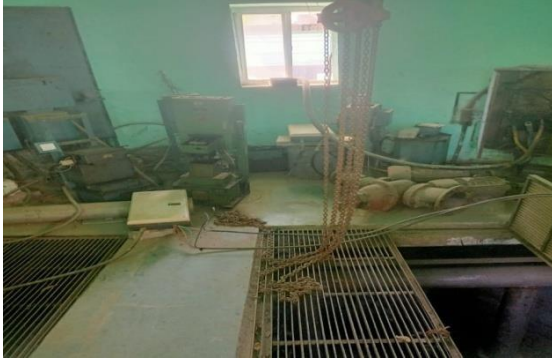
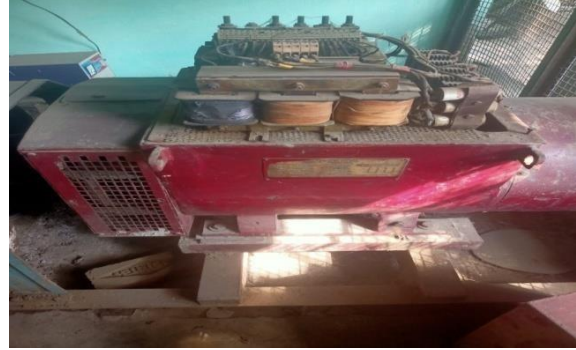
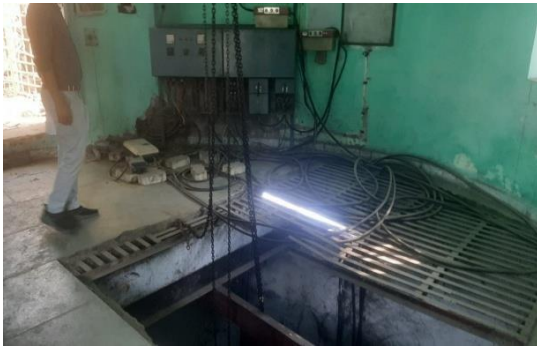
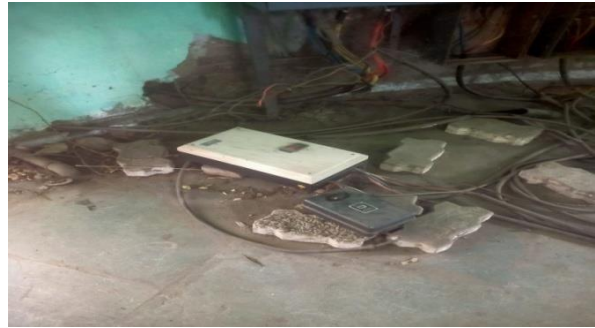
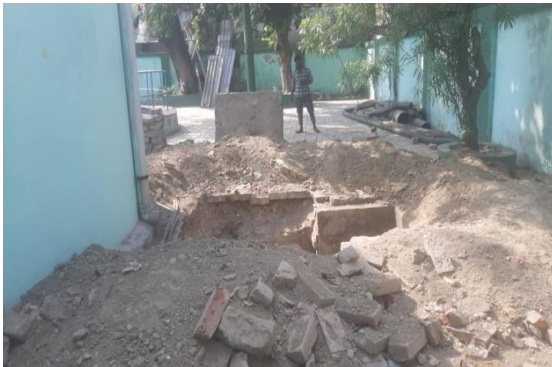
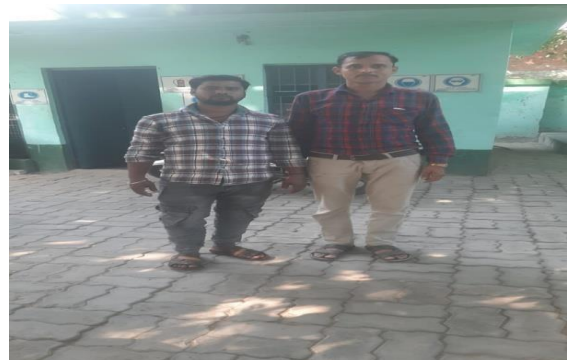
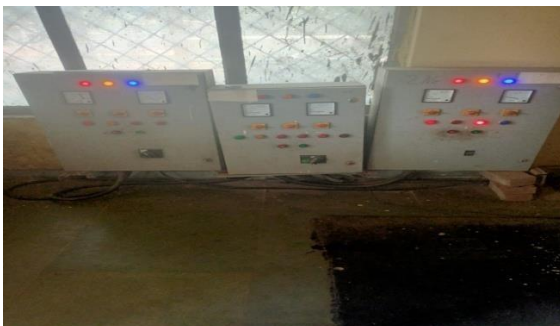
### **Nawabganj IPS 15 MLD:**

- Alternator coil of DG set has burnt on 30/04/24 so DG is non operational.

- Total pumps 3nos
- Operational 2nos.
- 1 no Pump not installed due to defect for last 6 months.

- Pump installed 4 nos
- Operational 2 nos
- 1 no Pump burnt for last 8 months and 1 no non operational due to defect in NRV valve.

- Starters are not installed on walls and are being used .They are layed on floor.

- Internal and external electrification is insufficient

- Maintenance and repair is very poor. No painting of pump houses, no repair works.
- Replacement of door/window pending
- Approach road & campus development pending.
- Scrap shifting pending.
- New Exhaust fan to be installed
- Flow meters are to be installed.
- Main valve handle to be repaired.
- New PDB and exhaust fans are to be installed.
- Ladder and screen to be installed in sump
- Minor boundary wall to be repaired.

- Operator and sweeper are working without PPE

- During the inspection it was found that there is neither safety arrangement of excavated area and nor covered open sump.

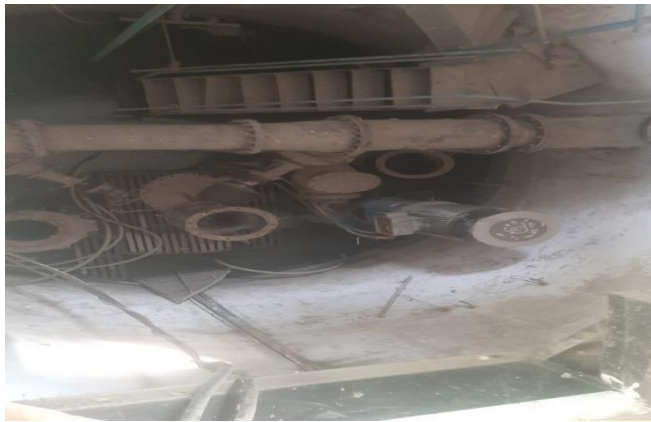
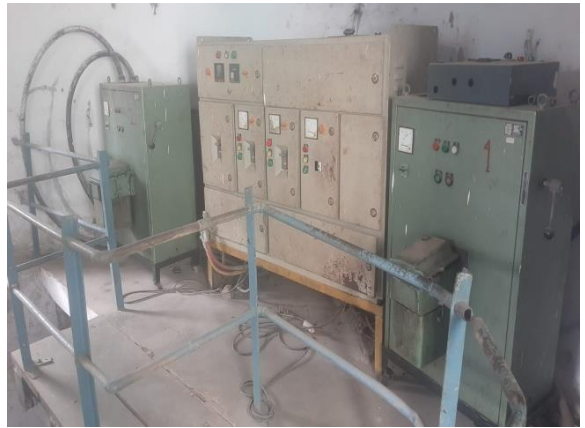
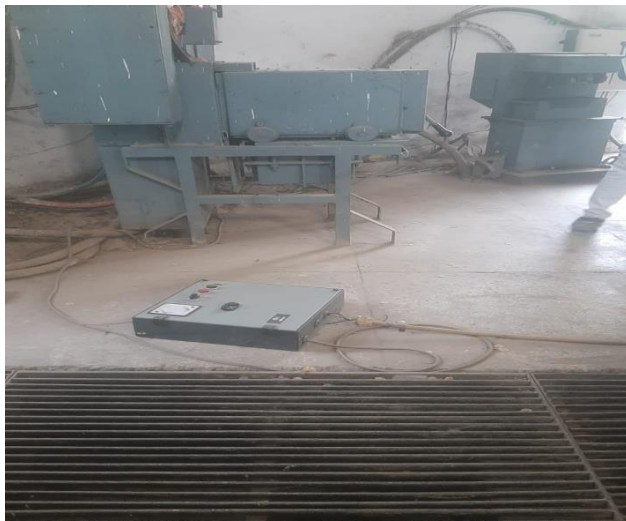
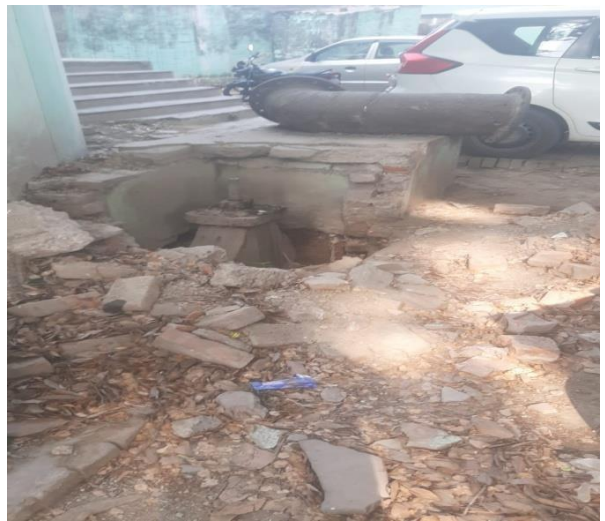
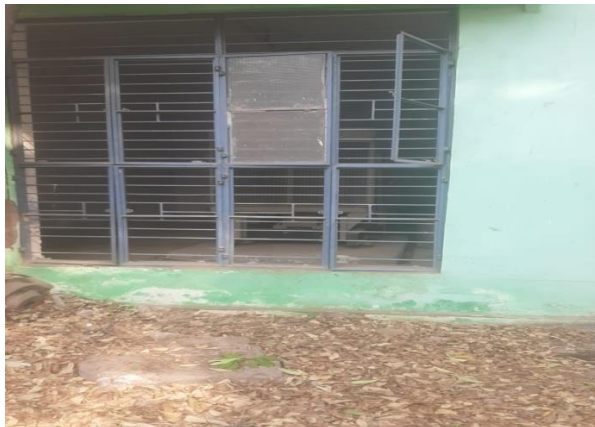
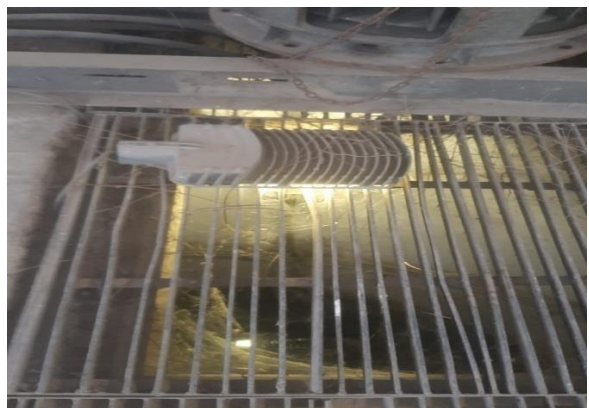
## **Paramath 56 MLD IPS**

- Total pumps 2 nos
- Operational 1 no
- 1 no Non operational for last 2-3 months.

- Total pumps 3 nos
- Operational 1 no
- Wrong supply of 2 nos pumps direction of rotation problem.

- HT panel bye passed. No protection available.

- Operator and sweeper are working without PPE
- During the inspection it was found that there is neither safety arrangement of excavated area and nor covered open sump.

- Maintenance very poor. No painting, no cleaning and no repair.
- Internal lightning pending.
- Dewatering pump not working.
- Renovation of DG room
- supply and installation of valves
- Replacement of door/window pending
- Approach road & campus development pending.
- Scrap shifting pending.
- New Exhaust fan to be installed
- Flow meters are to be installed.

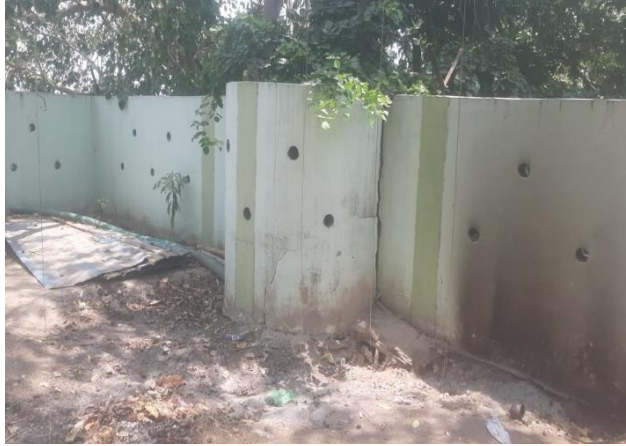
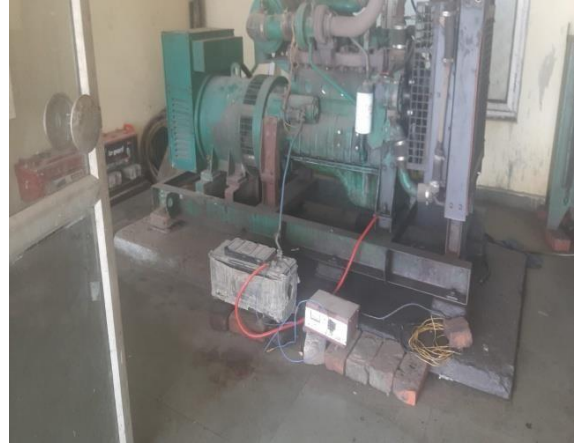
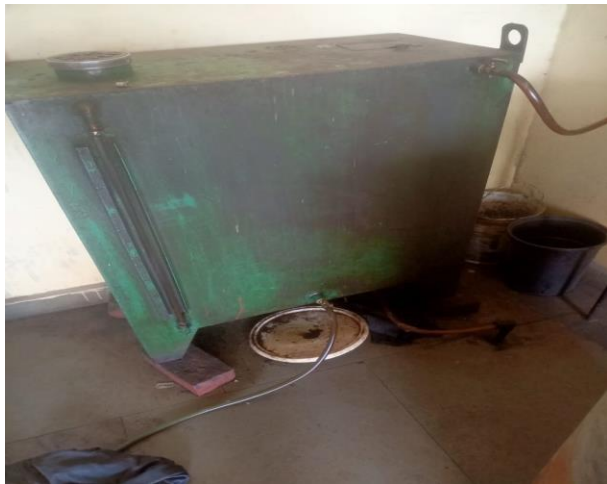
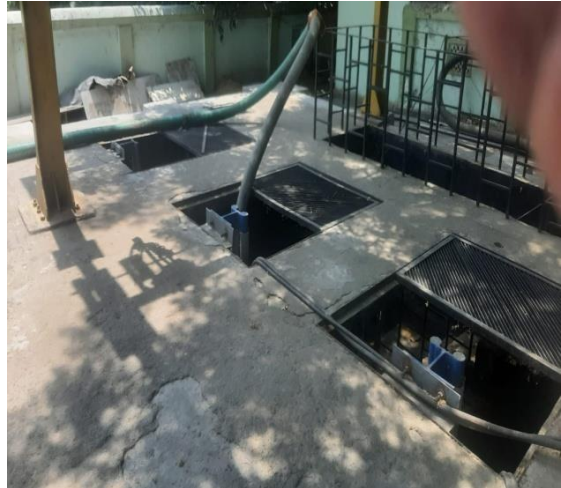
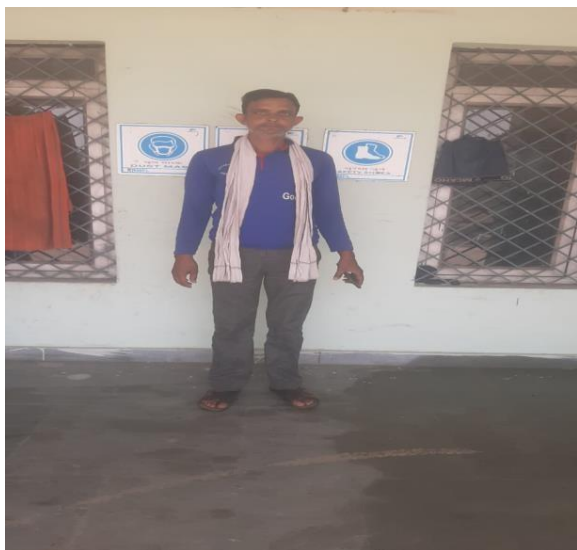
### **Babaghat 7 MLD IPS**

- Total 3 nos pump. 2 nos of 40 hp & 1 no of 20 hp
- 2 nos 40 hp pump Operational.
- 1 no 20 hp pump Non operational for the last 1 year

- 3 nos starter have not been installed on wall but kept on floor over bricks.

- Servicing done on 08/01/24 but radiator cleaning is pending. Leakages were observed in diesel feeding pipes.

- Operator and sweeper are working without PPE
- During the inspection it was found that there open sump not covered properly.

- Exhaust Fans not working .Not replaced.
- Lighting arrangements are very poor
- PDP Not replaced.
- Mono rail lifting arrangement not repaired/ replaced.
- Boundary Wall damaged to be repaired.
- Repairing of door & window.

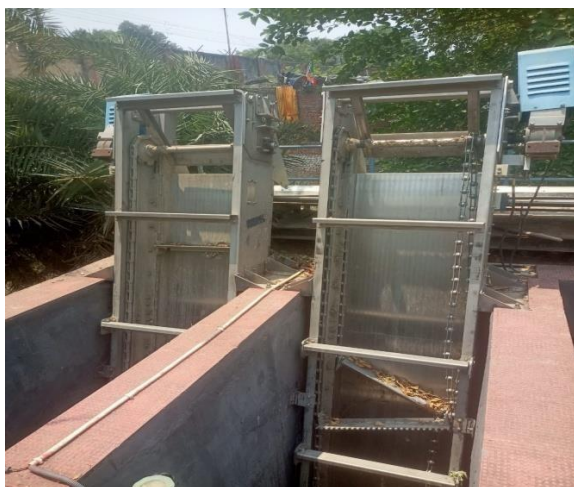
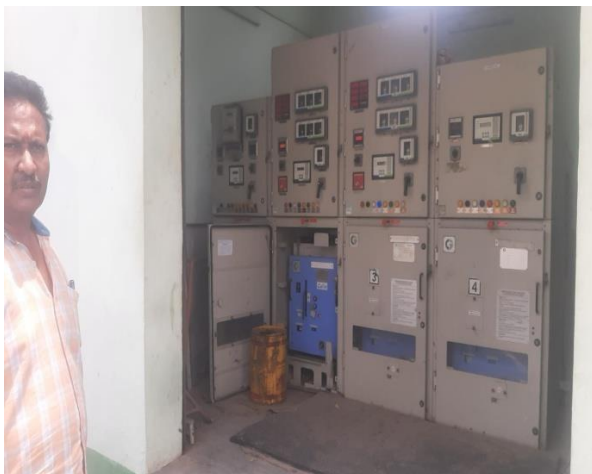
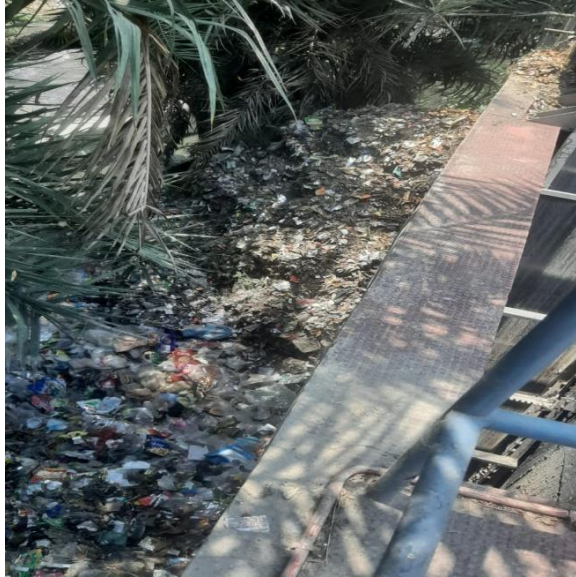
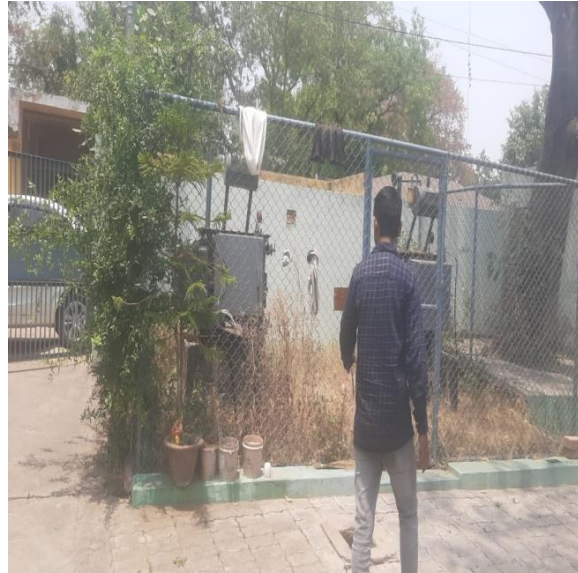
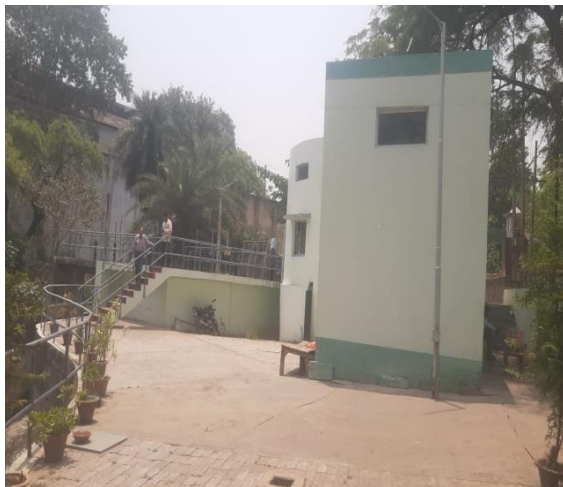
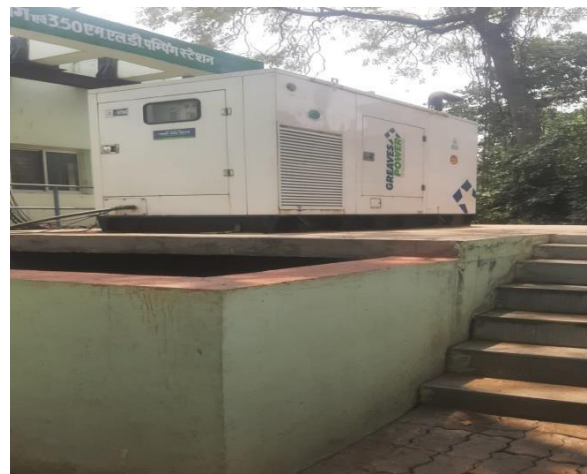
## **Guptarghat 3.5 MLD IPS**

- 4 nos pump of 25 hp
- 3 nos Operational
- 1 no non operational from 26/04/24

- Not working for last 3 months

- CT/PT problem not rectified for 6 months.
- Maintenance of full panel is required.
- HT panel bye passed. No protection available.

- Light fittings Very poor. Fittings not replaced
- DG set non operational from 07/05/24.
- One transformer has not been connected for last 1 year
- Mechanical screen.2 nos installed but non operational for last 2 months
- Level sensors not working.
- Operator and sweeper are working without PPE.
- The garbage was found near screen chamber since long and has not been disposed off.
