## Joint Site Inspection Report of 5 MLD Shuklaganj

Date of Inspection	14/03/2024
STP Site inspection Team	Mr. Anil Kumar Seth- Team Leader Mr. Subhash A.E. UPJN Mr. Ankur Saxena J.E. UPJN Mr. Indra Deo Pandey- Support Engineer
KRMPL Personal	Mr. Rajpal Singh Gill Construction Manager

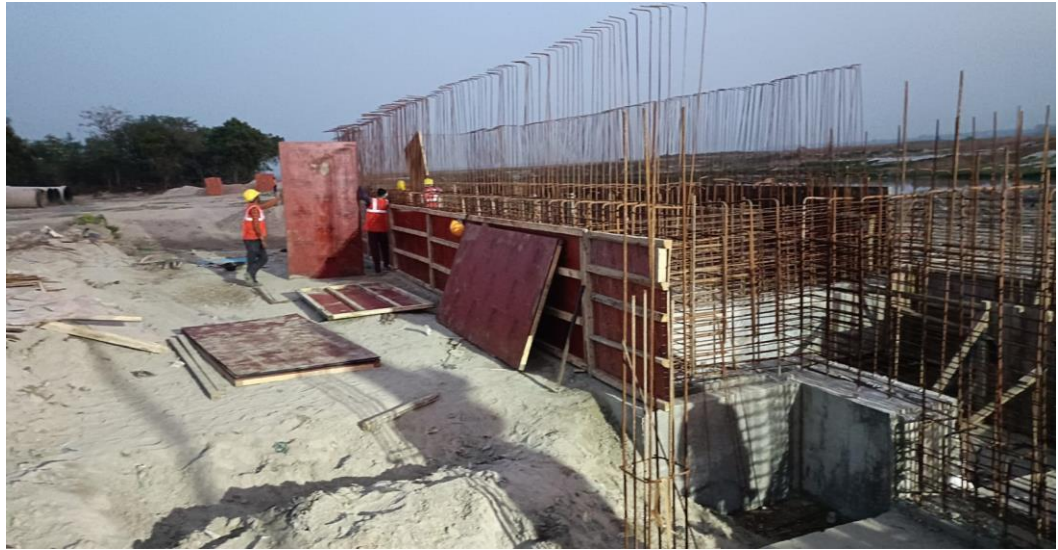
- i. **I&D Structure-** Work of I&D structure is in progress. Reinforcement work of wall

in progress for third lift. The casting of the all lift of the wall was done without informing UPJN and STC. In Approach channel, inlet channel and screen channel finishing and hydro test is pending. KRMPL not follow the approved design drawing. They are using other steel dia bar in all over structure. KRMPL has not used proper Clear cover exactly æper design. Due to use of wide range of cover blocks casting of wall by the Concessionaire is not proper.

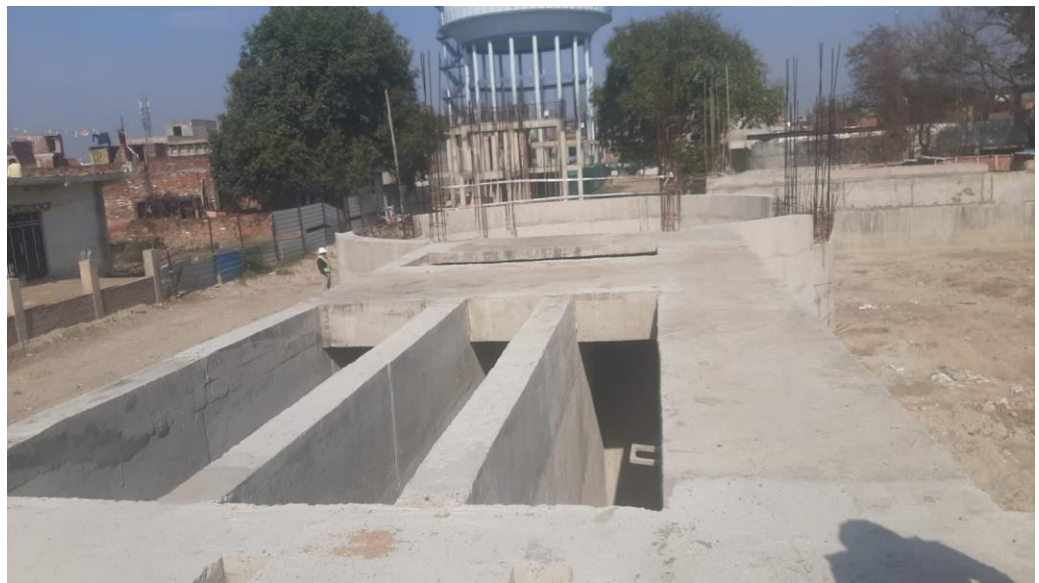
- ii. **MPS-** At inlet chamber step arrangement and proper footrest have not been provided. Column, beam and slab work is still pending. KRMPL needs to do hydro testing with clear water as per CEPHEEO MANUAL and IS code 3370 in presence of UPJN & STC, before grinding and tar coal epoxy work.

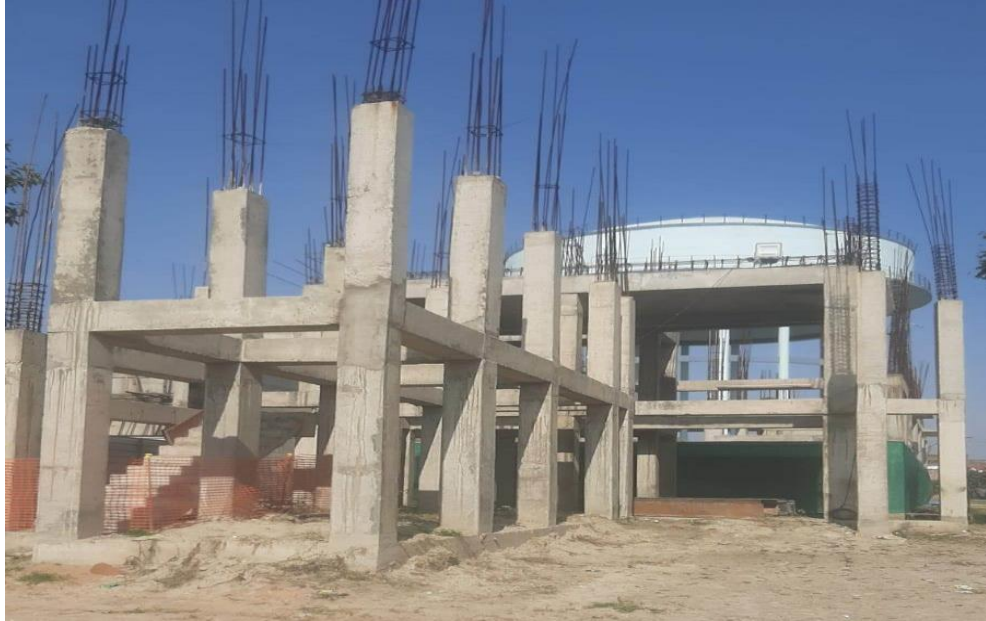
- iii. **PTU-** Most of Steel is corroded. PTU, Column work completed and slab shuttering and reinforcement work is pending. In Inlet chamber area finishing work, hydro test is pending. In Grit chamber and parshall flume RCC wall, walk way, platform and hydro test pending.

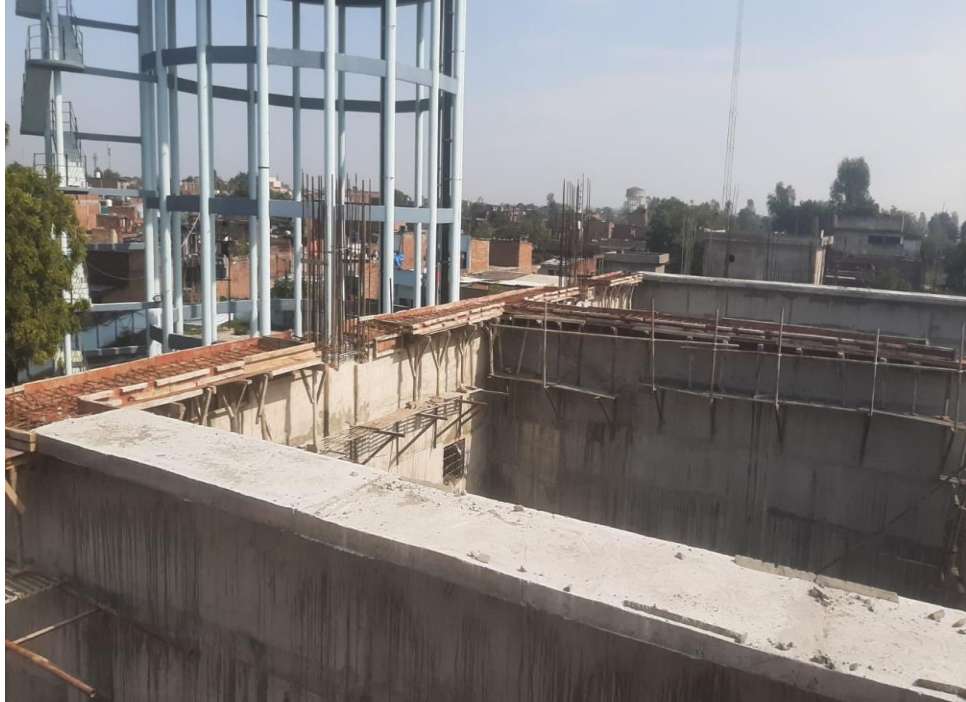
- iv. **SBR-** In SBR connecting channel, walkway platform, RAS and WAS pump column, Decanter foundation, finishing and hydro test are pending.

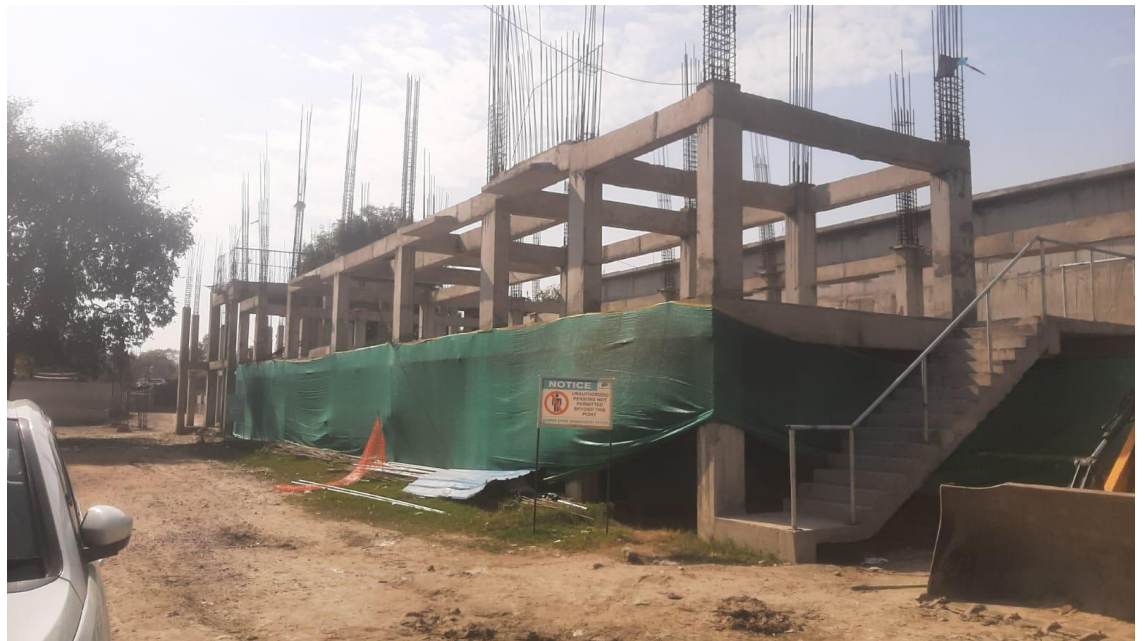
- v. **Admin building cum blower Room-** In admin Building first floor and second floor slab work, beam and column work is pending. In blower room roof slab and brick works are pending.

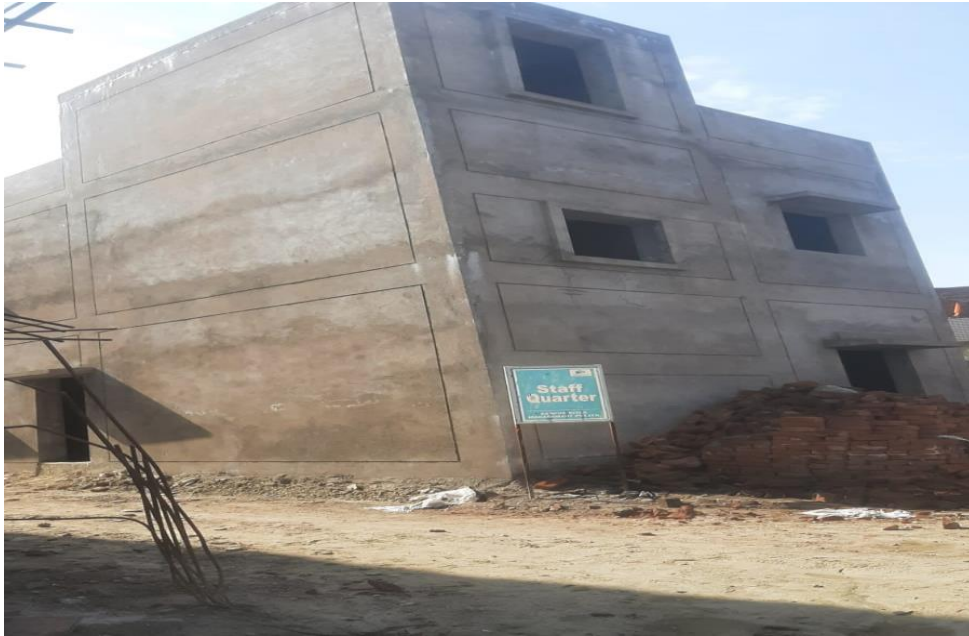
- vi. **Staff quarter-** Electric work, plumbing, sanitary fitting, floor, finishing and painting works are pending.

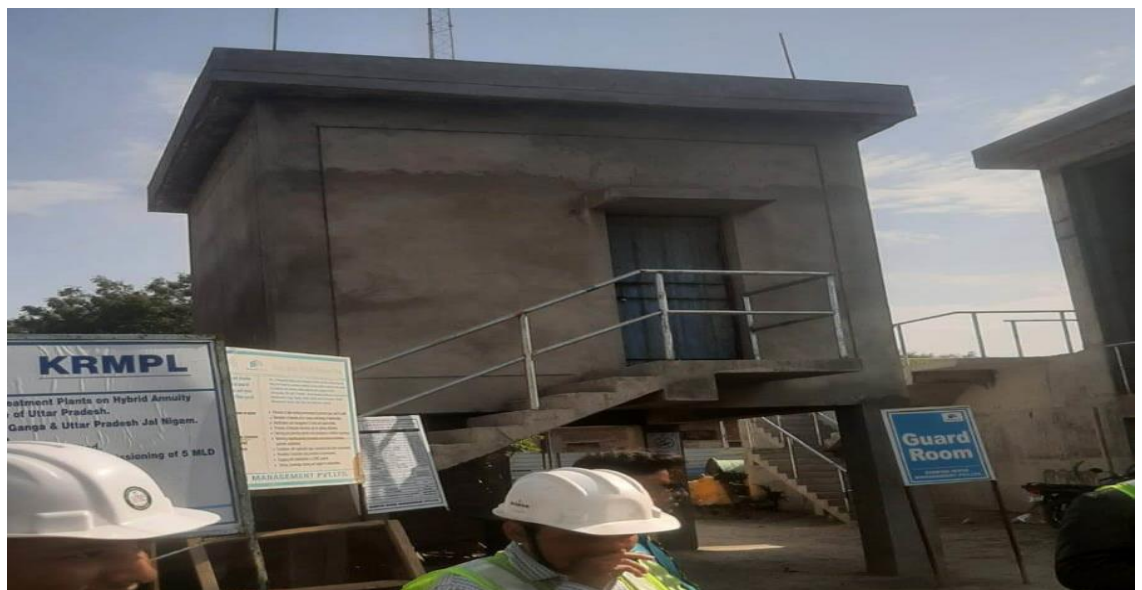
**vii. Guard Room-** Electric work, plumbing, sanitary fitting, floor, finishing and painting works are pending.

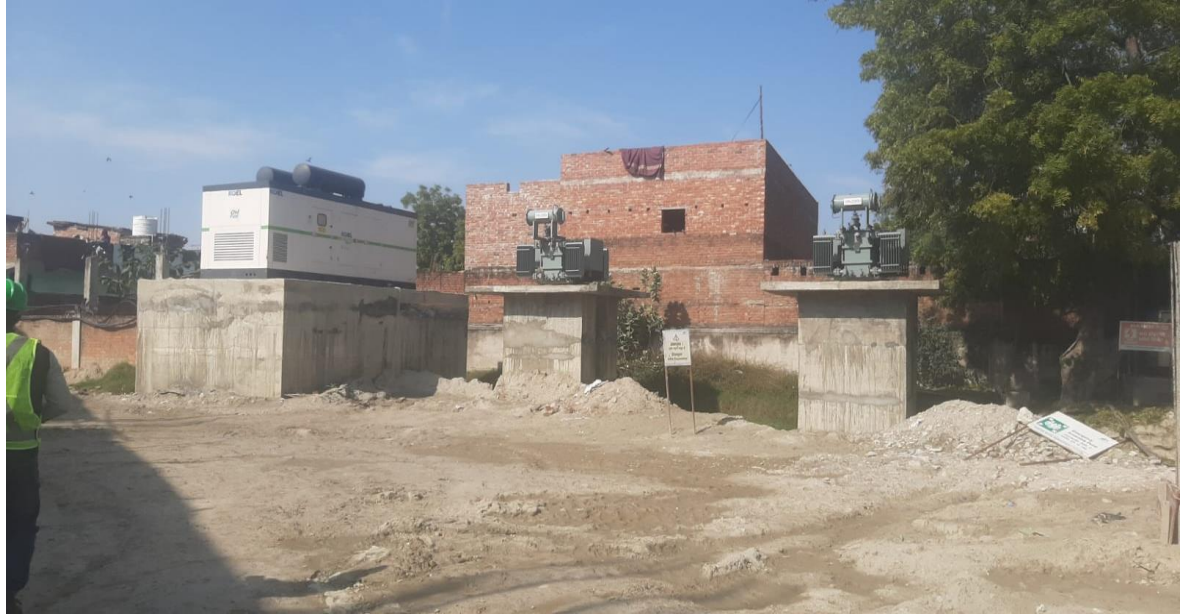
**viii. Transformer & DG Yard-** Staircase, finishing, approach and painting works are pending.

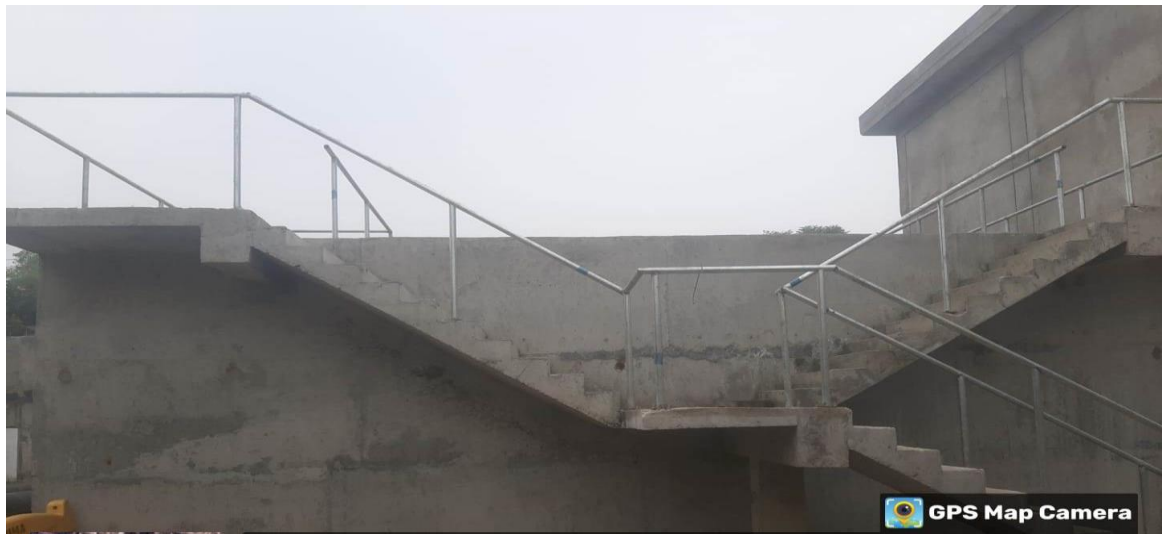
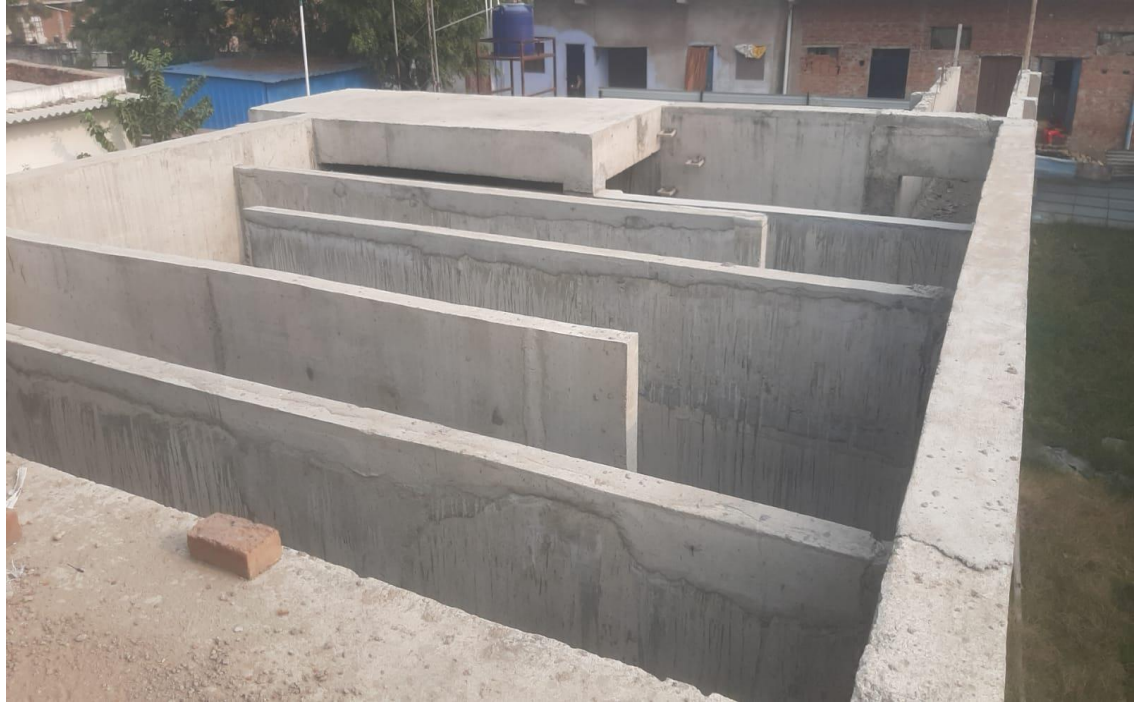
- ix. Chlorination building and CCT- In CCT outlet channel work, finishing of outlet chamber, grinding, finishing and painting works are pending. In building foundation of tonner, Electric work, plumbing, floor, finishing and painting works are pending. Booster pump and fitting pump can be install.

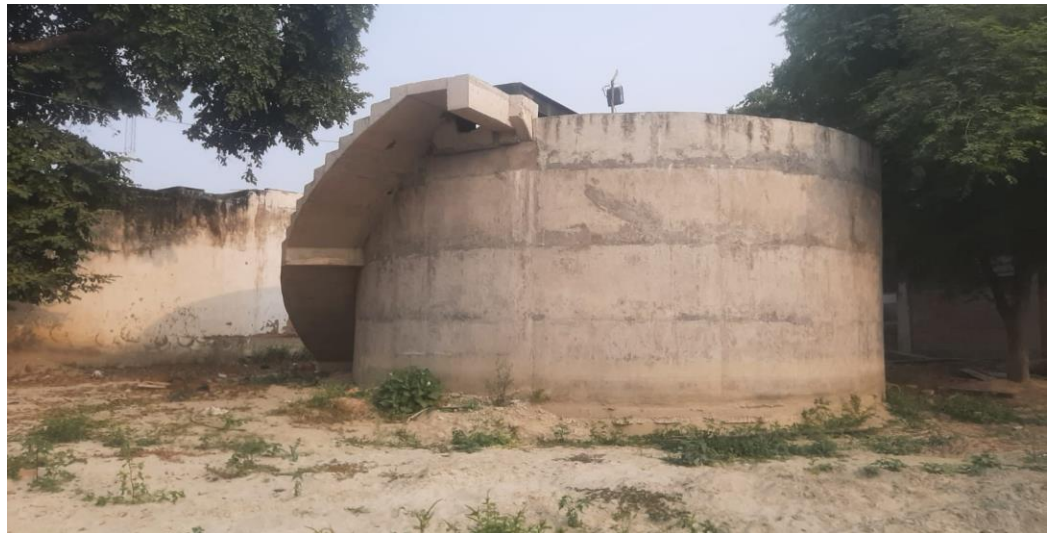
- x. **Sludge thickener and Supernatant sump-** Finishing, painting and hydro testing are pending. Scraper in thickener and pump in supernatant can be install as there is no hindrance.

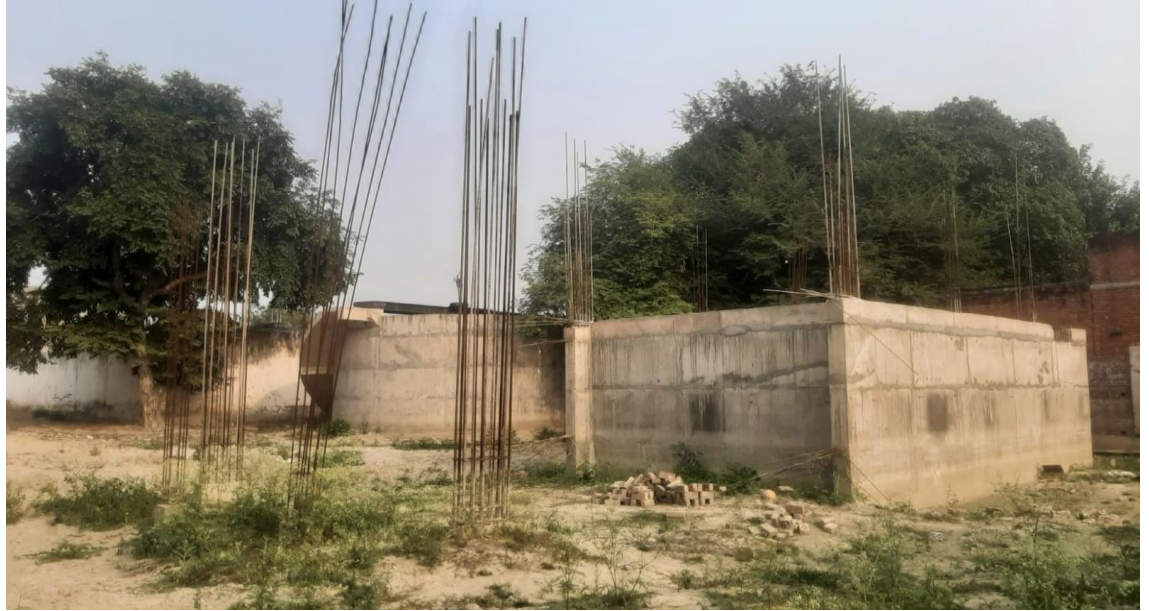
- xi. **Centrifuge building-** First and second floor slab work, column and beam works are pending.
