## Joint Inspection of Unnao 15 MLD STP dated 25.11.24 with EE UPJN, PE (STC) & KRMPL

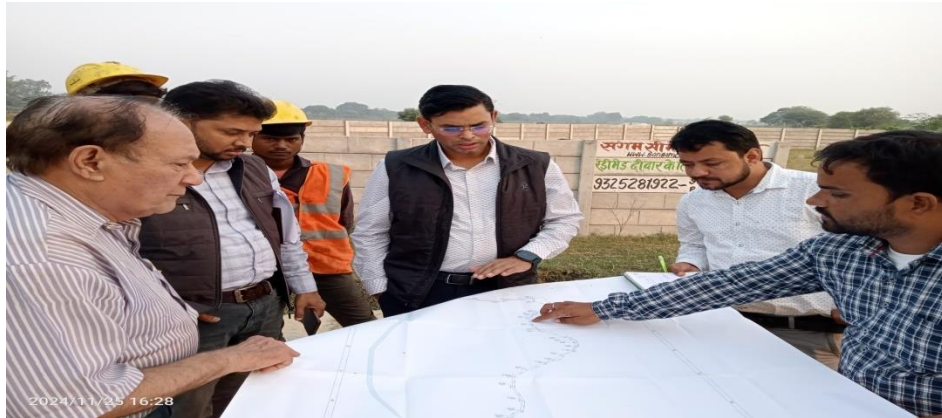
- It was instructed by EE UPJN(R) Unnao to prepare fresh drawing showing-
  - a) Line cleaning and checking done & found ok
  - b) Line cleaning and checking to be done
  - c) Line to be laid.

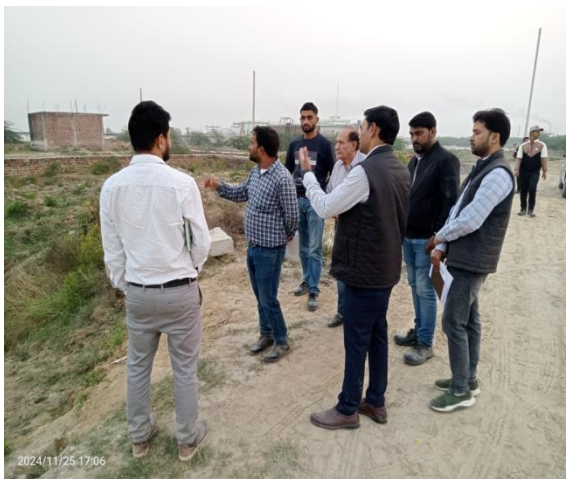
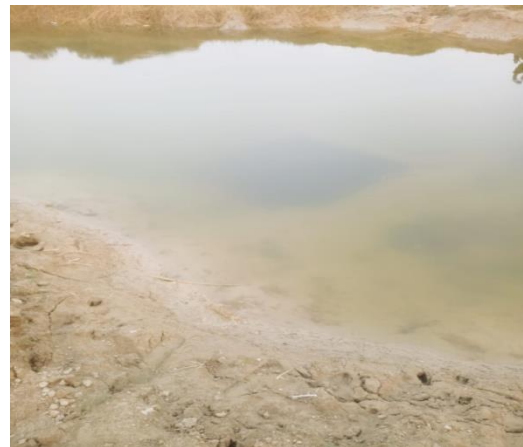
- MH 38 was found to be dislocated and it was submerged under stagnated water in pond.

It was instructed to dewater the pond and rectify the MH 38 along with settled pipes on both the sides.

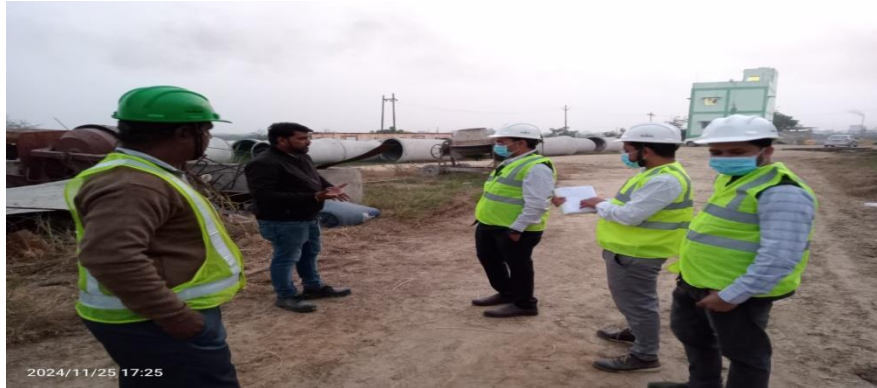
- The work of laying new pipeline (1200 mm dia NP3 RCC pipe) could not be started because of the following reasons-
  - a) Dewatering of the pond on the pipeline route.

- b) The vendor has not deployed the manpower. It was advice to arrange an alternative vendor.

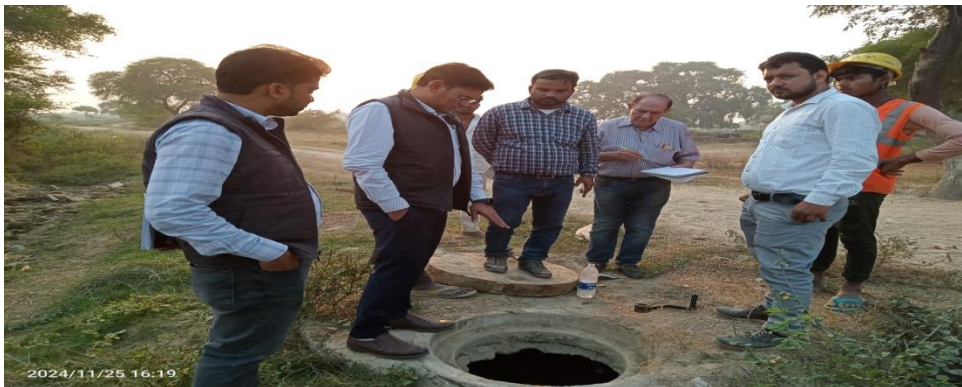
- KRMPL was instructed to submit work plan of new pipe line lying.
- KRMPL was instructed to submit work plan for Cleaning & checking of laid and to be laid pipes.
- Extension of time with a work plan and bar chart support.
- Retaining wall & boundary wall were found damaged on one side. Need to be reconstructed.
- MH 17 was inspected and found full with sand 600 mm, it was instructed to conduct a joint inspection with UPJN urban as layed pipe by urban has been jointed here

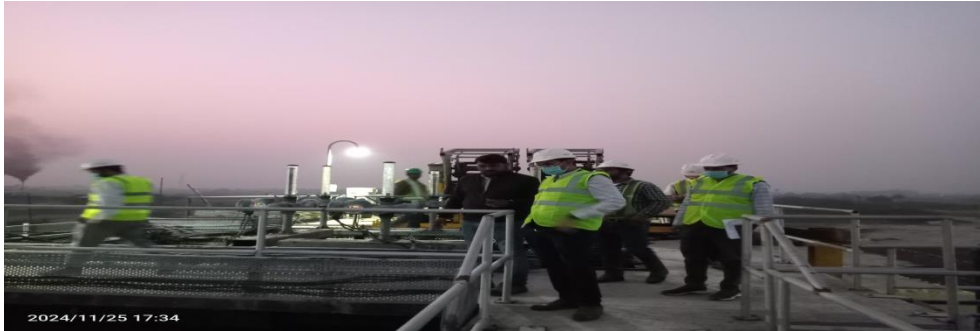
- Balance of plant PLC connection work was in progress. Main hindrance is commissioning of chlorinating plant and one sensor is defective.
- **SBR 2** no decanter was in manually mode, required rectification
- Trench covers from Checker plates which are available at site should be installed
- Expedite the OEM team for commissioning of chlorination plant. Which has been long pending.

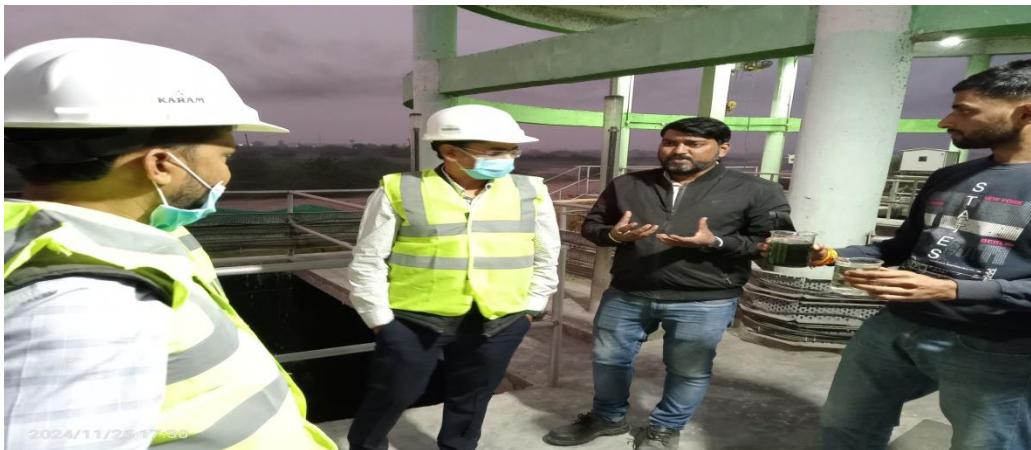
- Both organic pump were non operational. Similarly both Screw conveyors were also non operational since long.
- Commissioning of DG set is pending which needs walk way all around foundation which has not been made since long.
- Flow meters are to be calibrated properly. Discharge readings of inflow are less than outflow.
