## **Joint Inspection Report of 5 MLD STP Shuklaganj**

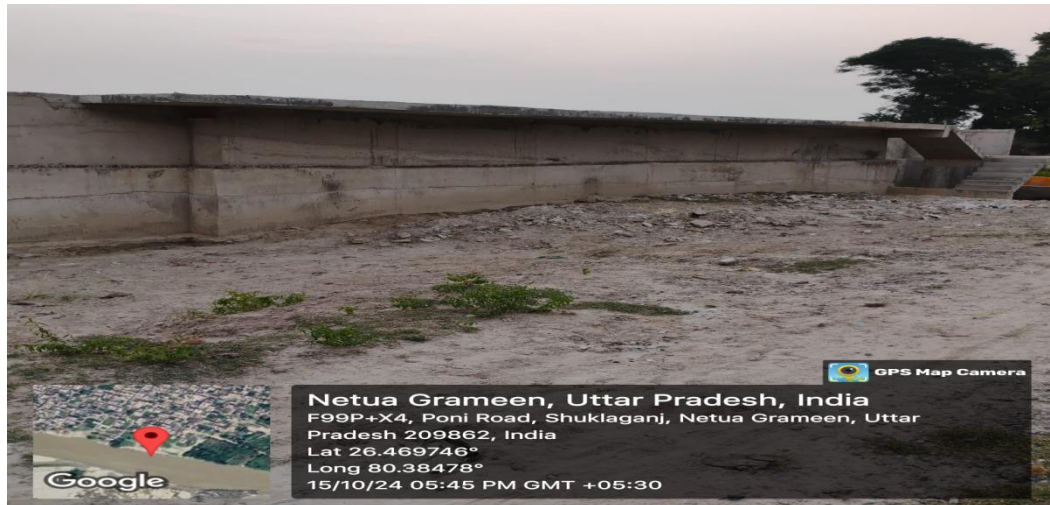
#### **A. I&D Structure-**

- i. Work of I&D structure is in progress. Reinforcement & shuttering work of wall is done. The casting of the all lift of the wall was done without informing UPJN and STC. In Approach channel, inlet channel and screen channel finishing and hydro test is pending.
- ii. During Site visit we found minor cracks are visible due to lack of curing.
- iii. Manual Screen's , Hand Rails are not installed.

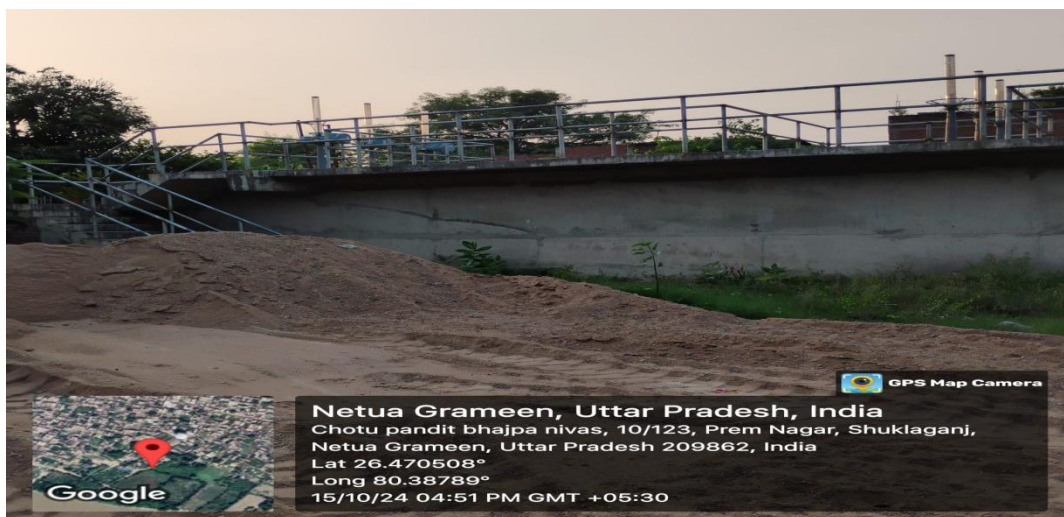
**B MPS-** At inlet chamber step arrangement and proper foot rest have not been provided. Column, beam and slab work is still pending. KRMPL needs to do hydro testing with clear water as per CEPHEEO MANUAL and IS code3370 in presence of UPJN & STC. It was advised to clean the open steel bar and coat with cement slurry.

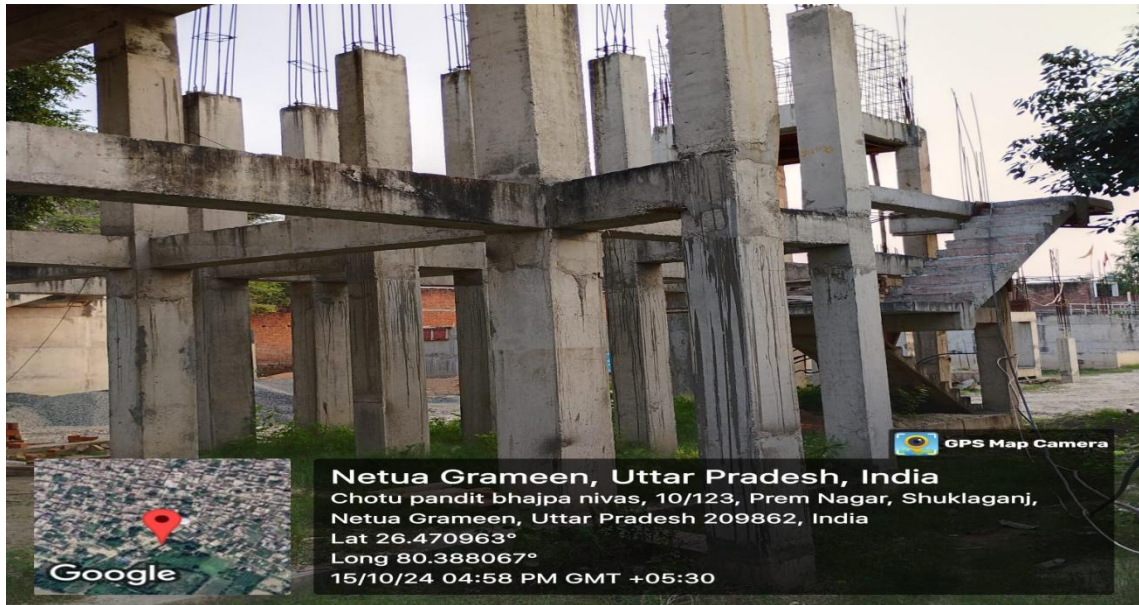
**C PTU-** Most of Steel found corroded. PTU, Column work completed and slab shuttering and reinforcement work is in progress. In Inlet chamber area finishing work, hydro test is pending. In Grit chamber and parshall flume RCC wall & slab, walk way, platform and hydro test pending. Stair casting done and connecting channel column on progress.

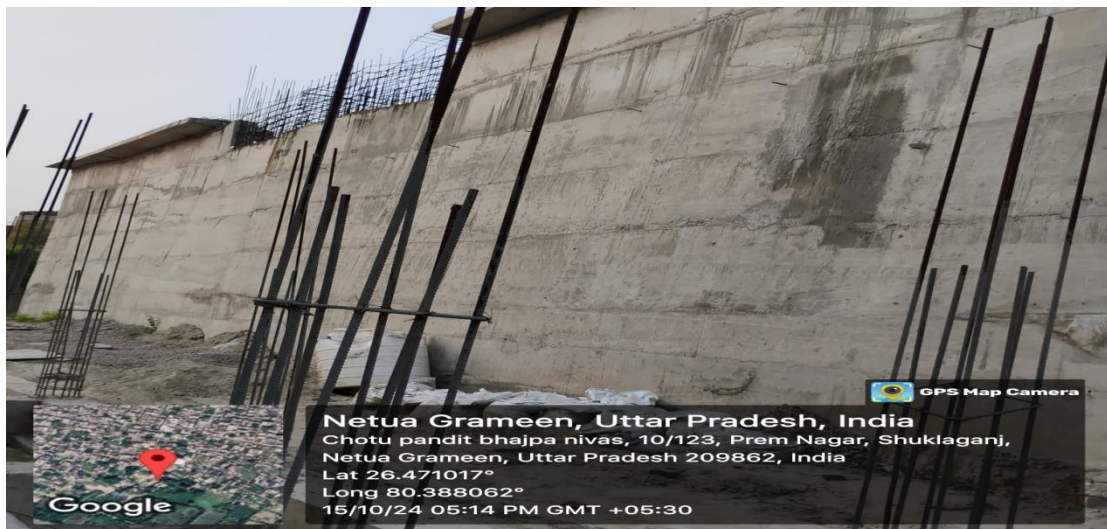
- B. SBR-** In SBR connecting channel, supporting column, walkway platform, RAS & WAS pump platform column, decanter foundation, finishing hydro test are pending. Selector zone wall pipe support beam reinforcement on progress.
- C. SBR Staircase** second lift is pending.

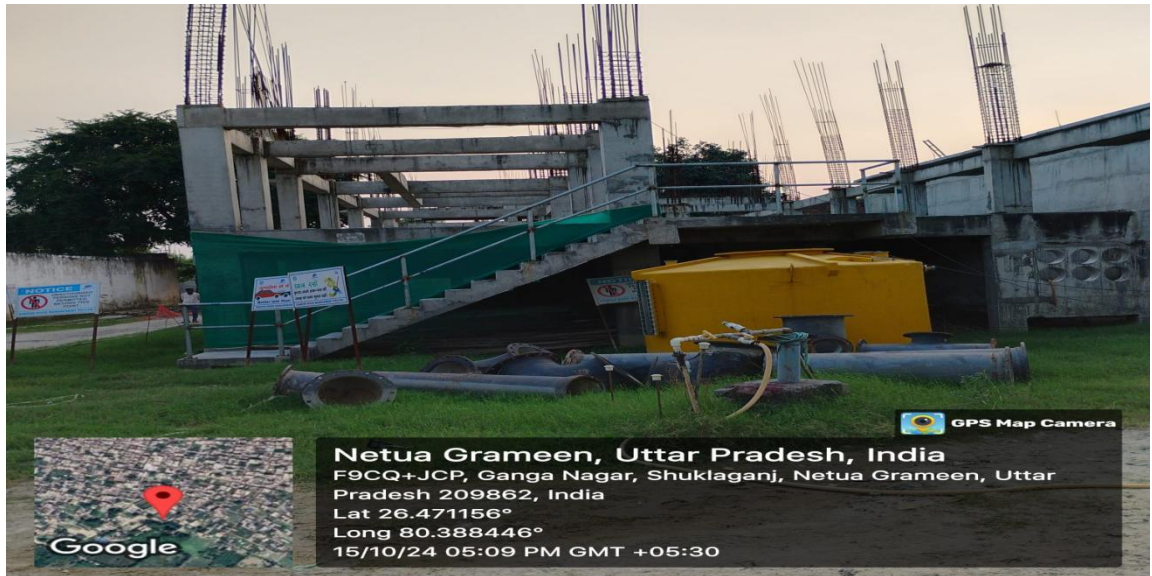
**Admin building cum Blower room-** In admin building room first floor and second floor slab work pending, brick work IPS flooring, electrification, sanitary fitting & plumbing, beam, column works are pending. In blower room roof slab, brick work, IPS flooring, roof treatment & finishing works are pending.

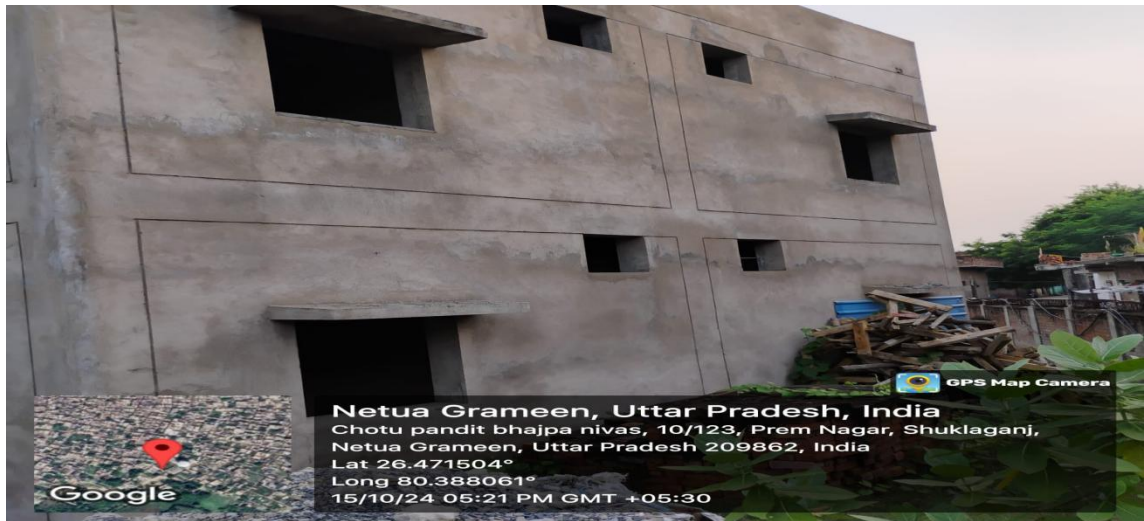
- D. Staff quarter-** Electric work, plumbing, sanitary fittings, floor, roof treatment, drainage, finishing and painting works are pending. There is no manpower on staff quarter during inspection.

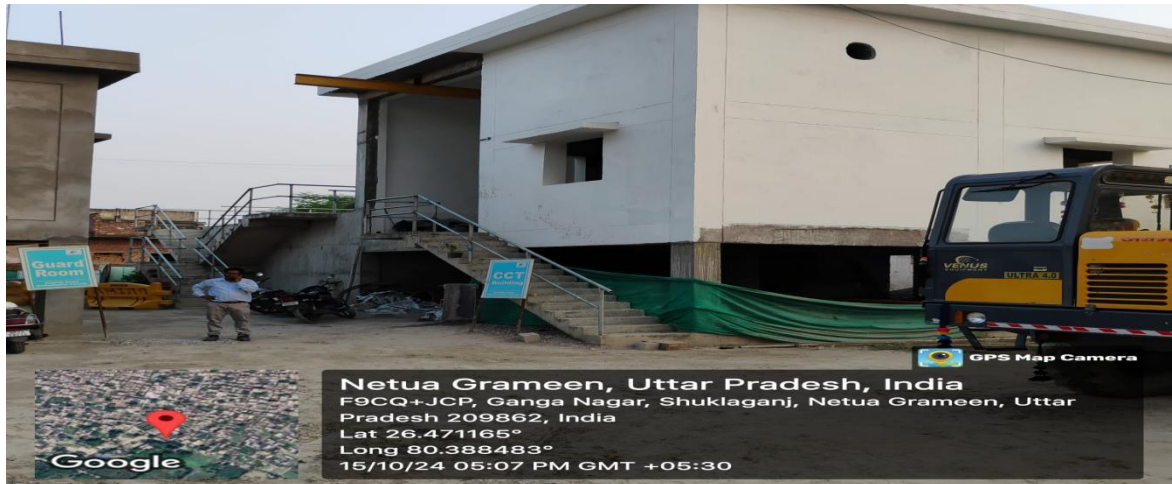
- E. Guard Room-** Electric work, plumbing, sanitary fittings, floor, roof treatment, drainage, finishing and painting works are pending.
- F. Transformer & DG Yard-** Staircase, finishing, approach and painting works are pending.
- G. CCT & Chlorination building -** In CCT outlet channel work, finishing of outlet chamber, grinding, finishing and painting works are pending. In building foundation of tonner, Electric work, plumbing, floor, finishing and painting works are pending. Putty work on progress. Booster pump and fitting pump can be install. EE UPJN advice for better housekeeping. And also to advice to complete the casting of tonner foundation quickly.

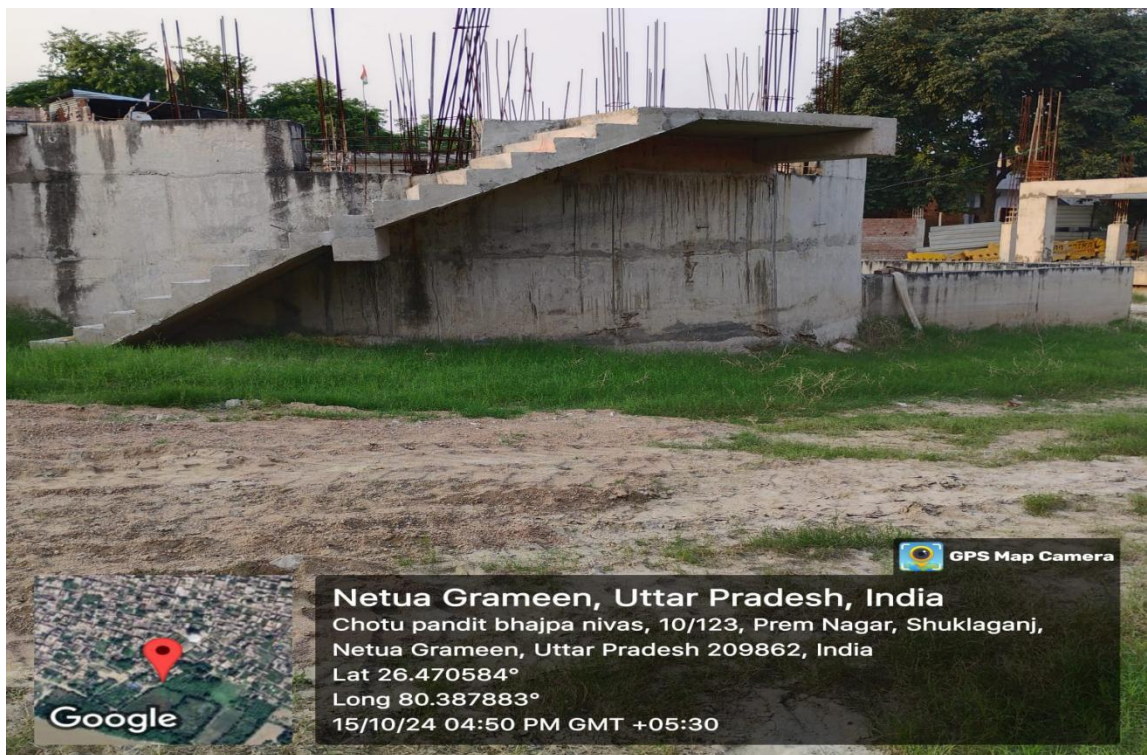
- H. Sludge Thickner & Supernatant Pump-** finishing, painting and hydro testing are pending. Scrapper in thickener and pump in supernatant can be install as there is no hindrance.

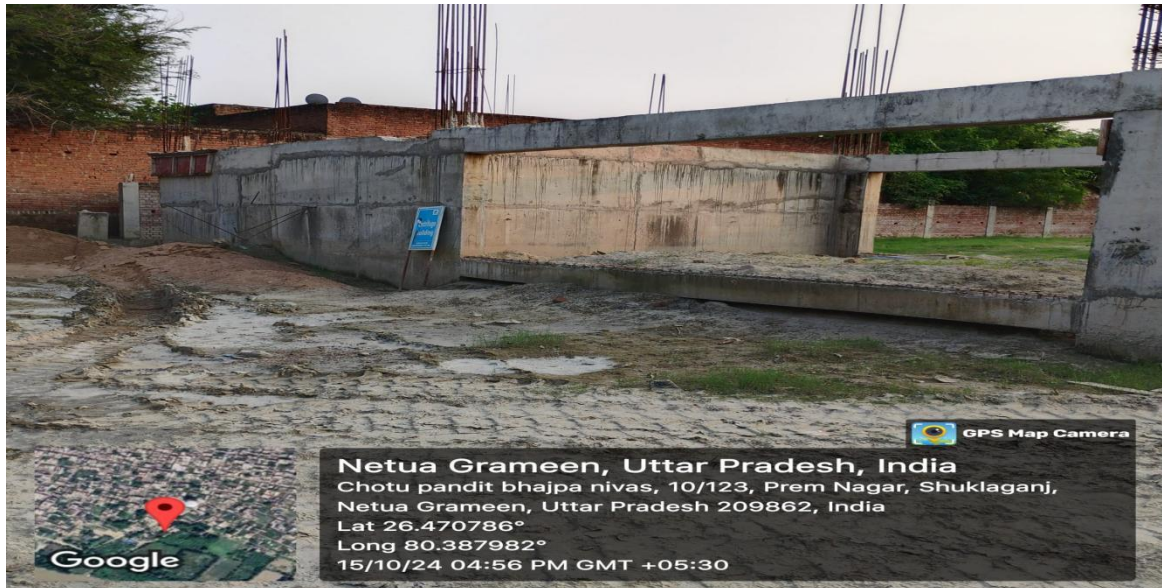
- I. Centrifuge Building-** First and second floor slab work is pending, column and beam work is in progress. Cracks found in the beam.
