Joint Inspection Report of 30 MLD STP, Pankha (23/10/2024)

STP Overview

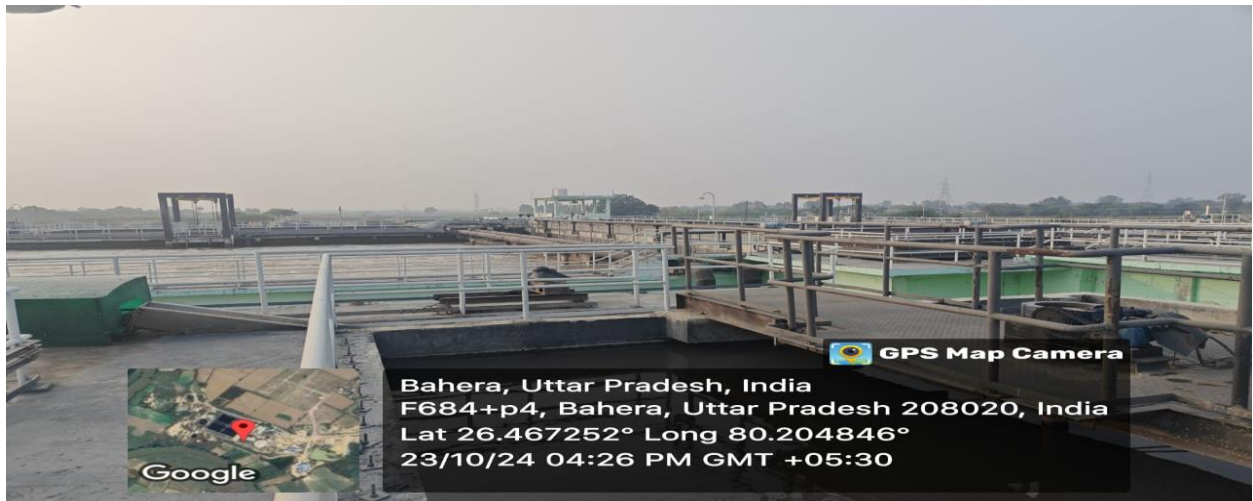
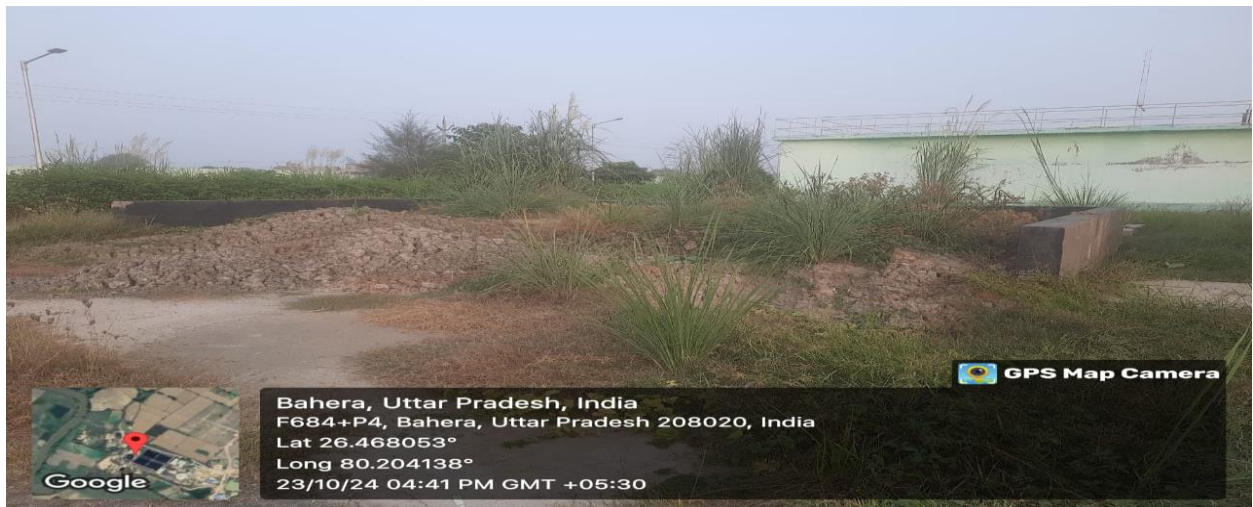
- **Pumps:** All 5 pumps are operational.
- **SBR Unit:** SBR No. 4 running in auto mode.
- **Dissolved Oxygen (DO) Sensor:** 1 sensor is non-operational.
- **Thickener:** Non-operational; under gear repair.
- **Sludge Feed Pumps:** All 3 pumps are functional.
- **Centrifuge:** 1 out of 3 centrifuges non-operational (shaft jammed).
- **Blowers:** 1 out of 6 blowers non-operational (gearbox assembly damaged).
- **Canopies:** Material available, but installation on motors is pending.
- **Organic Return Pump:** 1 pump has coupling issues.
- **Quality Analyzer:** Calibration required.
- **Poly Dosing Units:** 1 out of 3 units non-operational.
- **Organic Pumps:** 1 out of 2 pumps non-operational.
- **Screw Conveyor:** 1 unit non-operational.
- **Sludge Removal:** No sludge removal observed during inspection.

Sludge Removal Pending since long

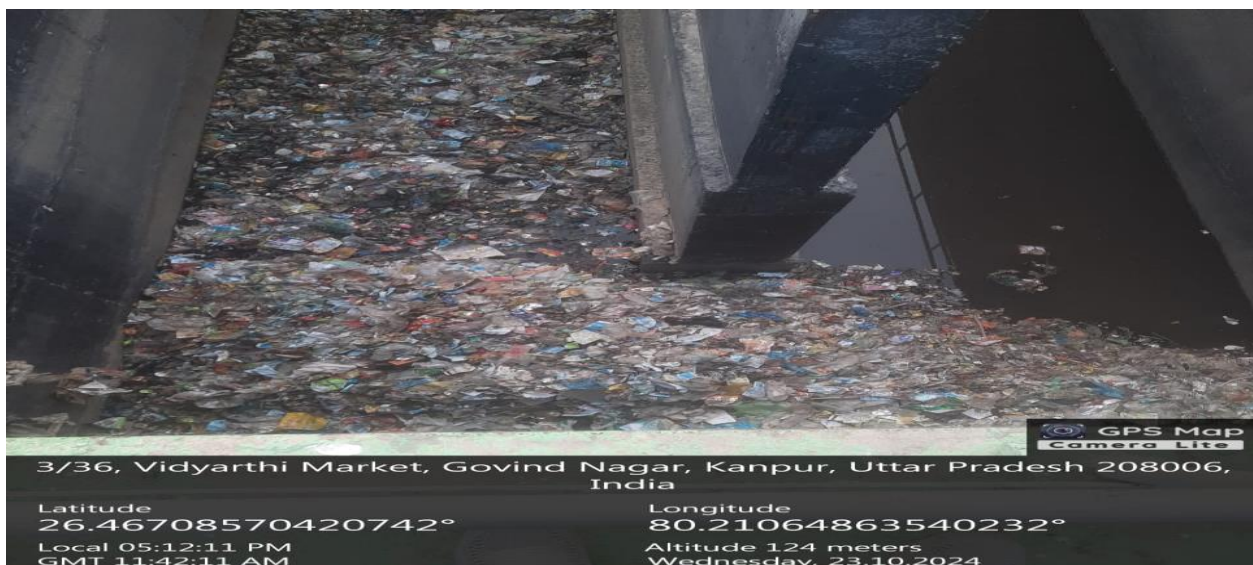
- **ICI Nala:** 4 exhaust fans need installation.
- **Housekeeping & Gardening:** Poorly maintained.
- **PLC Integration:** No PLC connection established for both IPS; pumping status not reflected on STP SCADA.
- **Pending Work Compliance:** Road restoration and related works by KRMPL are incomplete and were not inspected.
- **Road Sinking:** Ongoing work near Thermal Nala.
- **Water Supply Issues:** Water shortage at Sunder Nagar IPS.
- **Thermal Nala Overflow:** Overflow observed due to choking in the manual screen and channel.

Thermal nala channel and screen are choked

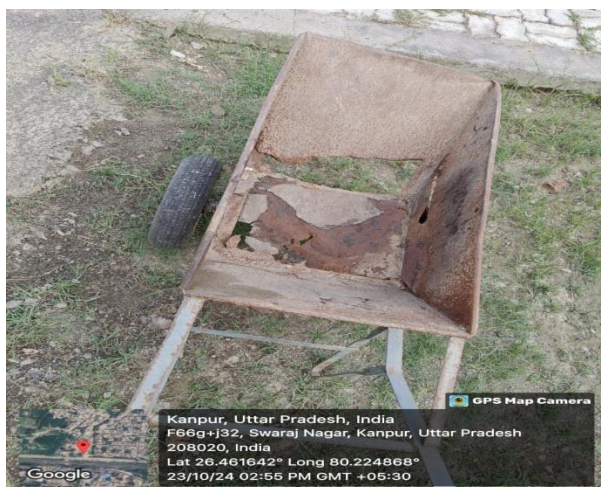
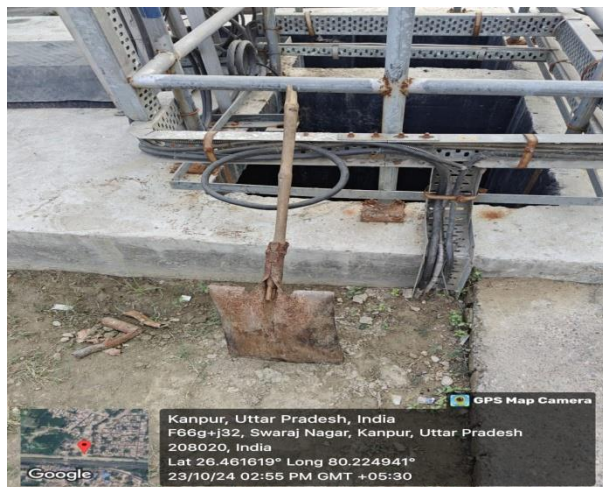
Condition of trolley and shovel in Sudarnagar IPS
