## VISIT REPORT ON INSTRUMENTATION CONTROL & AUTOMATION SYSTEM

**Project:** “Development of Sewerage Treatment Plants on Hybrid Annuity PPP basis at Kanpur, UP”.  
**Subject:** Site visit report of 30 MLD STP and associated IPS at Pankha, 15 MLD STP at Unnao & 130 MLD STP at Jajmau

Joint inspection visits by PE and Instrumentation Engineer along with UPJN team was made at 30 MLD STP at Pankha on 22.05.2025, 15 MLD STP at Unnao on 21.05.2025 and 130 MLD STP at Jajmau on 20.05.2025, to access the progress and performance of instrumentation and PLC & SCADA Systems at site.

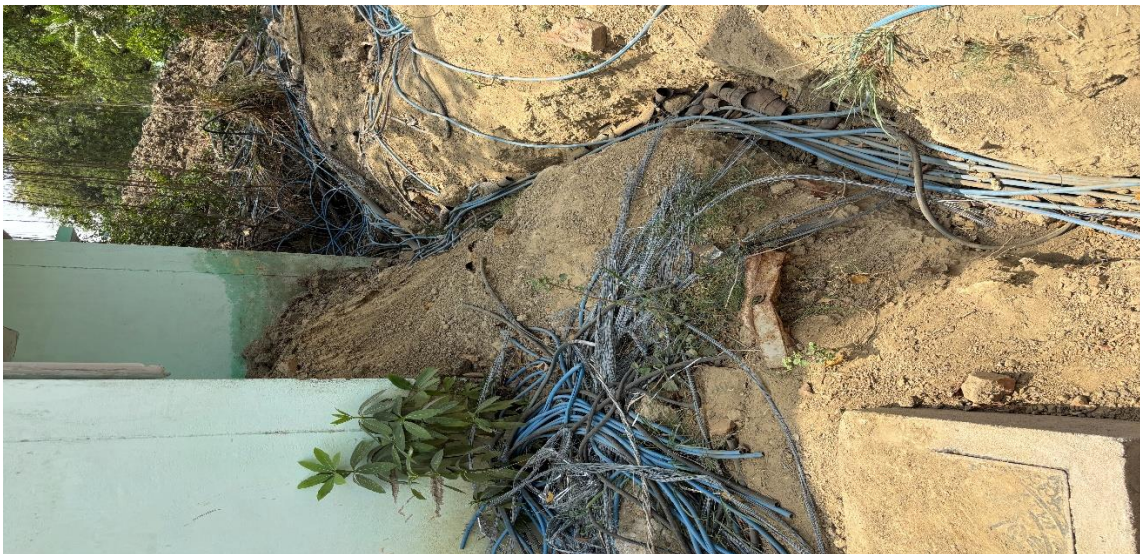
- During the visit no instrumentation activities were being carried out at the plant. It was informed due to lack of man-power the instrumentation cable laying activities and PLC cable terminations are not being carried out. It has been observed that only 2 persons were engaged for laying of cables. The concessionaire has been instructed several times by PE and UPJN to deploy sufficient man-power to expedite the instrumentation works, but still there is no action by the concessionaire.
- As evident from the pictures below, the cables are being laid in the haphazard manner without following the engineering practices.

The concessionaire has not prepared sand bed prior to laying the cables also there was no trace of protection bricks/pre-fabricated cable protection slabs at site. The cable trench depth has also not been maintained as per the approved drawings and engineering practices.

The PLC system integrator team shall be mobilized at site so as to expedite and complete the cable termination activities.

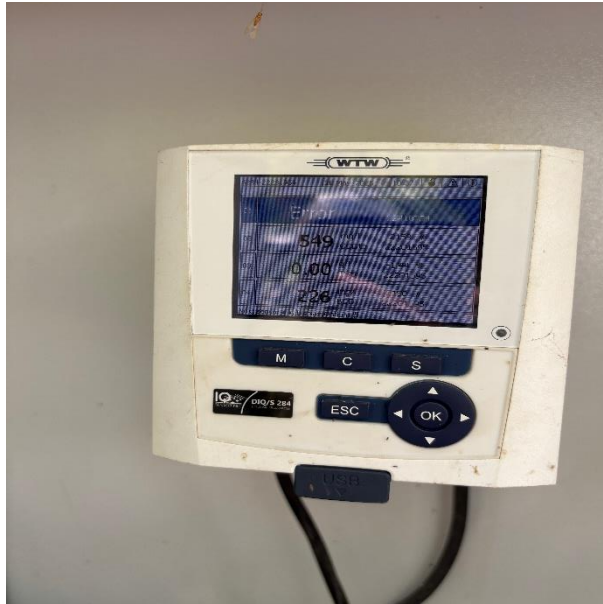
- The inlet sewage quality parameter analyser is not functional, specially the TSS and pH values are not being displayed. The cable terminations are also pending. The periodic calibration of the analytical instruments have not been performed and the calibration of the analysers is due since 05.05.2024.

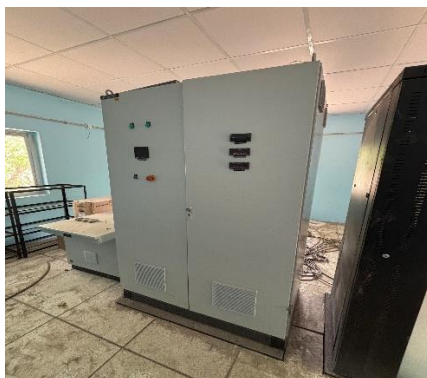
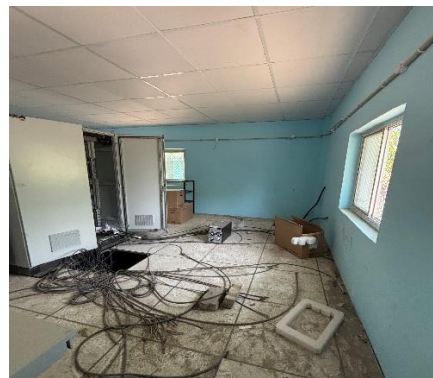
- The periodic cleaning of the submerged sensors of analytical instruments and remote type instruments is not being carried out. The concessionaire shall maintain a schedule of periodic cleaning and calibration records of each and every instrument.
- The mechanical screens are being operated manually and are also not working efficiently.
- The PLC panel has been installed in the control room; however, the orientation of the PLC panel needs to be changed so as to accommodate the operator consoles in front of the PLC panel.

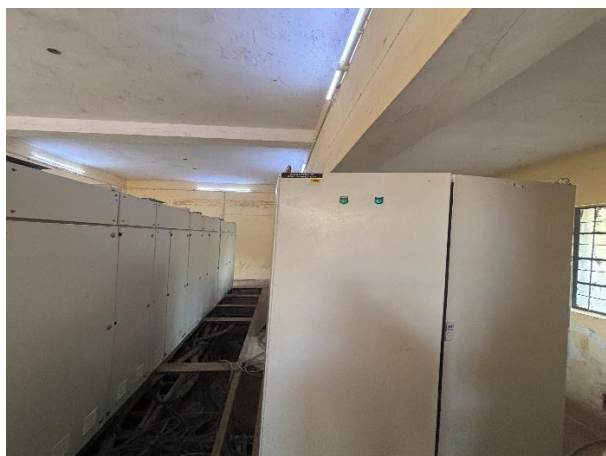
- At some locations RIO panels have been installed in the LT Switchgear rooms, it is important to isolate these panels from the electrical panels to avoid malfunctioning due to heat dissipation from the electrical panels. The concessionaire has agreed to provide isolation and air conditioning system for RIO panels not equipped with the integrated air conditioning system.

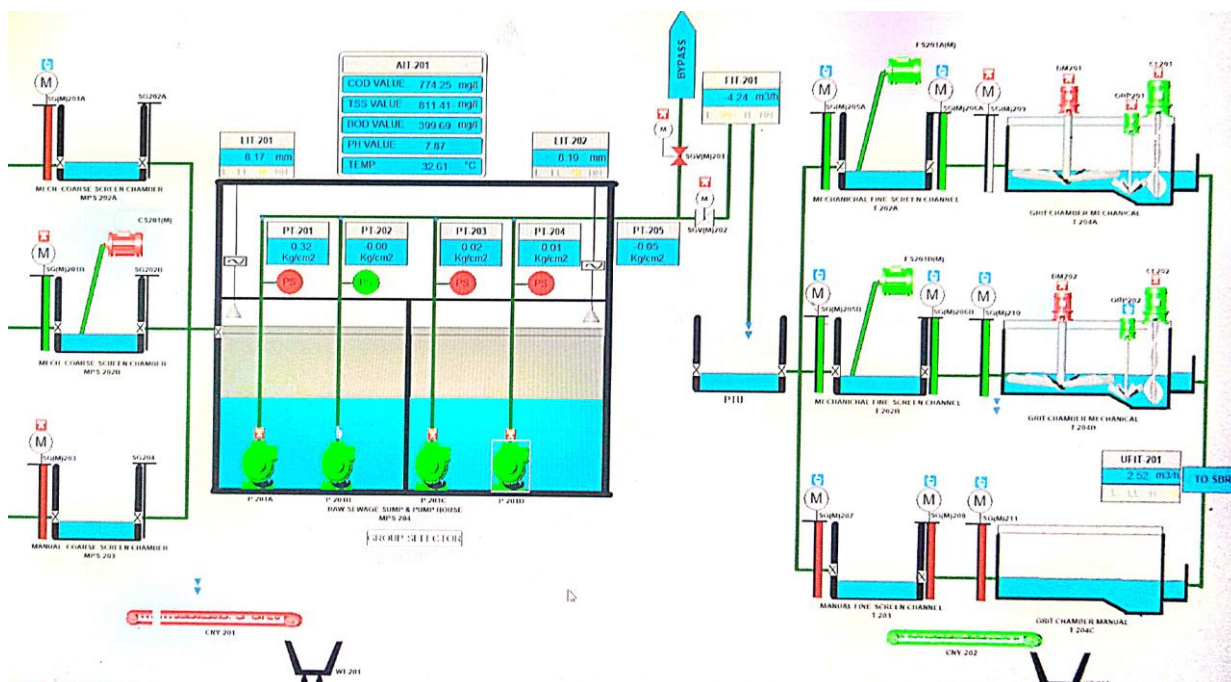
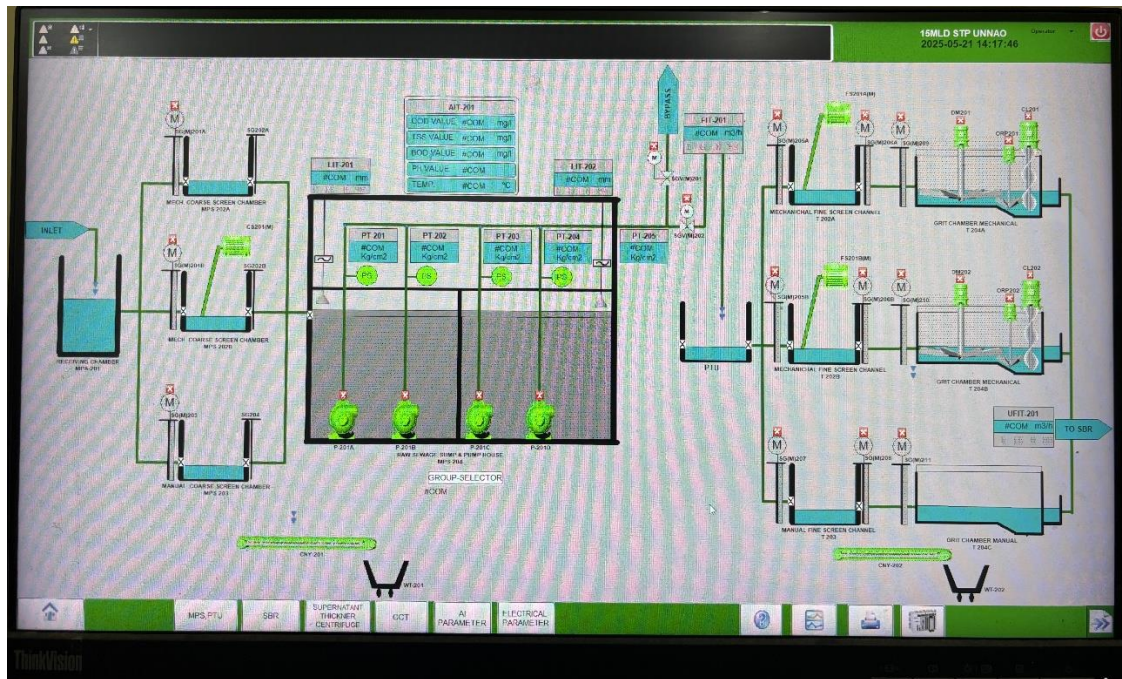
- Even after installation of PLC and SCADA system the plant is being operated in manual mode.

As evident from the screenshot all the valves, pumps and drives have been put in Local Mode (RED "X" symbol over the motorized valves and pumps) and operated locally by the local push button stations. The reason for manual operation was given that the plant is being run at partial load of about 4 to 6 MLD of its rated capacity, which can't be accepted. The plant automation system is not affected by the capacity of the plant and any minor adjustments can be done by altering the set points as per the requirements.

The alarms are not being acknowledged and the system is being bypassed without rectifying the defects and operated manually.

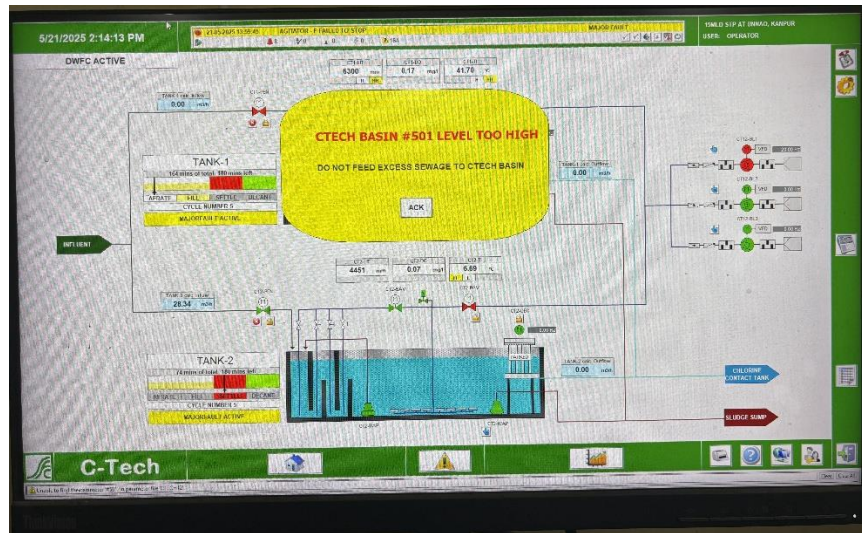
- It has been observed and confirmed by the concessionaire that the all the systems are affected when there is some update available in the server or any fault condition in the server. During investigation it has been observed that the PLC has been communicated to the SCADA system via server. The concessionaire has been instructed to provide parallel communication between PLC and SCADA system and the server to avoid such failures in future.
- The mechanical screens are being operated manually and timer based and are also not working efficiently. The DLIT has not yet been put in operation.
- The Hydrostatic level transmitter in the SBR – 1 tank is damaged and has not been replaced since long, hence, the decanter for SBR – 1 is operated manually, which is not advisable. The level transmitter shows HIGH level indication all times and thus providing erotic signal to the SBR operations.

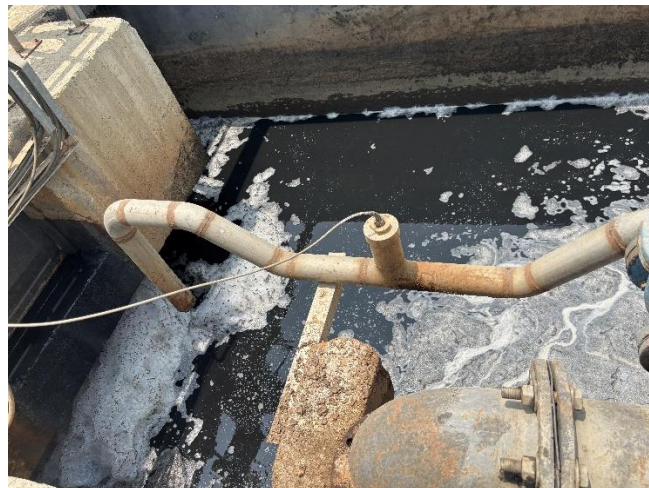
- The dynamic screens are not in-line with the field values and need to be calibrated as per the actual field value inputs.
- The DO analyzers have been installed in the delivery line of the RAS pumps in the SBR defeating the purpose of real-time continuous monitoring of DO levels as per the concessionaire agreement.

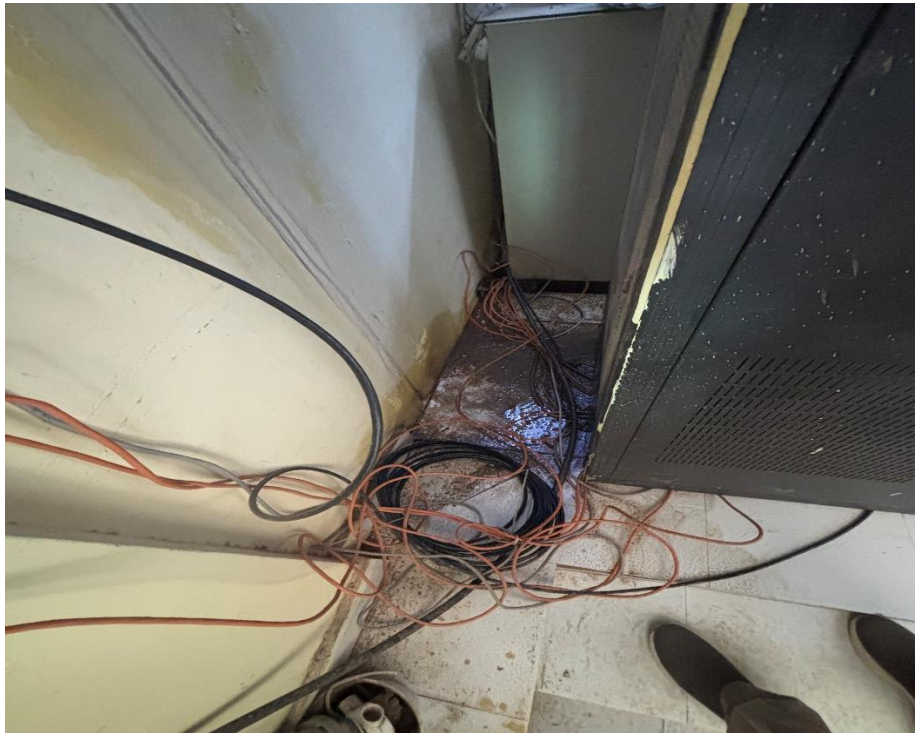
- The site calibration of all the plant Instruments and Analyzers has not been done yet, the concessionaire informed that they will arrange the same shortly.
- The chlorination system has not yet been commissioned and therefore the same has not yet been interfaced to the plant PLC SCADA system.
- Only one UPS has been observed in working and the other UPS is in fault condition and left unattended.
- The cable dressing in the control room has not been done properly and also water dripping around the server has been observed from the Air Conditioners as evident. The concessionaire has been instructed to rectify the same.

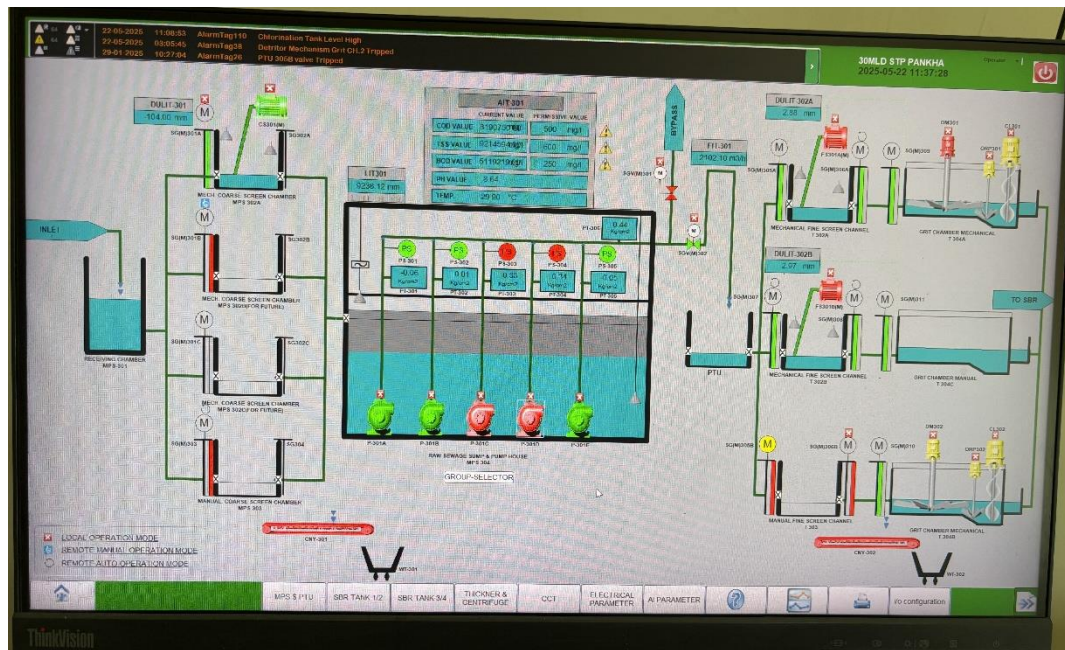
- As in case of Unnao, after installation of PLC and SCADA system the plant is being operated in manual mode except for SBR.

As evident from the screenshot all the valves, pumps and drives have been put in Local Mode (RED “X” symbol over the motorized valves and pumps) and operated locally by the local push button stations. The reason for manual operation was given that the plant is being run at partial load of about 20 to 25 MLD of its rated capacity, which can’t be accepted. The plant automation system is not affected by the capacity of the plant and any minor adjustments can be done by altering the set points as per the requirements.

The alarms are not being acknowledged and the system is being bypassed without rectifying the defects and operated manually.

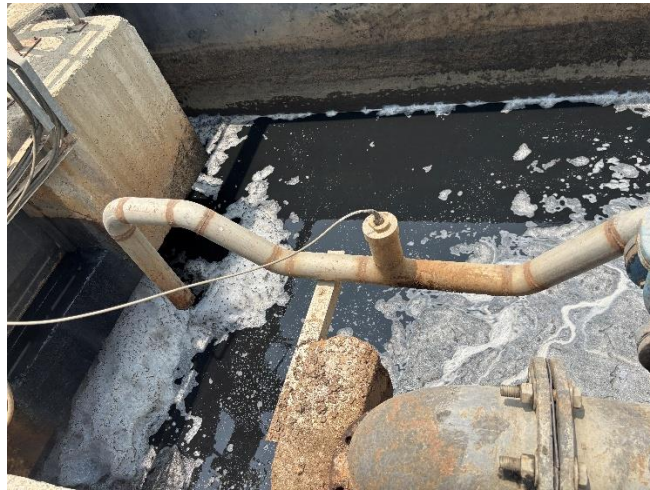
- The dynamic screens are not in-line with the field values and need to be calibrated as per the actual field value inputs.
- The DO analyzers have been installed in the delivery line of the RAS pumps in the SBR defeating the purpose of real-time continuous monitoring of DO levels as per the concessionaire agreement.

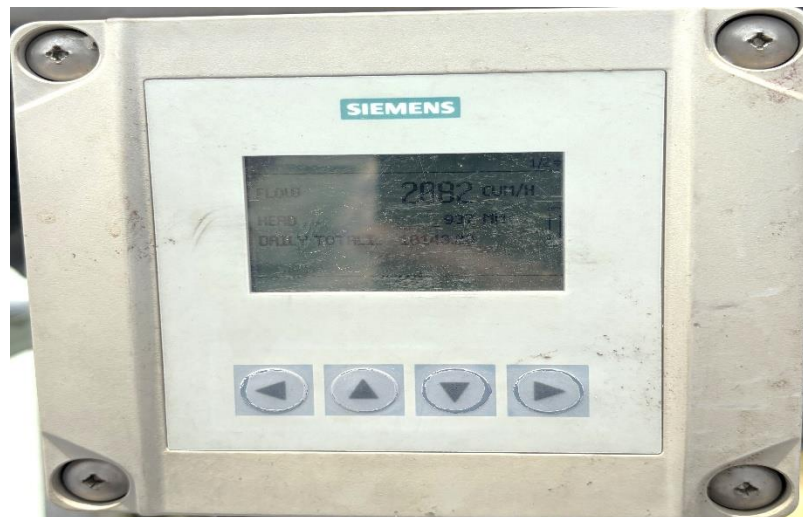
- As evident from the picture below the instantaneous flow value shown in the flow meter is higher than the pump discharge. The value on flow meter is 2082 Cum/hr, against two pumps running in parallel with each pump discharge of 992 Cum/hr.

Therefore, the site calibration of all the plant Instruments and Analyzers is necessary and the concessionaire has been instructed to immediately arrange for site calibration. The concessionaire informed that they will arrange the same shortly.

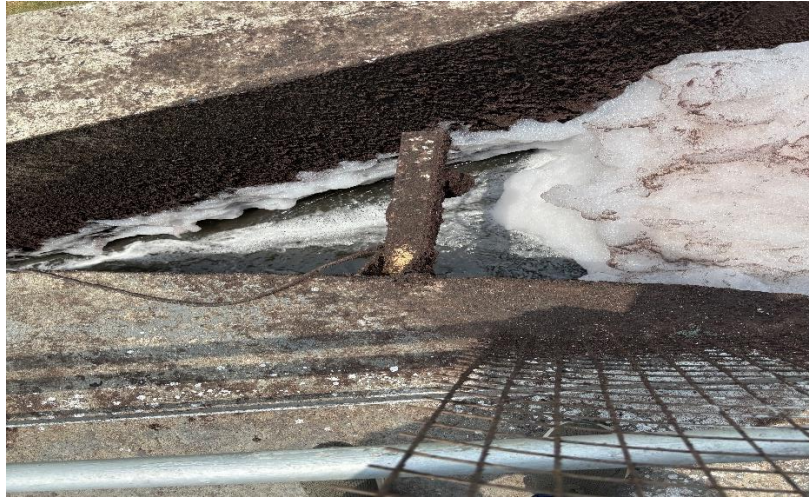
- The foaming in the Parshall flume is affecting the flow measurement at the plant inlet. The concessionaire has been instructed to provide remedial measures to arrest the foaming at the units affecting the field instrument measurements. The concessionaire has been advised to provide de-foaming agent dosing at the inlet to the plant and affected units. Also, it has been observed, the concessionaire is not doing any periodic maintenance and cleaning of the sensors as evident from the picture below.

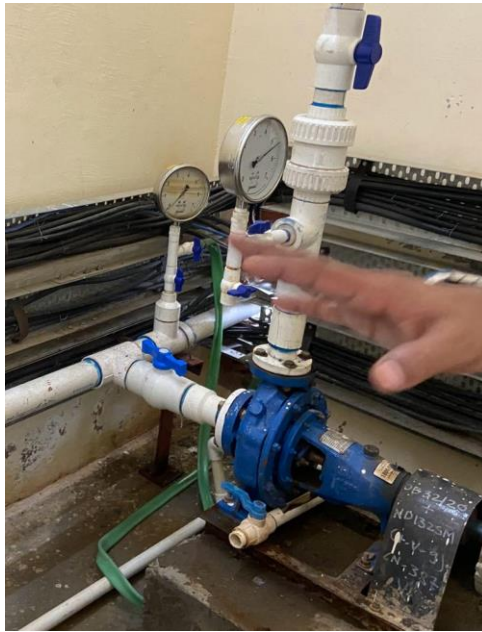
- The pressure gauges installed at the chlorinators are not functioning properly and need to be attended for rectification. Further the leakage of glycerin is observed in some of the pressure gauges.

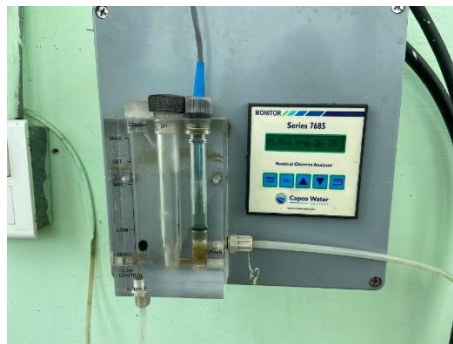
- The On-line Chlorine Analyzer does not show the correct residual chlorine values. The values were also checked using reagent but the values do not match. The analyzer needs to be calibrated.

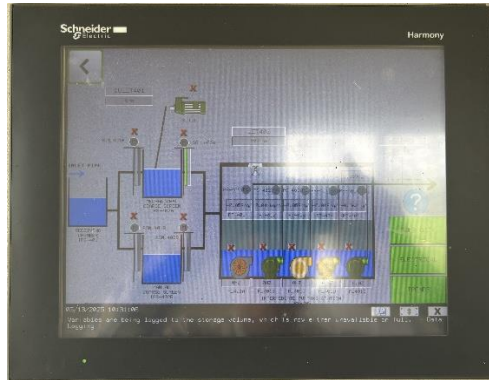
- The PLC-HMI system is not functional in any of the Intermediate pumping stations as evident from the picture below:

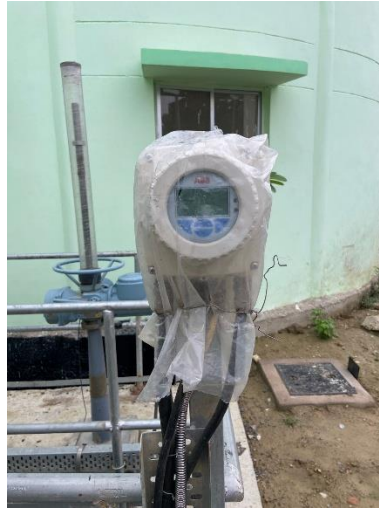
- The concessionaire has been instructed several times during the site visits, but still the Canopy for weather protection of field instruments has not yet been provided. The instruments have been covered with polythene.

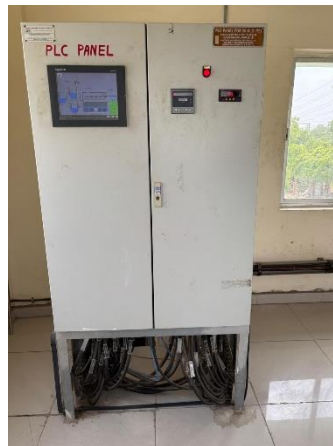
- PLC panel has been raised by 500 mm above the finished floor level, but the cable termination below the panel has not yet been covered.
